May 24, 2004

Subject: Notice of Intent to Enforce dated April 30, 2004, received May 5, 2004
Springfield Street School Complex, Case 99-018

TITLE: **PHOTOGRAPHS OF EROSION CONTROL REPAIRS**

LOCATION:
SPRINGFIELD STREET SCHOOL COMPLEX
SPRINGFIELD STREET
PROVIDENCE, RHODE ISLAND

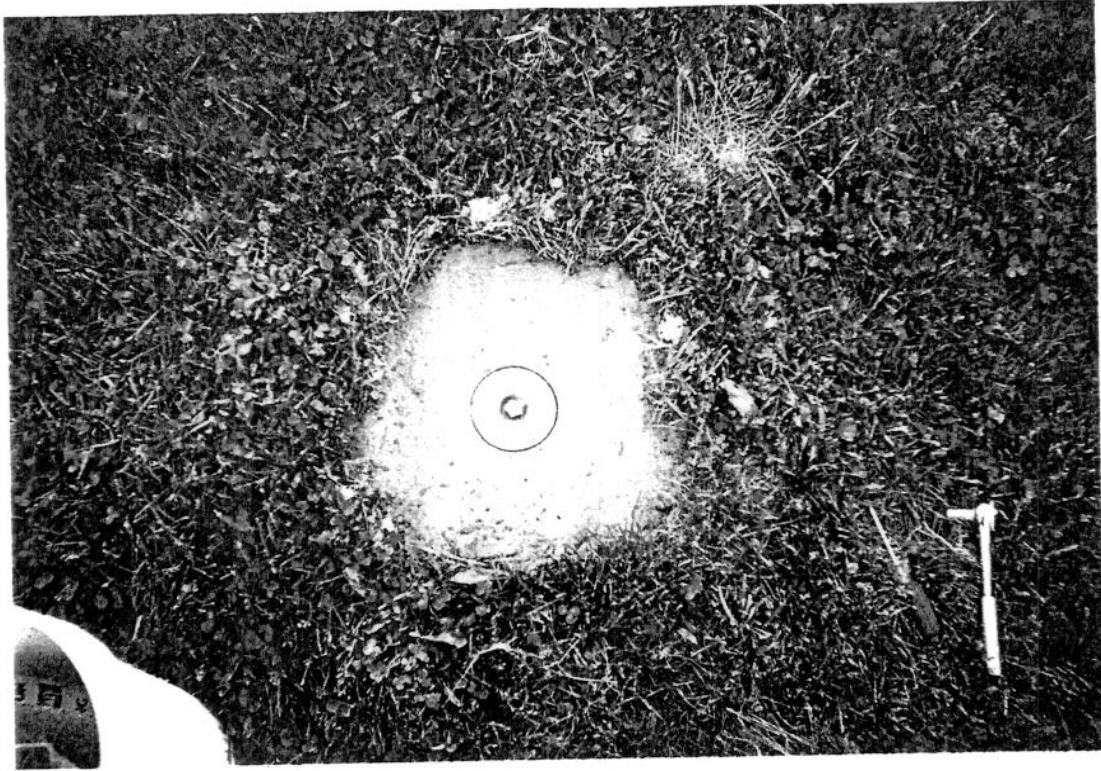
Monitoring Well ATC-3 after repairs

- a) All monitoring wells were inspected and repaired by May 14, 2004. Photographs of wells which were repaired by installing new protective road boxes are attached. Some other wells were repaired by replacing missing gripper caps or bolts, or removing debris. Wells MPL-3 and WB-3 which were noted as damaged during the January monitoring event have been repaired.

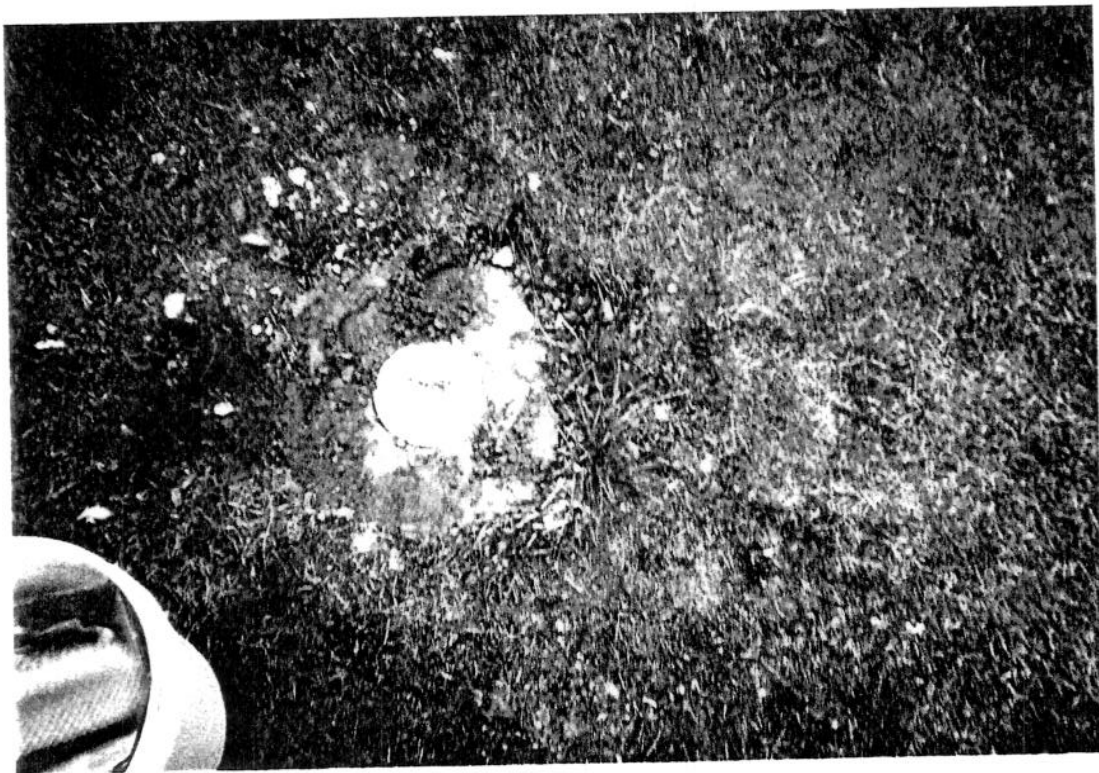
Monitoring Well ATC-4 after repairs

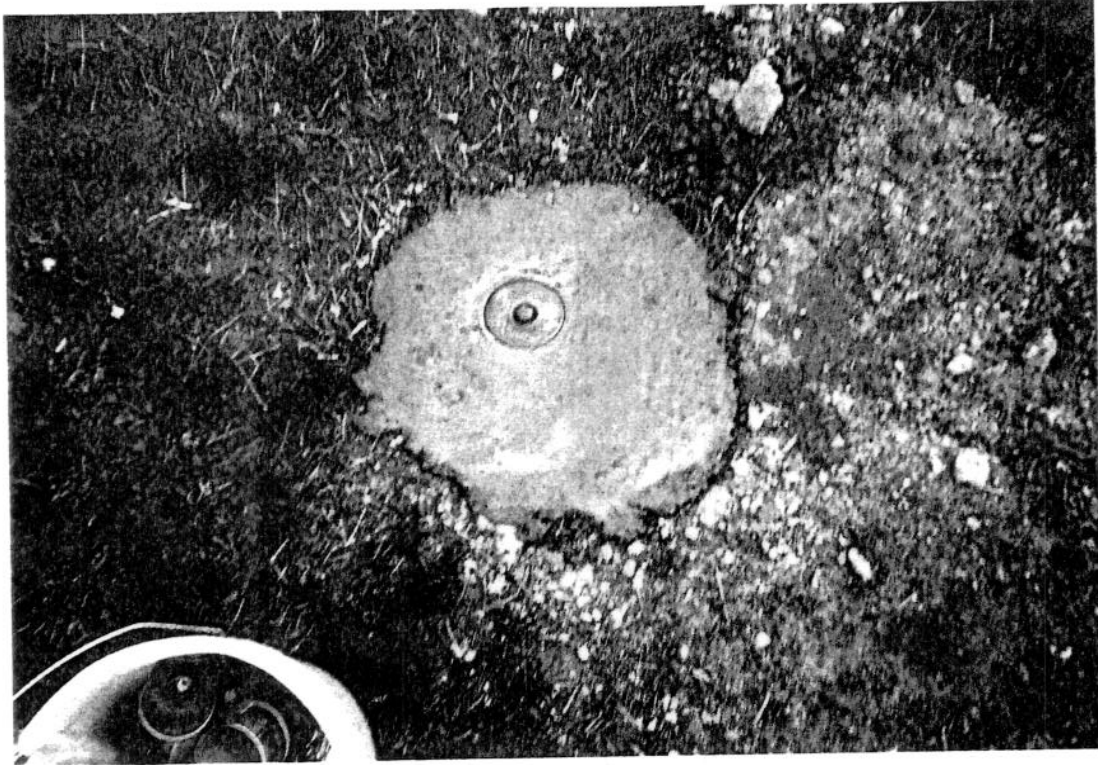
Monitoring Well WB-5 after repairs

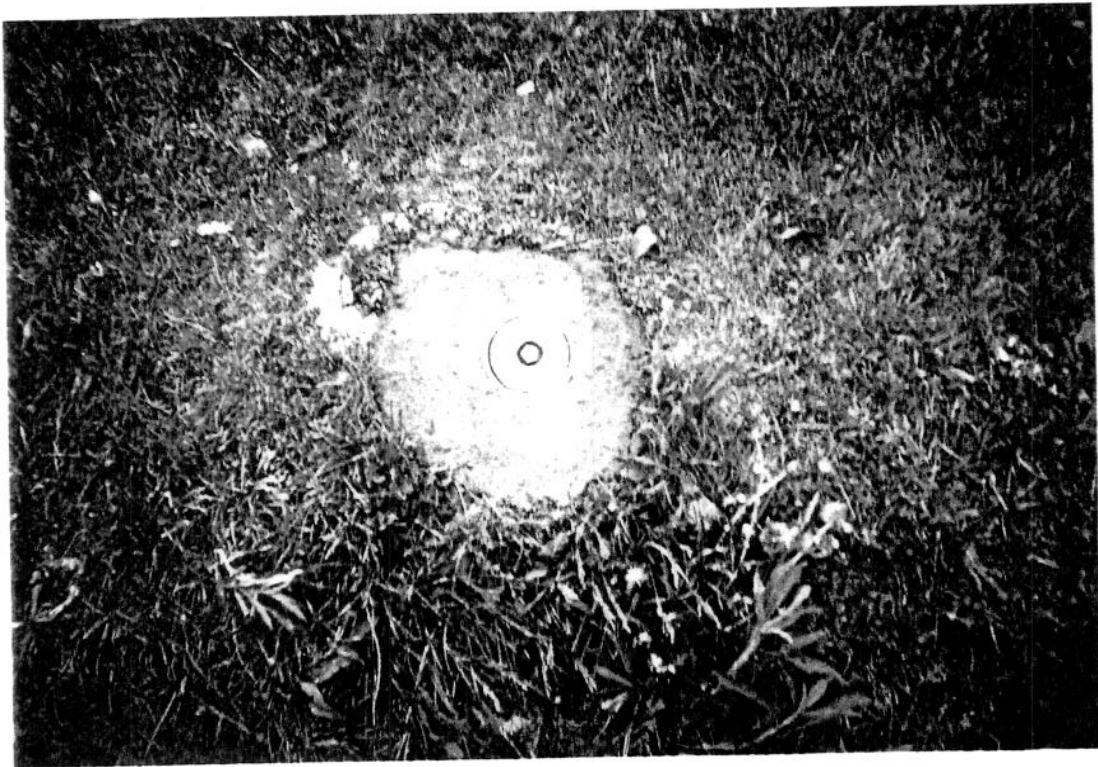
Monitoring Well WB-13 after repairs

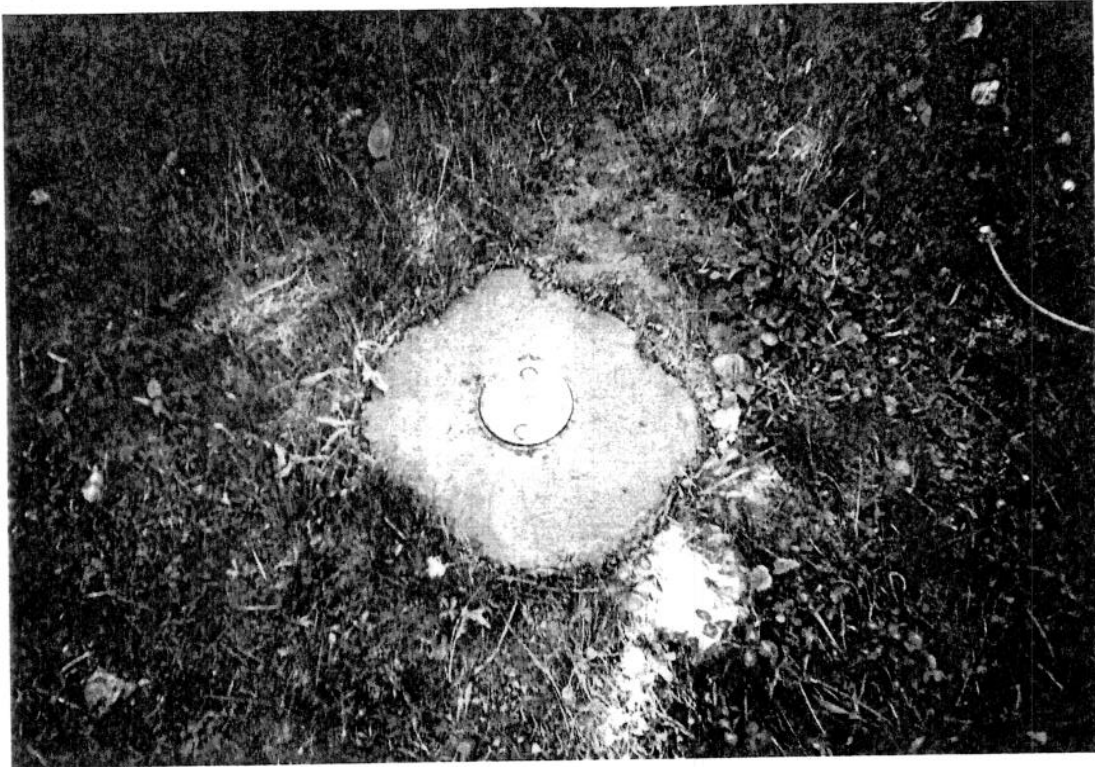
Monitoring Well WB-14 after repairs

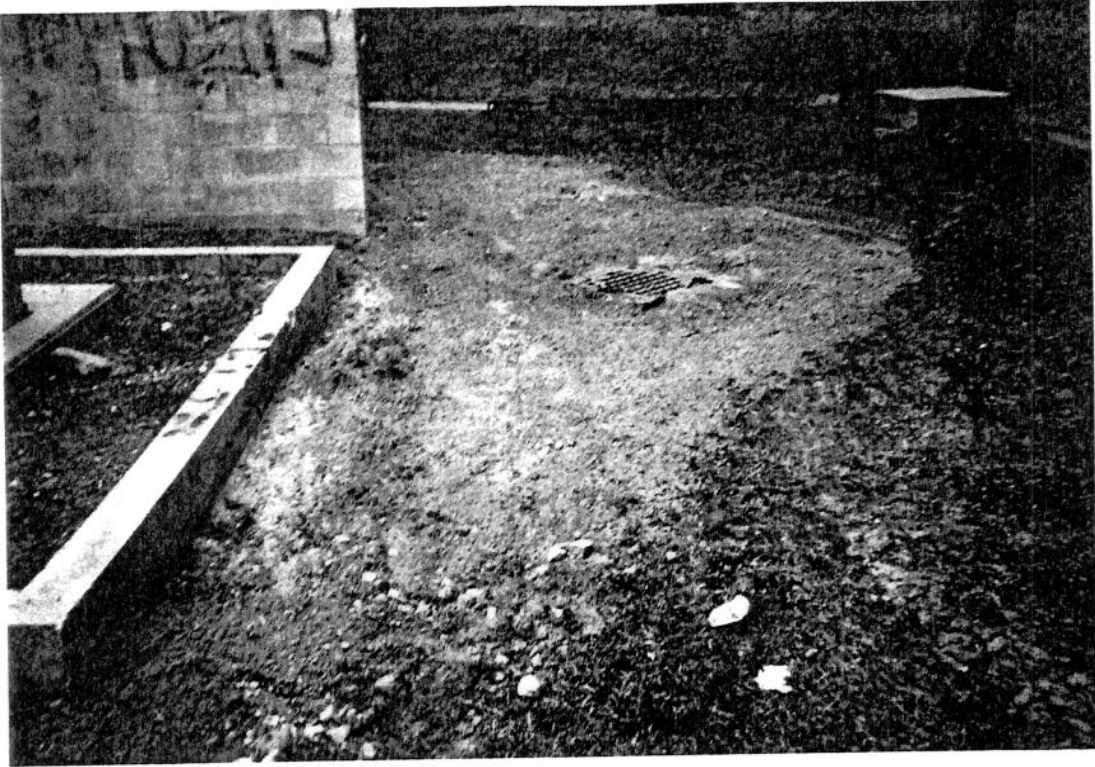
Photograph 1: Catch basin near back corner of middle school, adjacent to utility area

- b) Settled and eroded areas were repaired on May 13, 2004. Photographs taken on May 14, 2004 showing the repaired areas are attached along with a map showing the locations of the repairs.

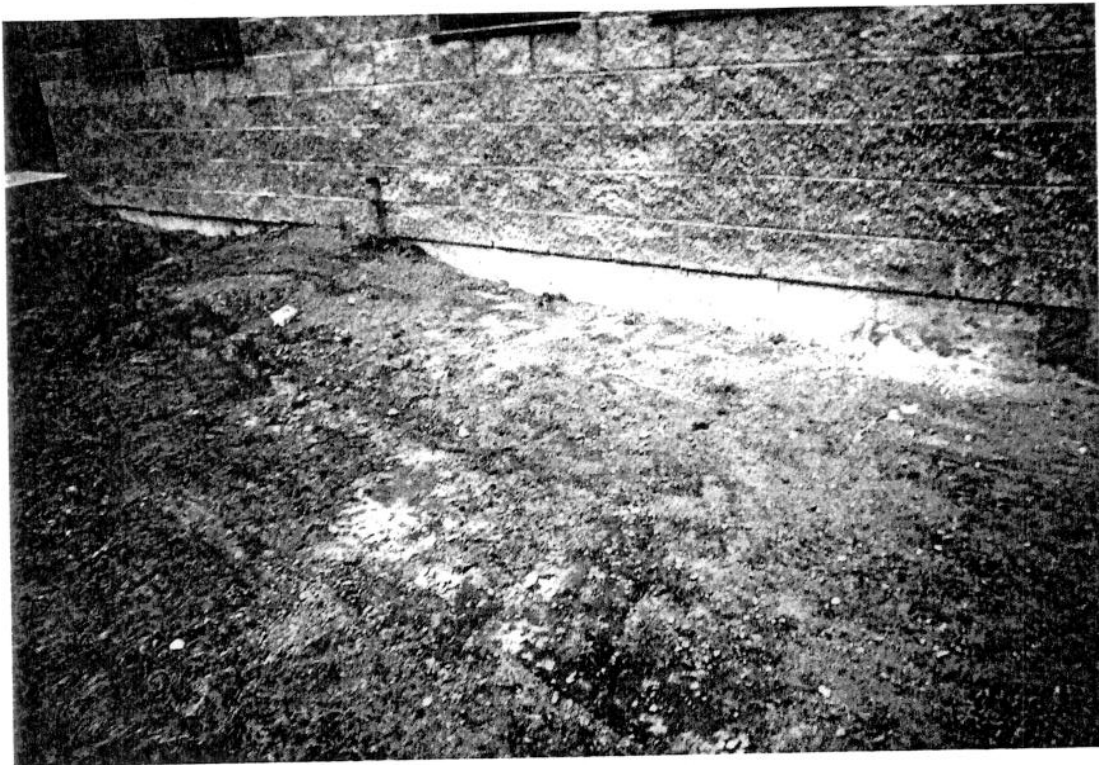
Photograph 2. Southwestern wall of middle school near utility area

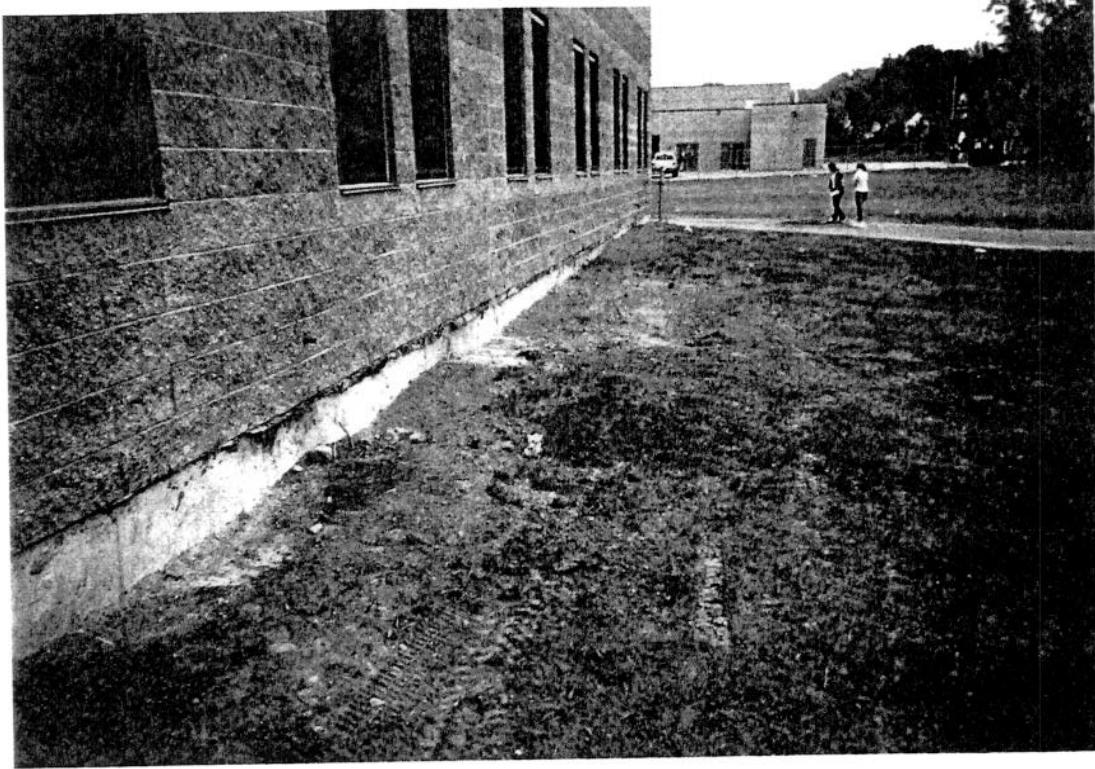
Photograph 3, southwest wall of middle school near utility area

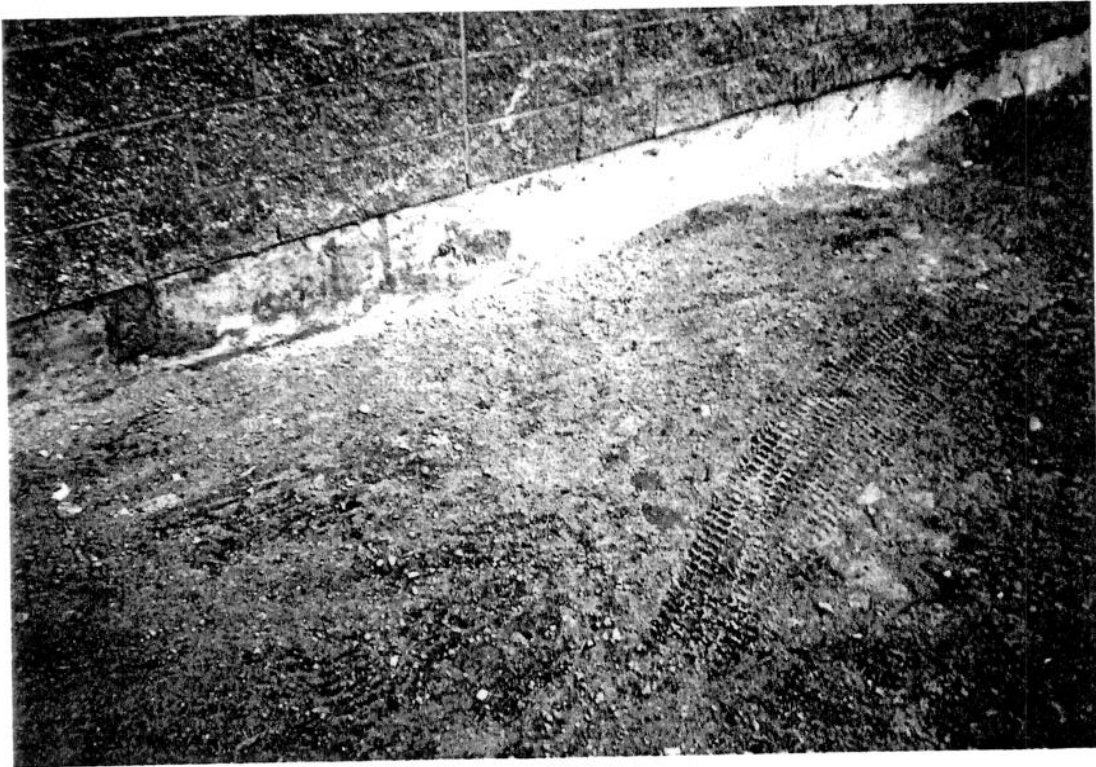
Photograph 4. South wall of middle school near utility area

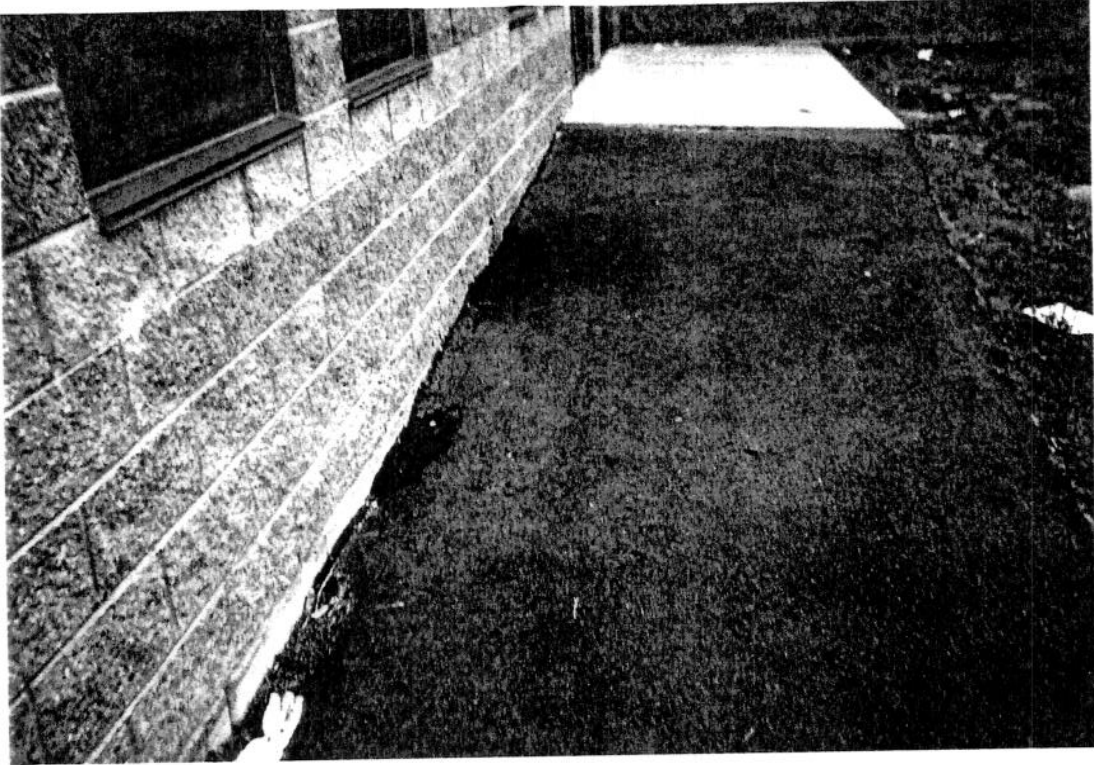
Photograph 5. South wall of middle school near door to outside

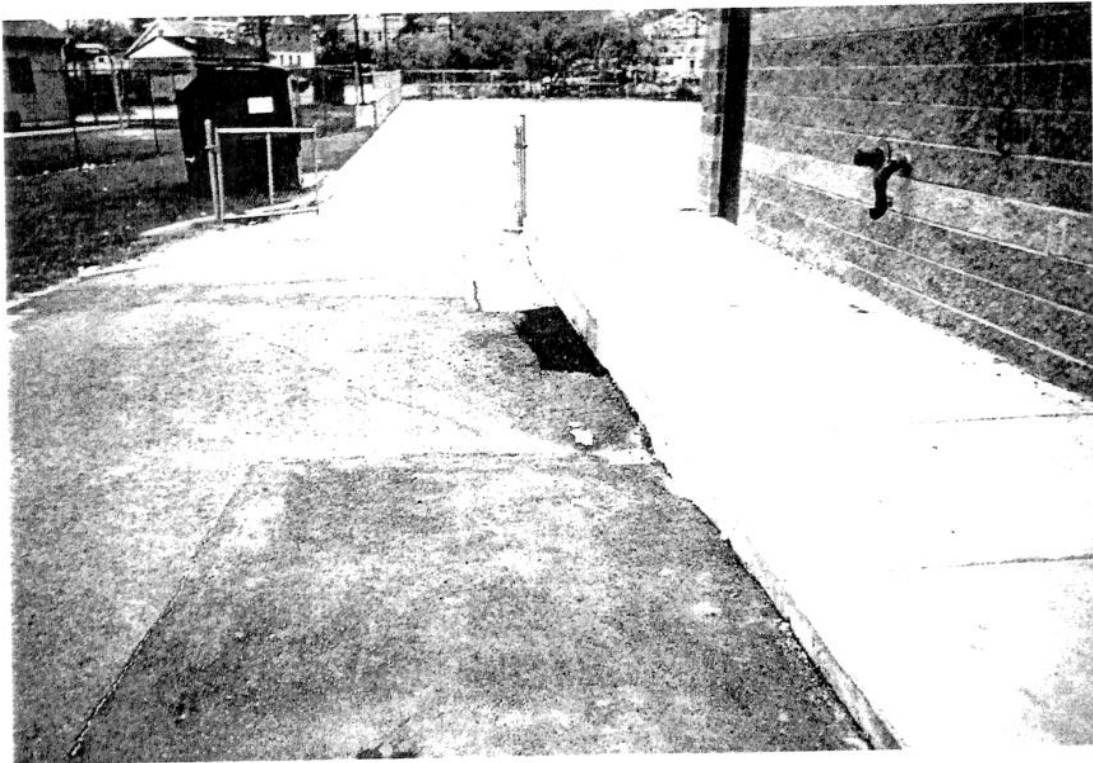
Photograph 6. Northwest wall of middle school gym

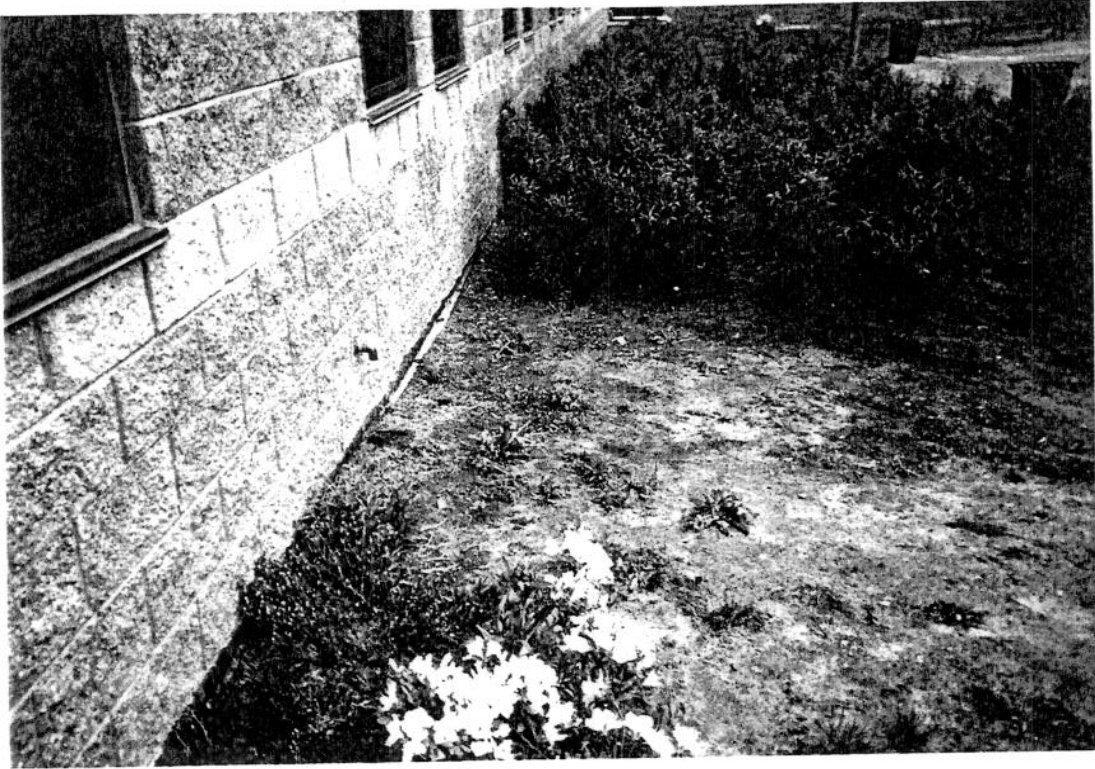
Photograph 7. Eastern wall of middle school courtyard

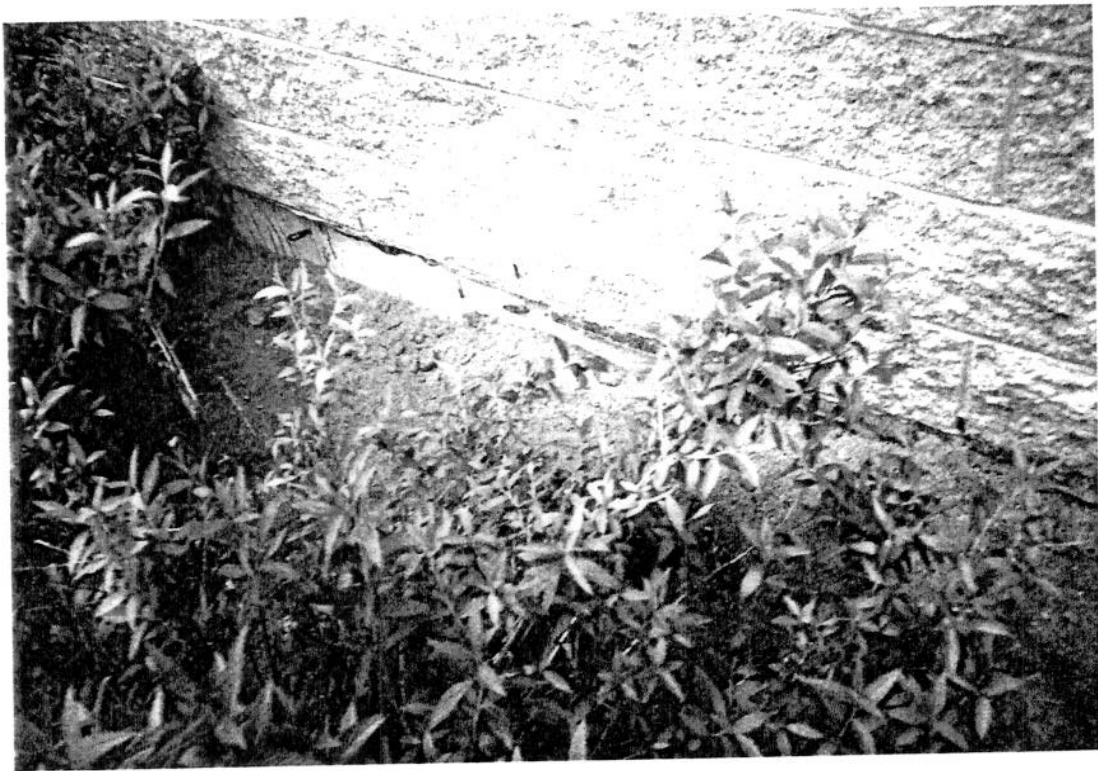
Photograph 8. Eastern wall of middle school courtyard

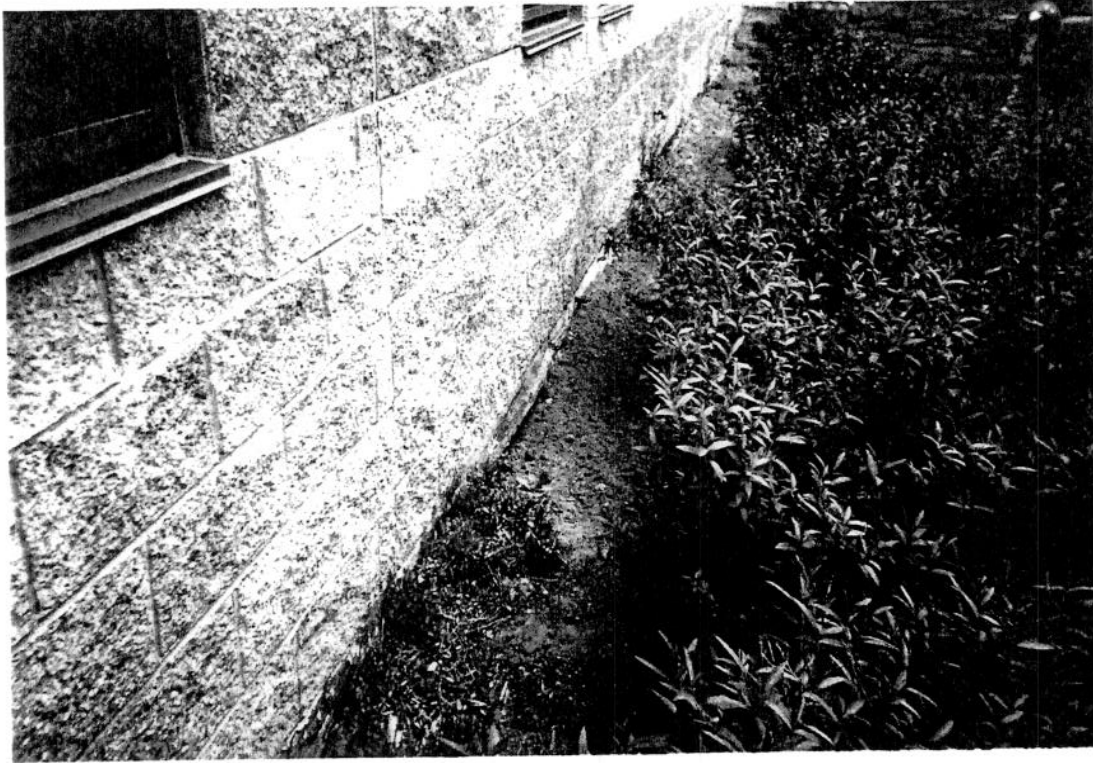
Photograph 9. Eastern wall of middle school courtyard

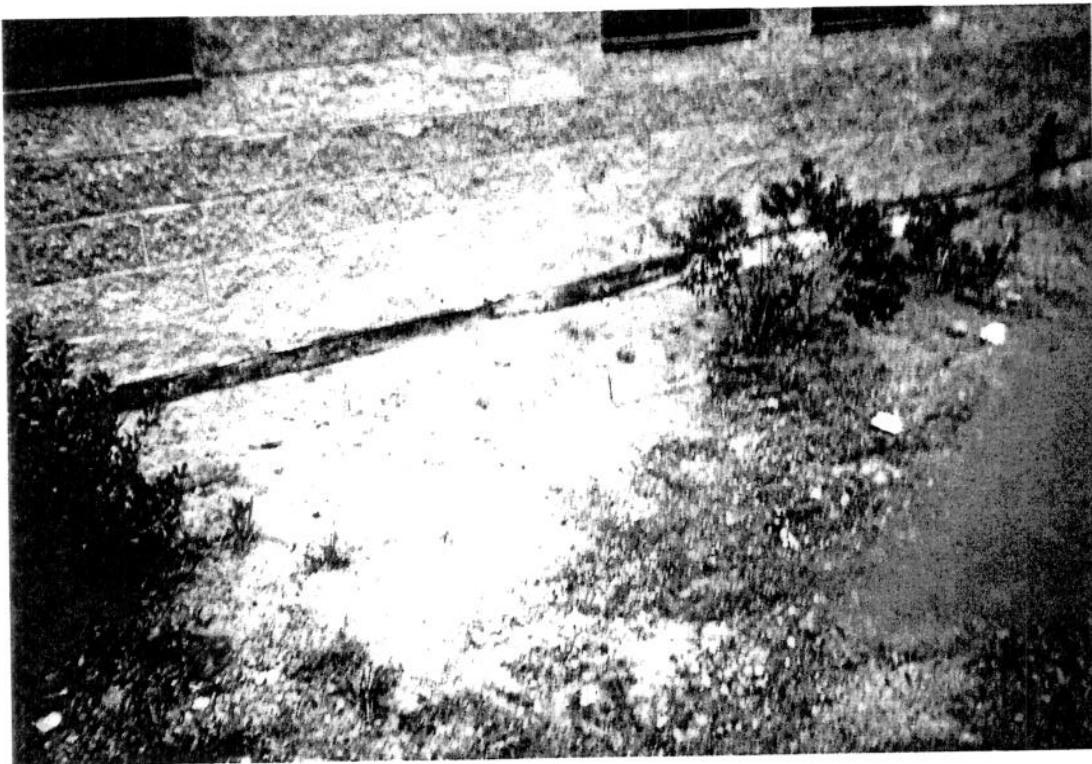
Photograph 10. Eastern wall of middle school courtyard

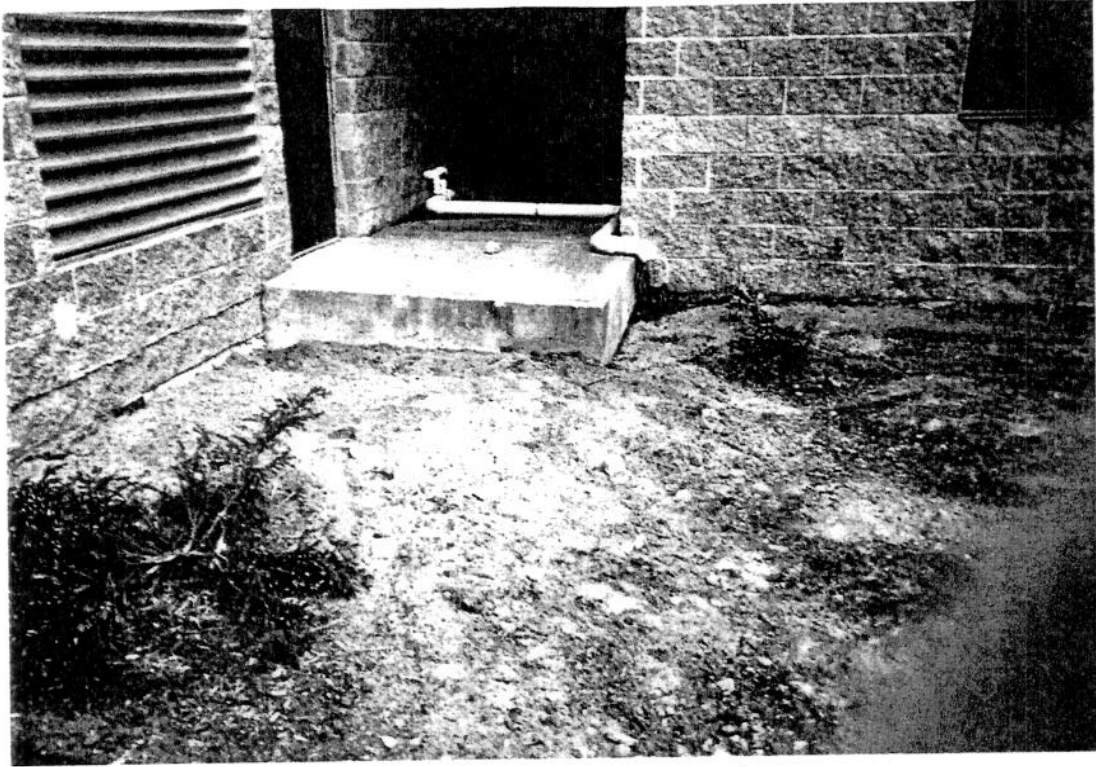
Photograph 11. Southeastern corner of middle school courtyard

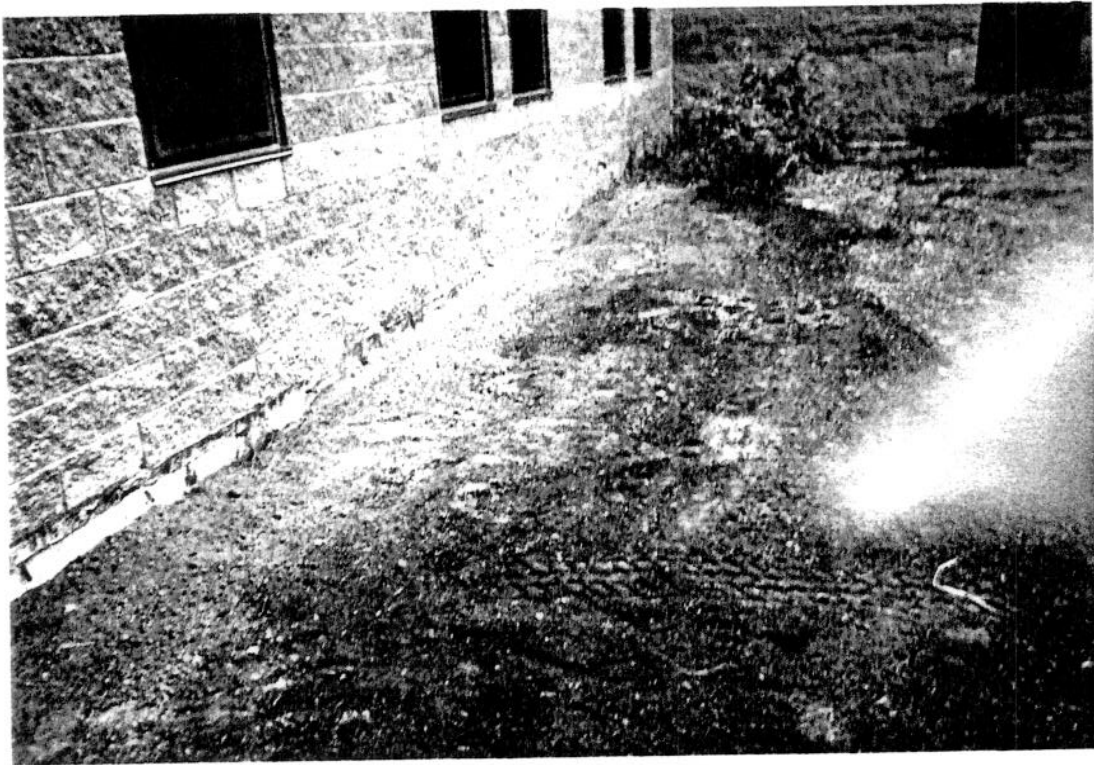
Photograph 12. South wall of middle school courtyard

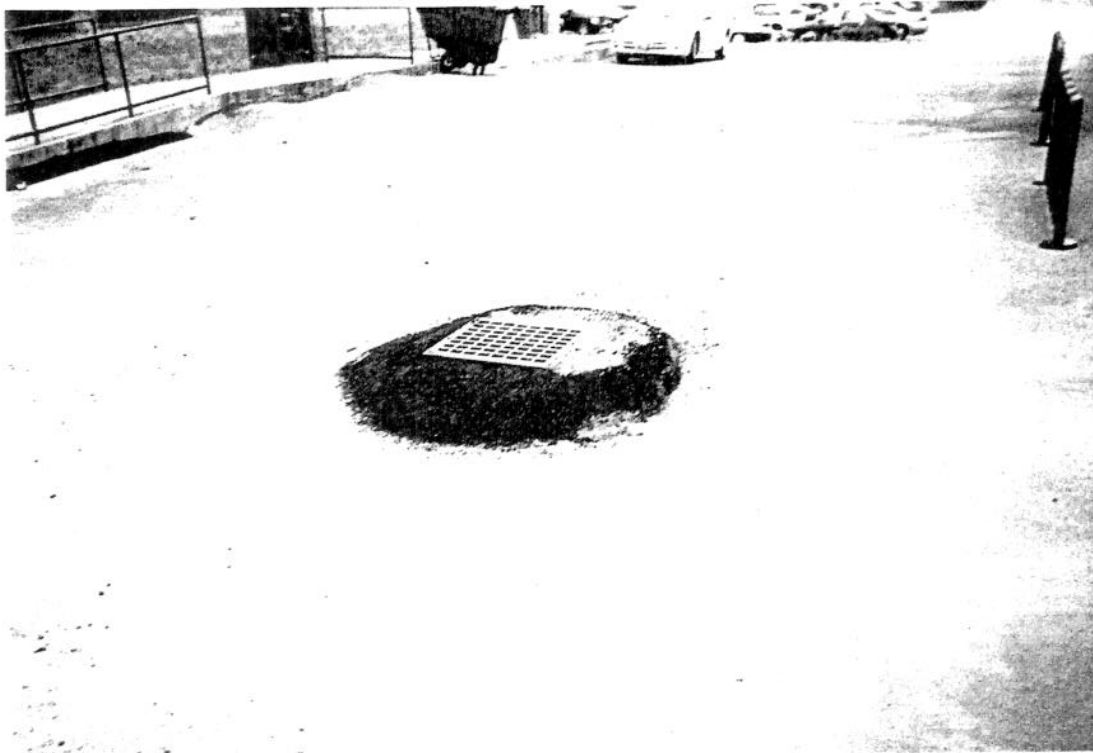
Photograph 13. Catch basin in center of middle school courtyard

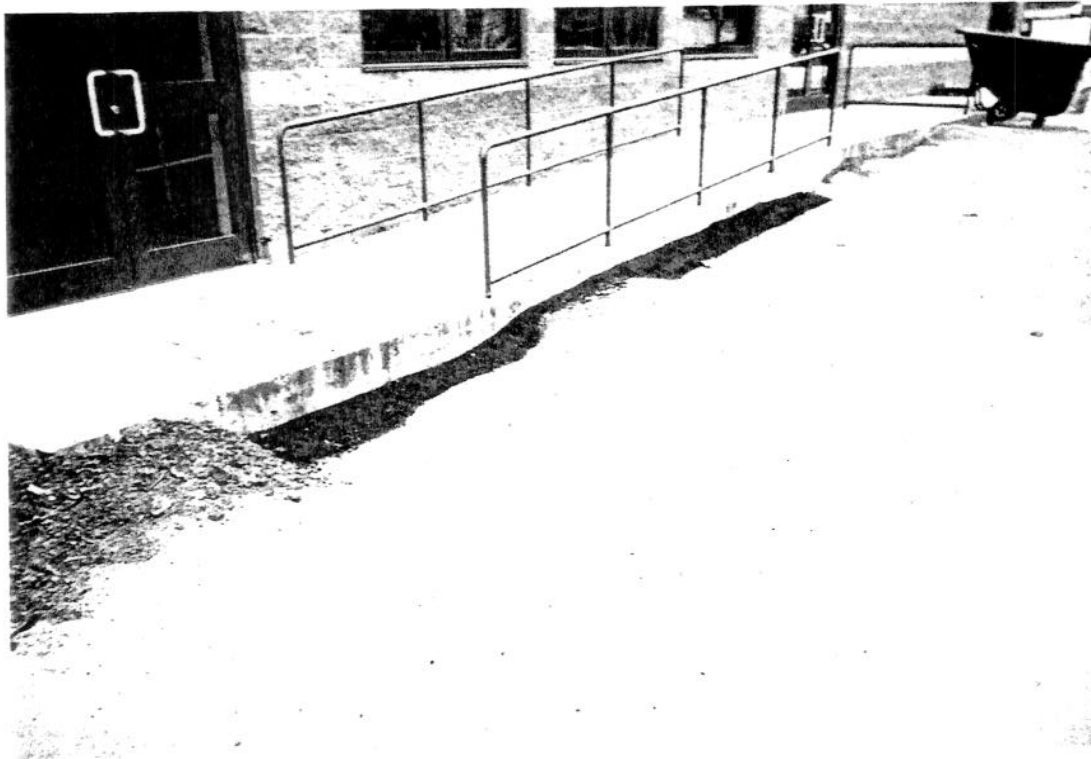
Photograph 14. Northwest wall of middle school courtyard
