Field Inspection Report

September 27, 2006
Anthony Carnevale Elementary School
Christopher Del Sesto Middle School
Springfield Street, Providence R.I.

RE: RIDEM Office of Waste Management
2006 Inspection of exterior cap and grounds of the elementary and middle school property
(approx. 9:50 am- 10:40 am)

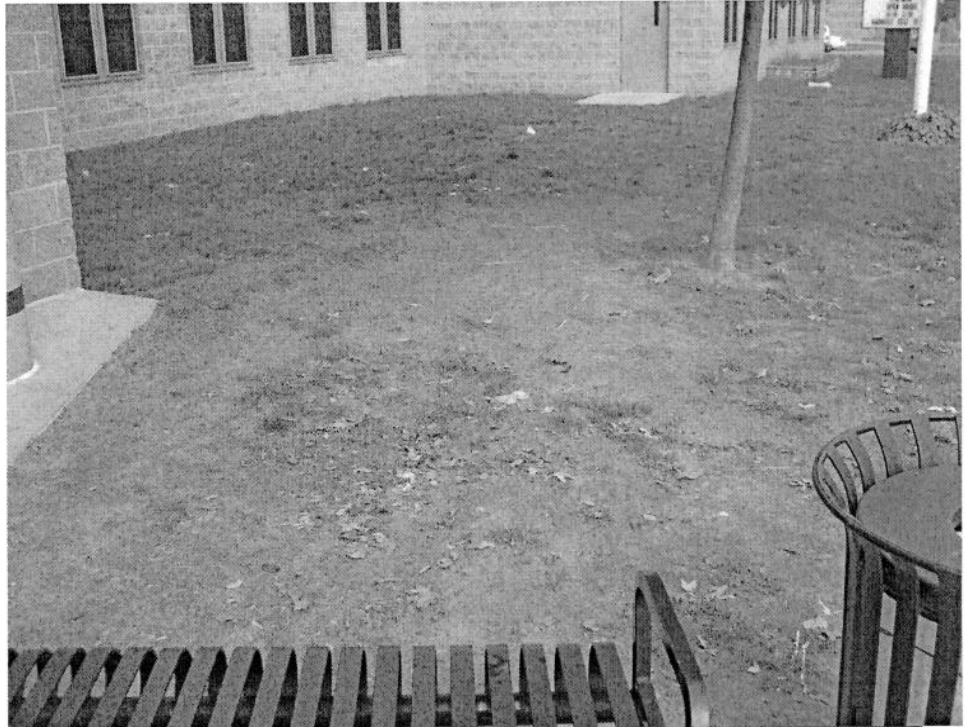
1

At the entrance to the elementary school, there is evidence of exposed surface soil where the lawn has been worn away on the north side of the entrance (Photo#1). Proceeding along the concrete walkway north, most of the lawn area is satisfactory, however barren spots are visible where the grass has worn away or failed to grow. The north parking lot asphalt surface appears to be satisfactory and along the edge of the building, asphalt patching has been used to fill in a small area. Near the mechanical room on the northwest corner, there are two cracks in the asphalt that should be repaired with liquid asphalt filler (Photo #2). The equipment in the mechanical room was running at the time of my inspection. The grass hill area located outside of the mechanical room near the monitoring well shows some signs of wear (Photo#3). The asphalt on the west side of the mechanical room had a small depressed area with 2 inches of standing water (Photo #4).

Bare exposed soil outside elementary school front entrance

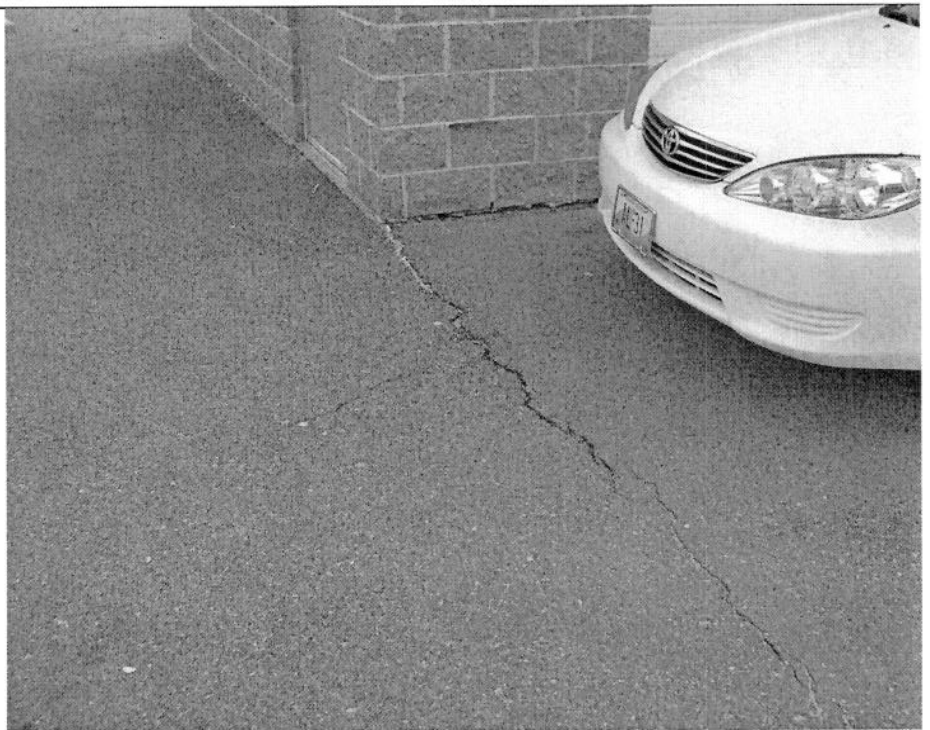
2

Crack in asphalt surface outside of mechanical room of elementary school

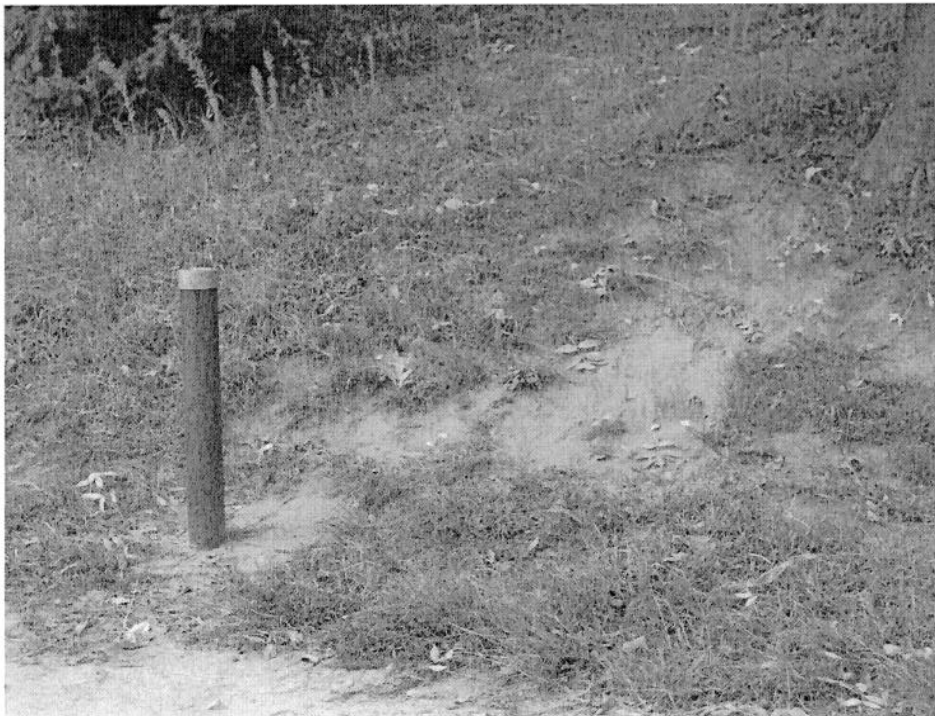
3

Exposed Soil near monitoring well outside mechanical room of elementary school

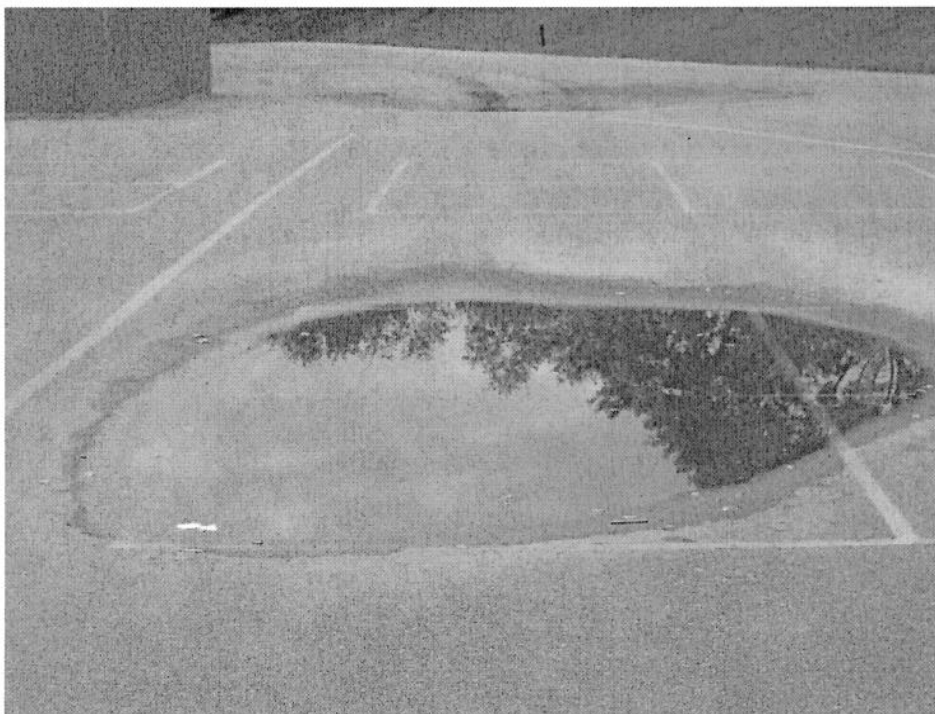
4

Depression with standing water in rear parking lot of elementary school

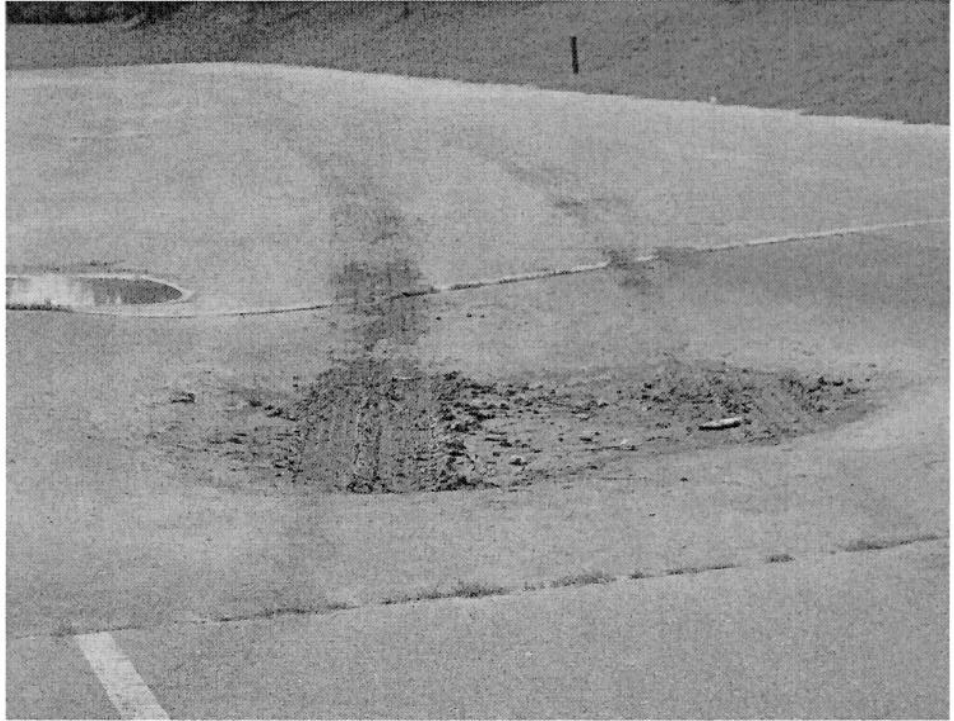
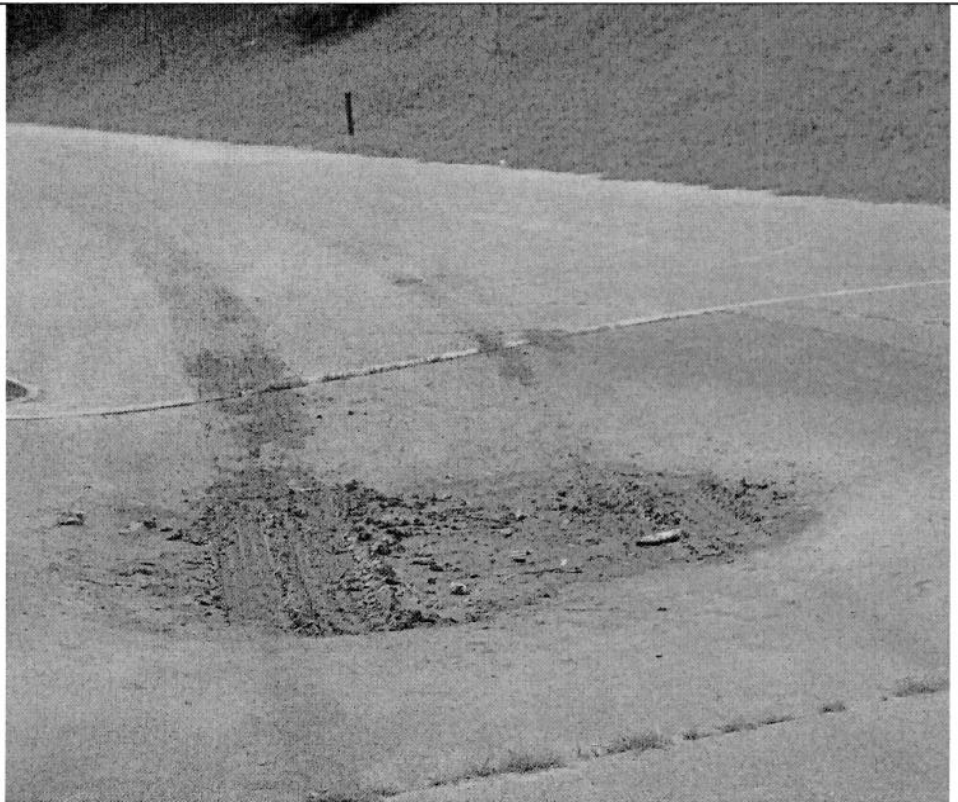
Once again and as previously reported in December 2005, at the rear of the Elementary School, (west side) there is a large depression (now approx. 20 foot x 20 foot) in the asphalt area where the asphalt surface had been previously cut and repaired by the City (Photos #5 and#6). This depression has gotten worse and there was evidence of someone driving through the depression. It does not appear any effort has been made to correct this problem since the December 2005 inspection. The asphalt has not broken through exposing the waste material below and there is no evidence of the orange marker barrier, however it appears to be only a matter of time. This needs to be put on an immediate repair schedule. There is a small depression near the storm drain on the south west side of the elementary school (Photo# 7).

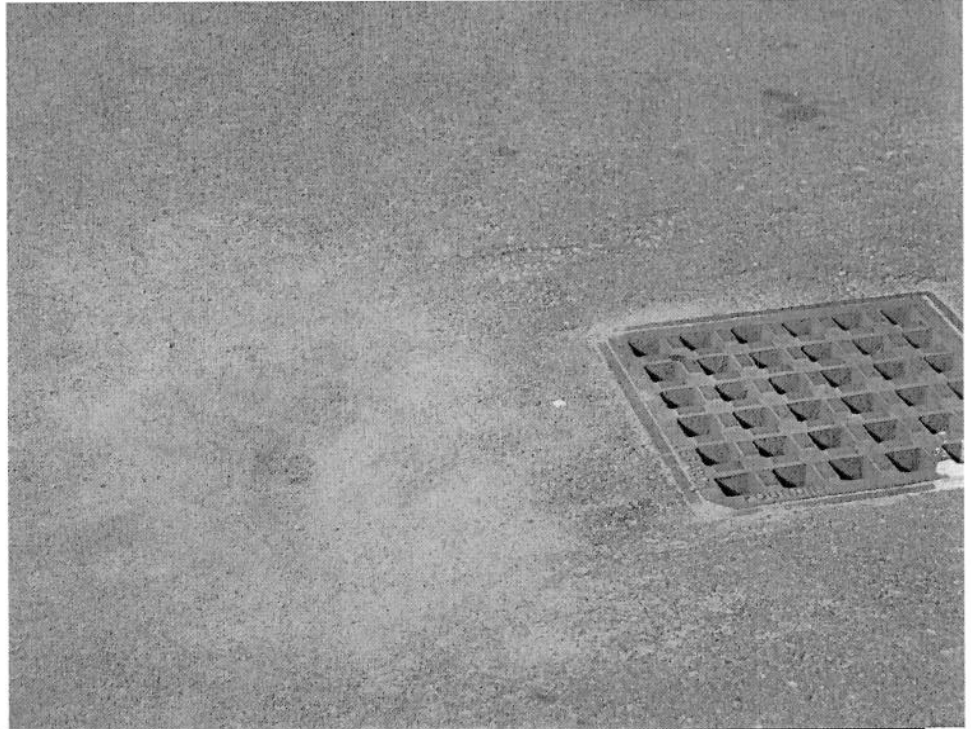
7

Small depression in rear parking lot of elementary school near storm water drain

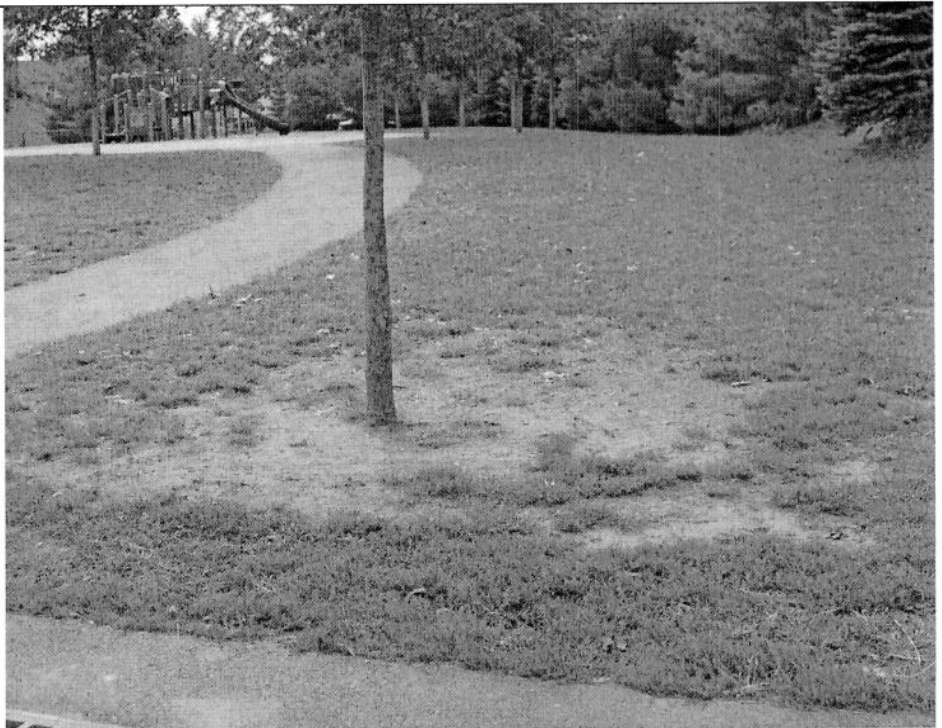
8

Bare soil in southwest corner of rear parking lot of elementary school near playground

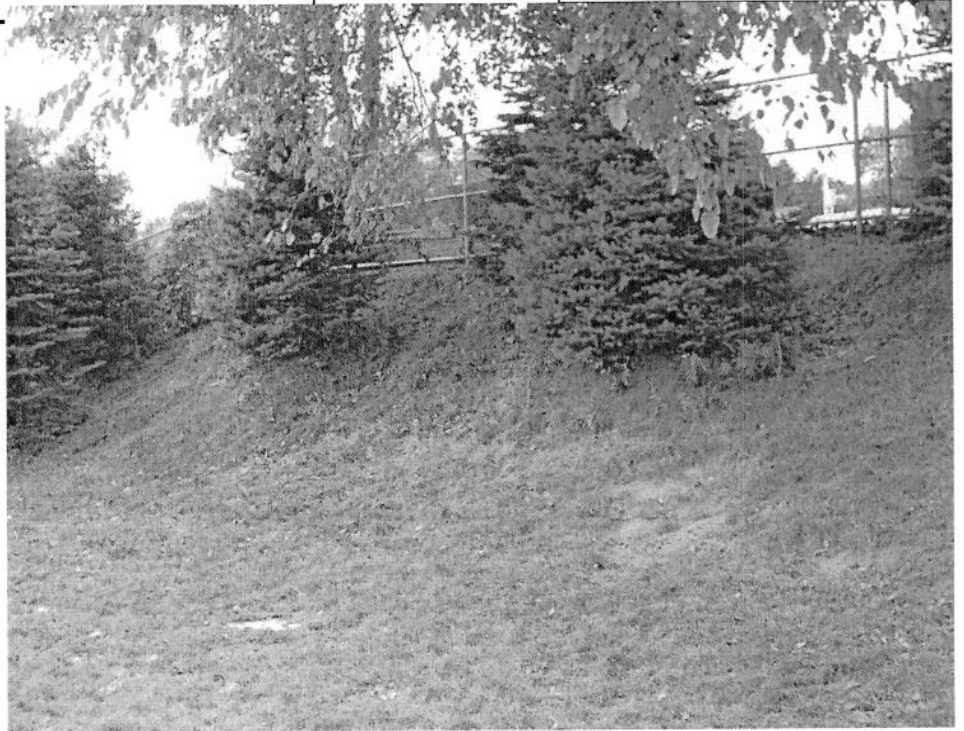
Description:
Bare soil along hill near playground on the south end of the school

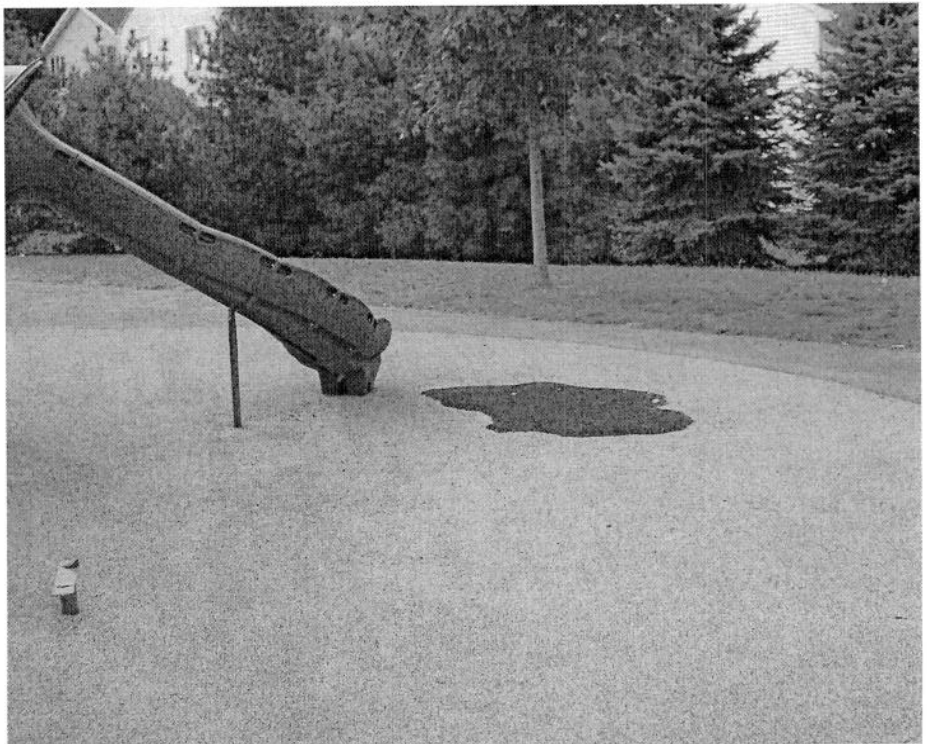
On the south side of the elementary school, there is a lawn and hill area and an adjoining playground (Photos #8, 9 and 11). The lawn has some random brown spots where it is evident that the grass is worn or failed to grow. The only observed damage to the cap in this area is at the base of the slide (Photo #10). The playground topcoat (asphalt/rubberized surface appears to be worn in this area and require some cosmetic repair.

Description:
Worn surface at the base of the slide on the south playground

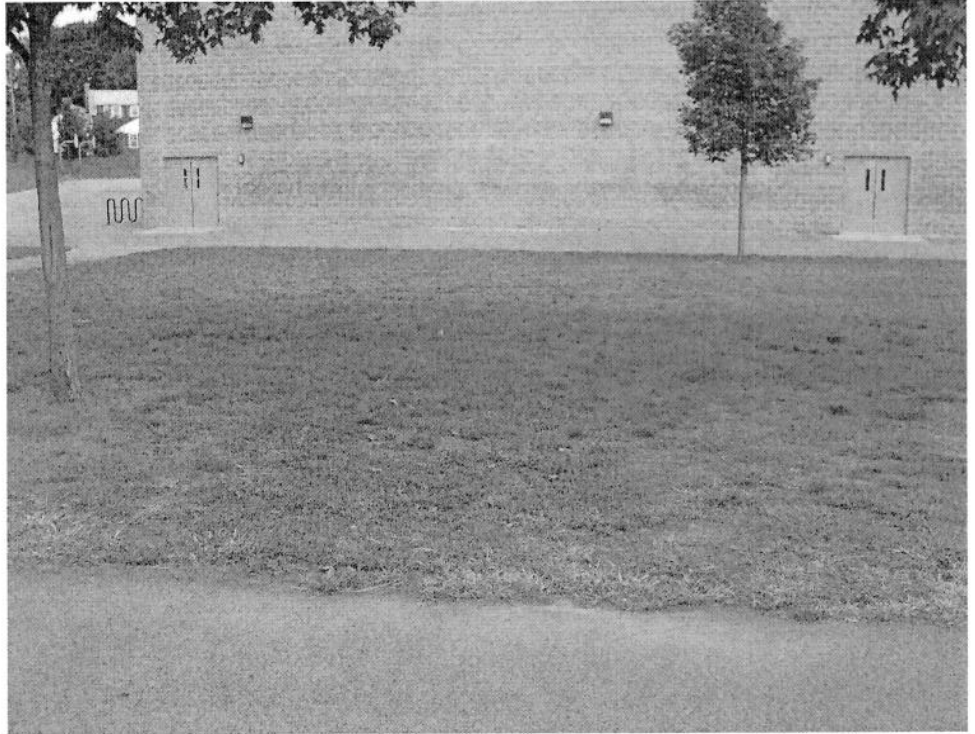
11

Bare soil in lawn area near playground on the south end of the school

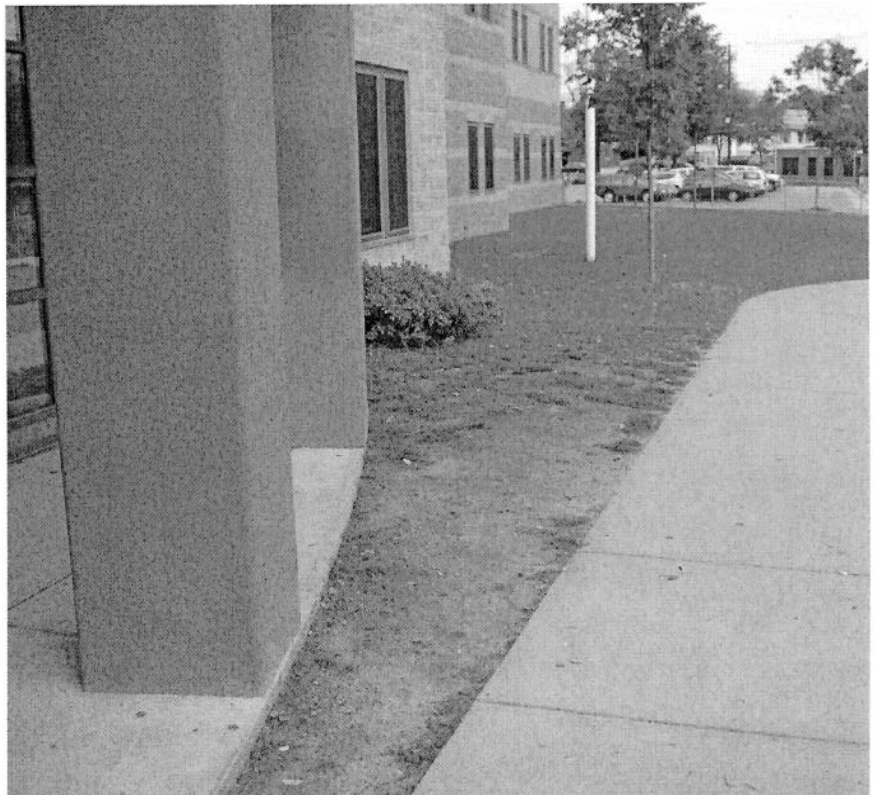
12

The grass on the north side of the main entrance appears to have exposed surface soil along with some brown spots where the grass has either worn out or failed to grow (Photos #12 and 13). On the north side of the middle school building and near the faculty parking lot, there are some areas of exposed soils near the building exits #18 and #19 (Photo #14). As previously reported, in the courtyard on the north end of the building standing water and asphalt patching is present around the storm drain that is need of a major repair (Photos #15 and 16). There are some cracks visible, but no evidence of the underlying marker barrier or waste materials. Also as previously reported the handicap ramp, walkways on the north and west side have been affected by the ground settling and door's labeled #9, #10 and #11 (Photos#17-20). The equipment in the mechanical room was running.

Worn soil in front of the middle school

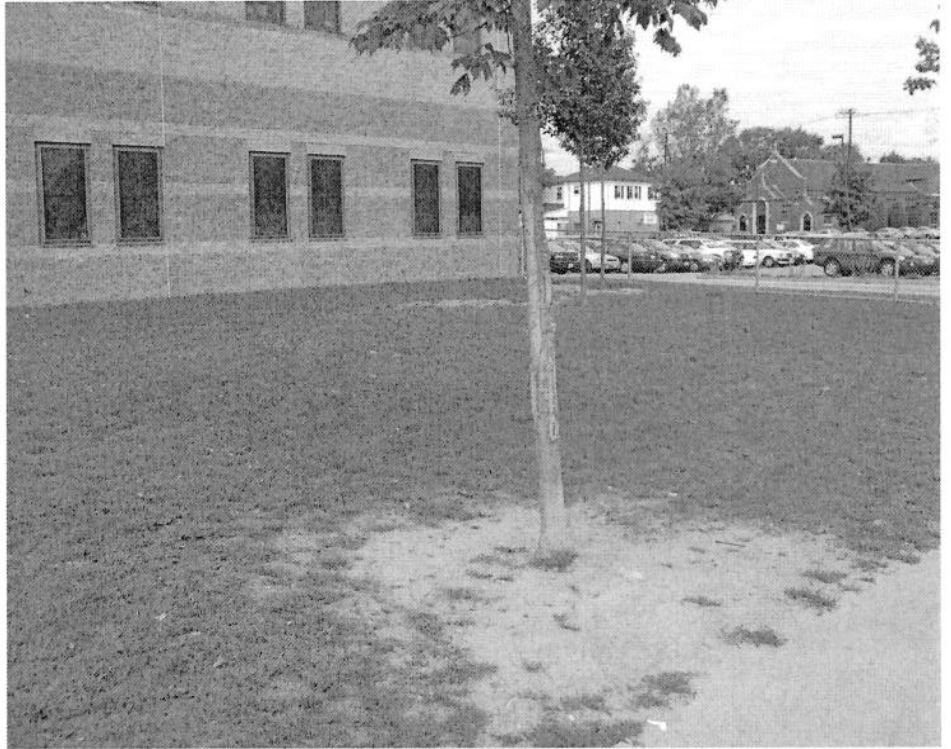
13

Bare soil in lawn area near front yard of middle school

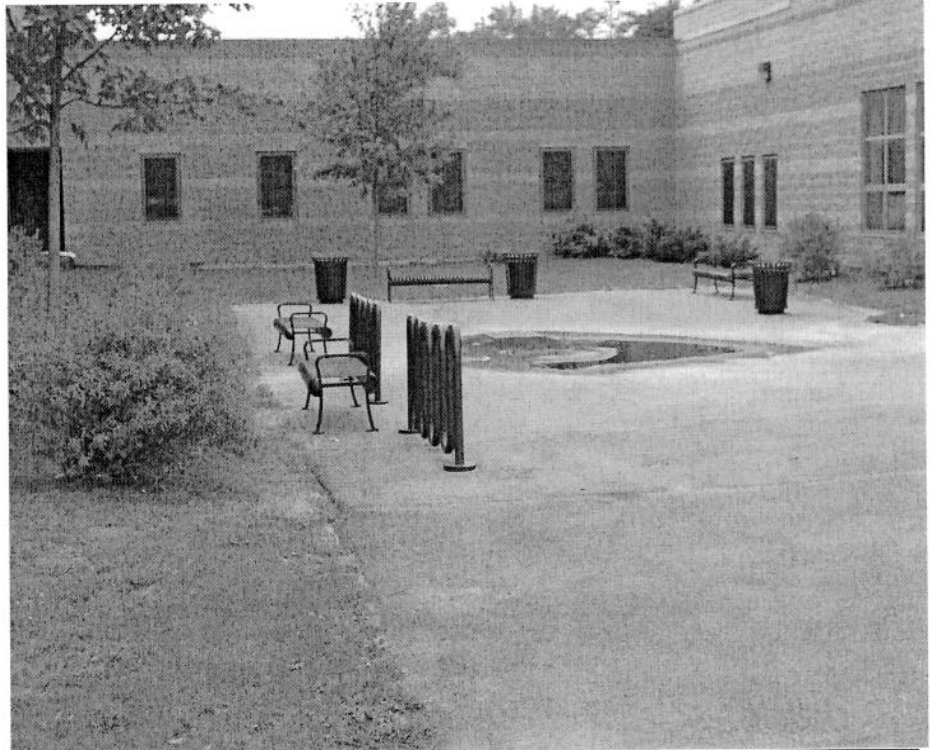
15

Court yard depression and drain on north side of middle school

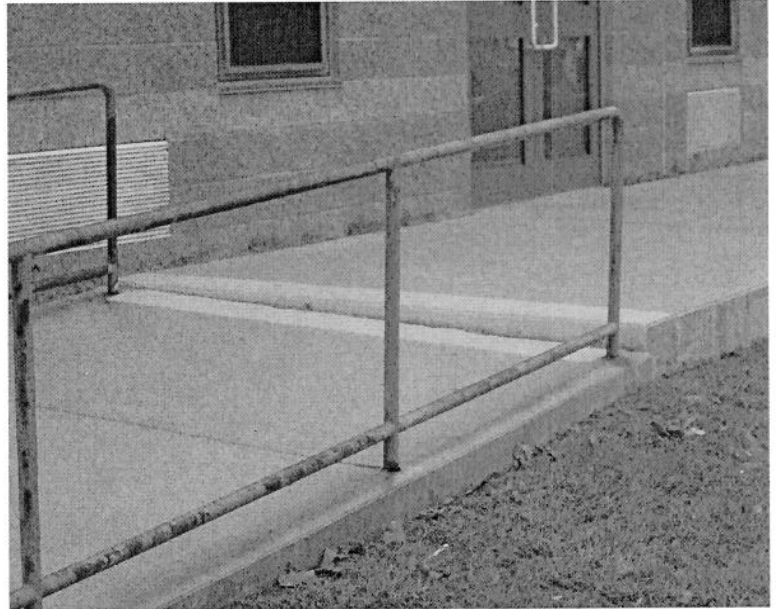
17

Handicap ramp affected by settling on the north side of middle school

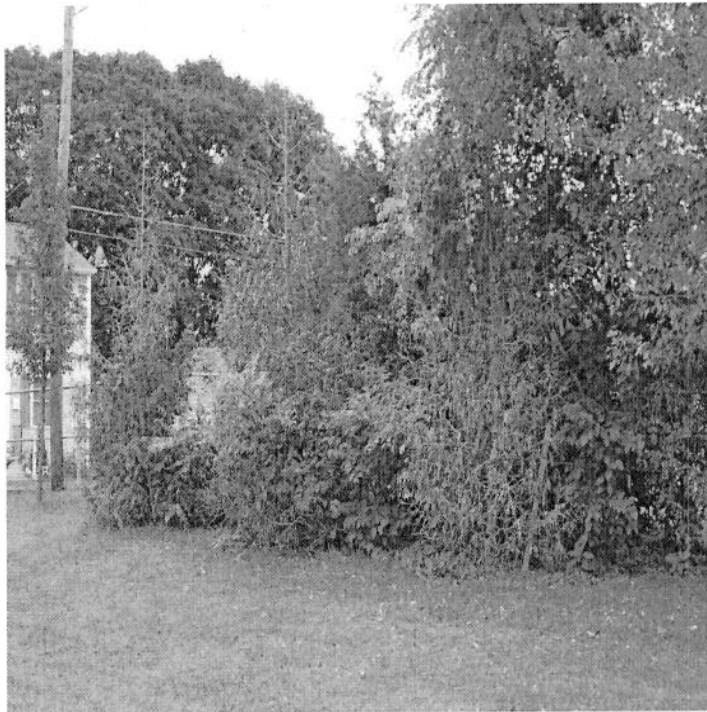
23

Three trees behind middle school that have died

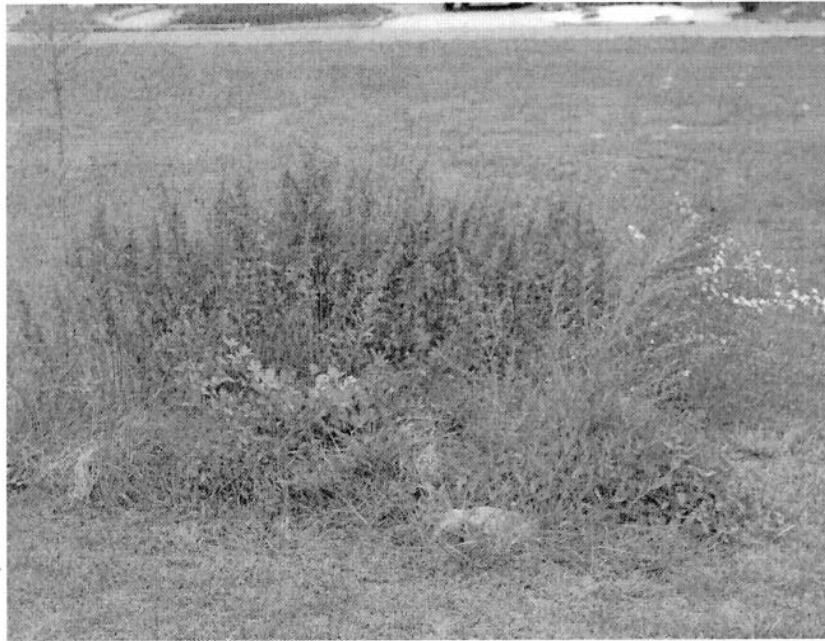
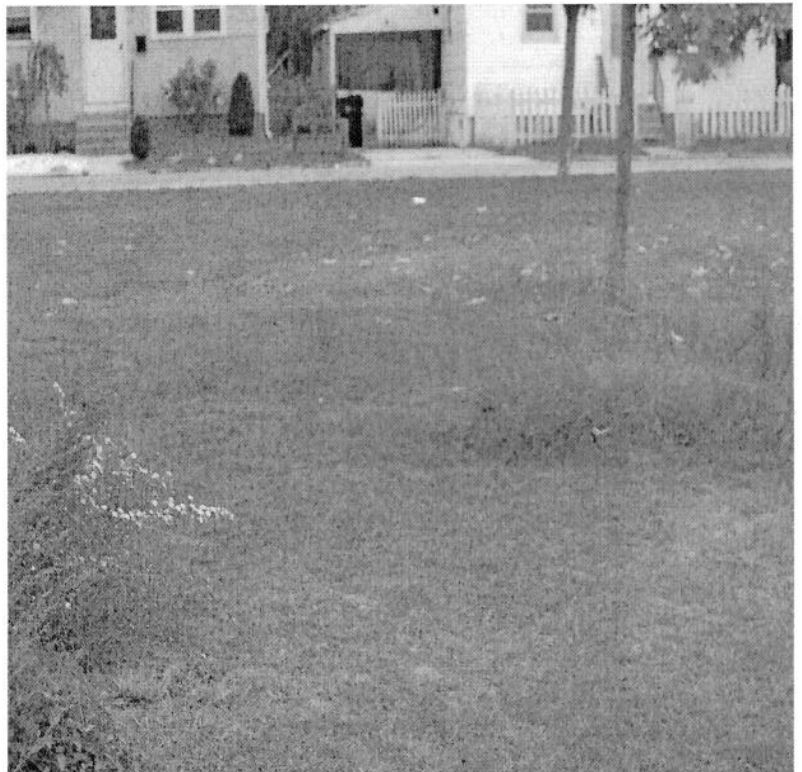
The southern lawn area is in a satisfactory state, however, some brown spots were observed there are three small raised dirt areas where previously attempts at a surface garden performed. The front lawn located south of the main entrance is in good shape (Photos # 25 and 26).
