Textron, Inc.  
Former Gorham Manufacturing Facility, Providence, RI  
Remedial Action Completion Report: Phase II Area – Mashapaug Inner Cove,  
Phase III Area – Northeast Upland And Parcel C  
Project No.: 3652160001  
February 12, 2016

**APPENDIX C**  
**PHOTOGRAPHS**

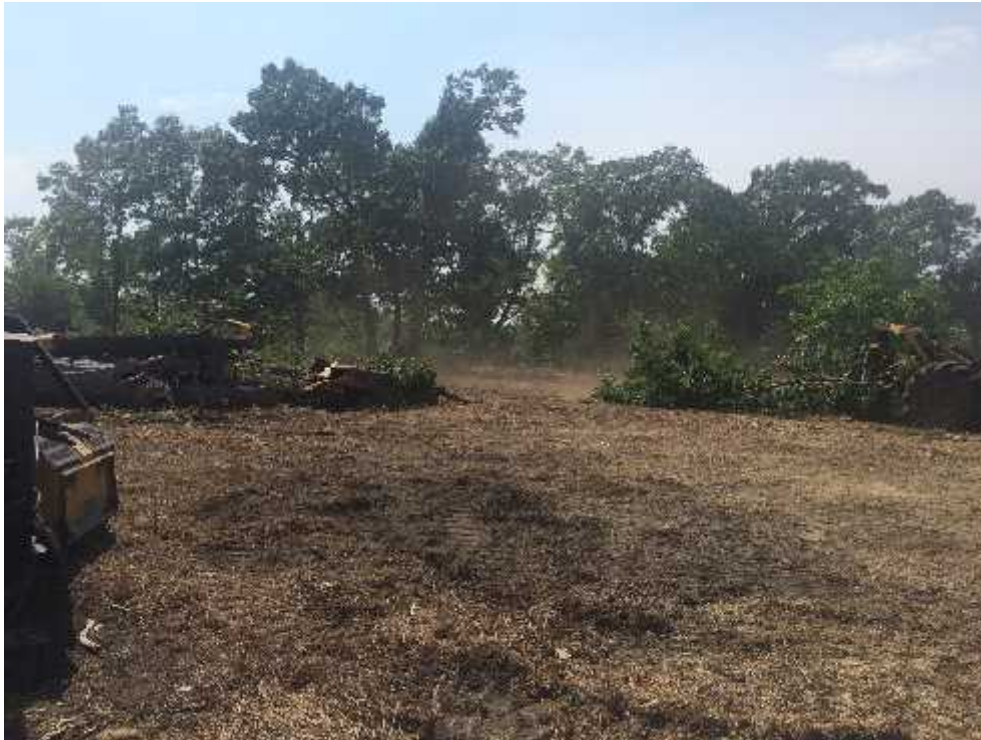
**Photo 1**  
Phase III Tree Clearing

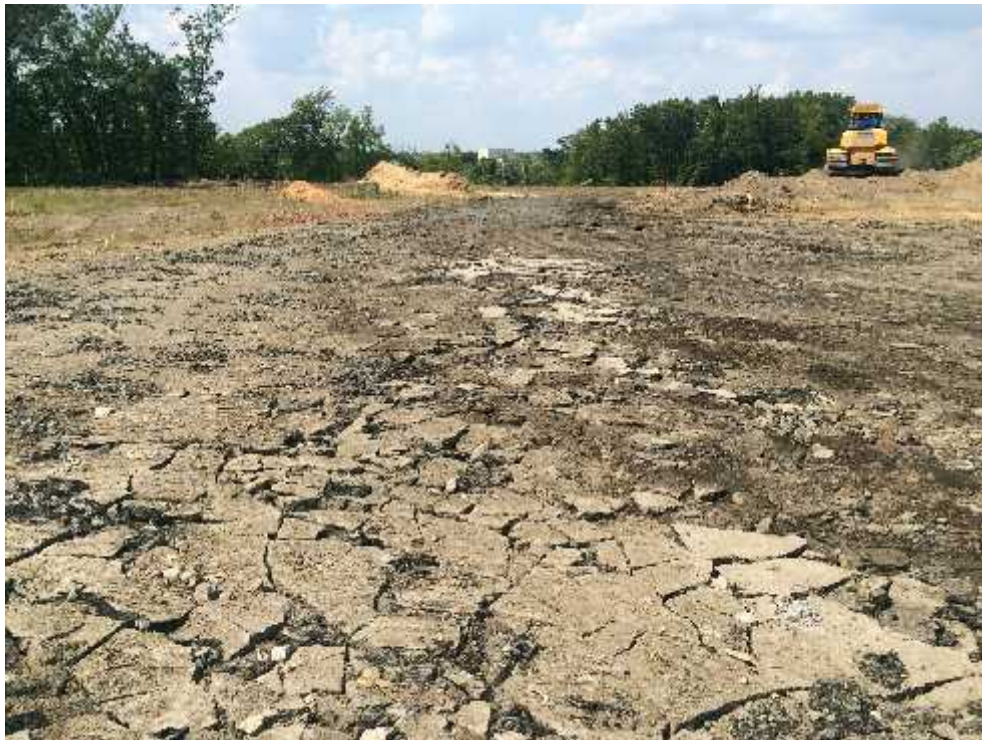
**Photo 2**  
Parcel C Tree Clearing

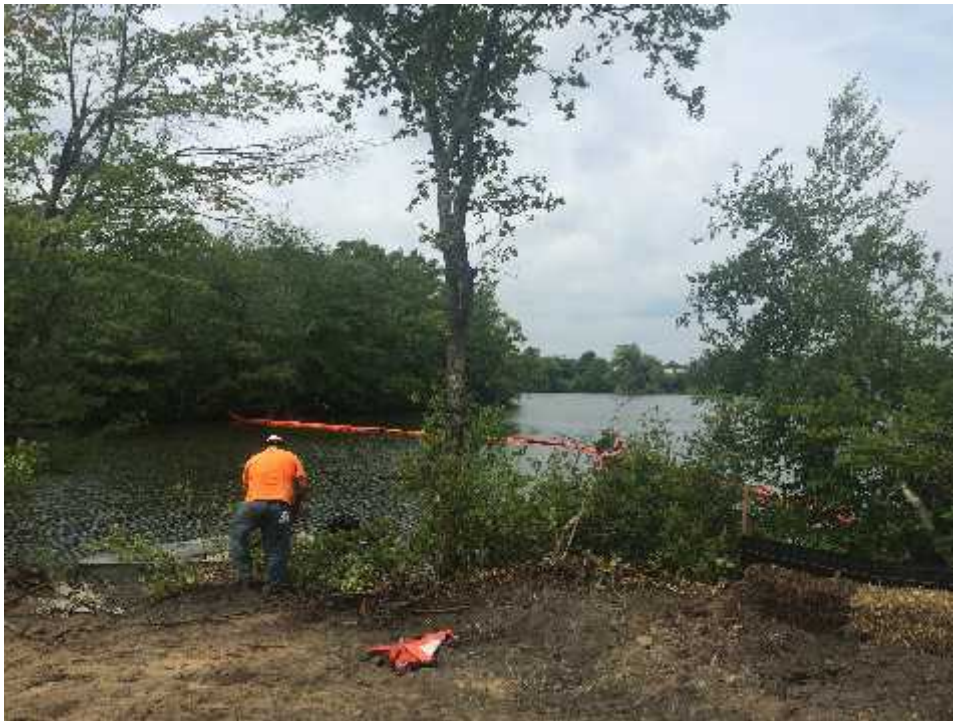
**Photo 3**

Inner Cove turbidity curtain installation

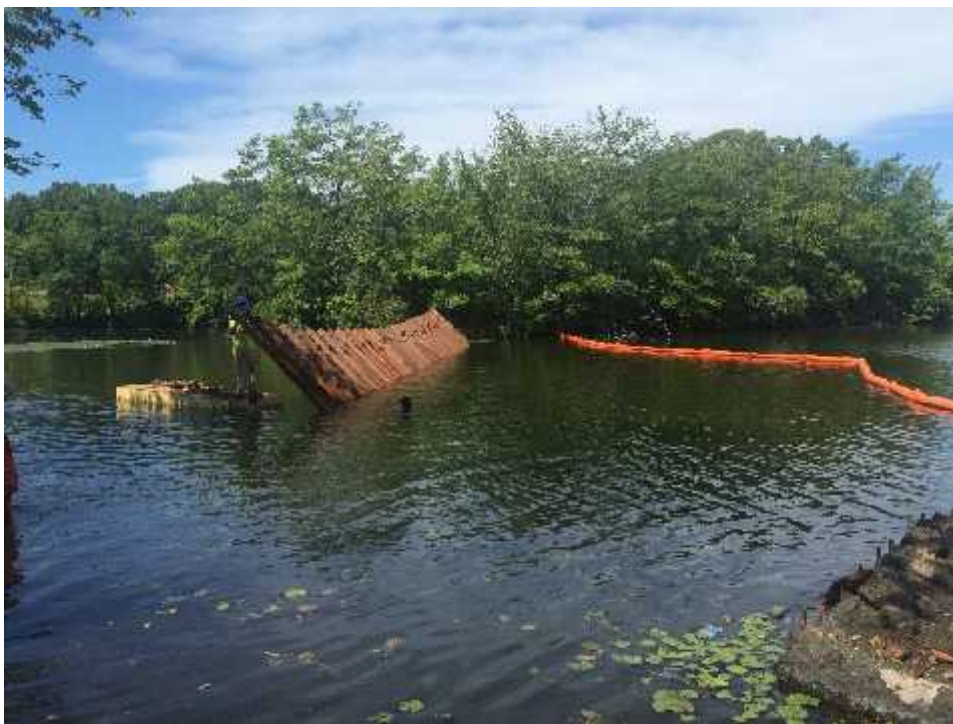
**Photo 4**

Port-A-Dam framing installed between Inner and Outer Coves

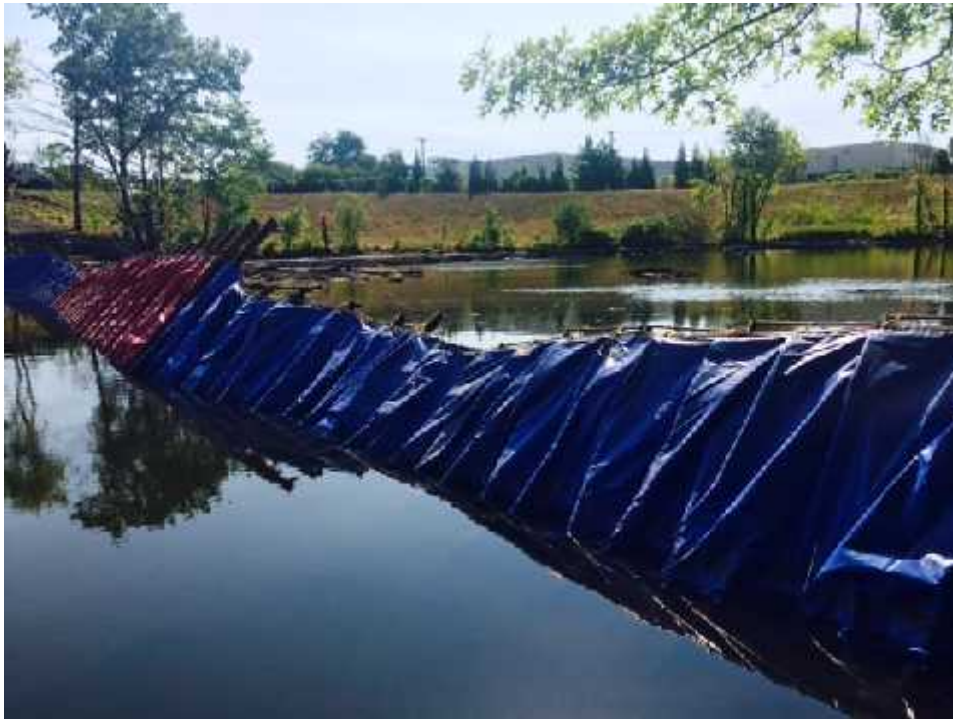
**Photo 5**  
Port-A-Dam installation complete

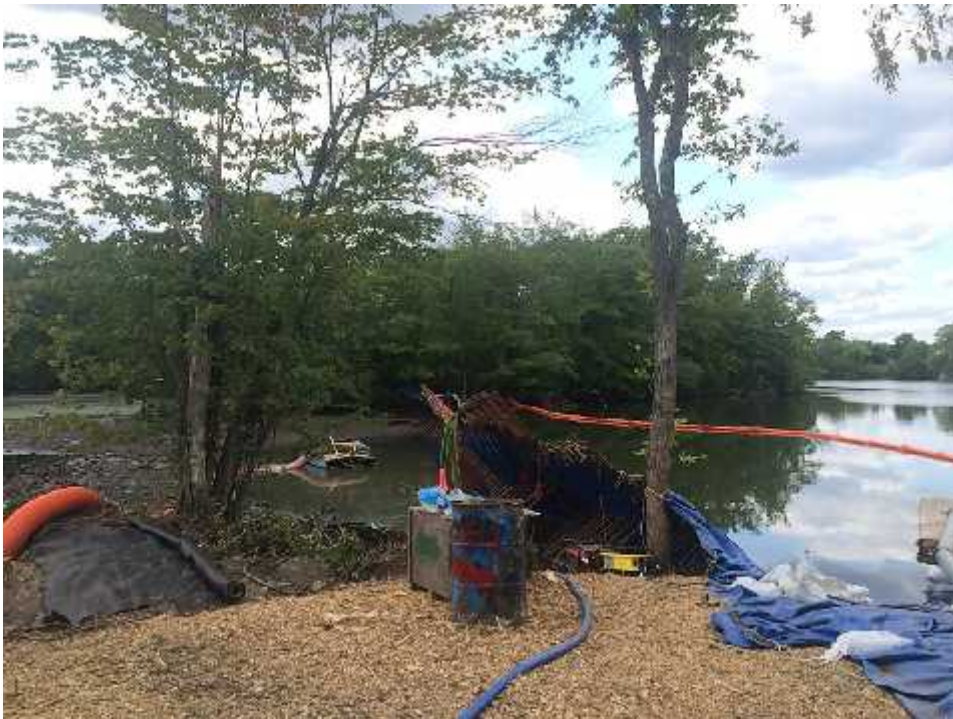
**Photo 6**  
Inner Cove initial dewatering

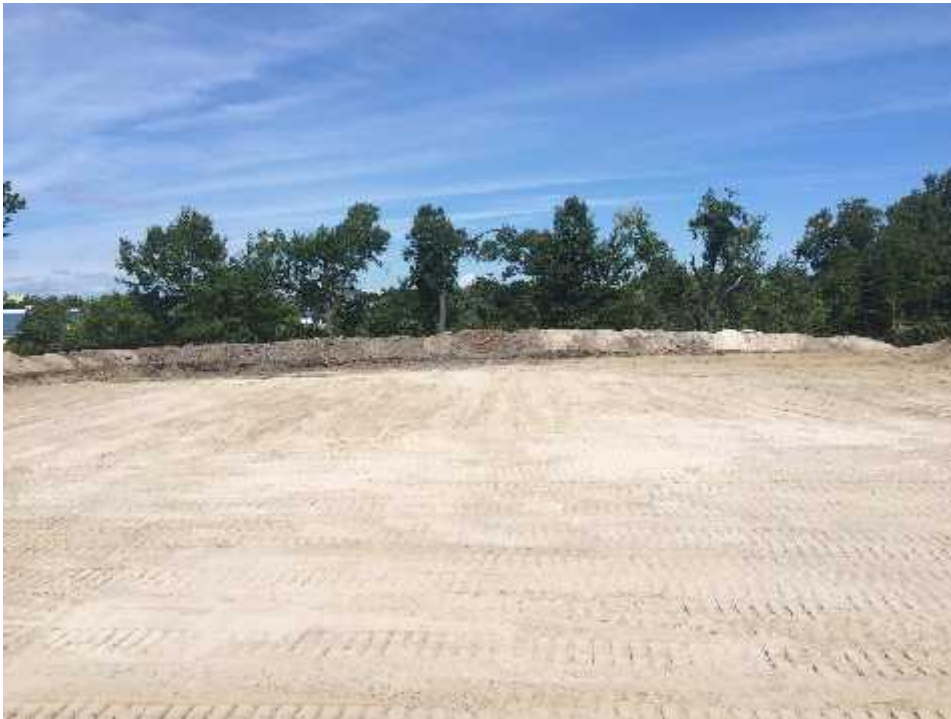
**Photo 7**

Infiltration gallery on  
Phase III area

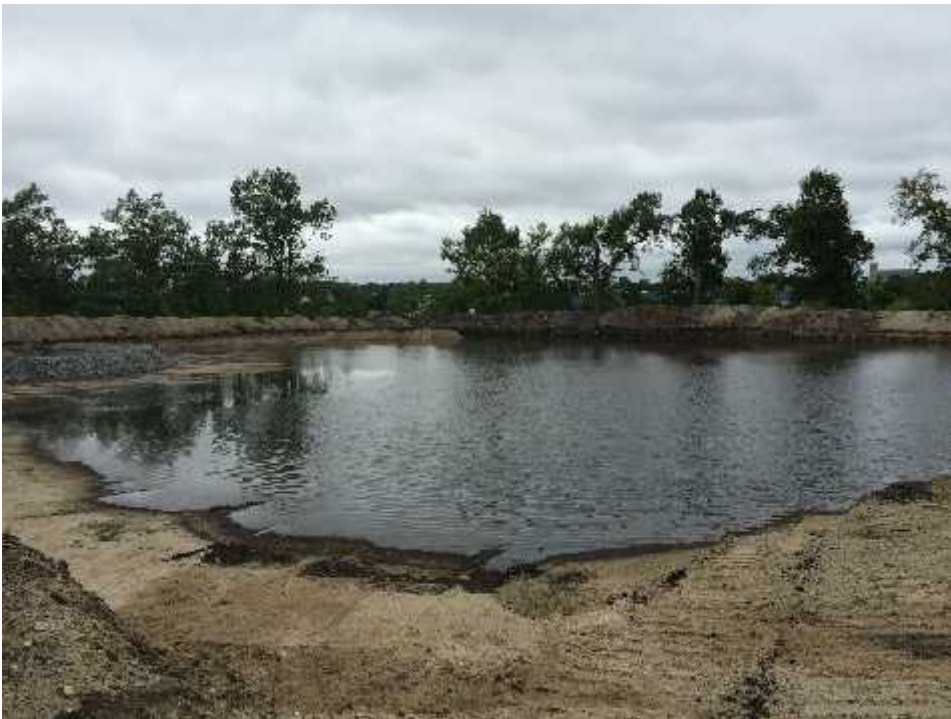
**Photo 8**

Infiltration gallery with  
water from Inner Cove  
dewatering frac tank

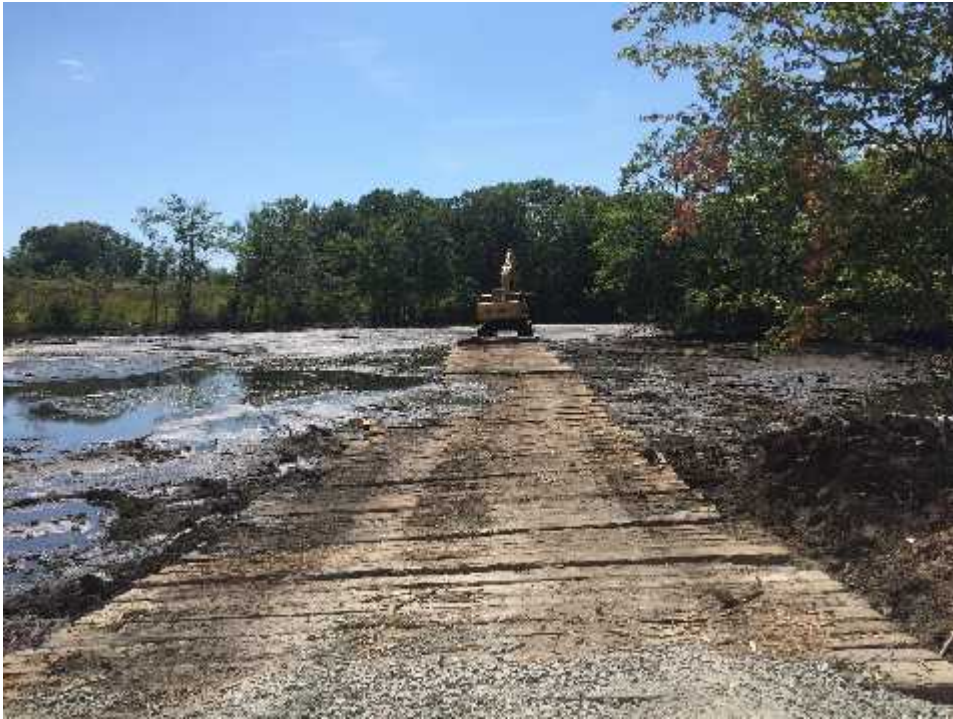
**Photo 9**

Timber mat road  
installation in the Inner  
Cove

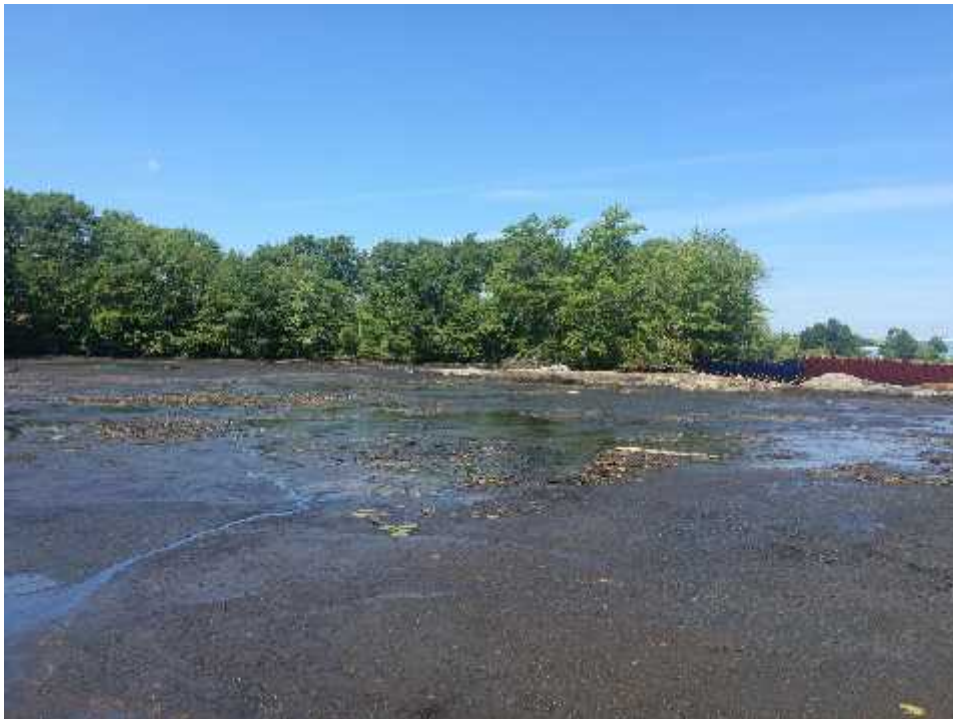
**Photo 10**

Inner Cove sediments  
drying following  
dewatering

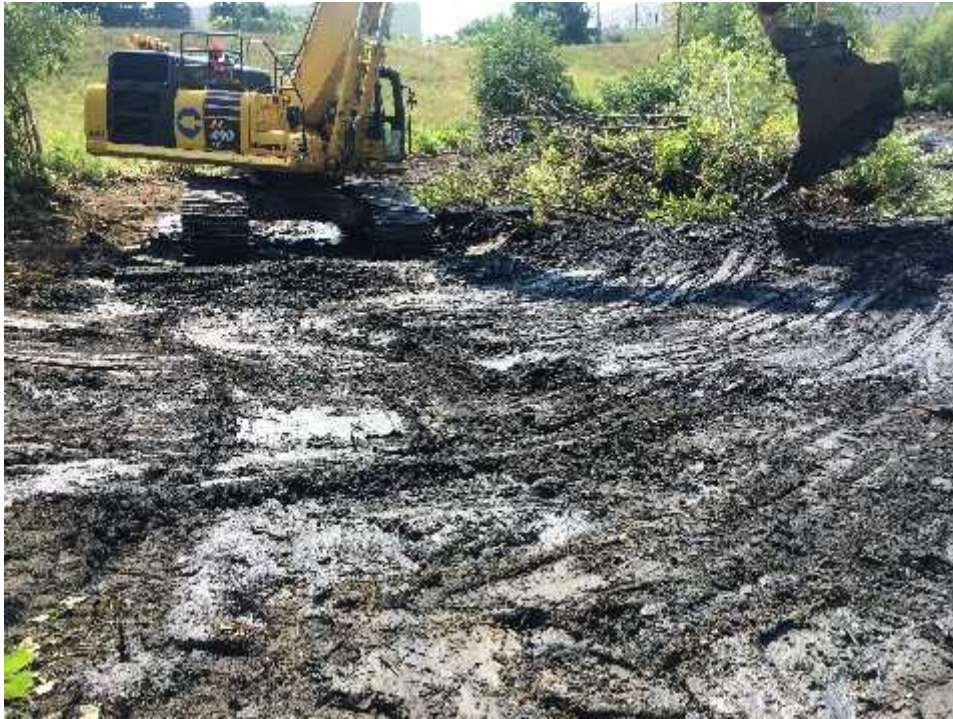
**Photo 11**

Inner Cove sediment removal

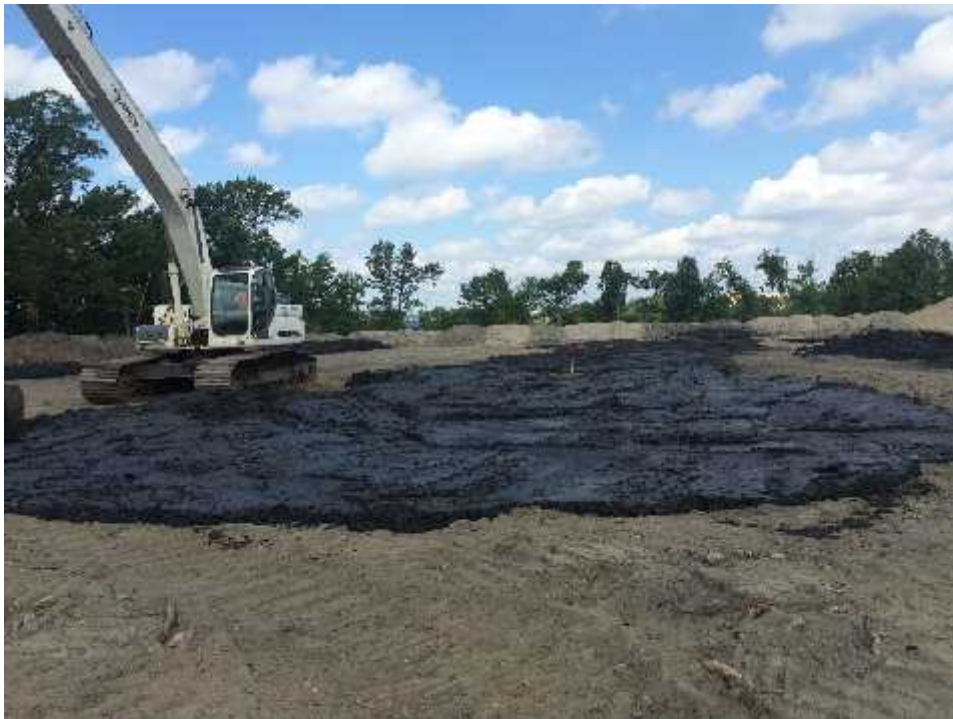
**Photo 12**

Excavated Inner Cove sediments spread out in sediment drying area

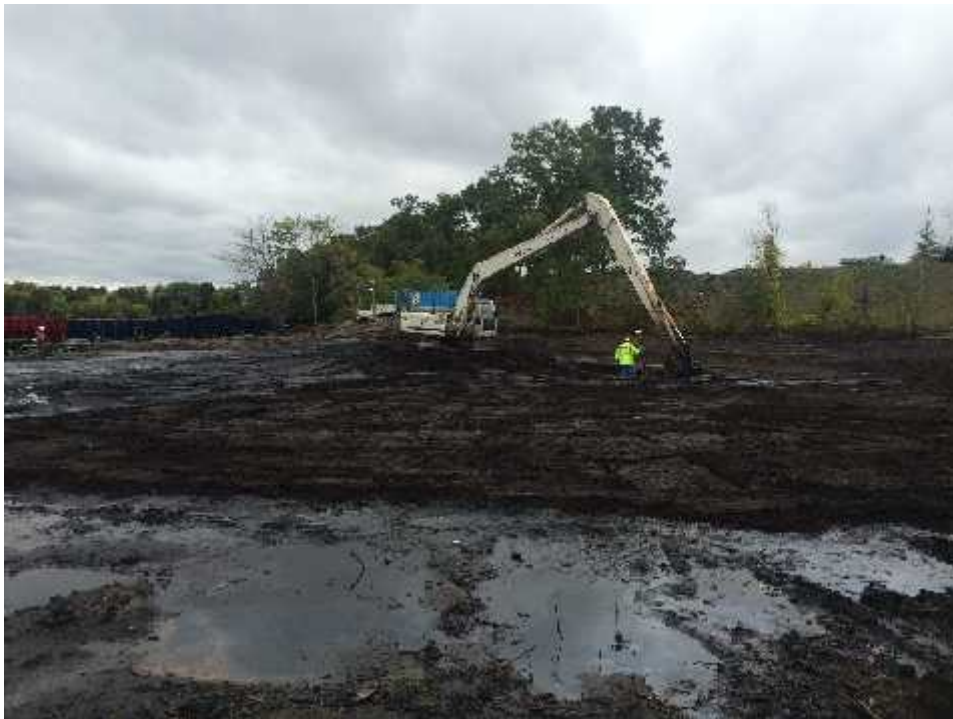
**Photo 13**  
Backfilling of Inner Cove

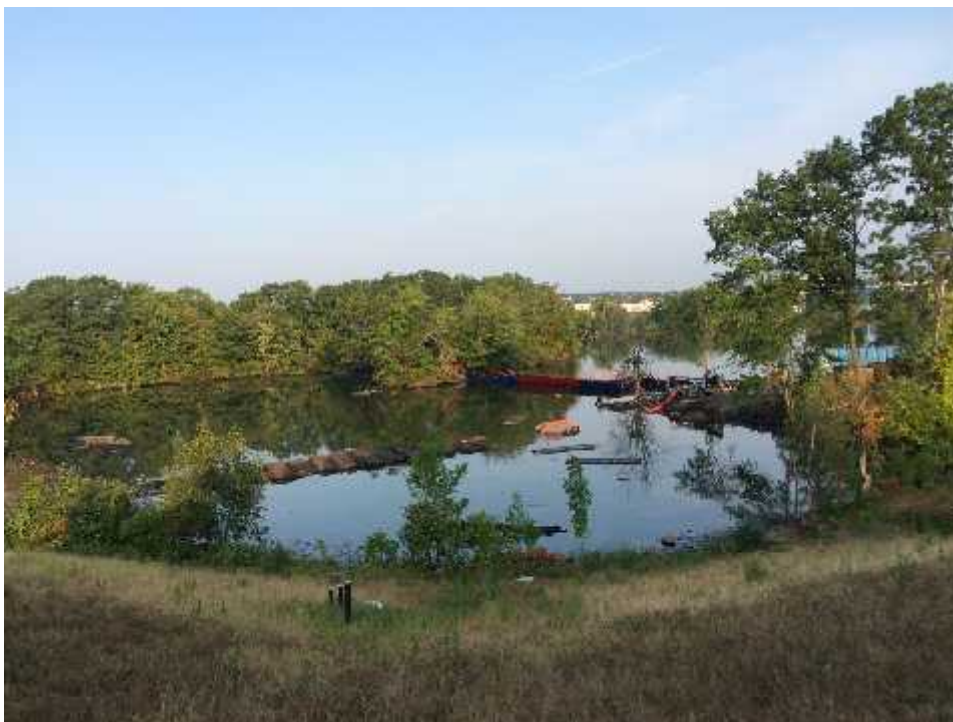
**Photo 14**  
Second Inner Cove  
dewatering following  
dam breach

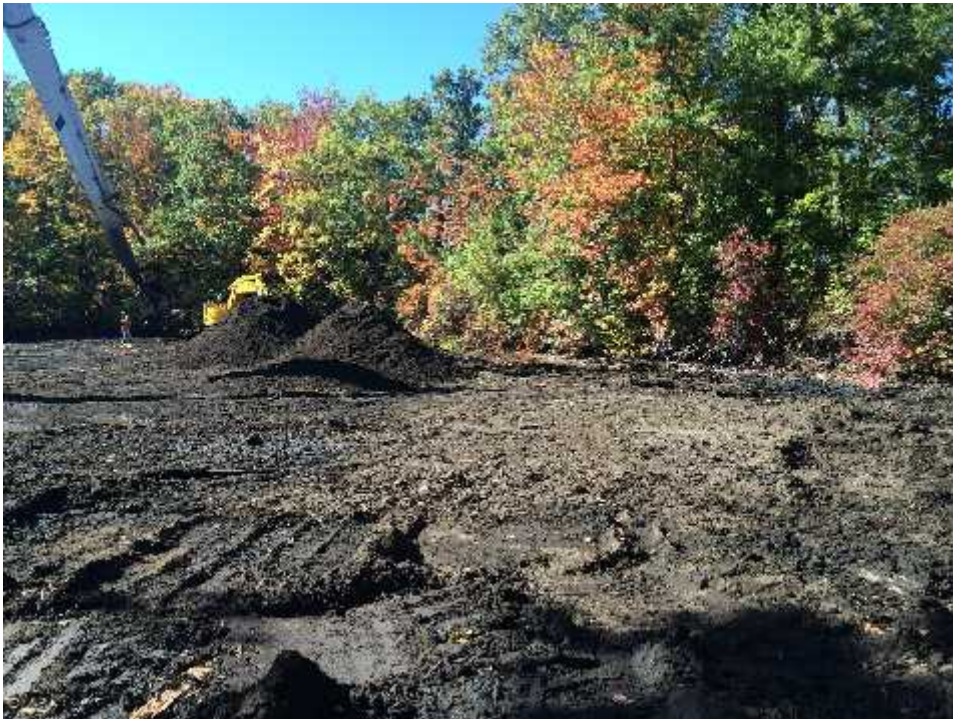
**Photo 15**  
Inner Cove cap  
installation

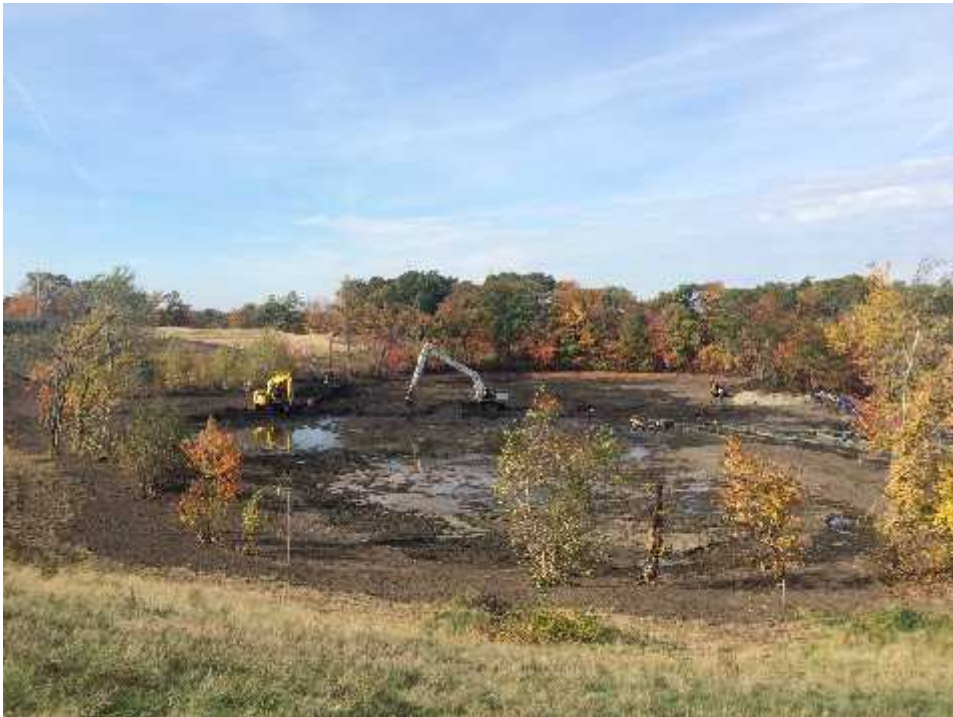
**Photo 16**  
Inner Cove cap  
installation

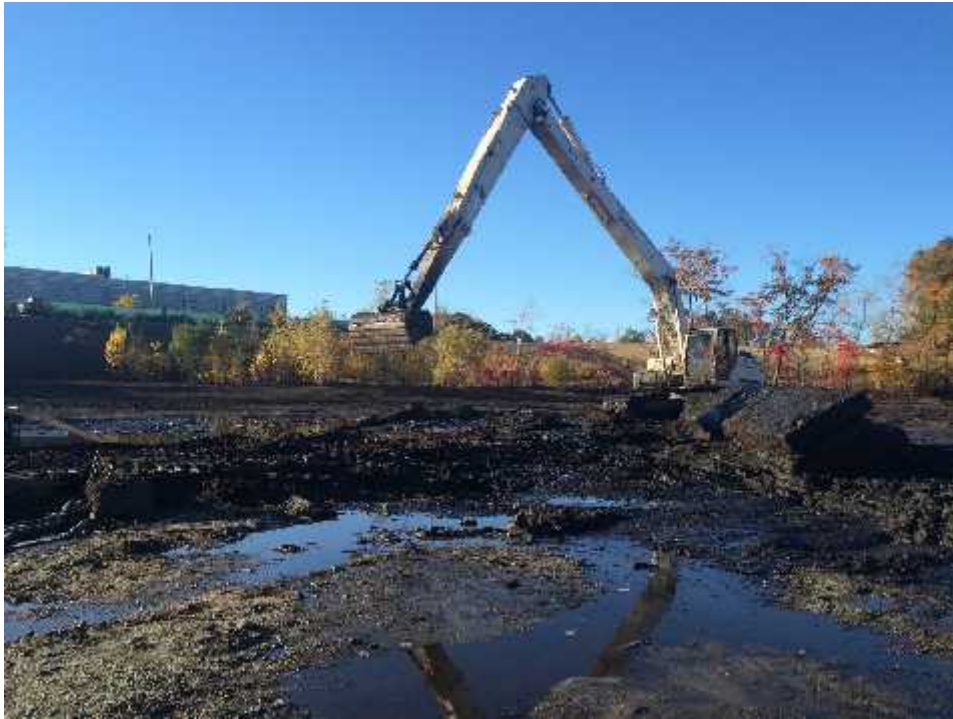
**Photo 17**  
Removal of timber mat road

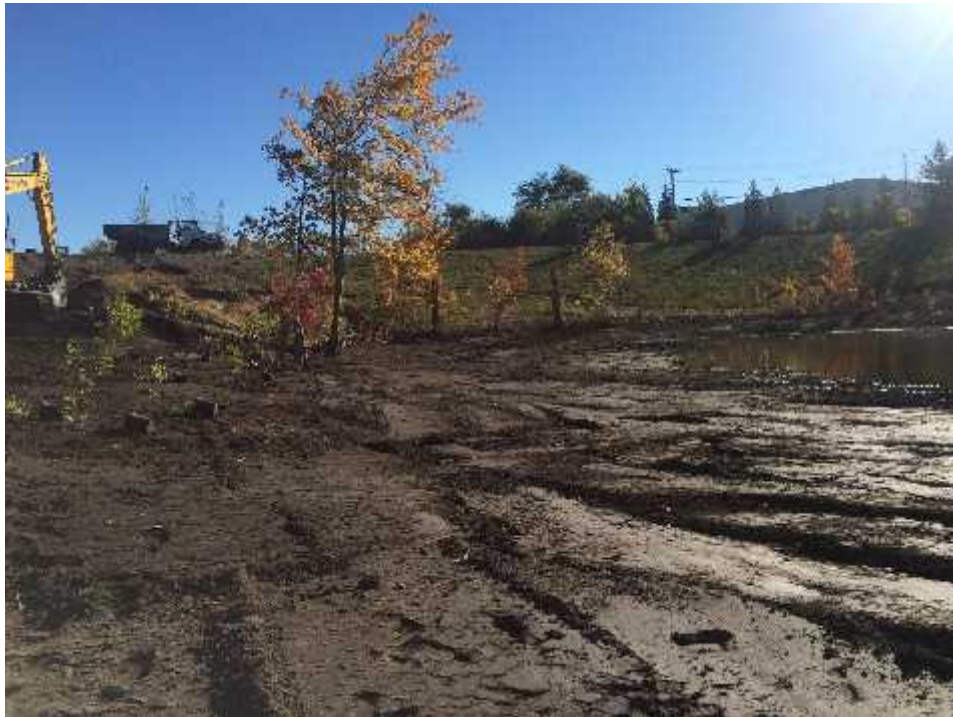
**Photo 18**  
Inner Cove cap and wetland restoration

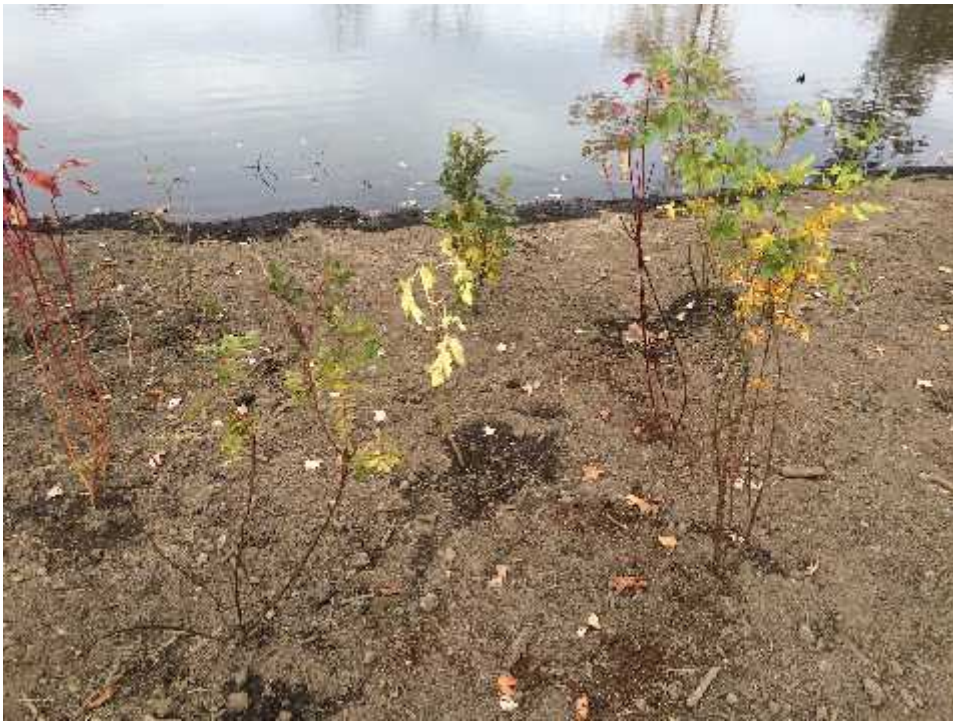
**Photo 19**  
Wetland restoration at  
Inner Cove shoreline

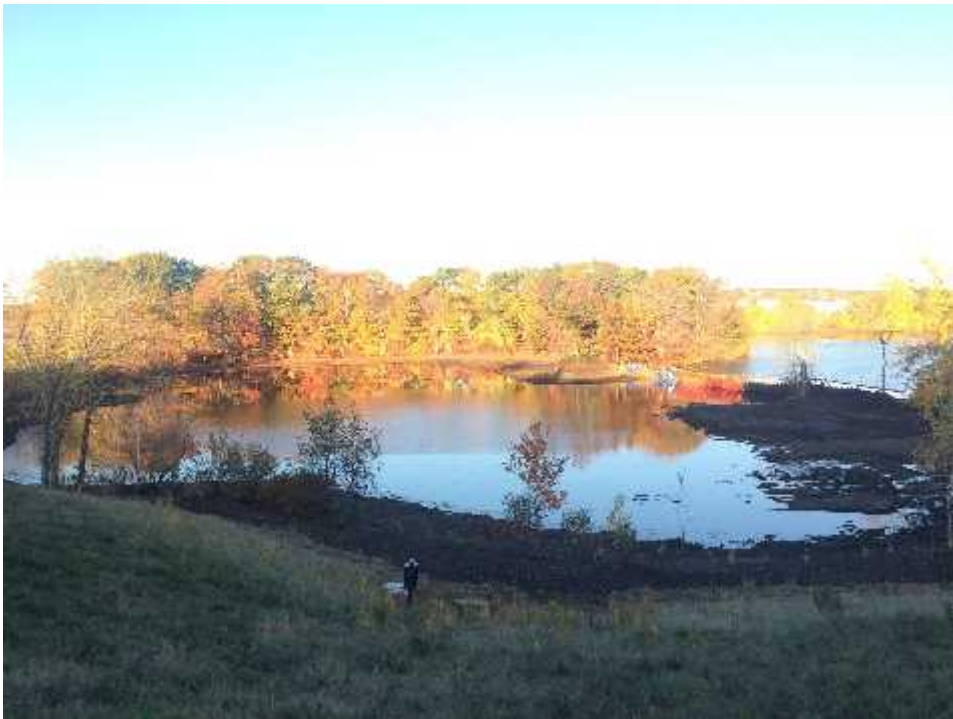
**Photo 20**  
Re-flooding of Inner  
Cove

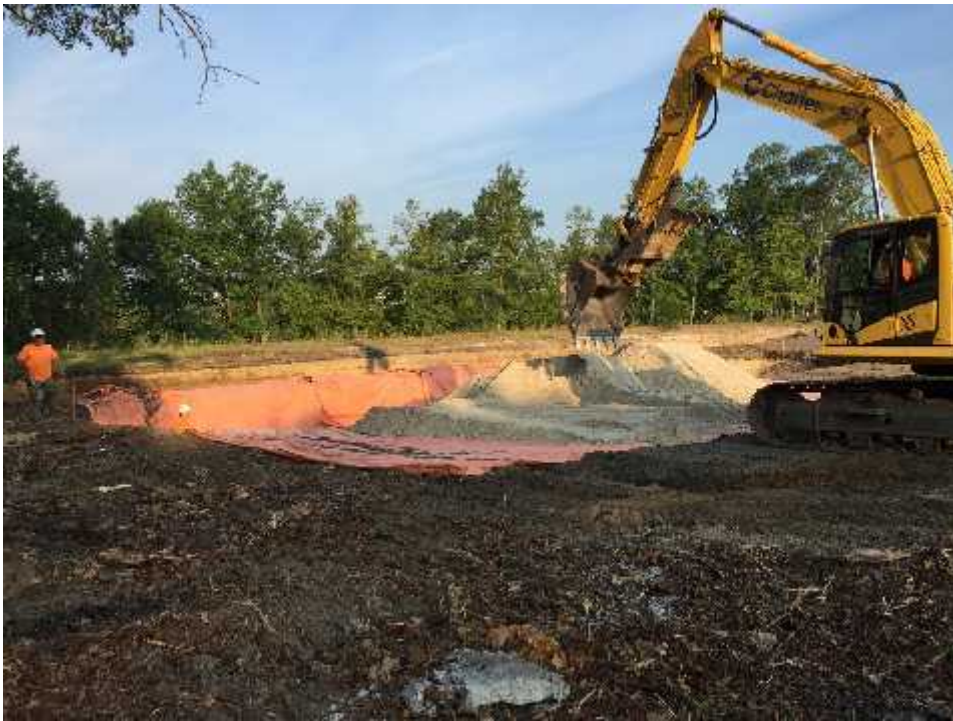
**Photo 21**

Capping of detention basin on Parcel C

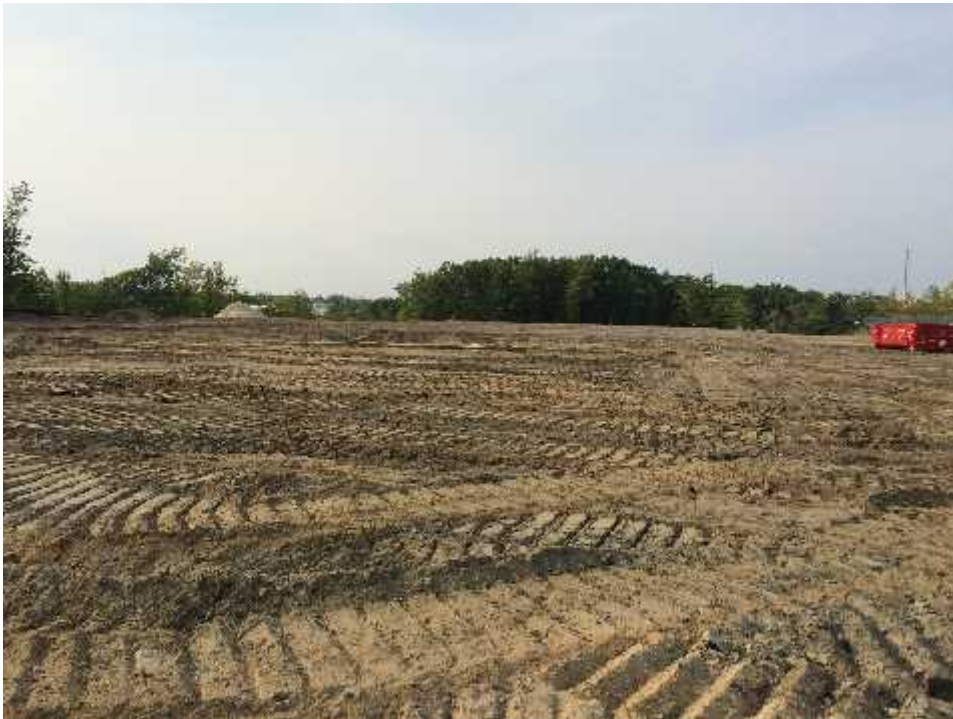
**Photo 22**

Common borrow placement on southern portion of Parcel C

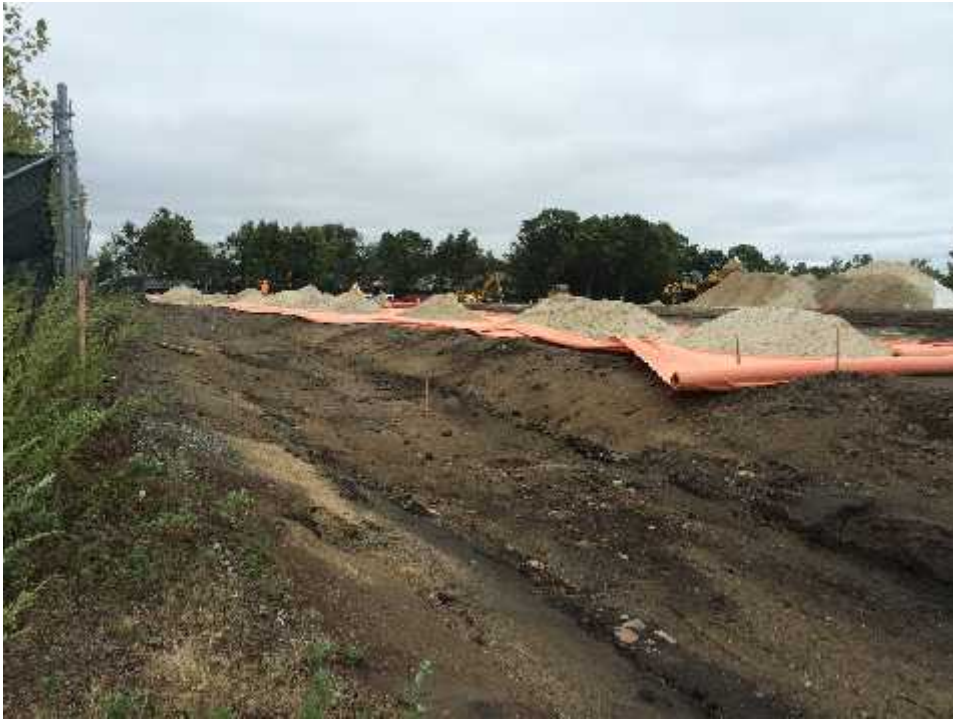
**Photo 23**

Fabric and common borrow prep on eastern portion of Parcel C

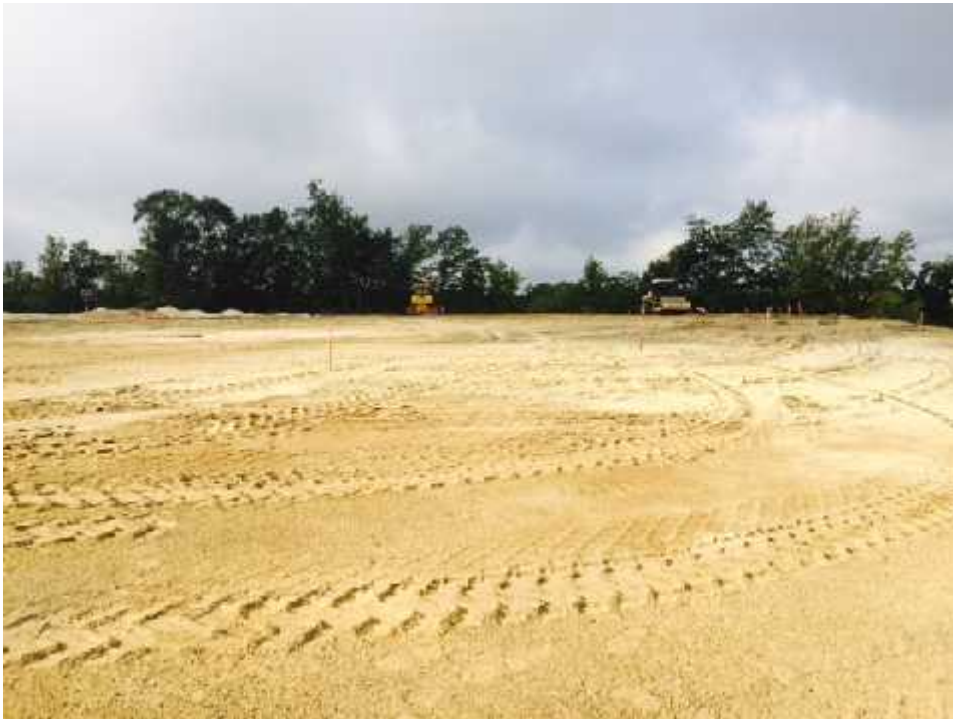
**Photo 24**

Common borrow grading on northern portion of Parcel C

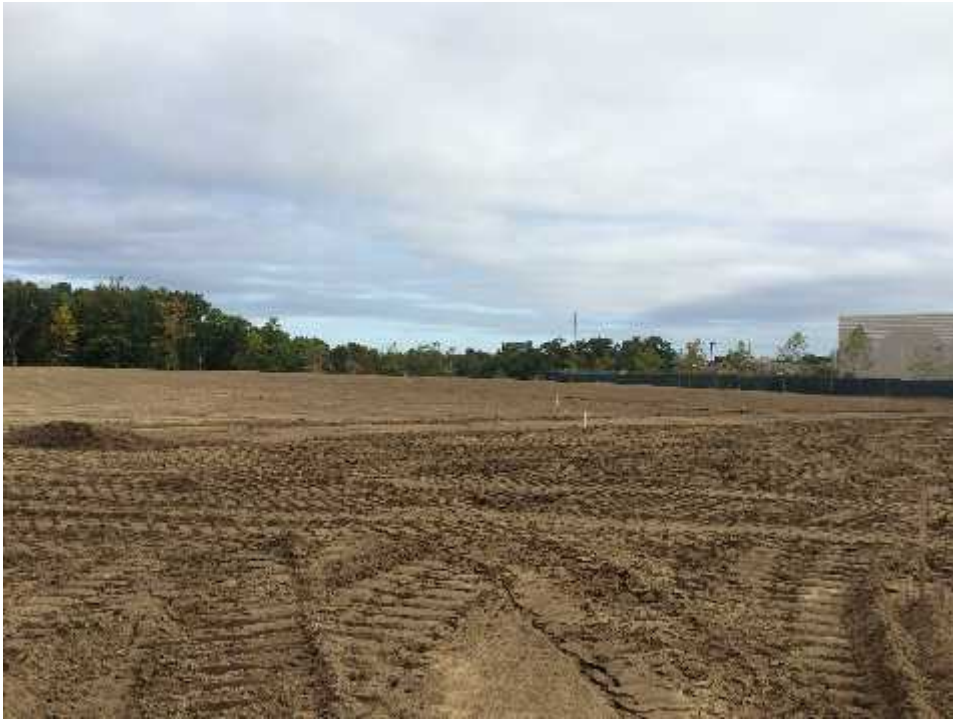
**Photo 25**

Parcel C final grading

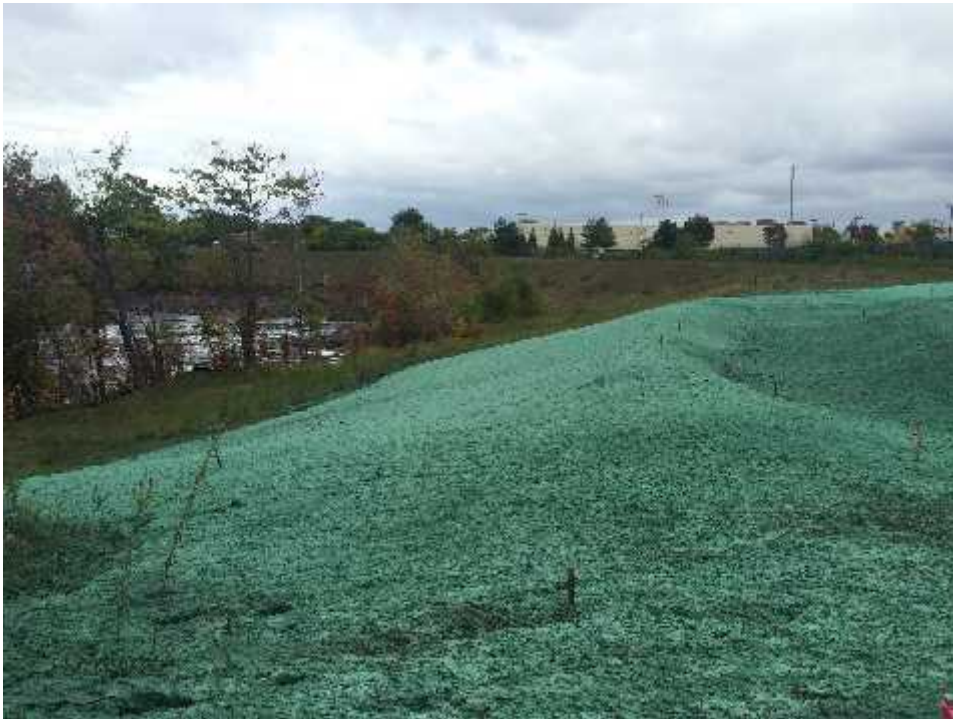
**Photo 26**

Hydroseed on Parcel C

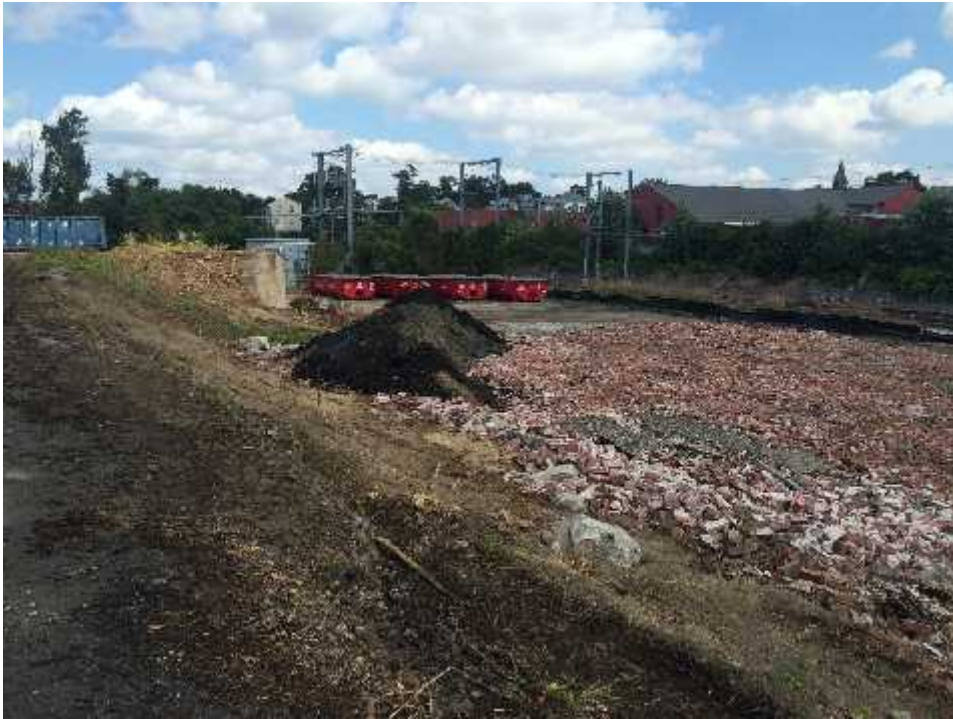
**Photo 27**

Carriage House area with  
Inner Cove sediment

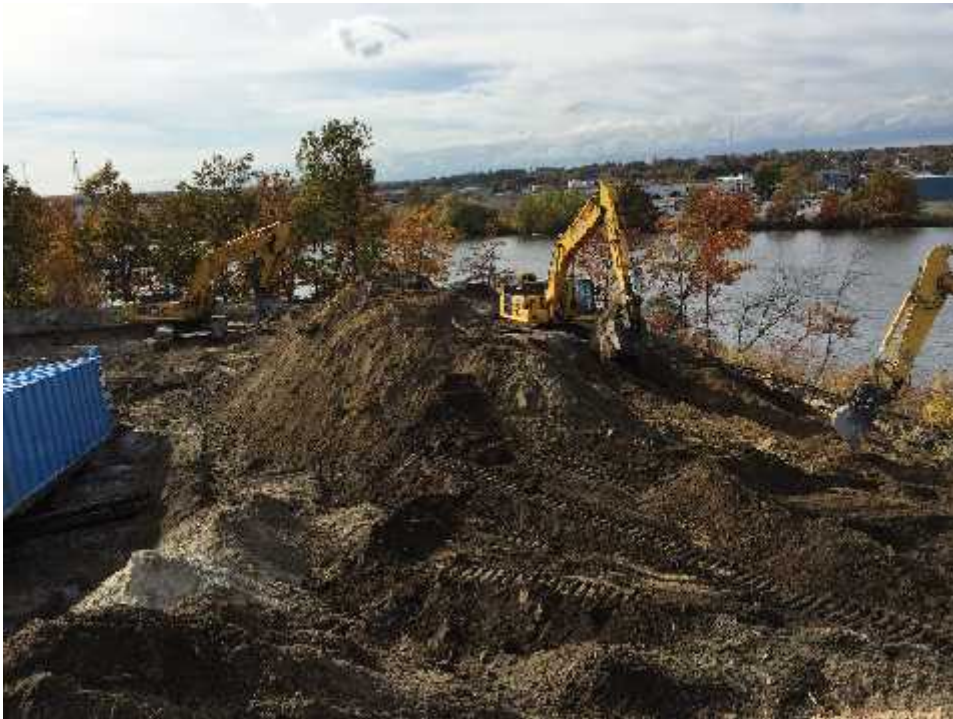
**Photo 28**

Subgrade prep of Phase  
III

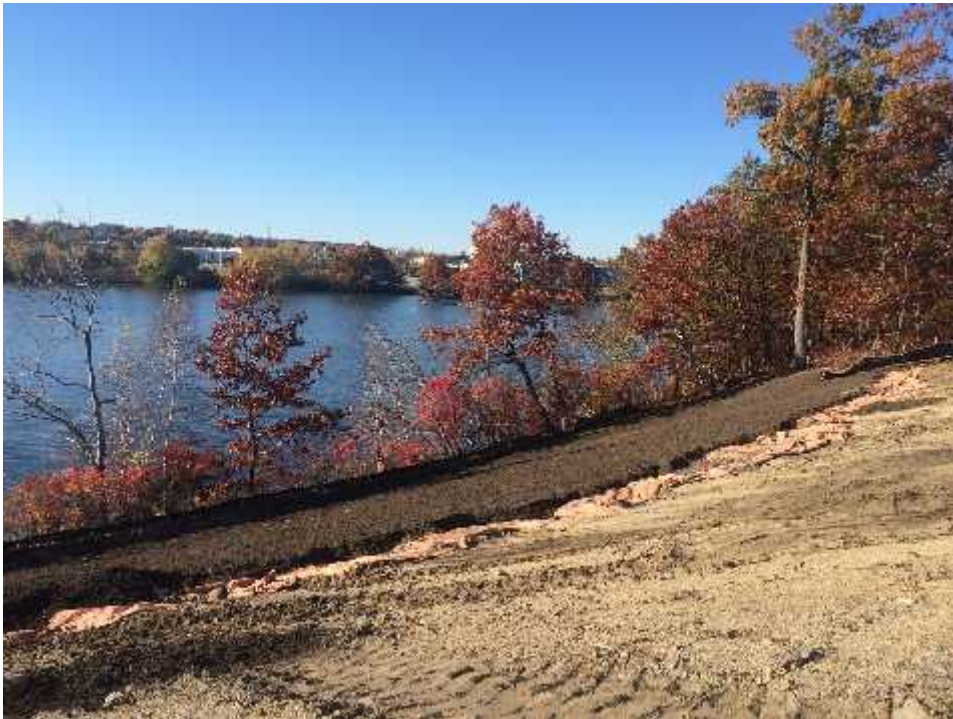
**Photo 29**  
Capping of Phase III

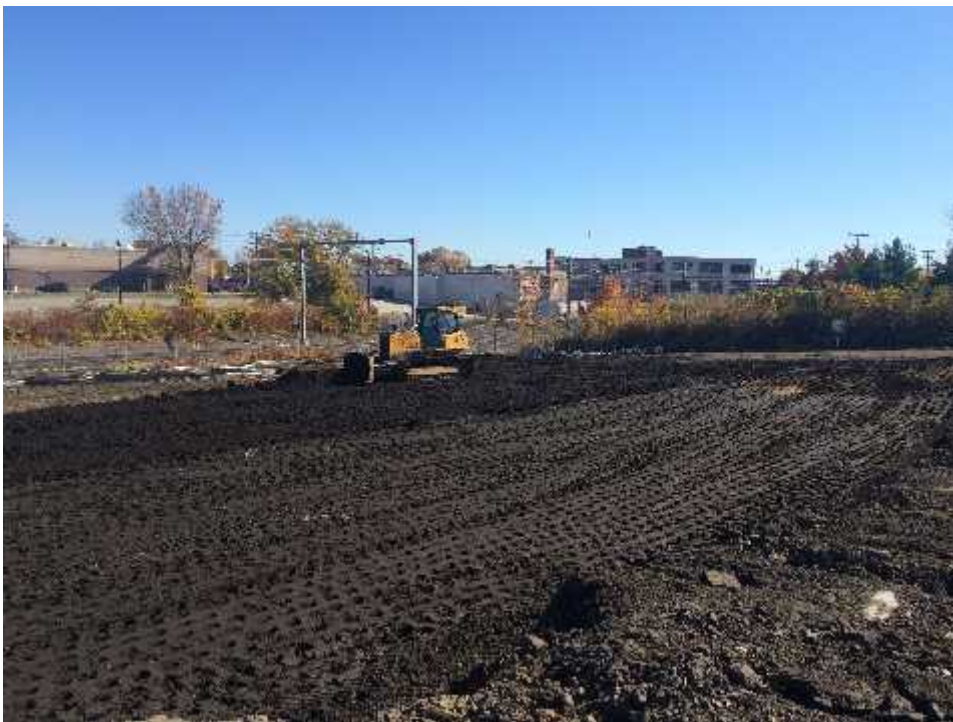
**Photo 30**  
Capping of Inner Cove  
sediments in Carriage  
House Area

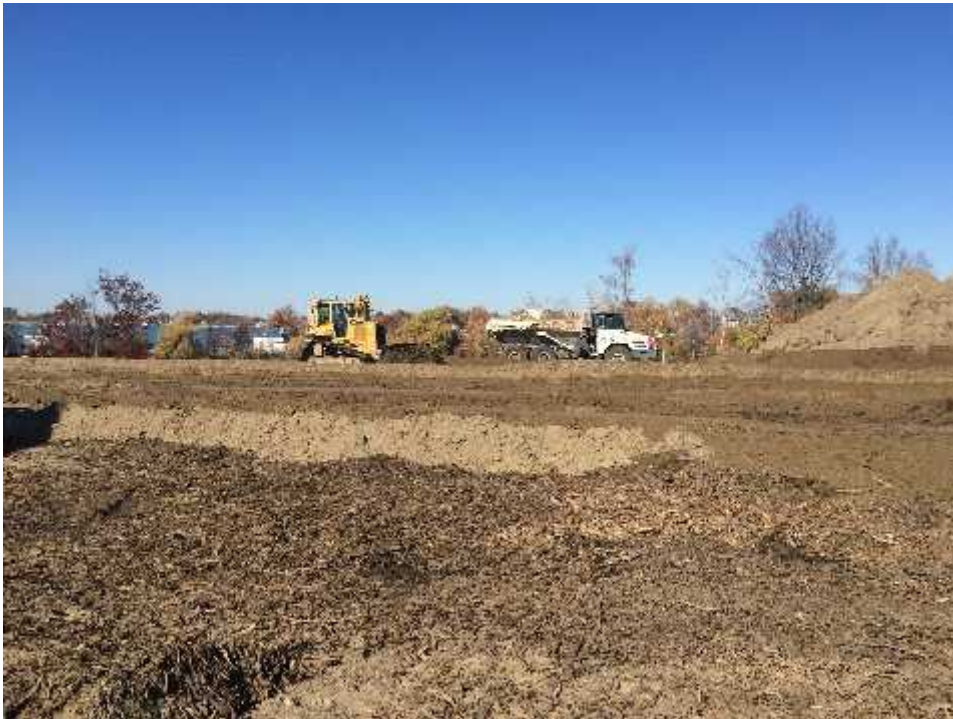
**Photo 31**  
Capping of Phase III

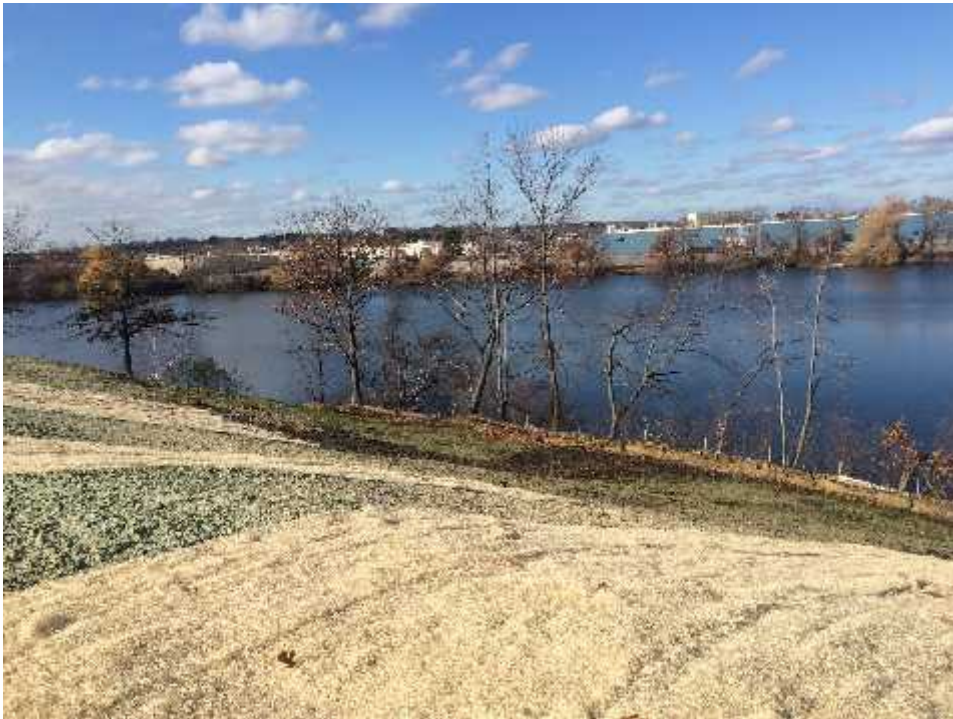
**Photo 32**  
Completed Phase III  
with hydroseed and  
erosion control matting

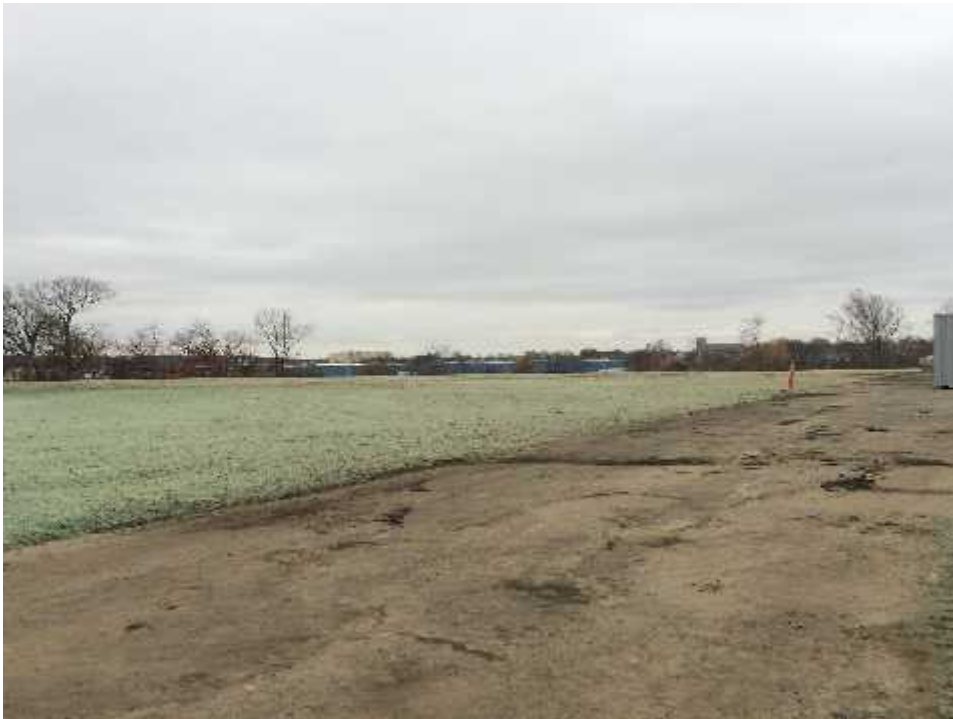
**Photo 33**  
Phase III area after  
hydroseeding
