Textron, Inc.  
Former Gorham Manufacturing Facility, Providence, RI  
Remedial Action Completion Report: Phase II Area – Mashapaug Inner Cove,  
Phase III Area – Northeast Upland And Parcel C  
Project No.: 3652160001  
February 12, 2016

**APPENDIX C**  
**PHOTOGRAPHS**

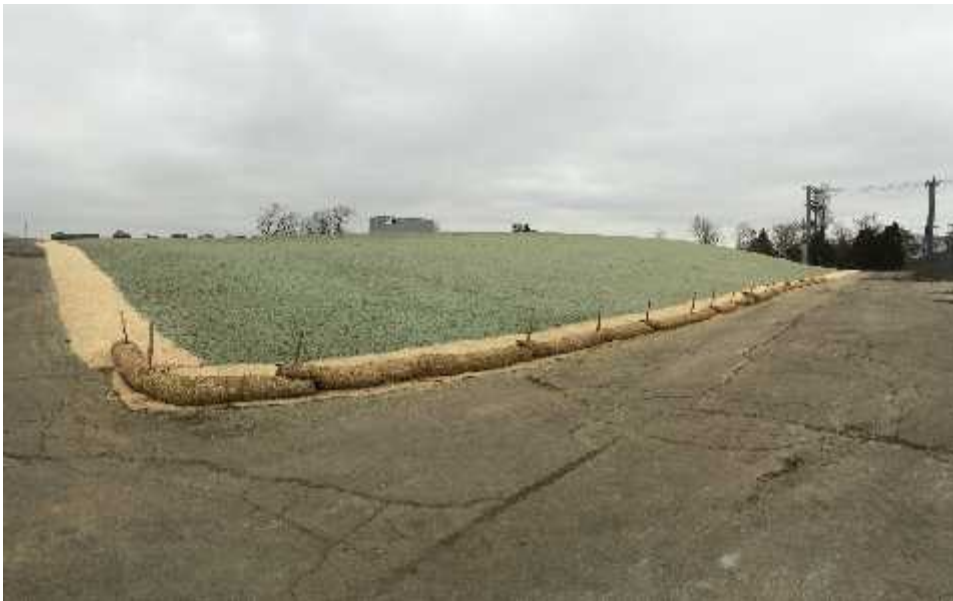
**Photo 34**  
Phase III, sediment area,  
final grades with  
hydroseed
