February 19, 2019

Re: Gould Island Bunker Wall Structural Evaluations

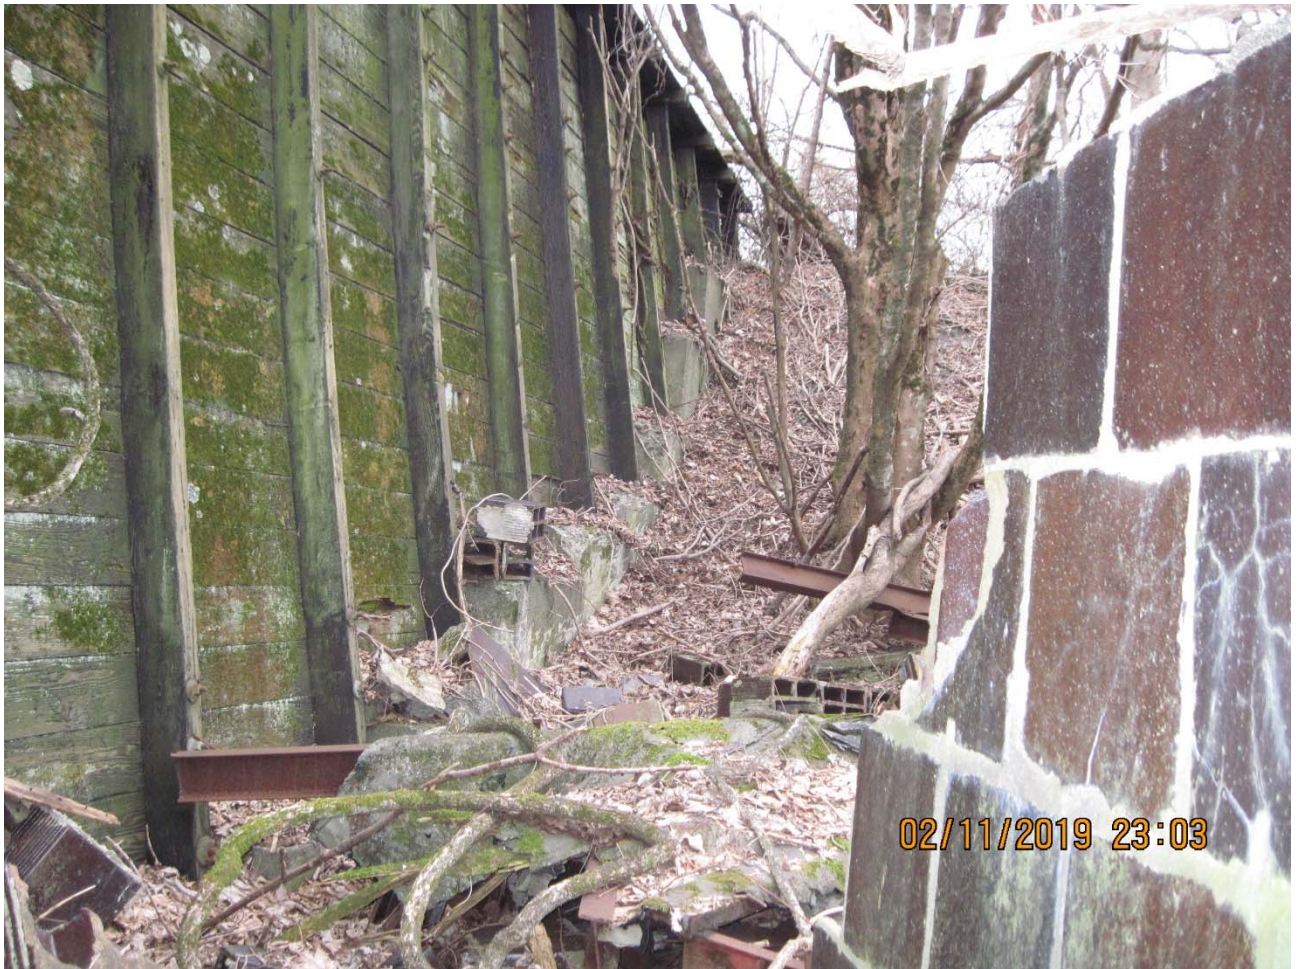
Photo #1: View of West side of Wall

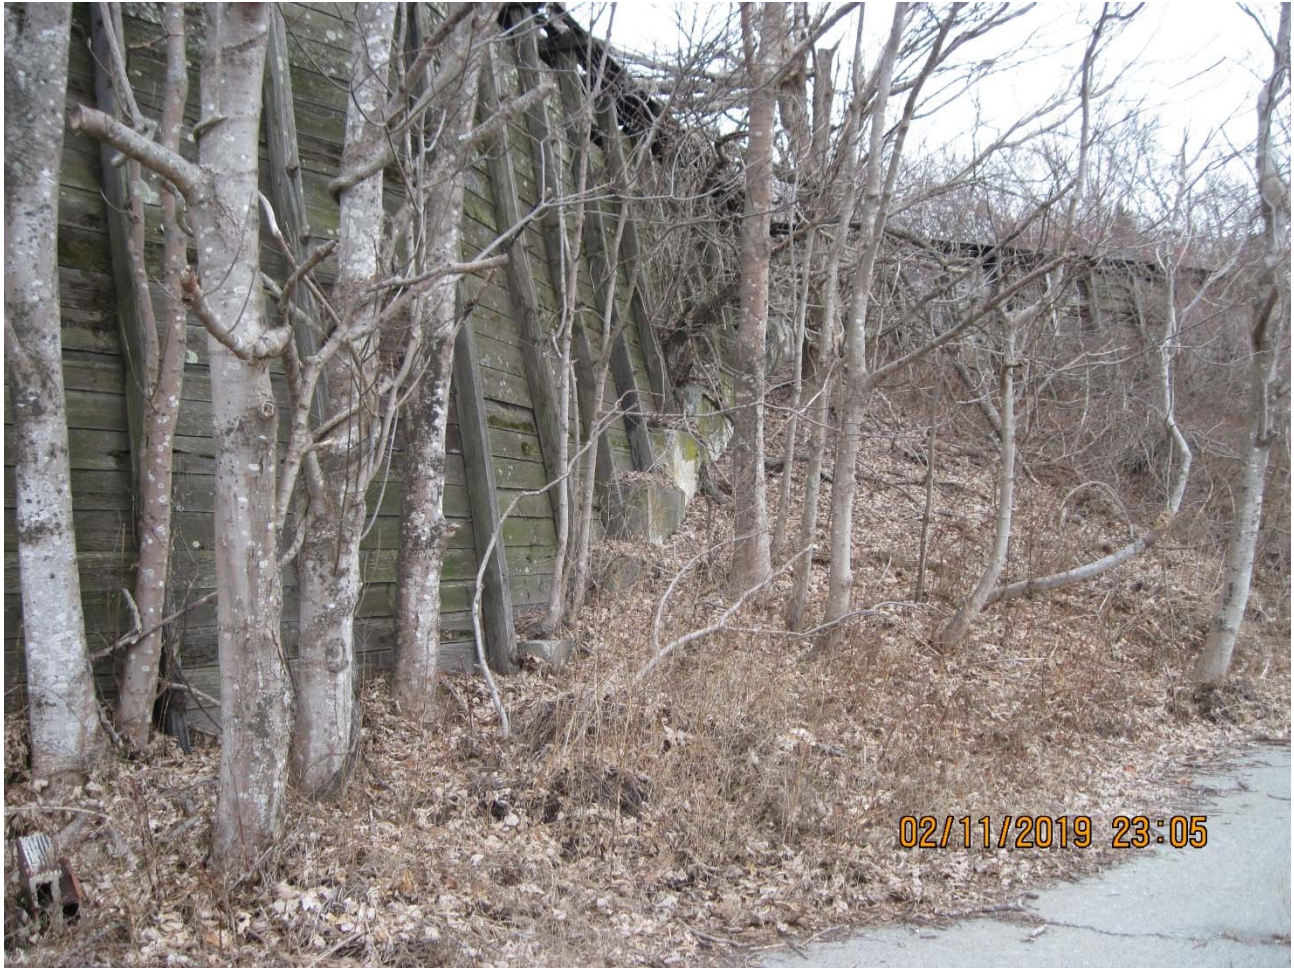
Photo #2: View of East side of Wall

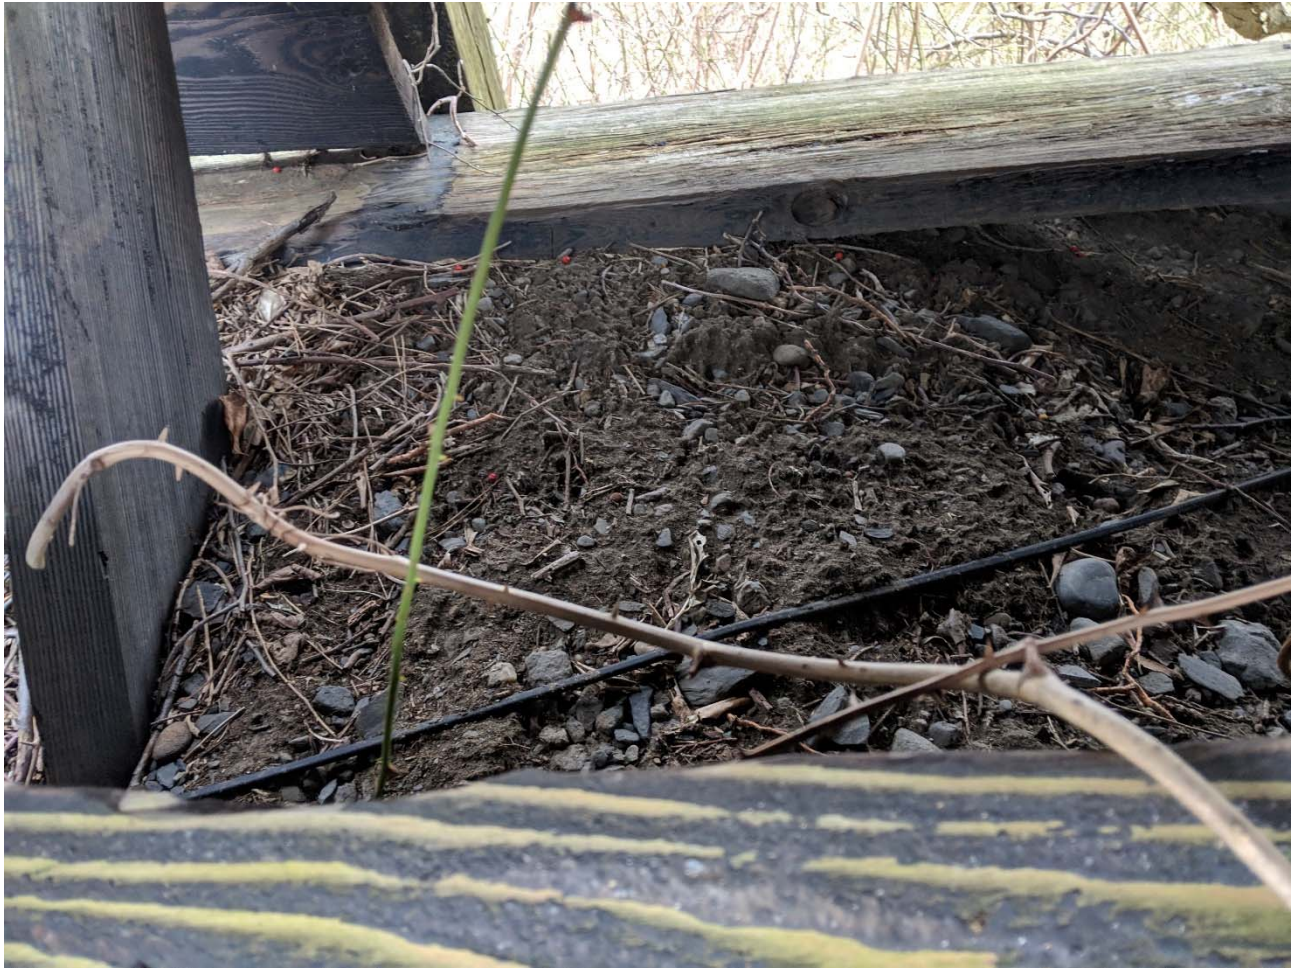
Photo #3: View of Earthen Fill Within Wall

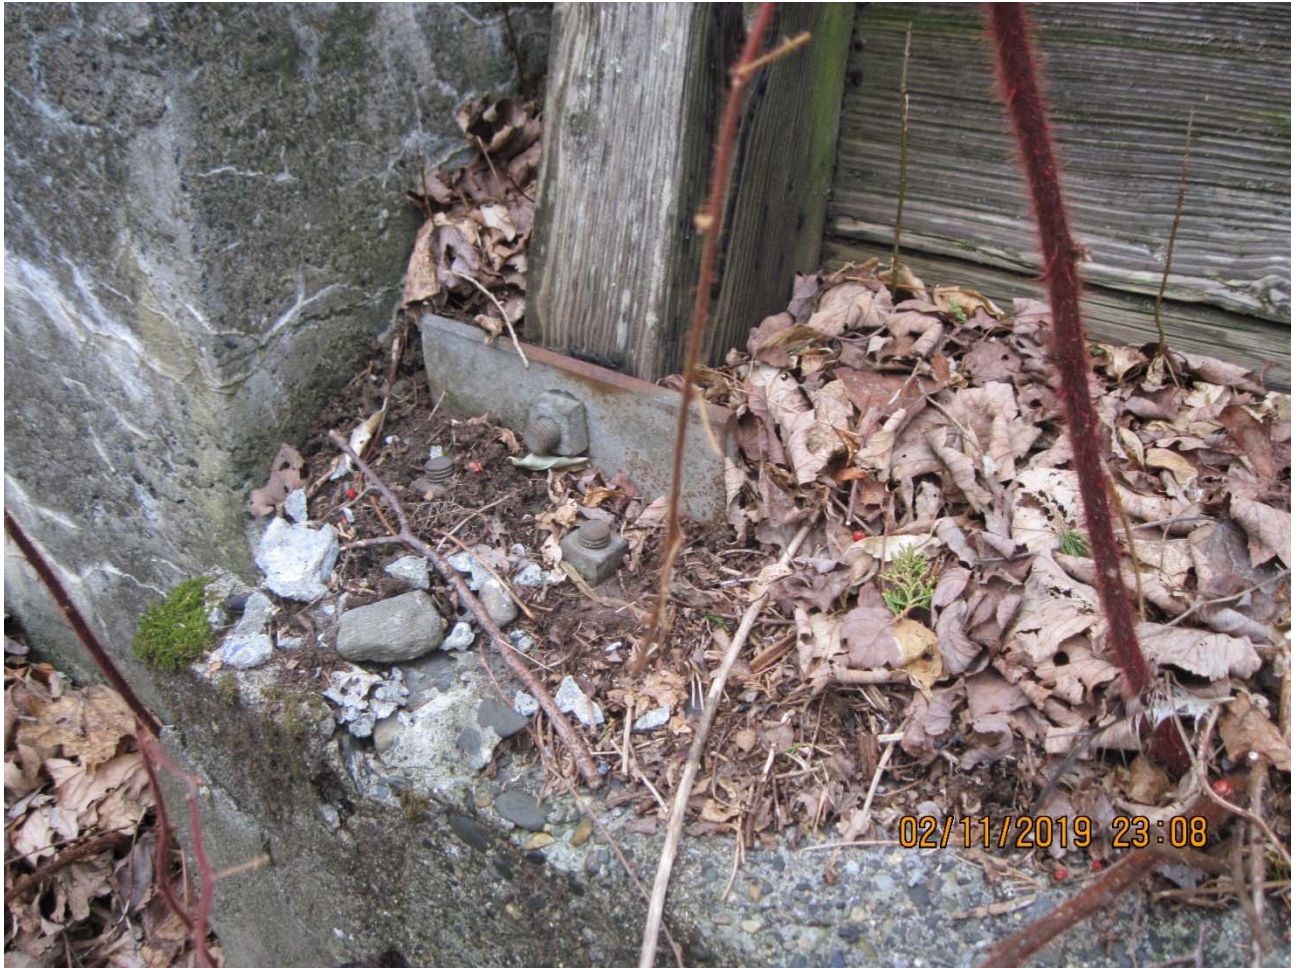
Photo #4: Typical Wall Anchorage to Foundation

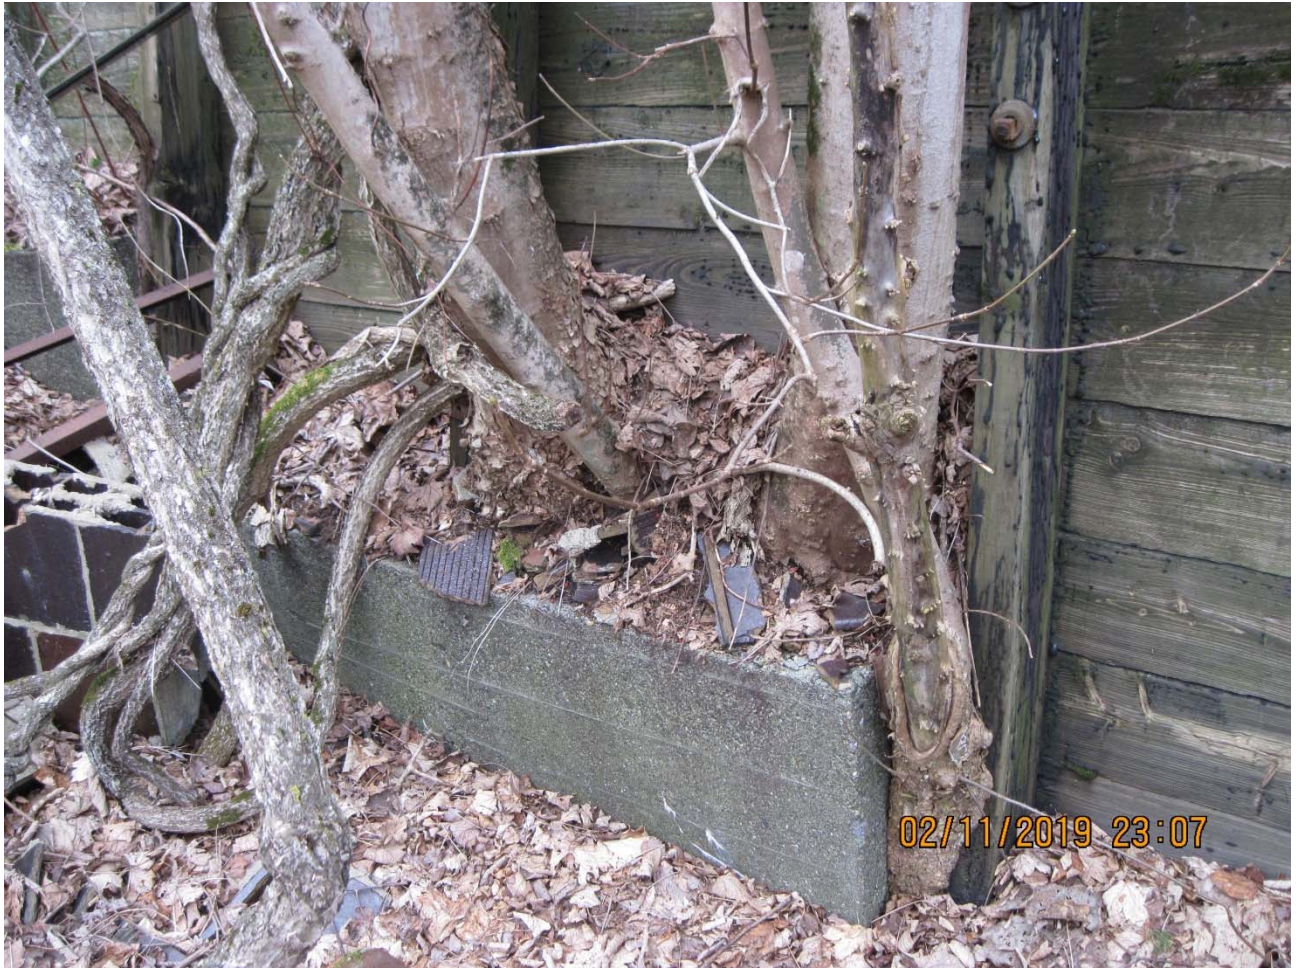
Based on our visual assessment and sounding of the timber framing and concrete foundation, the wall appears to be in stable condition, albeit showing signs of deterioration. Some of the timber framing showed signs of deterioration but not significant enough to warrant concern. The east side of the wall faces a road and the water while the west side of the wall is filled with debris. The existing debris did not appear to be exerting a significant lateral pressure on the wall. Several trees and vegetation were observed growing near or through the wall but did not appear to be destabilizing the wall in any way (Refer to attached Photo #5).

Photo #5: Vegetation Growing within Wall

- The excavator should take care not to accidentally hit the wall with the bucket or claw potentially puncturing the existing planks. Although the wall is structurally redundant and is unlikely to progressively collapse from inadvertent damage, damage to the planks could cause the earth between the planks to spill out.
- When grabbing debris near the wall, the excavator should make sure not to accidentally grab one of the wall vertical uprights.
- If trees or vegetation needs to be removed near the wall, it should be fully sheared and not pulled in anyway to be removed. Under no circumstances may the excavator pull trees vegetation near the wall.
