-- WATERMAN LAKE DAM --

VISUAL INSPECTION / EVALUATION REPORT

Owner: *Citizens for the Preservation of Waterman Lake, Inc.*

Date of Inspection: *June 9, 11, and 12, 2020*

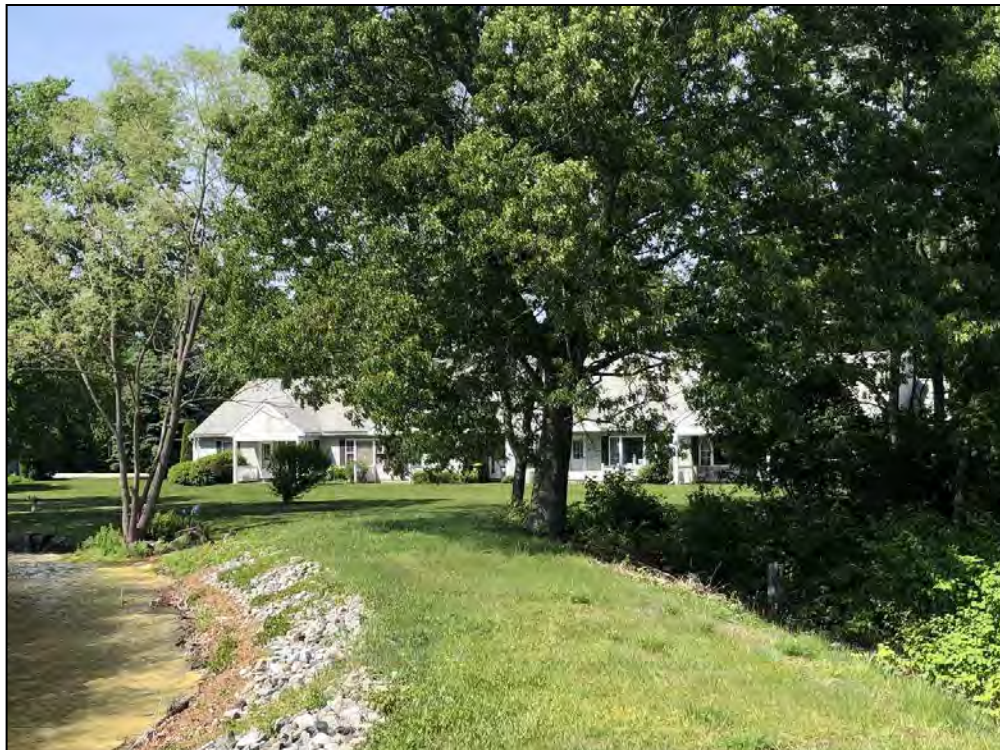
Photo No. 4: Main Dam – Crest at the left abutment. Note the 30-inch diameter tree at the downstream side of the crest. .

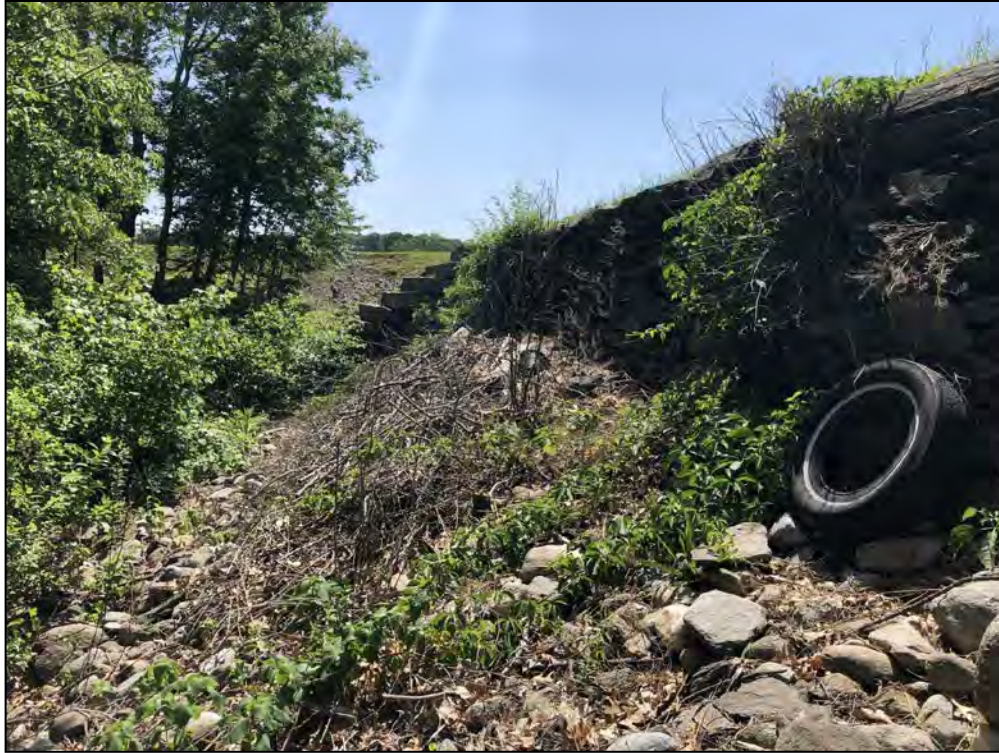
- The short section of slope between the crest and the top of the downstream wall had irregularities and areas of bare soil throughout. A collapsed animal burrow, approximately 16 inches in diameter and 4 inches deep, was noted near STA 1+30 and was located at the mid-slope above the downstream wall.

Photo No. 9: Main Dam - Area downstream of the downstream wall from near STA 1+30 looking right.

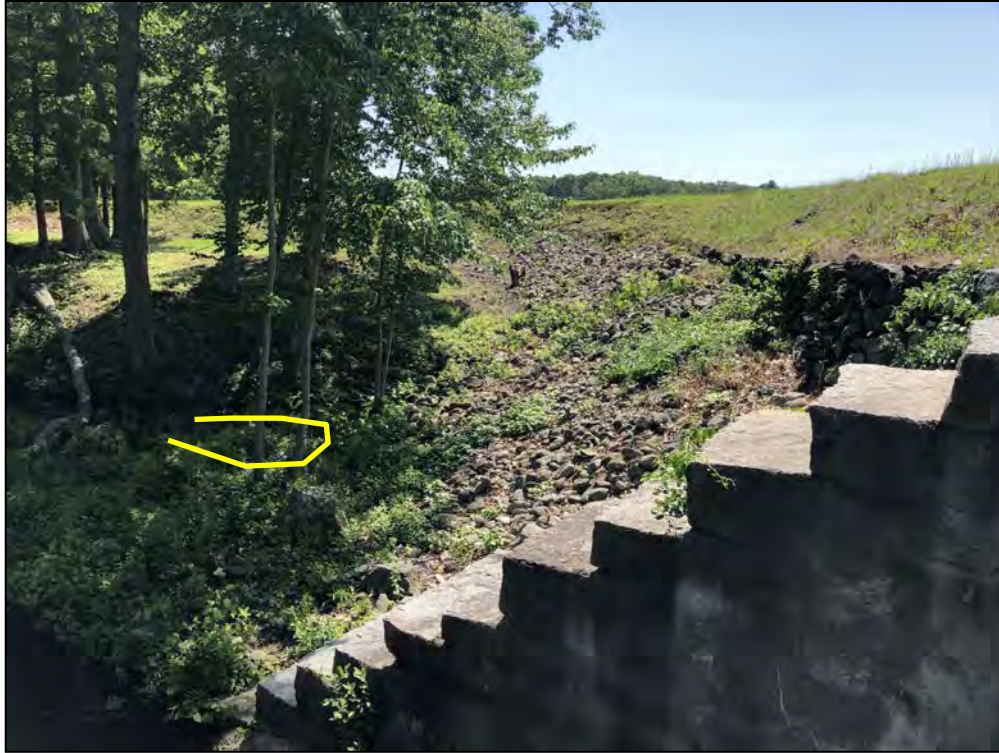
- The wall right of the outlet was buttressed with 3 to 6-inch diameter stone and was generally clear of unwanted vegetation.
 - An area of seepage was previously observed along a 3 to 5-foot long section of the toe of the buttress stone with clear flow approximated at 10-20 gpm. During this inspection, the tailwater (approximately 6 inches higher than reported during the previous inspection) inhibited confirmation of this observation. No signs of flow were observed during this inspection. Minor scarping up to 6 inches was located along this area at the waterline.

Photo No. 11: Main Dam - Downstream side of the embankment right of the outlet structure. Note the location of the previously reported seepage.

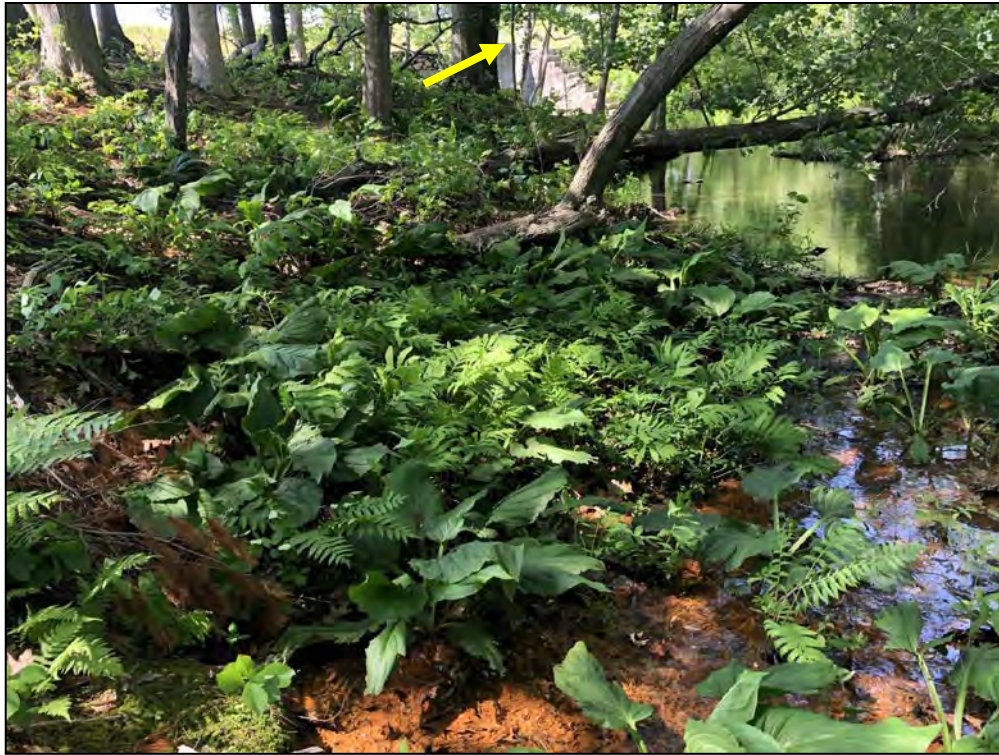
- A 24-inch diameter stump was noted near the toe of the slope near STA 2+10.
 - 50 feet downstream of the toe, and near the right abutment of the mild wooded slope of the downstream area, several areas (3±) of seepage were noted, each approximated between 1-3 GPM, some with iron oxide staining and one with a possible accumulation of sand downstream of the seepage area. More areas that were noted in the previous inspection report may be present during lower tailwater conditions, but were not observed during this inspection.

Photo No. 13: Main Dam - Seepage at the toe of the wooded slope 100 feet downstream and right of the outlet structure (arrow).

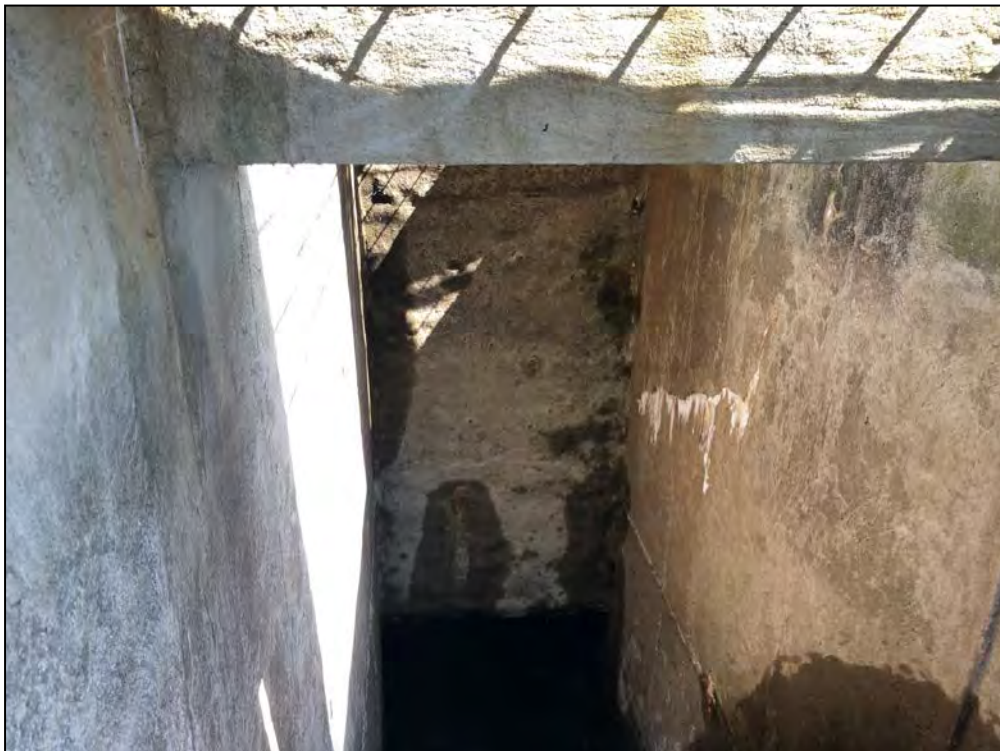
Photo No. 16: Main Dam - View of the upstream end of the outlet conduit. Note the hairline crack with efflorescence on the interior of the right wall of the intake structure and the saturated areas along the conduit upstream headwall.

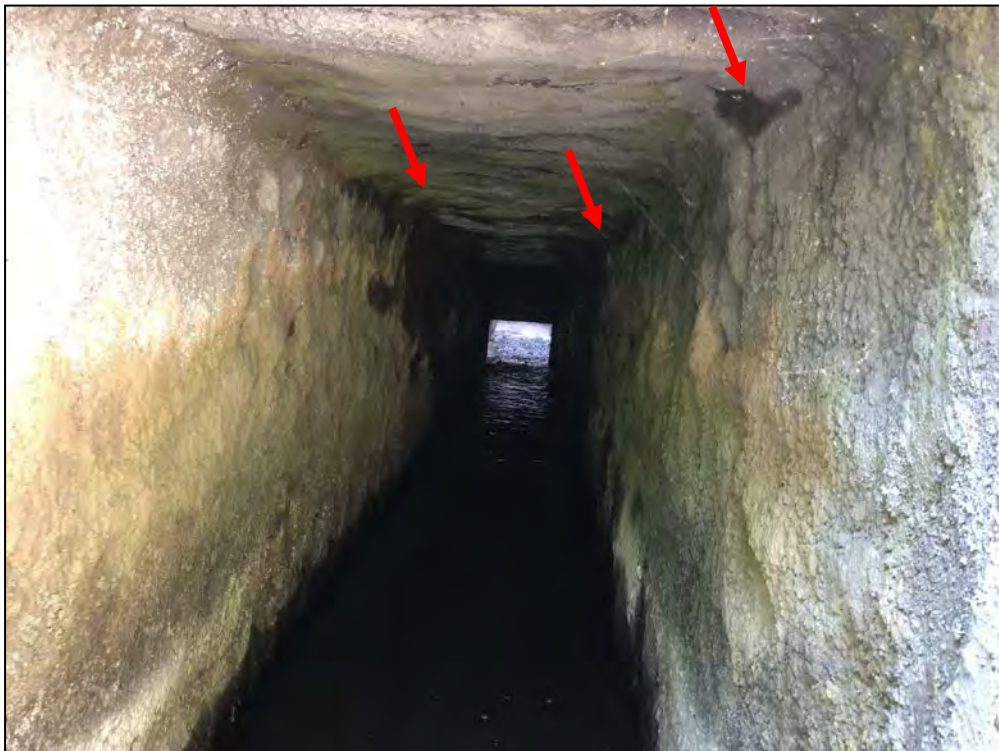
Photo No. 18: Main Dam - Interior of the outlet conduit as viewed from the downstream end looking upstream. Note the saturated wall and ceiling areas along the upstream portion of the conduit.

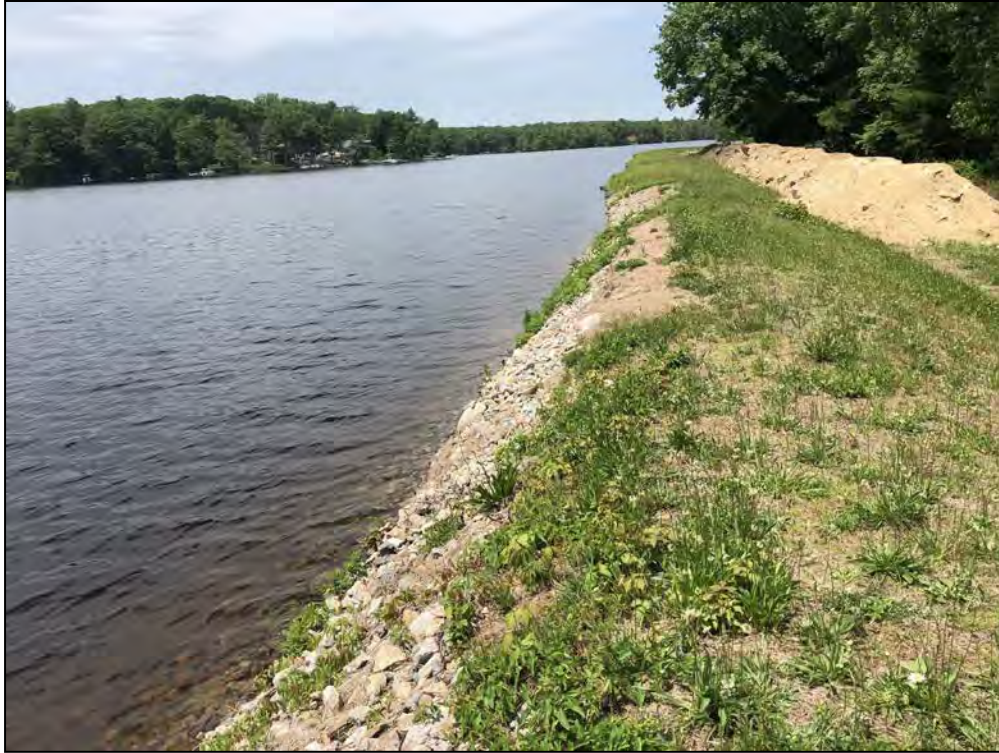
Photo No. 25: Bookers Dam - Upstream slope and crest from near STA 9+00 looking left. Note area of damaged slope and stored material along the downstream toe of the slope.

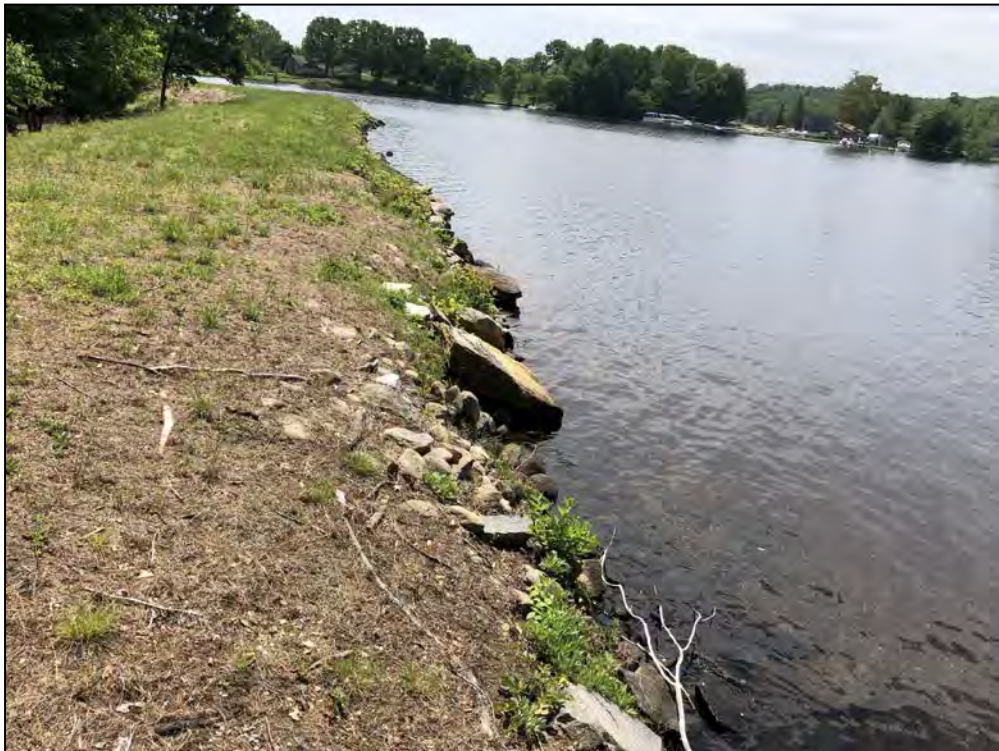
- The alignment of the slope was irregular in areas.
- In general, the 12-inch diameter riprap along the lower section of the slope appeared okay.
 - Areas of near vertical slope were observed between STA 0+00 and 0+30 between the mid-slope of the embankment to near the water line.

Photo No. 26: Bookers Dam - Upstream slope from near the right abutment looking right. Note the irregular alignment of the slope.

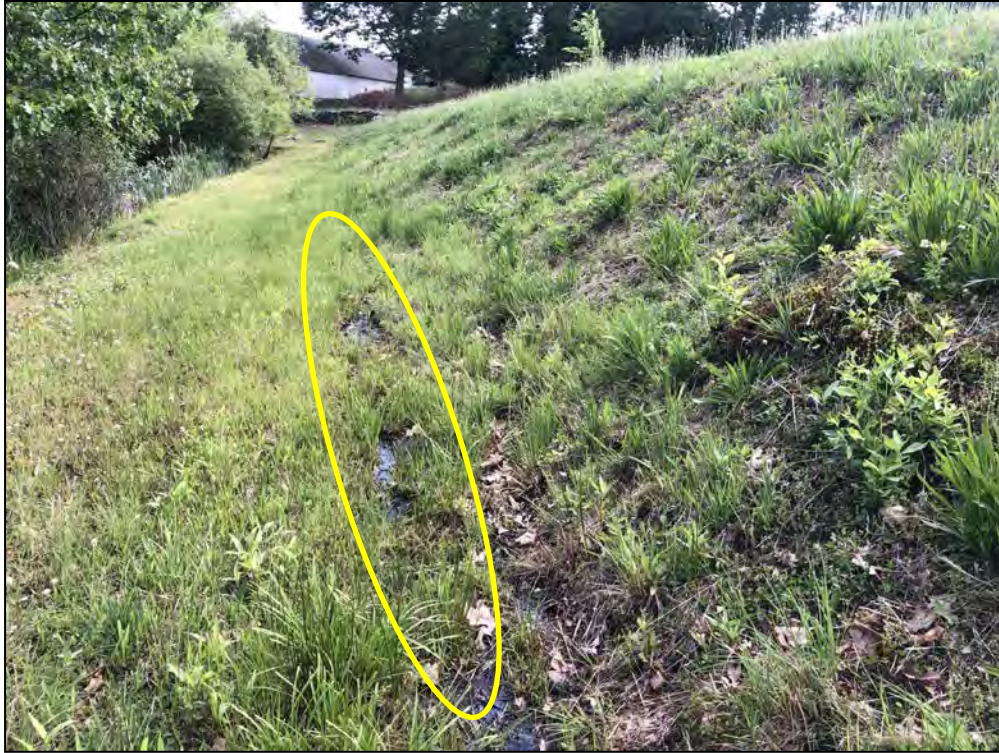
- STA 1+36 to 1+44 – Low-flow seepage, approximately 1-foot above the toe of the slope above the seepage channel.
 - STA 6+90 – Approximately ½ gpm of seepage was noted at the toe of the slope along the seepage channel with orange staining.

Photo No. 31: Bookers Dam - Downstream embankment from near STA 2+50 looking right. Note seepage areas along the toe of the slope.

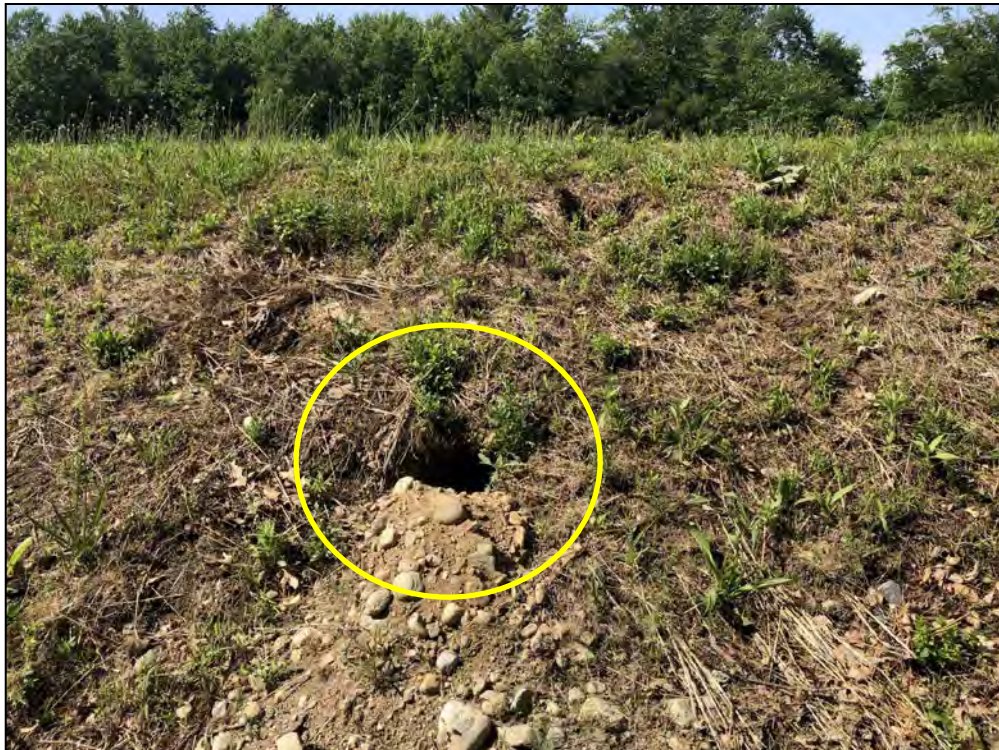
- The following was noted between the right abutment and STA 7+50.
 - Numerous significant animal burrows were noted along the slope. Some were measured at 10-inch diameter and up to 48 inches deep. Fresh spoils were located outside of the animal burrows. Gophers were actively observed on the dam slopes and entering the burrows during the time of the inspection. Please refer to the following locations for significant animal burrows:

Photo No. 32: Bookers Dam - Typical active animal borrow near 4+00 along the downstream side of the embankment. Note the fresh gravelly-sand spoils along the underside of the borrow.

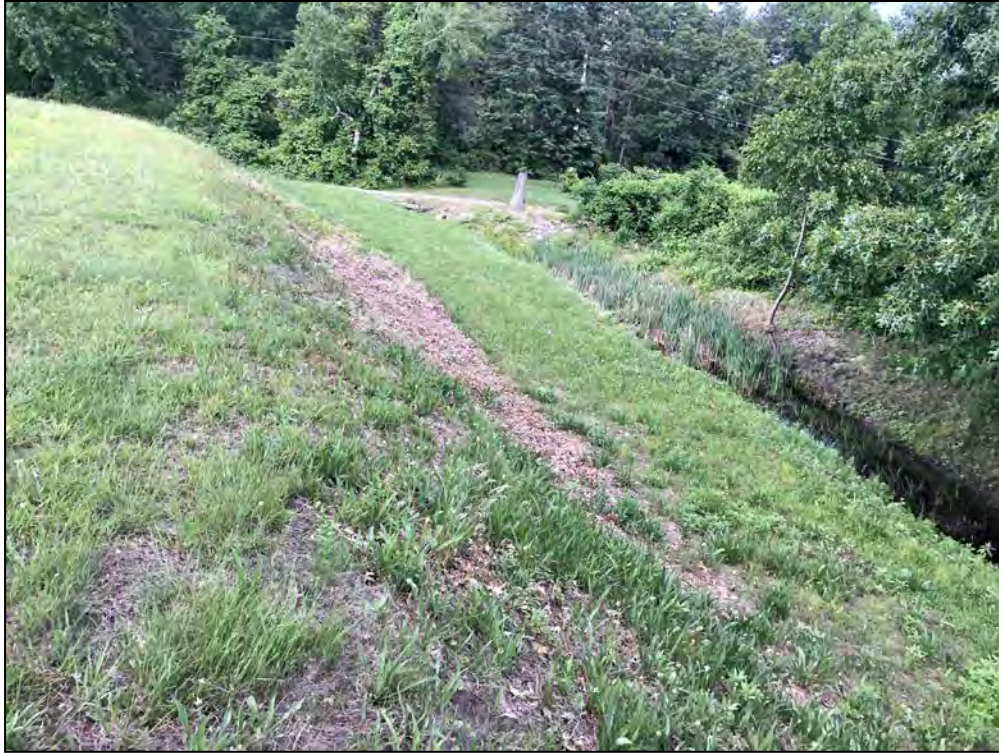
Photo No. 33: Bookers Dam - Downstream slope from near STA 6+00 looking left. Note the seepage channel along the downstream end of the embankment.

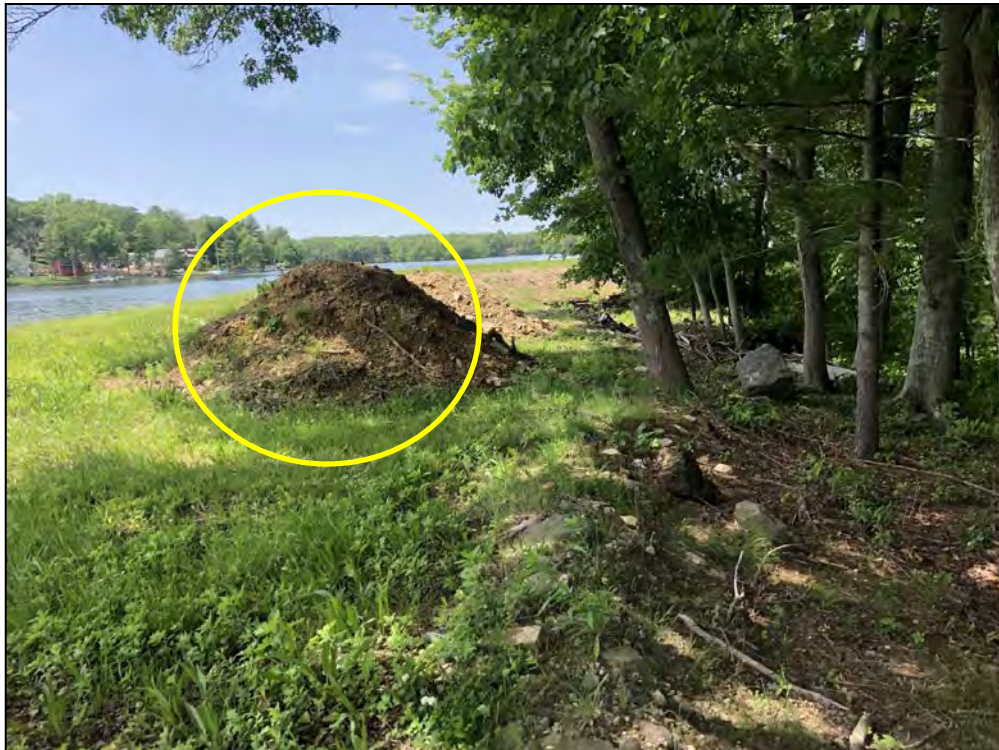
Photo No. 34: Bookers Dam - Downstream slope from near STA 9+50 looking left. Note stored material along the mid-slope.

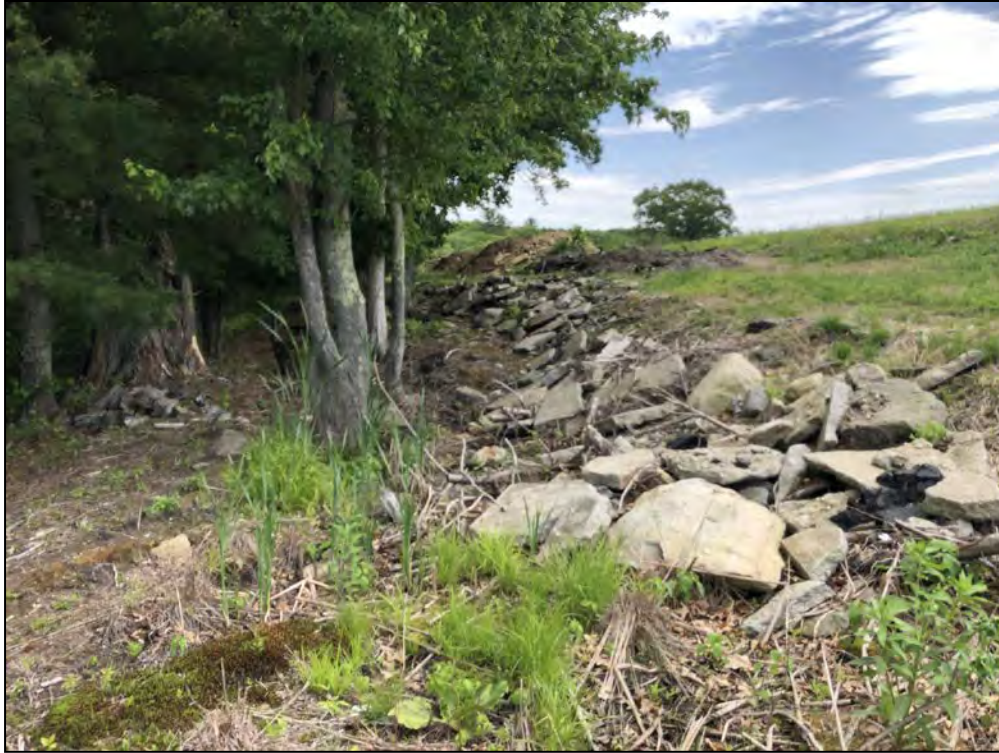
Photo No. 35: Bookers Dam – Concrete debris dumped along the downstream slope near STA 12+00.

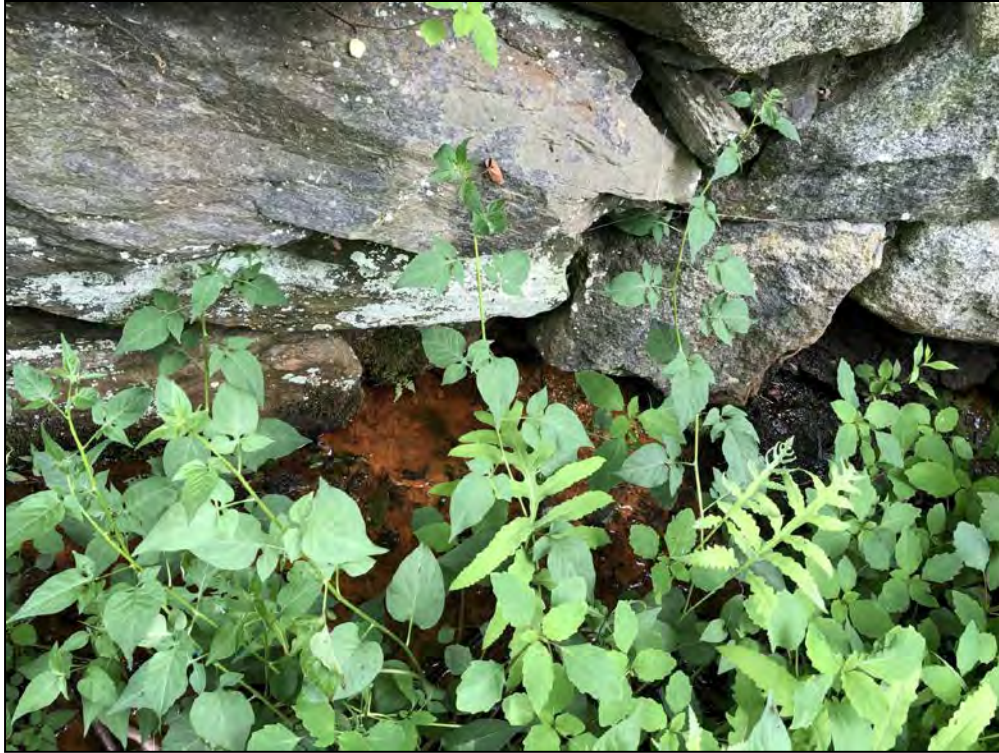
- The ground surface along the toe of the wall was saturated with wetland vegetation from STA 12+95 to 14+00. Several areas (4 to 6) of seepage flow (approximated between 0.5 and 1 GPM) were observed along the base of the wall at the tallest section of the wall.

Photo No. 37: Bookers Dam – Seepage along the base of the downstream stone masonry wall near STA 13+25.

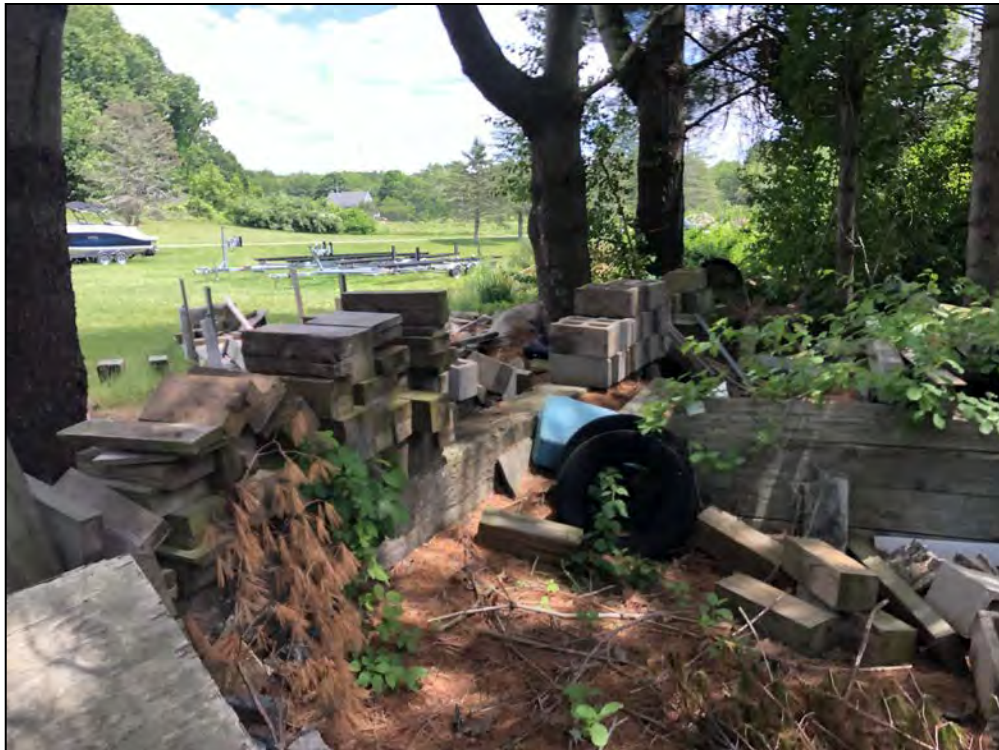
Photo No. 40: Marina Dam – Overview of the marina walls looking right towards pine ledge road. Note materials stored along and on top of the flood walls.

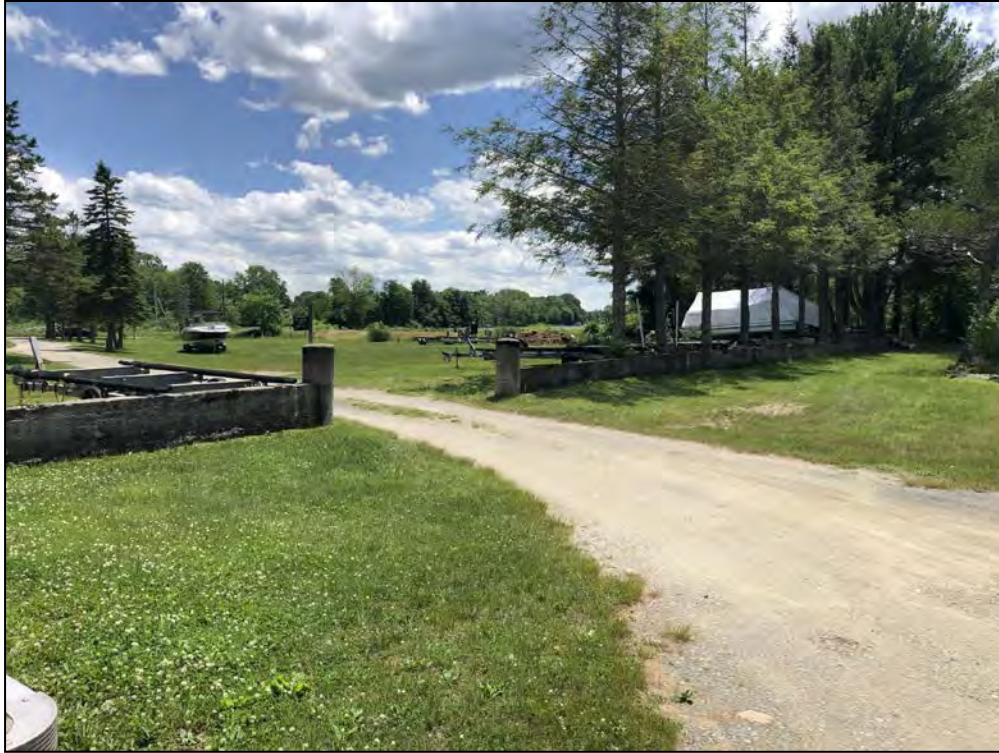
Photo No. 41: Marina Dam – View of the floodwalls at the Marina from the upstream side looking downstream. Note the area of the access road through the floodwalls is lower than the floodwalls.

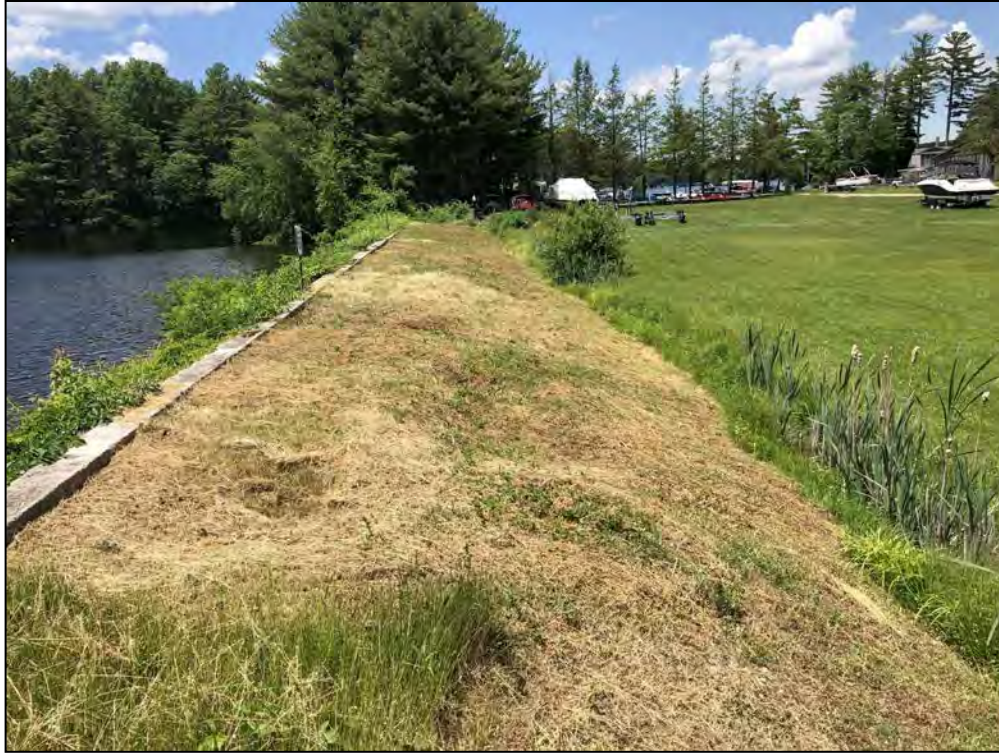
- The top of the concrete core wall was exposed with numerous deficiencies observed included cracks and spalled sections.
- The downstream slope had significant vertical irregularities including depressions and bulges up to 6 feet in diameter and 24 inches in variability.

Photo No. 45: Pine Ledge Road to West Greenville Road Dam – Crest and downstream slope of the embankment left of Pine Ledge Road. Note the vertical irregularities along the downstream slope.

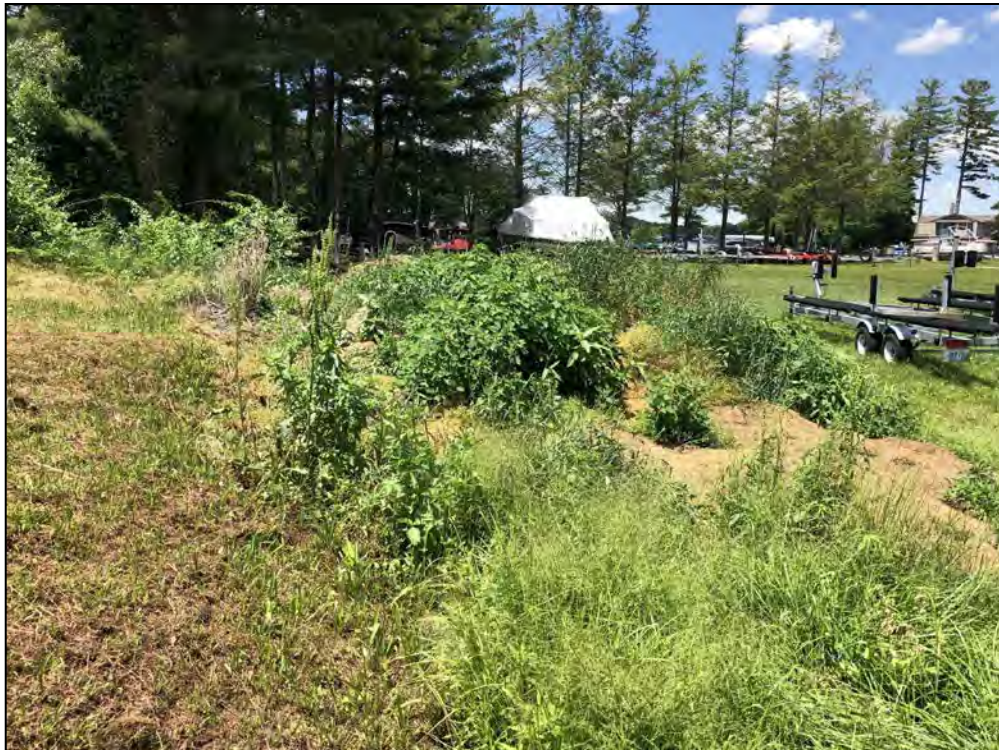
Photo No. 46: Pine Ledge Road to West Greenville Road Dam – Accumulated clippings and vegetation along the toe of the embankment left of Pine Ledge Road near the left abutment.

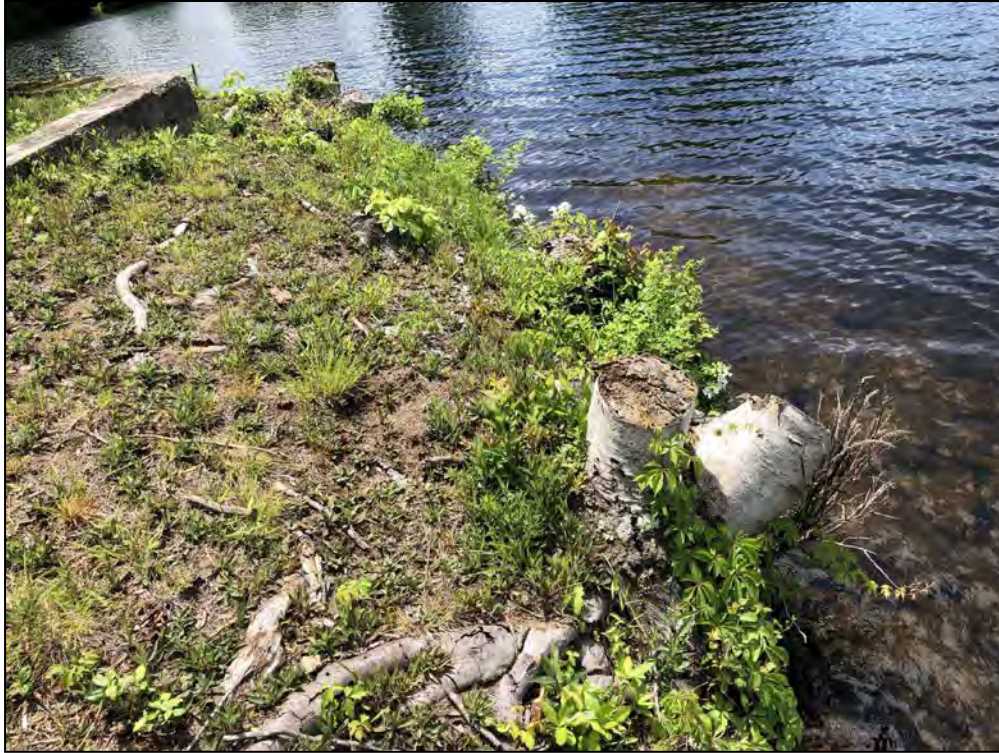
Photo No. 49: Pine Ledge Road to West Greenville Road Dam – Tree stumps along the upstream slope near STA 3+25.

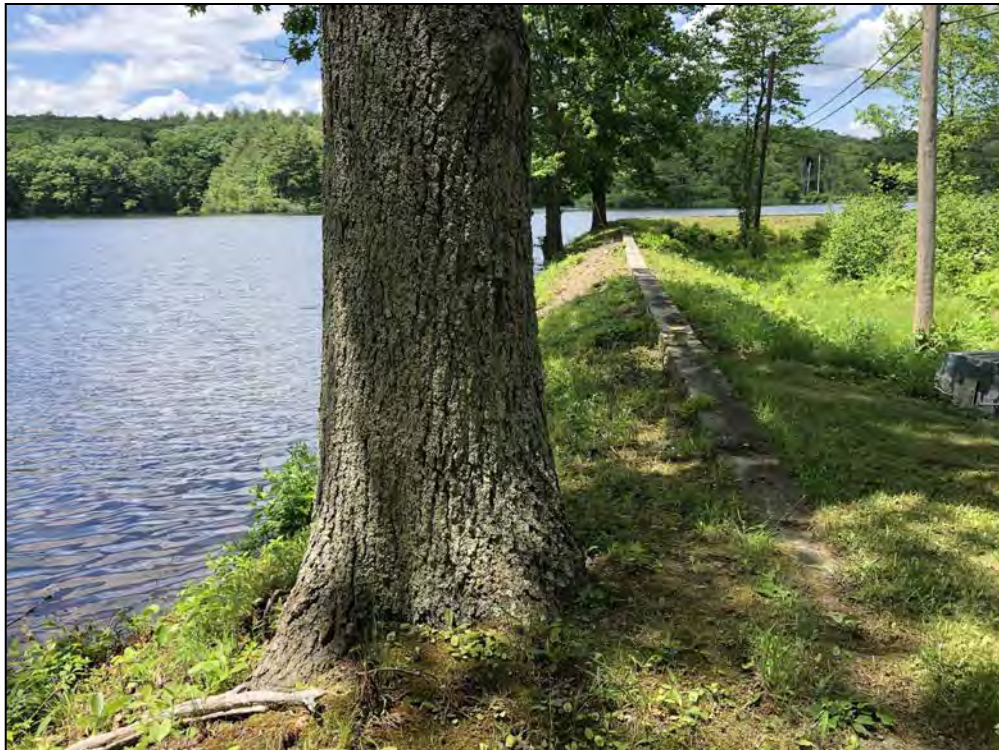
Photo No. 50: Pine Ledge Road to West Greenville Road Dam – Crest, concrete corewall, and upstream slope of the embankment right of Pine Ledge Road from near the right abutment looking left. Note the 30-inch tree located at the right abutment and the two trees in the background of the photo near STA 4+00.

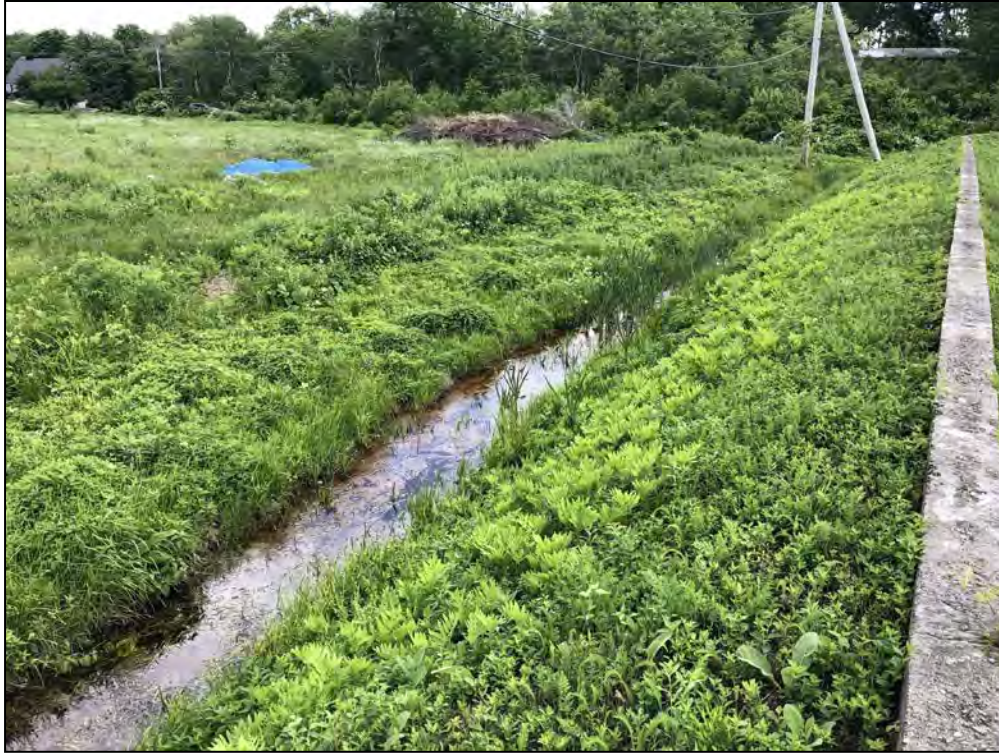
- The drainage/seepage swale was generally clear of debris right of the stockpiled grass clippings and was observed to be flowing with iron oxide stained flow. Flow was approximated at 3 GPM at the right end of the swale just upstream of the culvert crossing that

Photo No. 51: Pine Ledge Road to West Greenville Road Dam – Overview of the downstream slope from near STA 0+10 looking right. Note the orange stained seepage channel along the toe of the embankment.

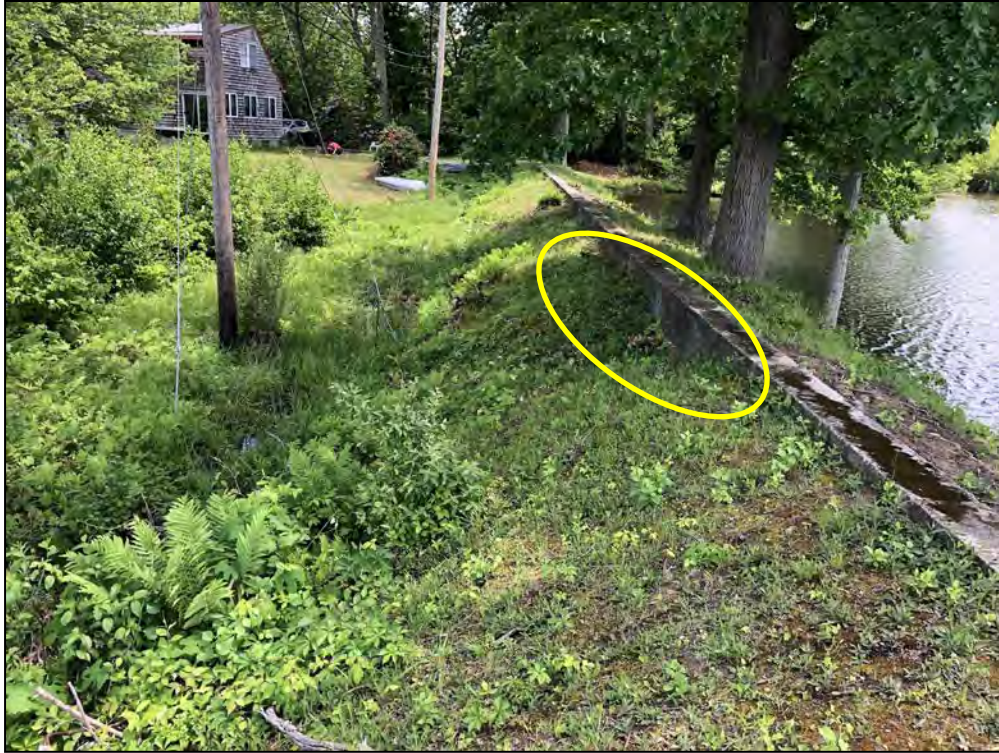
Photo No. 53: Pine Ledge Road to West Greenville Road Dam – Overview of the downstream slope from near STA 3+75 looking right. Note the eroded area of the downstream slope near STA 4+00 exposing the corewall.

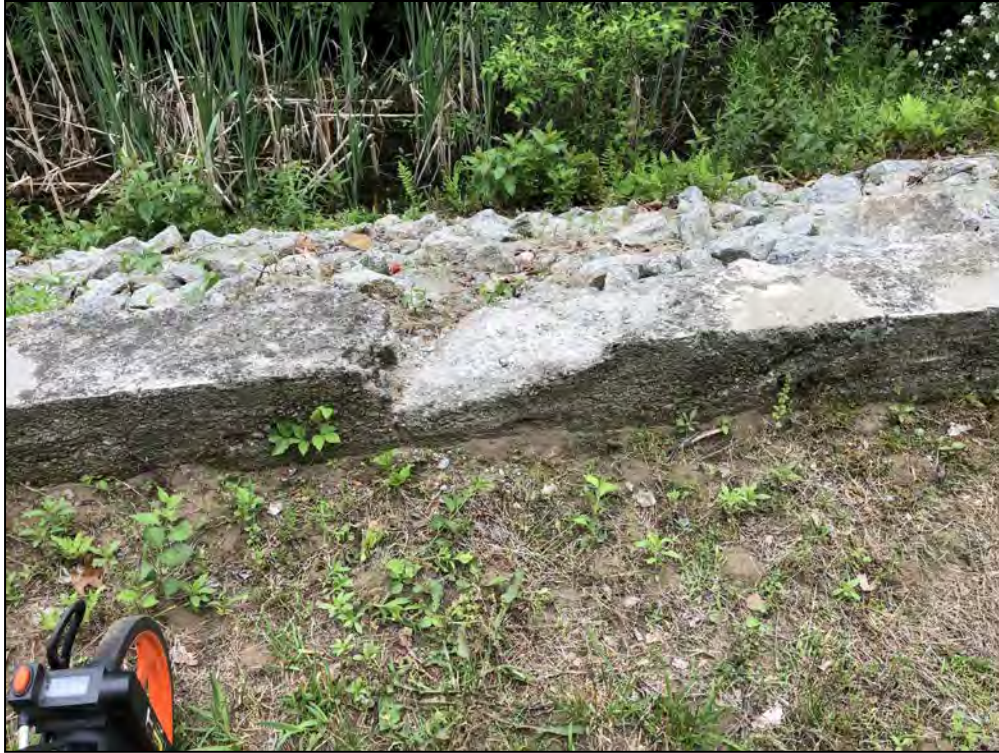
Photo No. 57: Spillway Section – Spalled and cracked concrete near STA 9+00.

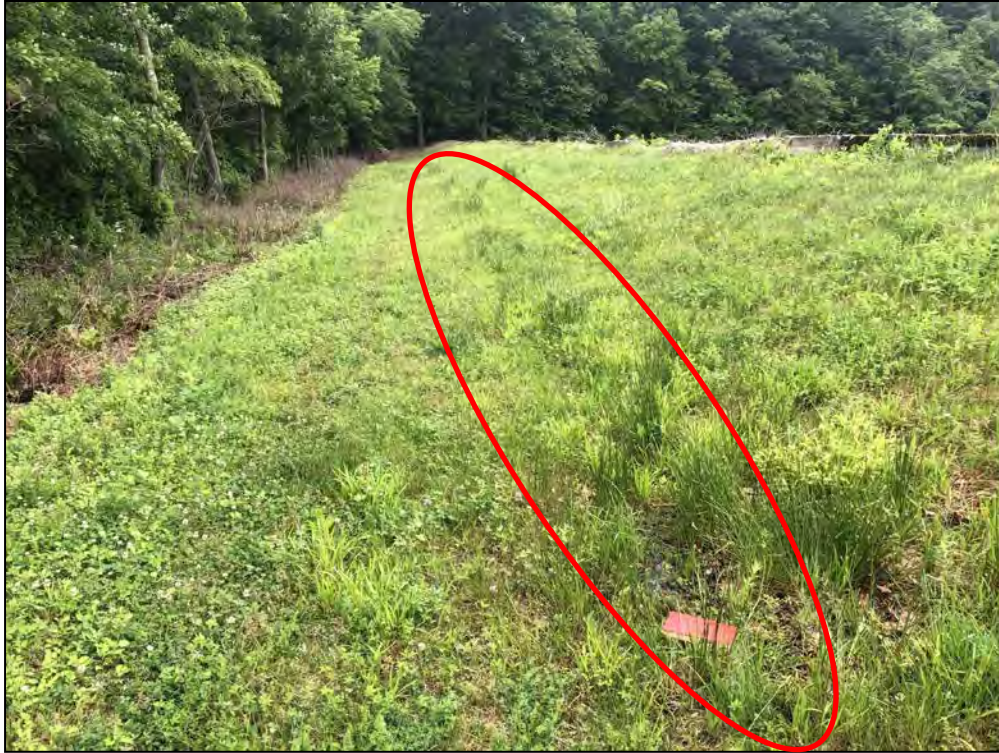
Photo No. 59: Spillway Section – Downstream slope from near STA 2+50 looking right. The locations of the saturated areas are evidenced by tall grass at the toe of the slope.

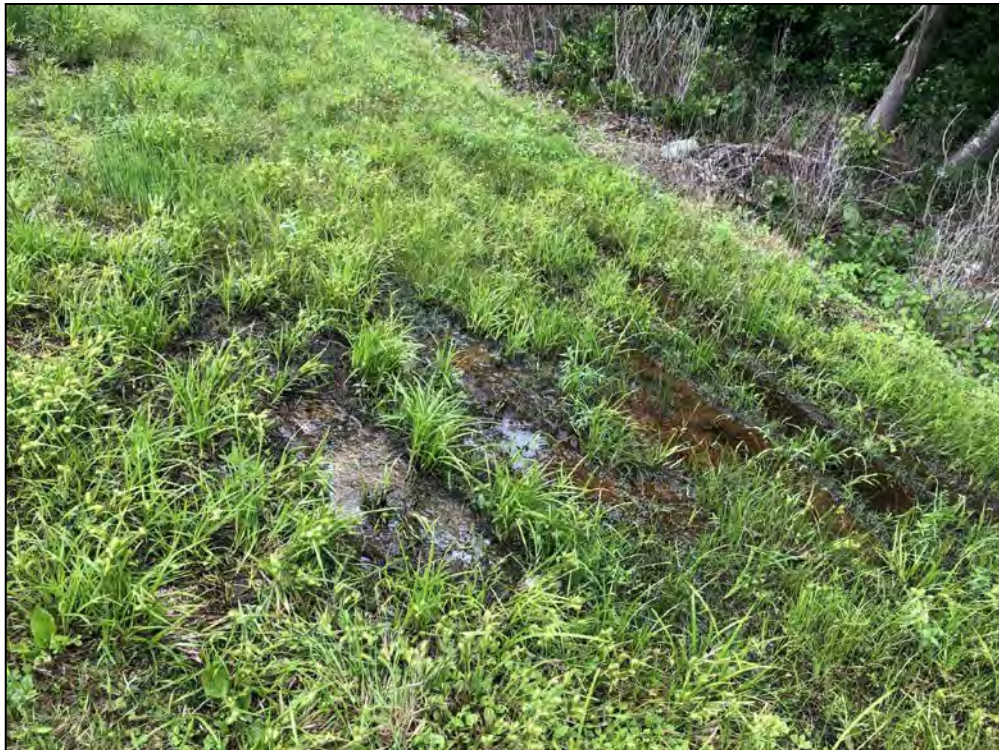
Photo No. 60: Spillway Section – Tire rutting with seepage near STA 1+70 along the toe of the slope.

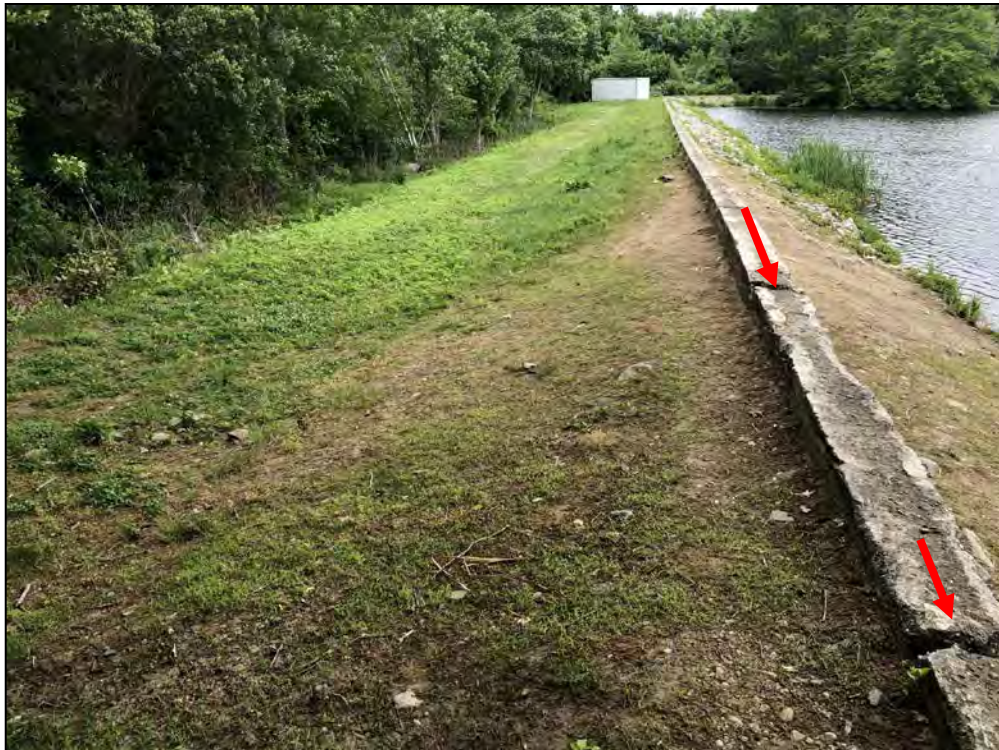
Photo No. 62: Spillway Section – Downstream slope from near the left abutment looking right. Note through cracks along the corewall.
