OLNEY POND DAM, LINCOLN (102)

Olney Pond Dam (**Figure 1**) has been classified by DEM as having a **High Hazard** potential. The following report summarizes GZA's evaluation of the dam's potential impact area due to failure of the dam.

1.00 SUMMARY OF SITE AND POTENTIAL DOWNSTREAM IMPACT AREA

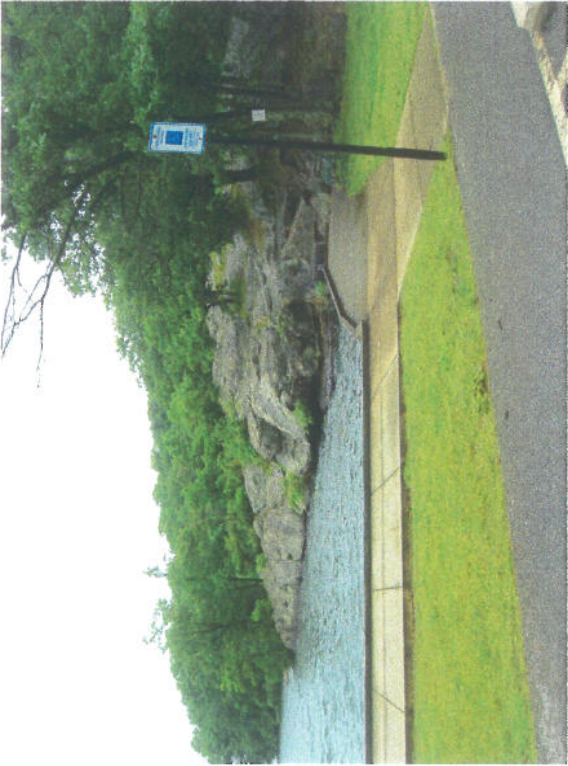
Photo 1. View of left side of dam and primary spillway from downstream.

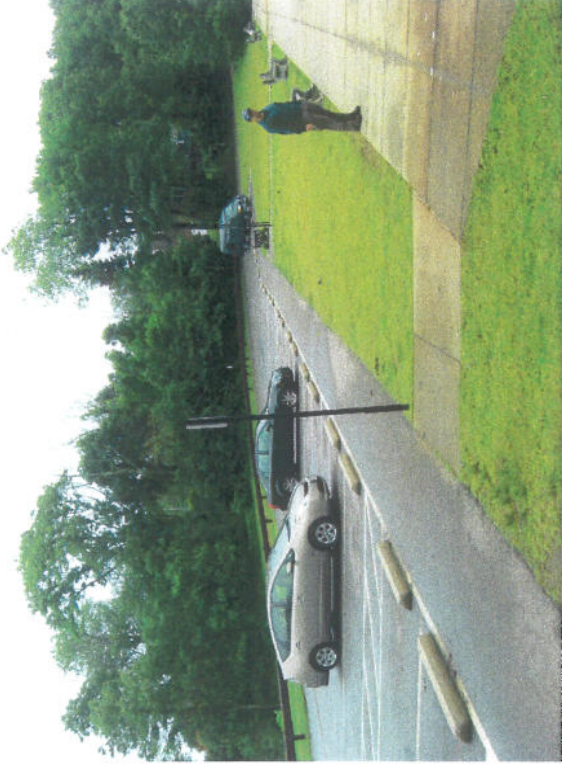
Photo 2. View looking at dam from left abutment.

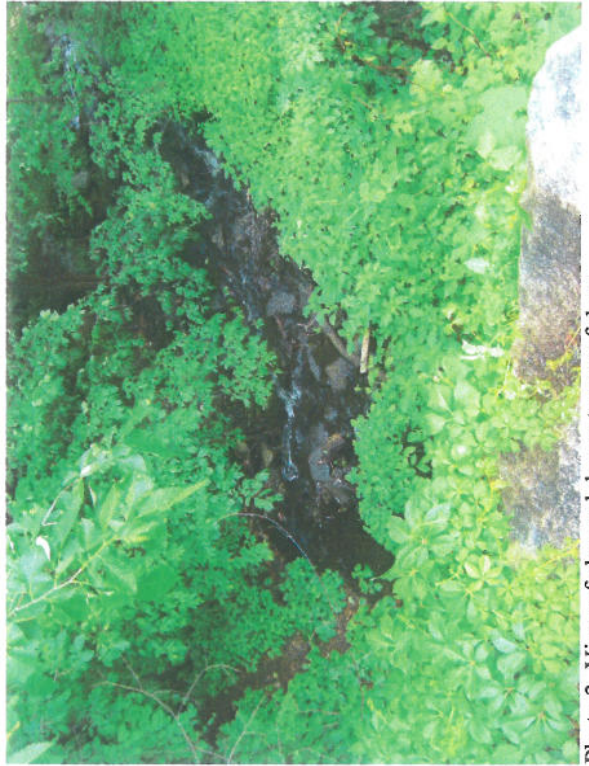
Photo 3. View of channel downstream of dam.

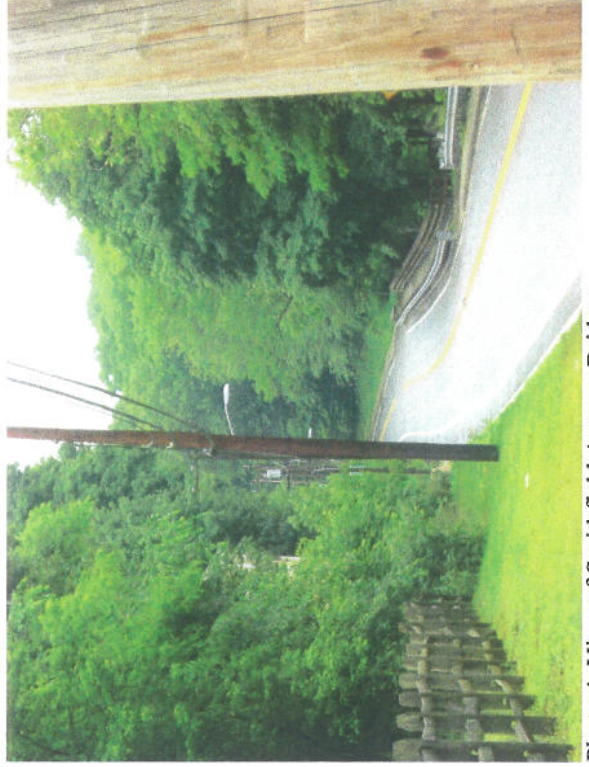
Failure of the dam would also likely overtop and wash out the Smithfield Avenue Bridge, among others located downstream. Finally, since the flood wave is likely to be considerably larger than the spillway capacity of the downstream dams, it is GZA's opinion, that it is likely that both of the dams summarized in section 1.21 will overtop and fail due to the large flows expected in the event of failure of Olney Pond Dam.

Photo 4. View of Smithfield Avenue Bridge.

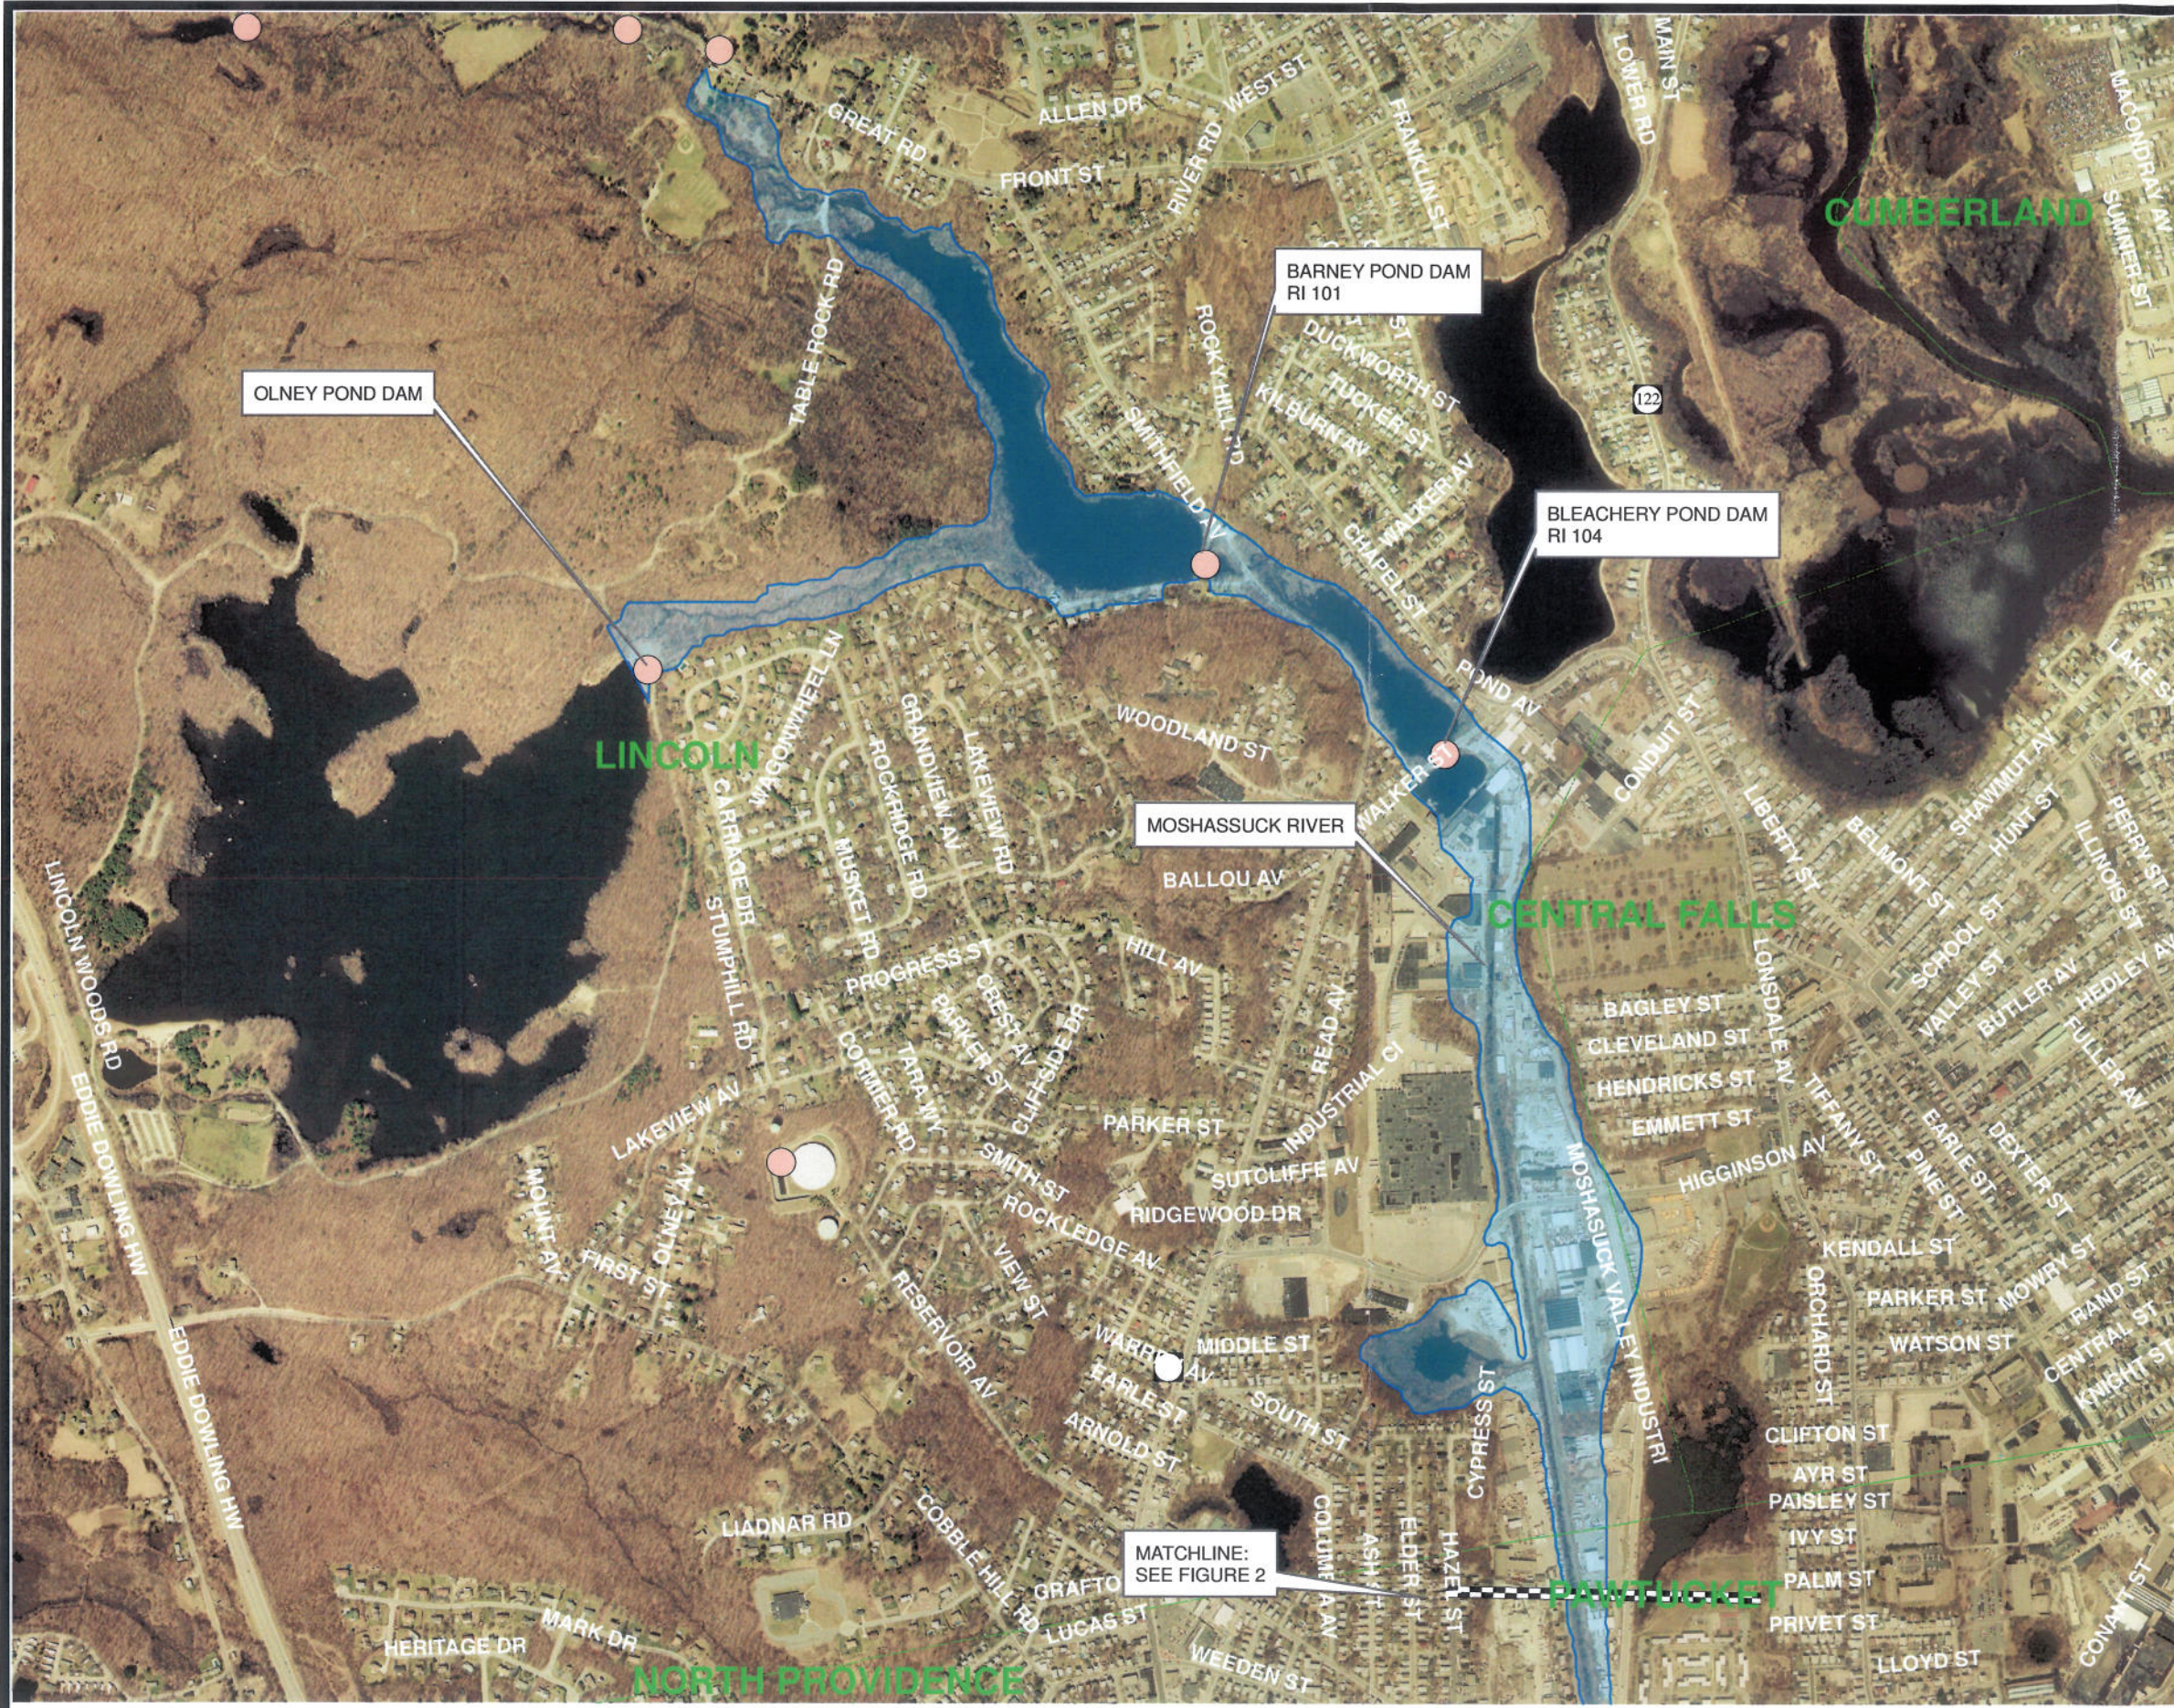
Proj. Mgr.: DML Designed By: CNF Reviewed By: PHB Operator: CNF	Dwg. Date: 2009 Job No.: 17085.40	Figure No.: 24
--	--------------------------------------	--------------------------

Several riverine cross sections, developed by GZA from USGS 7.5 minute quadrangle maps and RIGIS mapping data, were input into the SMPDBK model to preliminarily estimate approximate peak water surface elevations. The results of the analysis are provided as the approximate inundation area depicted in **Figures 2A through 2D**.

Results of the analysis indicate a peak flood depth of about 22 feet downstream of the dam on the Threadmill Brook.

The hypothetical failure of the dam would likely flood the residential, commercial and industrial buildings and facilities in the low-lying areas along the Threadmill Brook and Moshassuck River throughout the inundation zones. The inundation area is anticipated to include several occupied buildings. Loss of life is considered probable, in GZA's opinion.
