SAFER SEAS DIGEST

LESSONS LEARNED FROM MARINE ACCIDENT INVESTIGATIONS

2016

NATIONAL
TRANSPORTATION
SAFETY BOARD

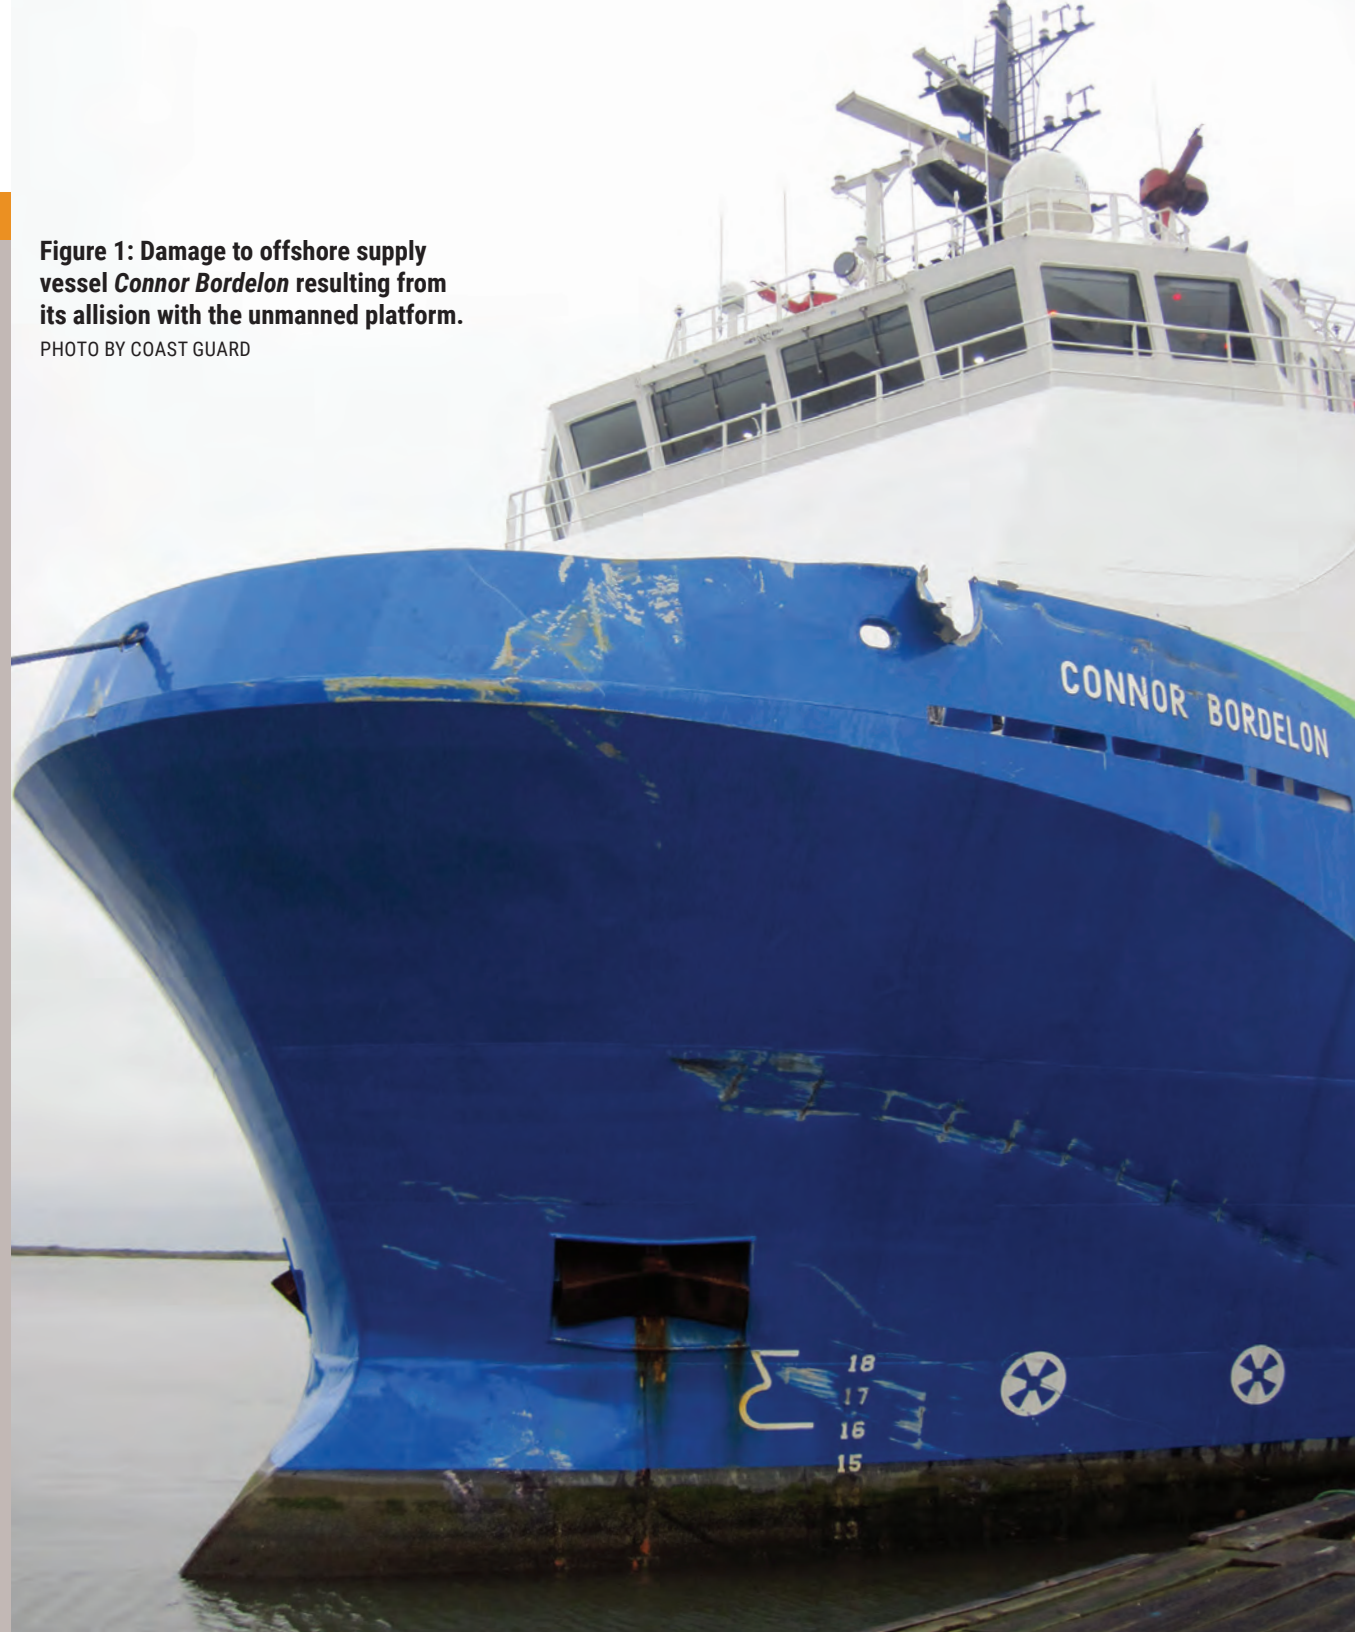
Figure 1: Damage to offshore supply vessel *Connor Bordelon* resulting from its allision with the unmanned platform.

The allision caused the pipelines attached to the platform to rupture and the natural gas and oil inside the pipelines to ignite. After the allision, the pipelines were shut down, while three good Samaritan vessels in the area applied water to put out the fire. The allision also resulted in a breach in the *Connor Bordelon's* hull below the waterline that caused the vessel to begin taking on water. The captain contacted the US Coast Guard to report the accident, and the Coast Guard released the vessel from the accident area. The *Connor Bordelon* proceeded to Port Fourchon while the crew addressed the flooding.

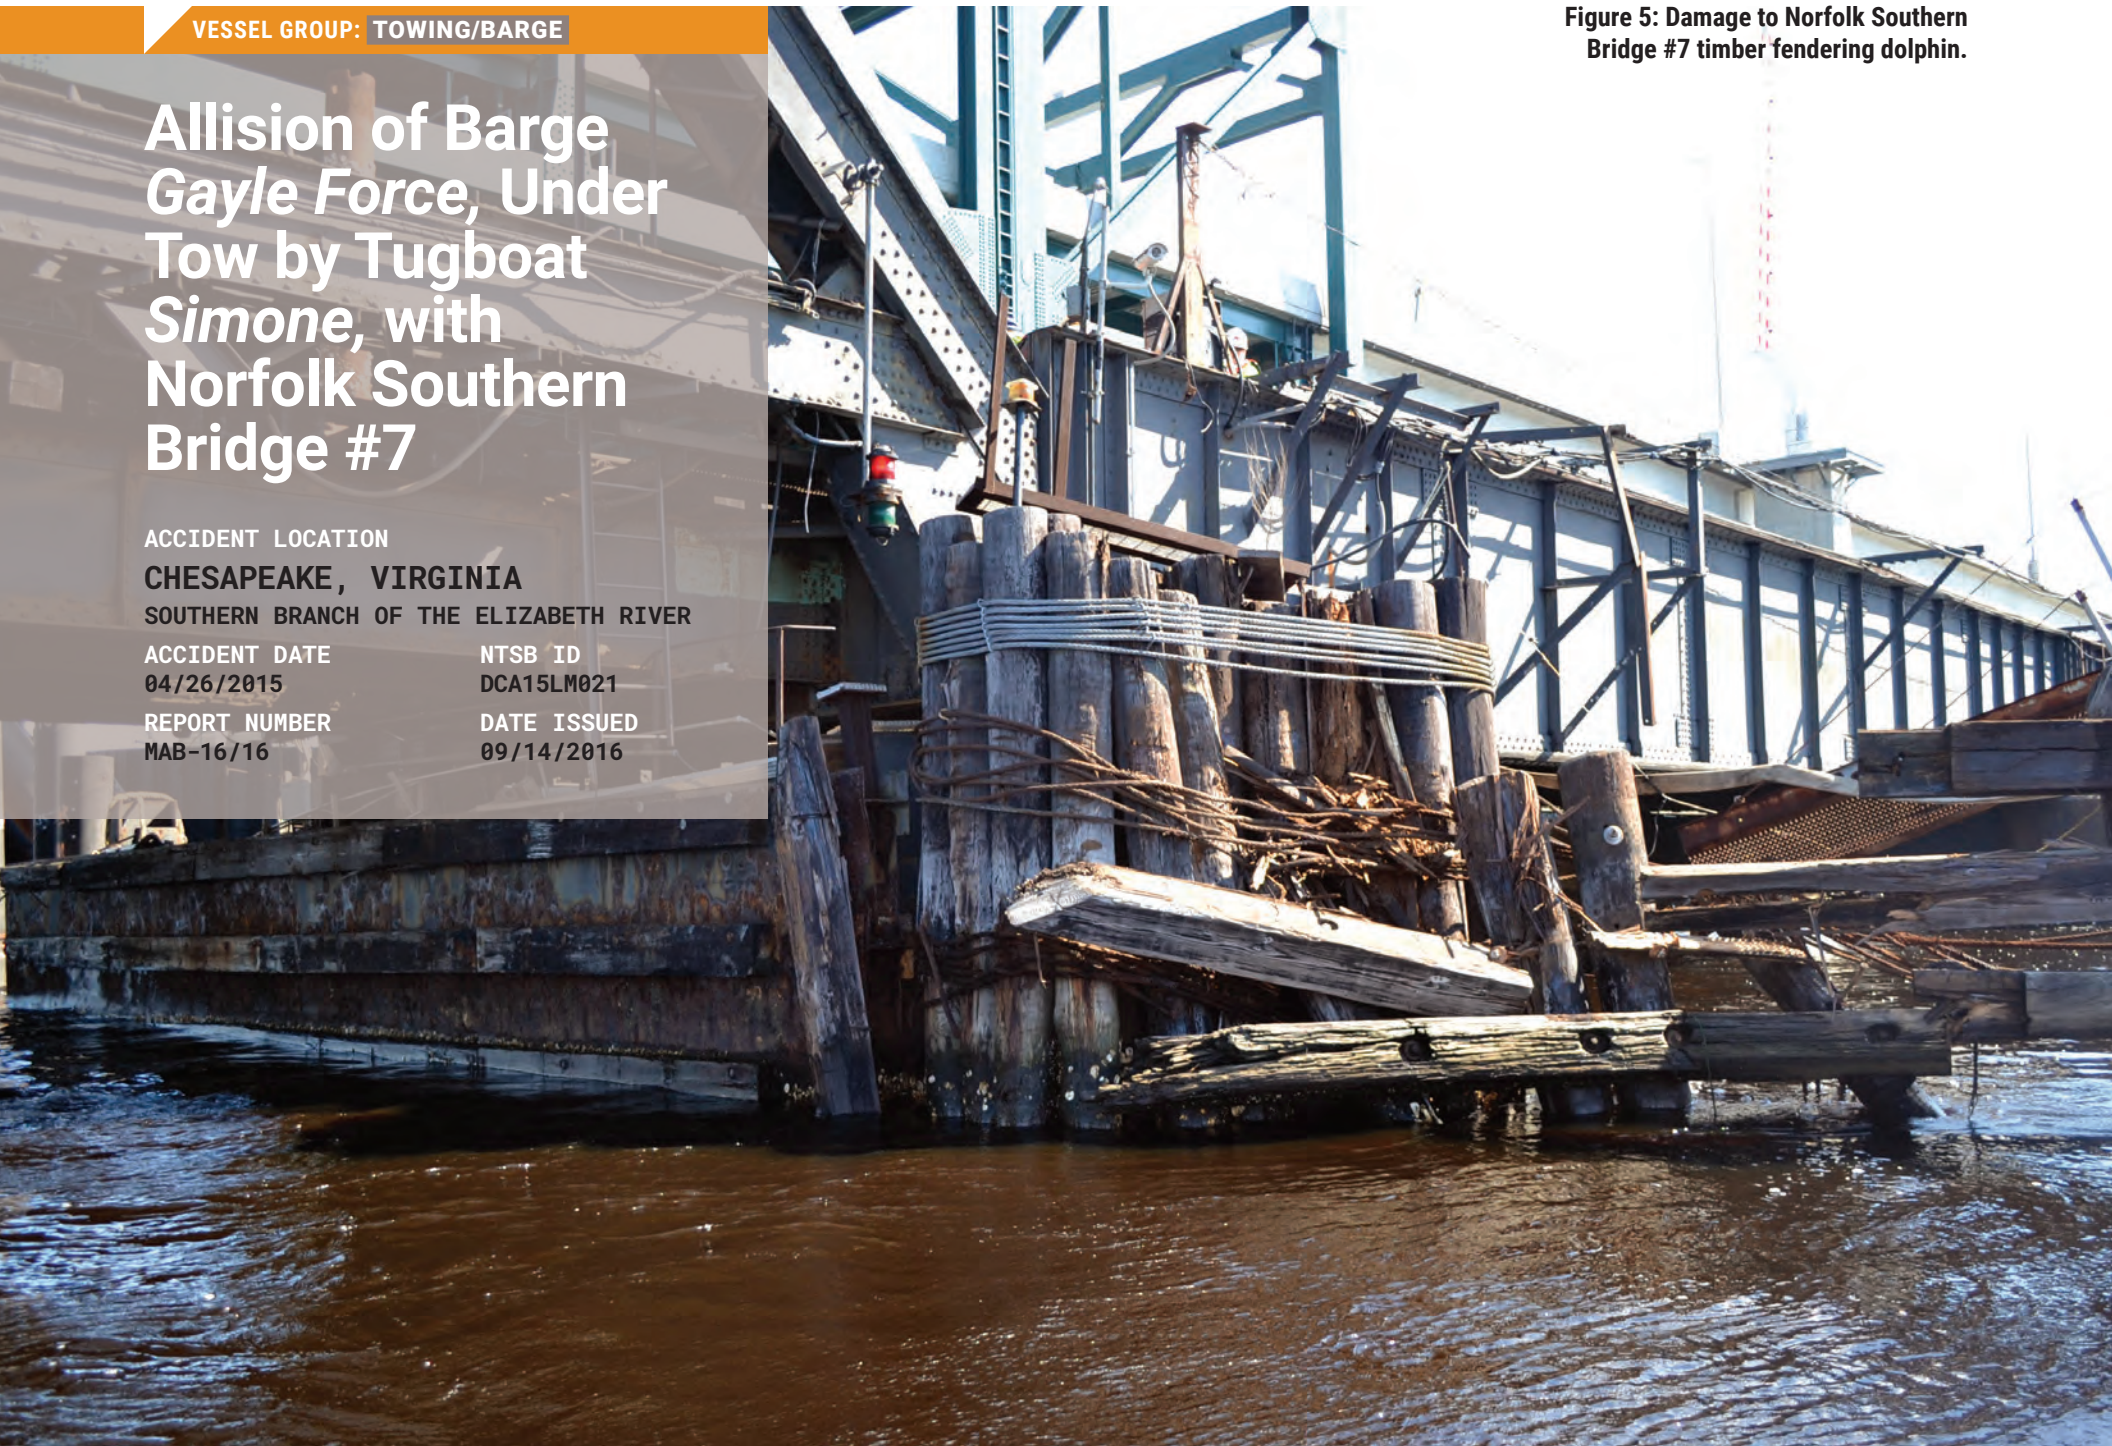
Figure 5: Damage to Norfolk Southern Bridge #7 timber fendering dolphin.

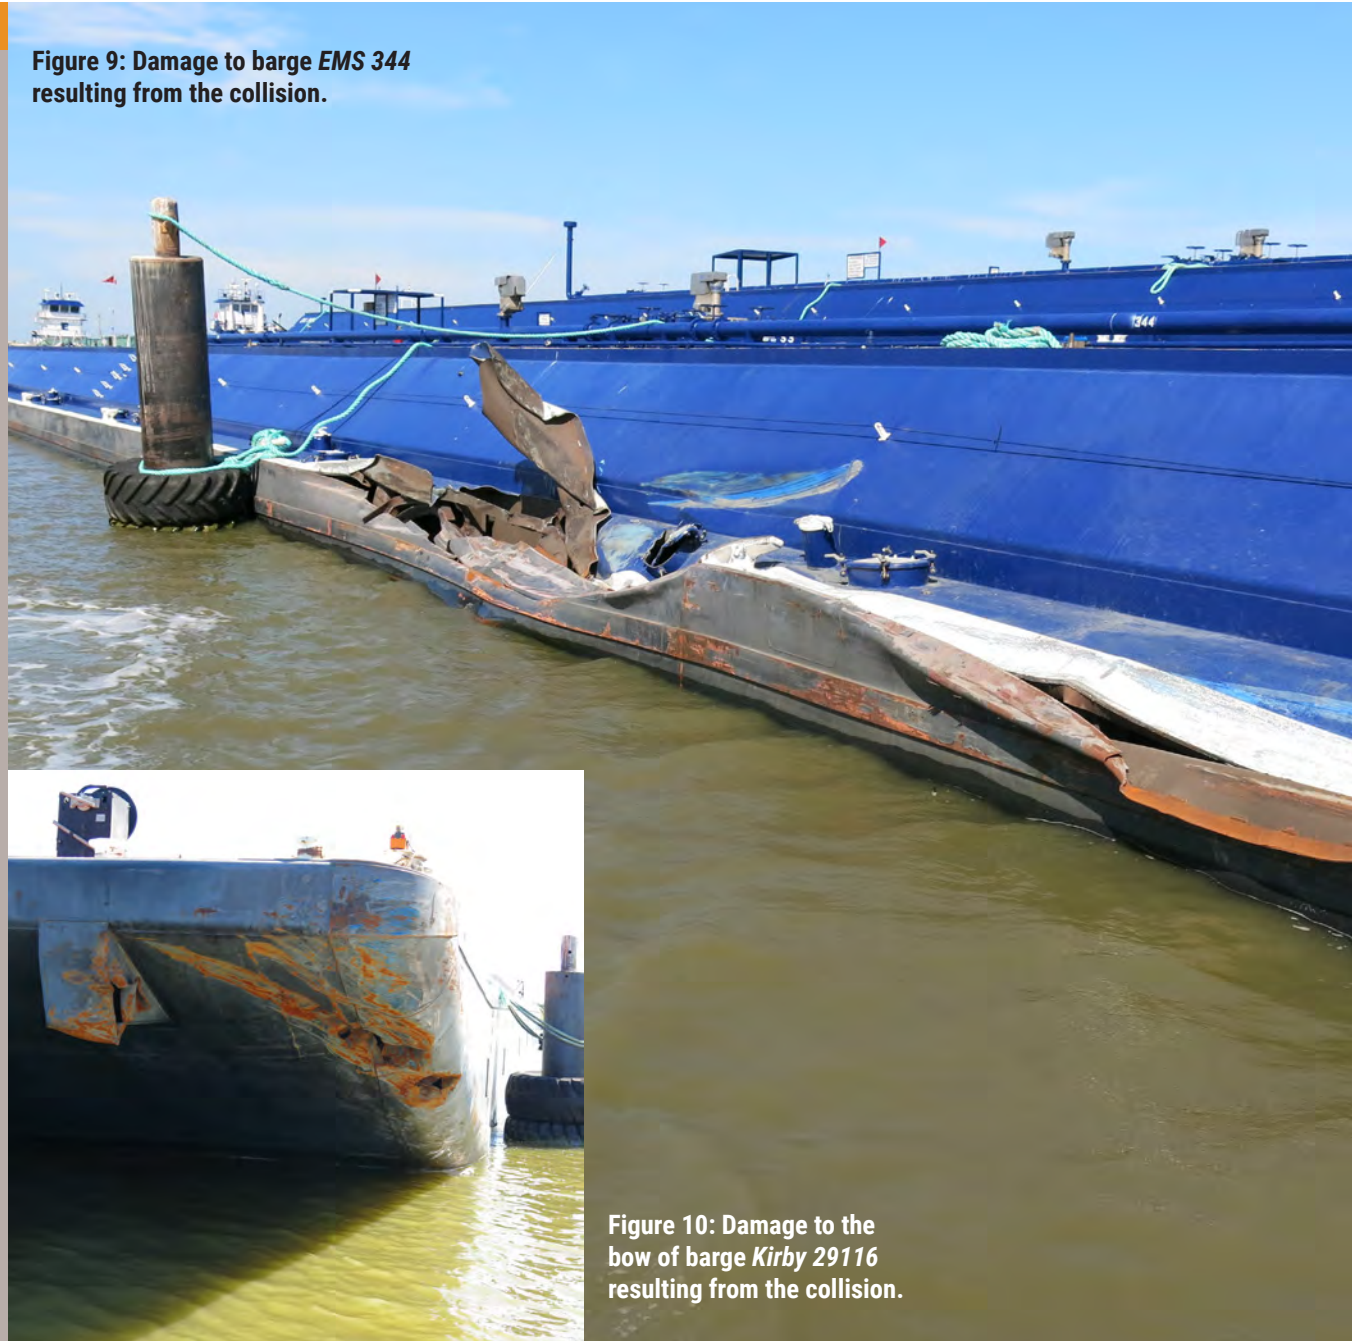
Figure 9: Damage to barge *EMS 344* resulting from the collision.

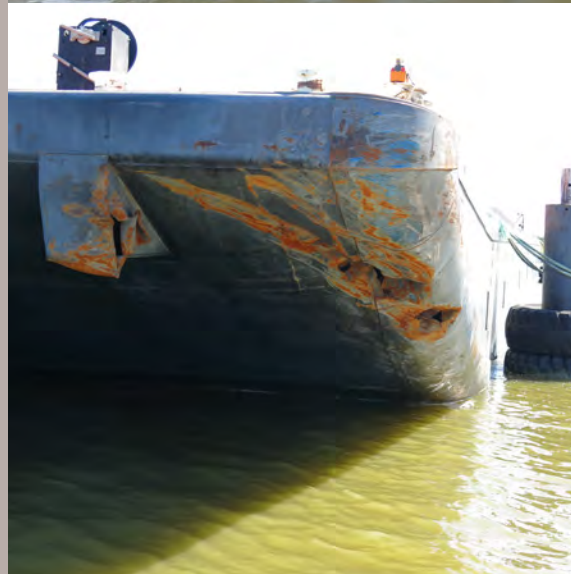
Figure 10: Damage to the bow of barge *Kirby 29116* resulting from the collision.

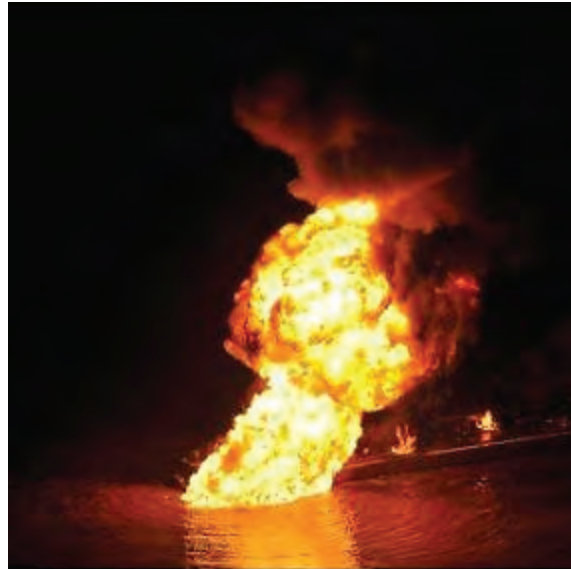
Figure 11: Fire aboard barge EMS 343 after the collision. PHOTO BY PENNENERGY, JULY 2015

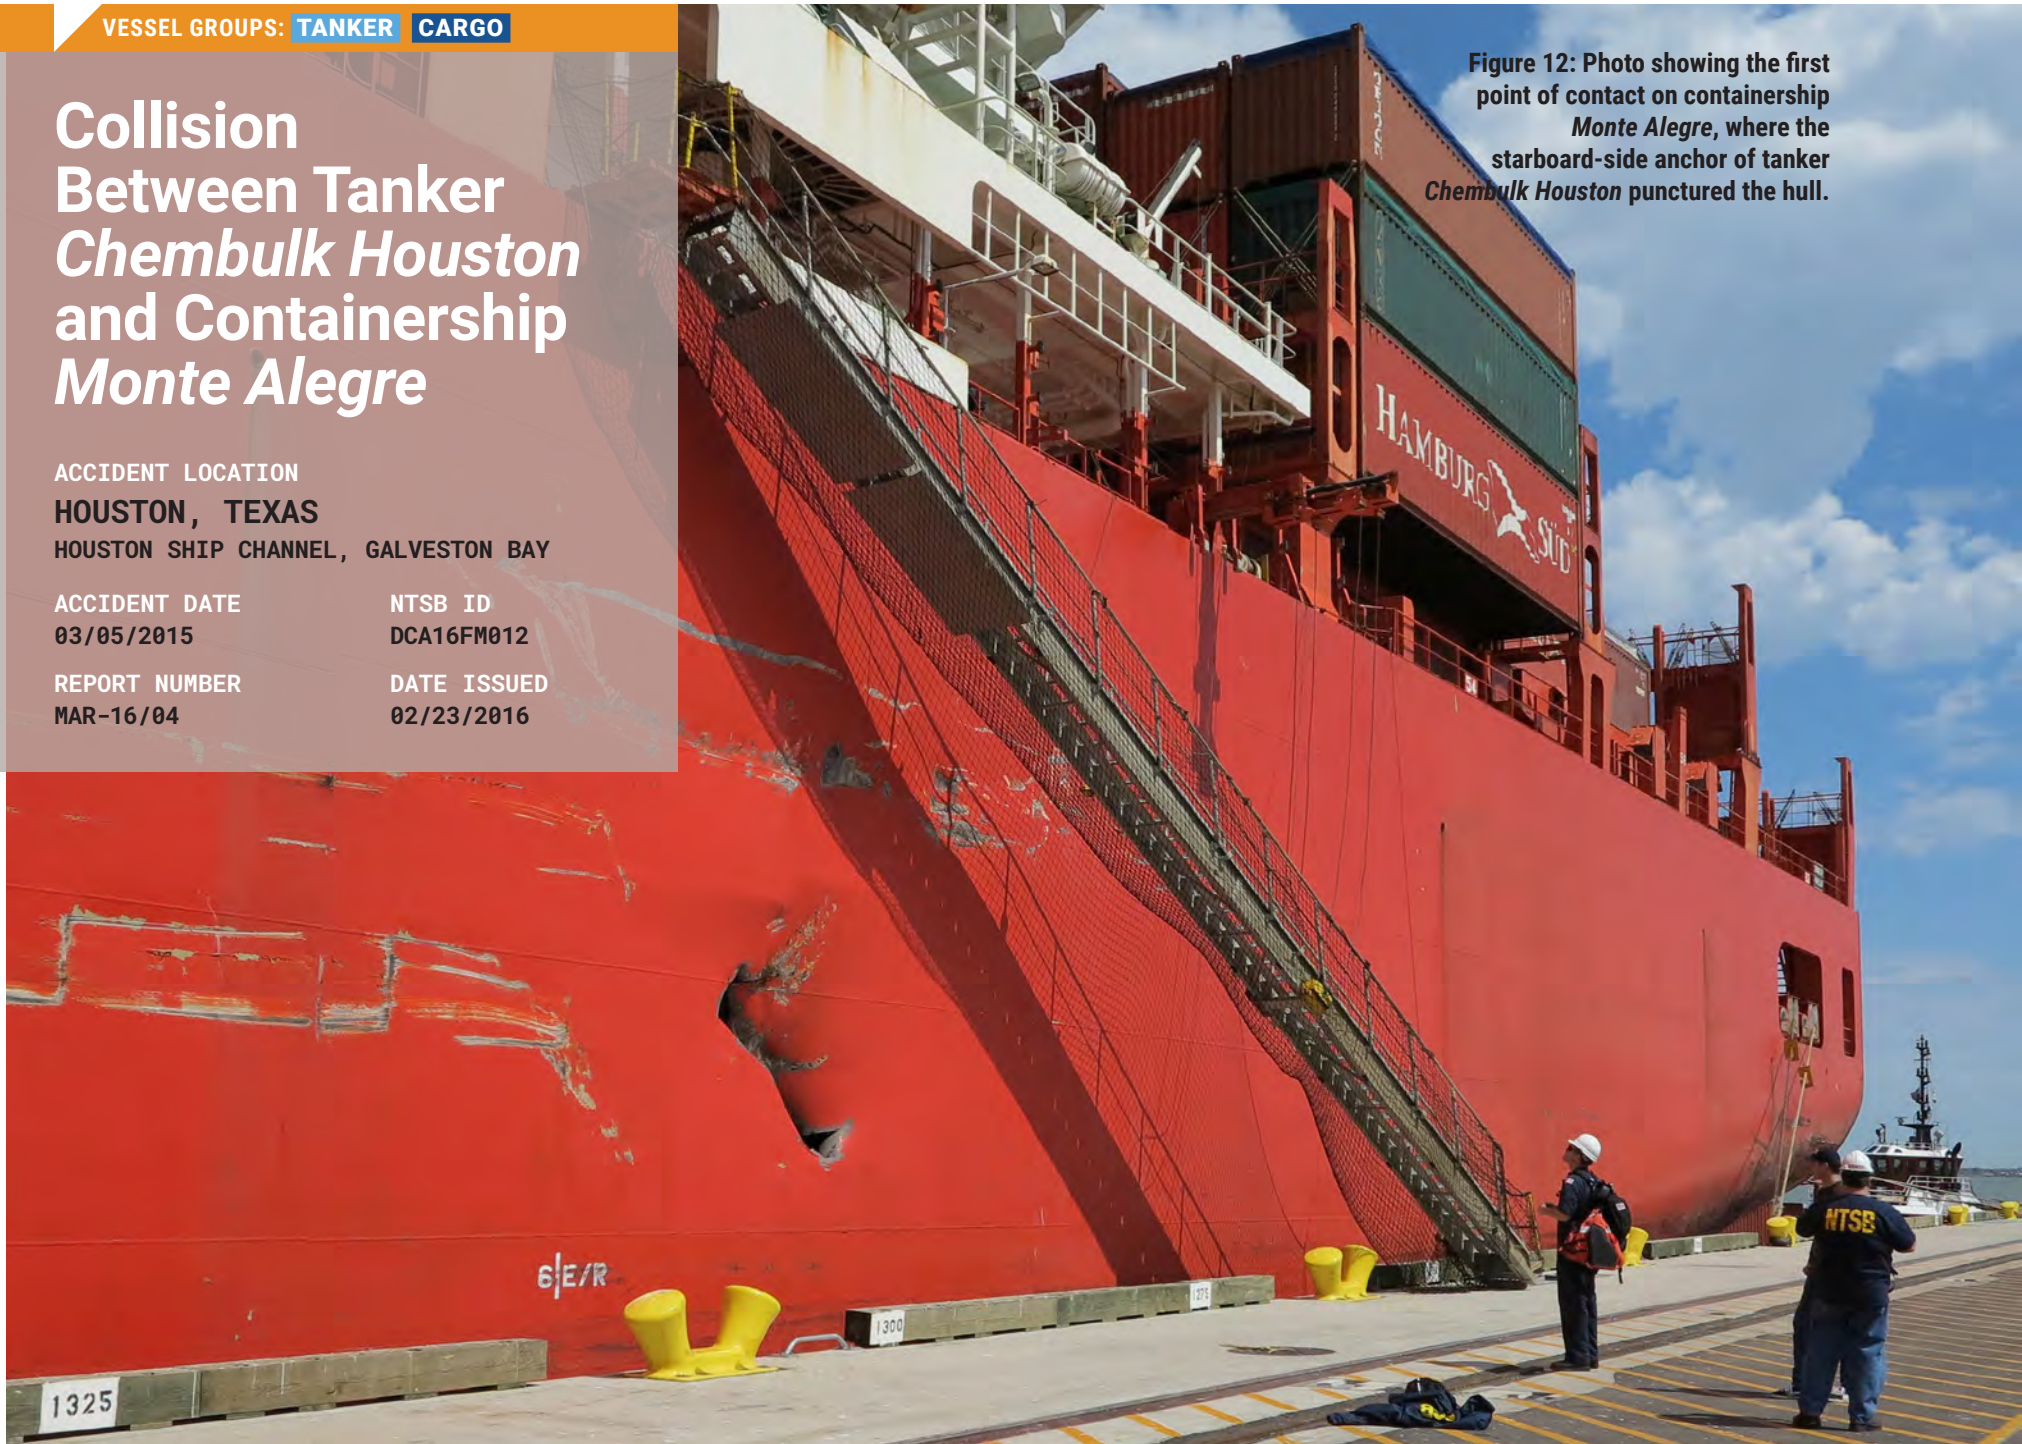
Figure 12: Photo showing the first point of contact on containership *Monte Alegre*, where the starboard-side anchor of tanker *Chembulk Houston* punctured the hull.

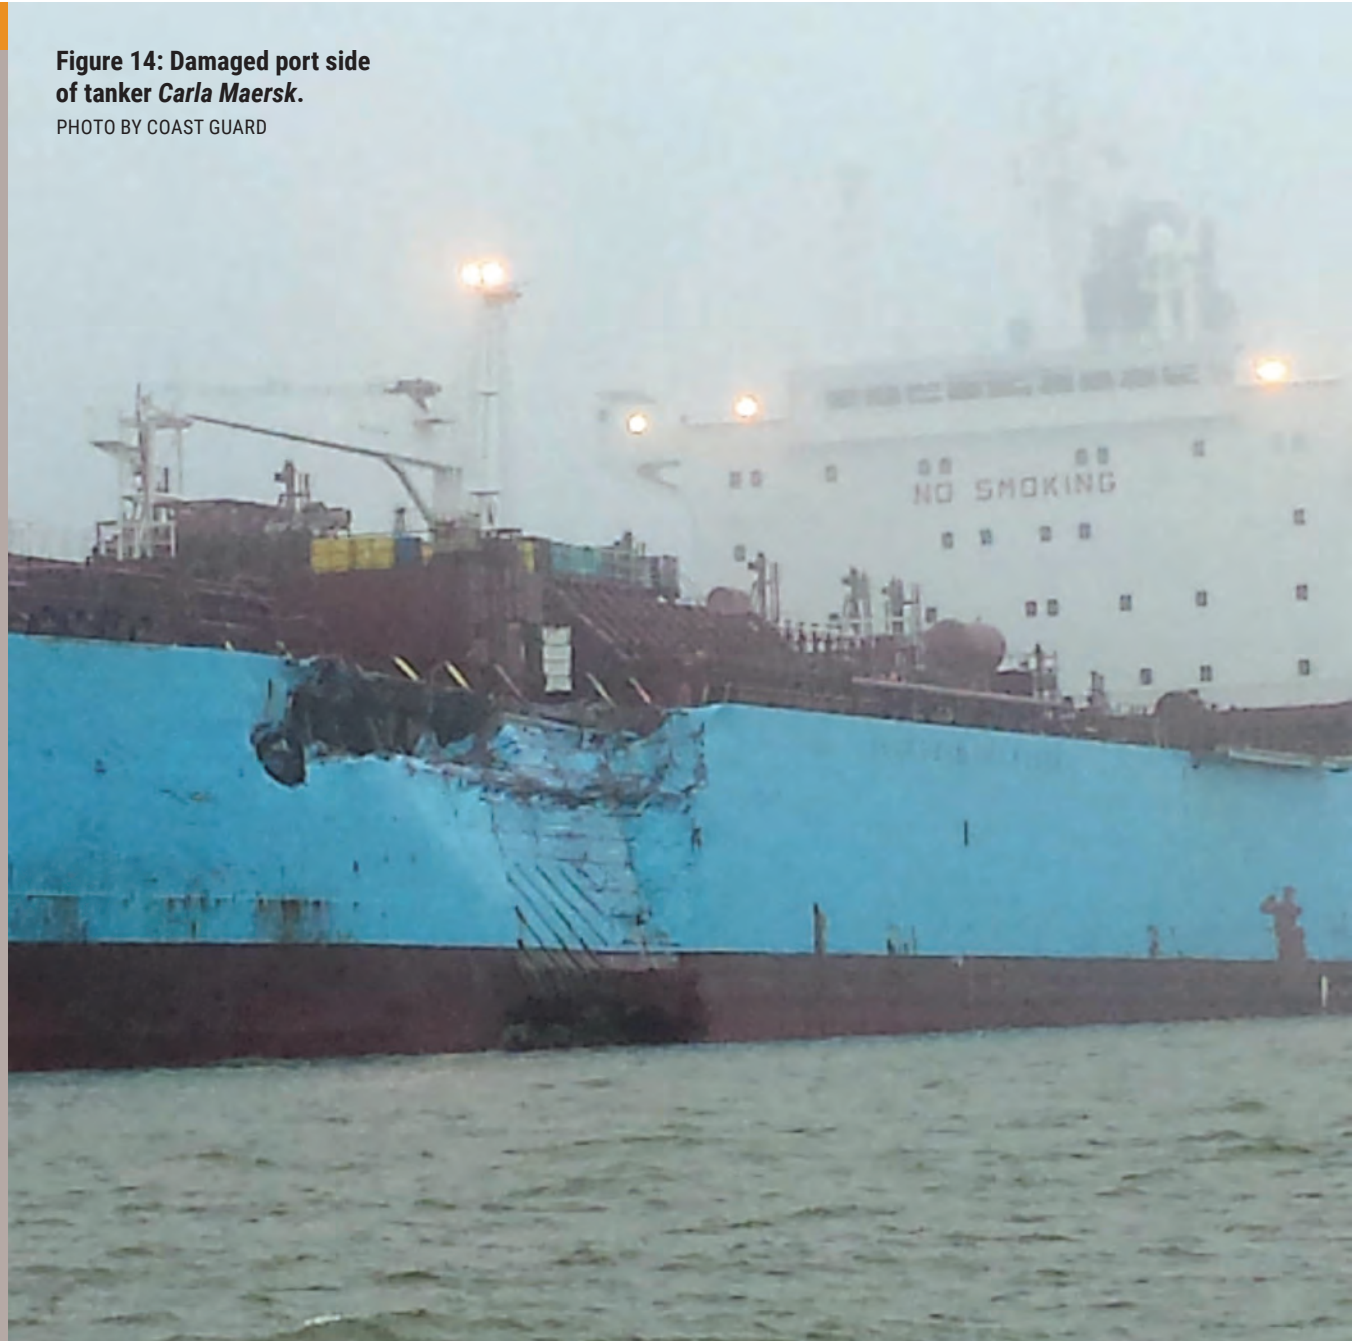
**Figure 14: Damaged port side
of tanker *Carla Maersk*.**

At 1230, the bow of the *Conti Peridot* struck the port side of the *Carla Maersk* just forward of midship. The collision ruptured several ballast tanks and cargo tanks on the *Carla Maersk* and damaged the bow on the *Conti Peridot*. An estimated 88,200 gallons of methyl tertbutyl ether spilled from the *Carla Maersk*, and the two vessels sustained about \$8.2 million in total damage.

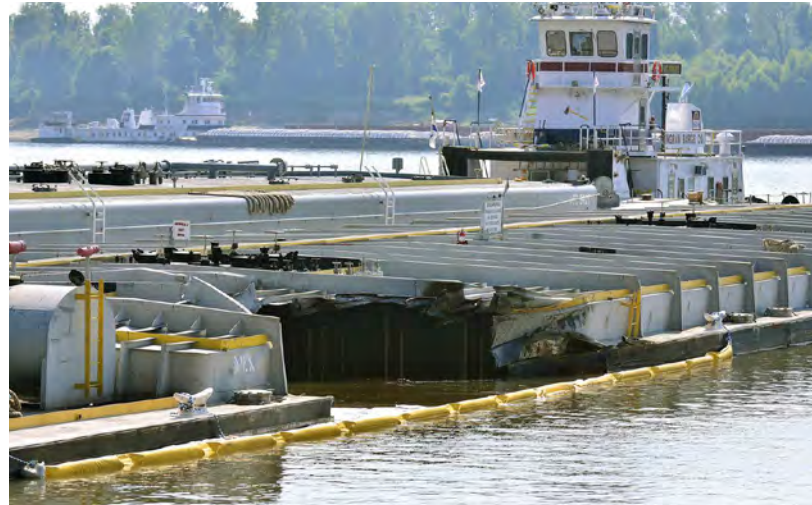
Figure 17: Damaged barge APEX 3508 from *Dewey R* tow; shell and deck plate have been removed. PHOTO BY COAST GUARD

The collision breached the no. 3 starboard wing void and the no. 3 starboard cargo tank on the *APEX 3508*, resulting in a discharge of 120,000 gallons of clarified slurry oil into the river. The collision also caused damage to the *Dewey R*'s three other barges.

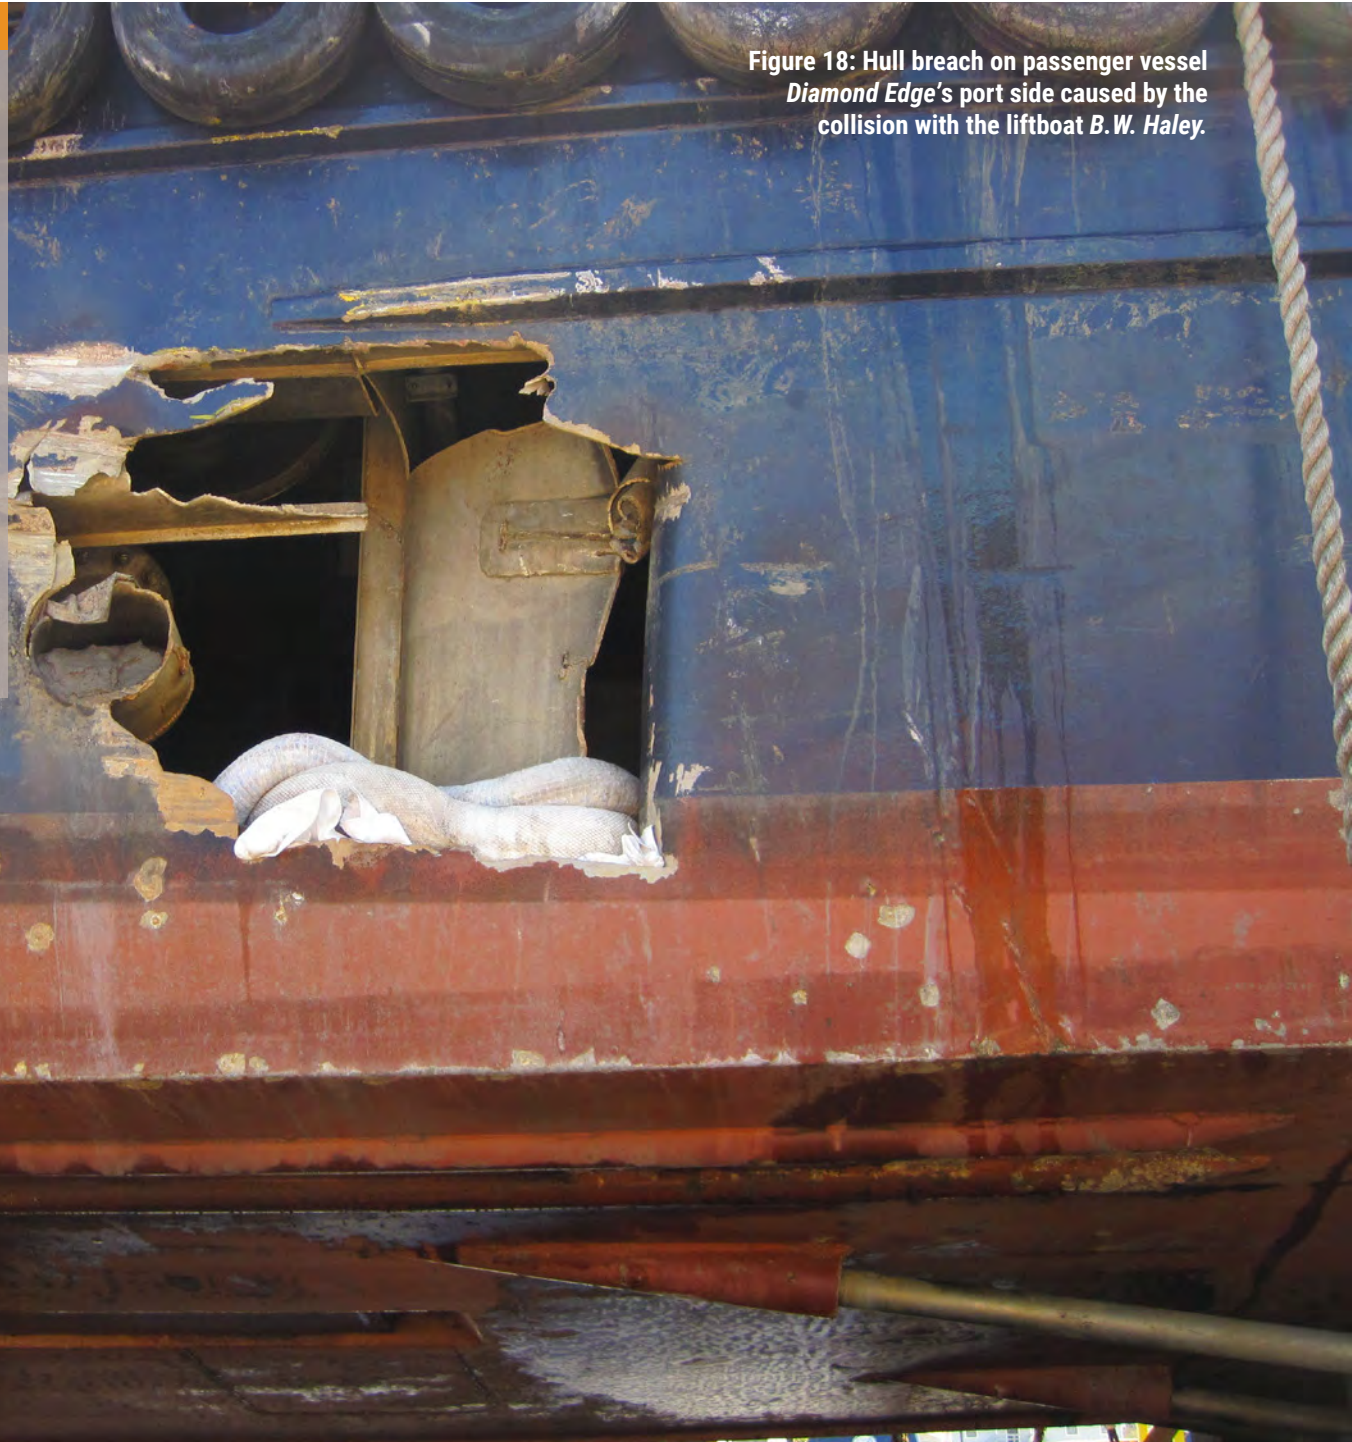
Figure 18: Hull breach on passenger vessel *Diamond Edge*'s port side caused by the collision with the liftboat *B.W. Haley*.

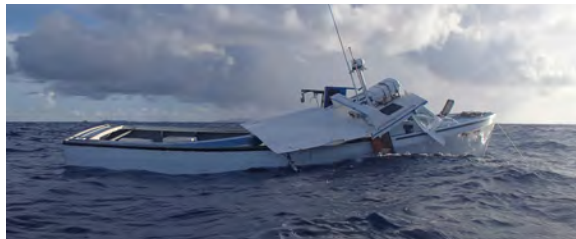
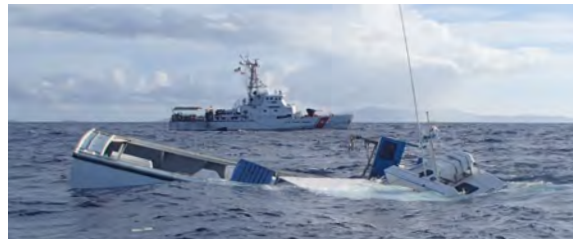
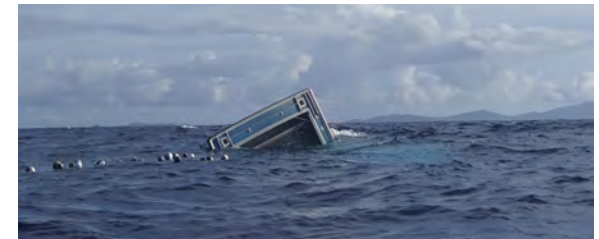
starboard side of the *Sea Shepherd*, pushing the fishing vessel sideways 50–70 feet before the two vessels separated. The *Sea Shepherd* sustained a 4-inch-wide vertical fracture on the starboard side just aft of the raised cabin, running from the top of the deck to below the waterline.

Figures 22–24: Flooding of the *Sea Shepherd* from damage due to the collision. The vessel sank about 2 hours after it was struck.

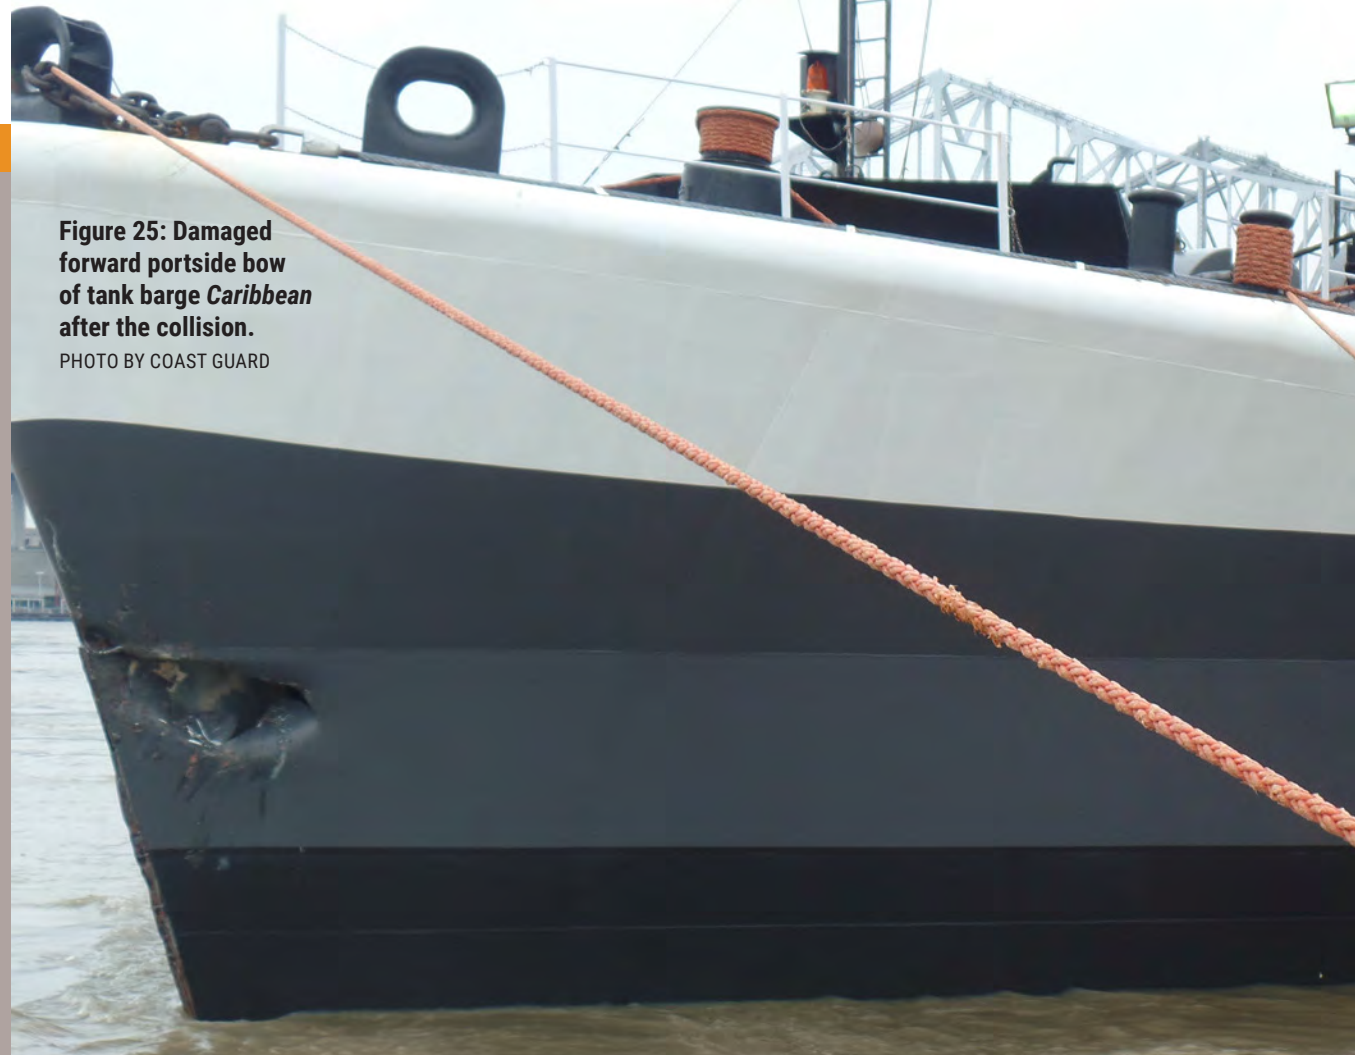
Figure 25: Damaged forward portside bow of tank barge *Caribbean* after the collision.

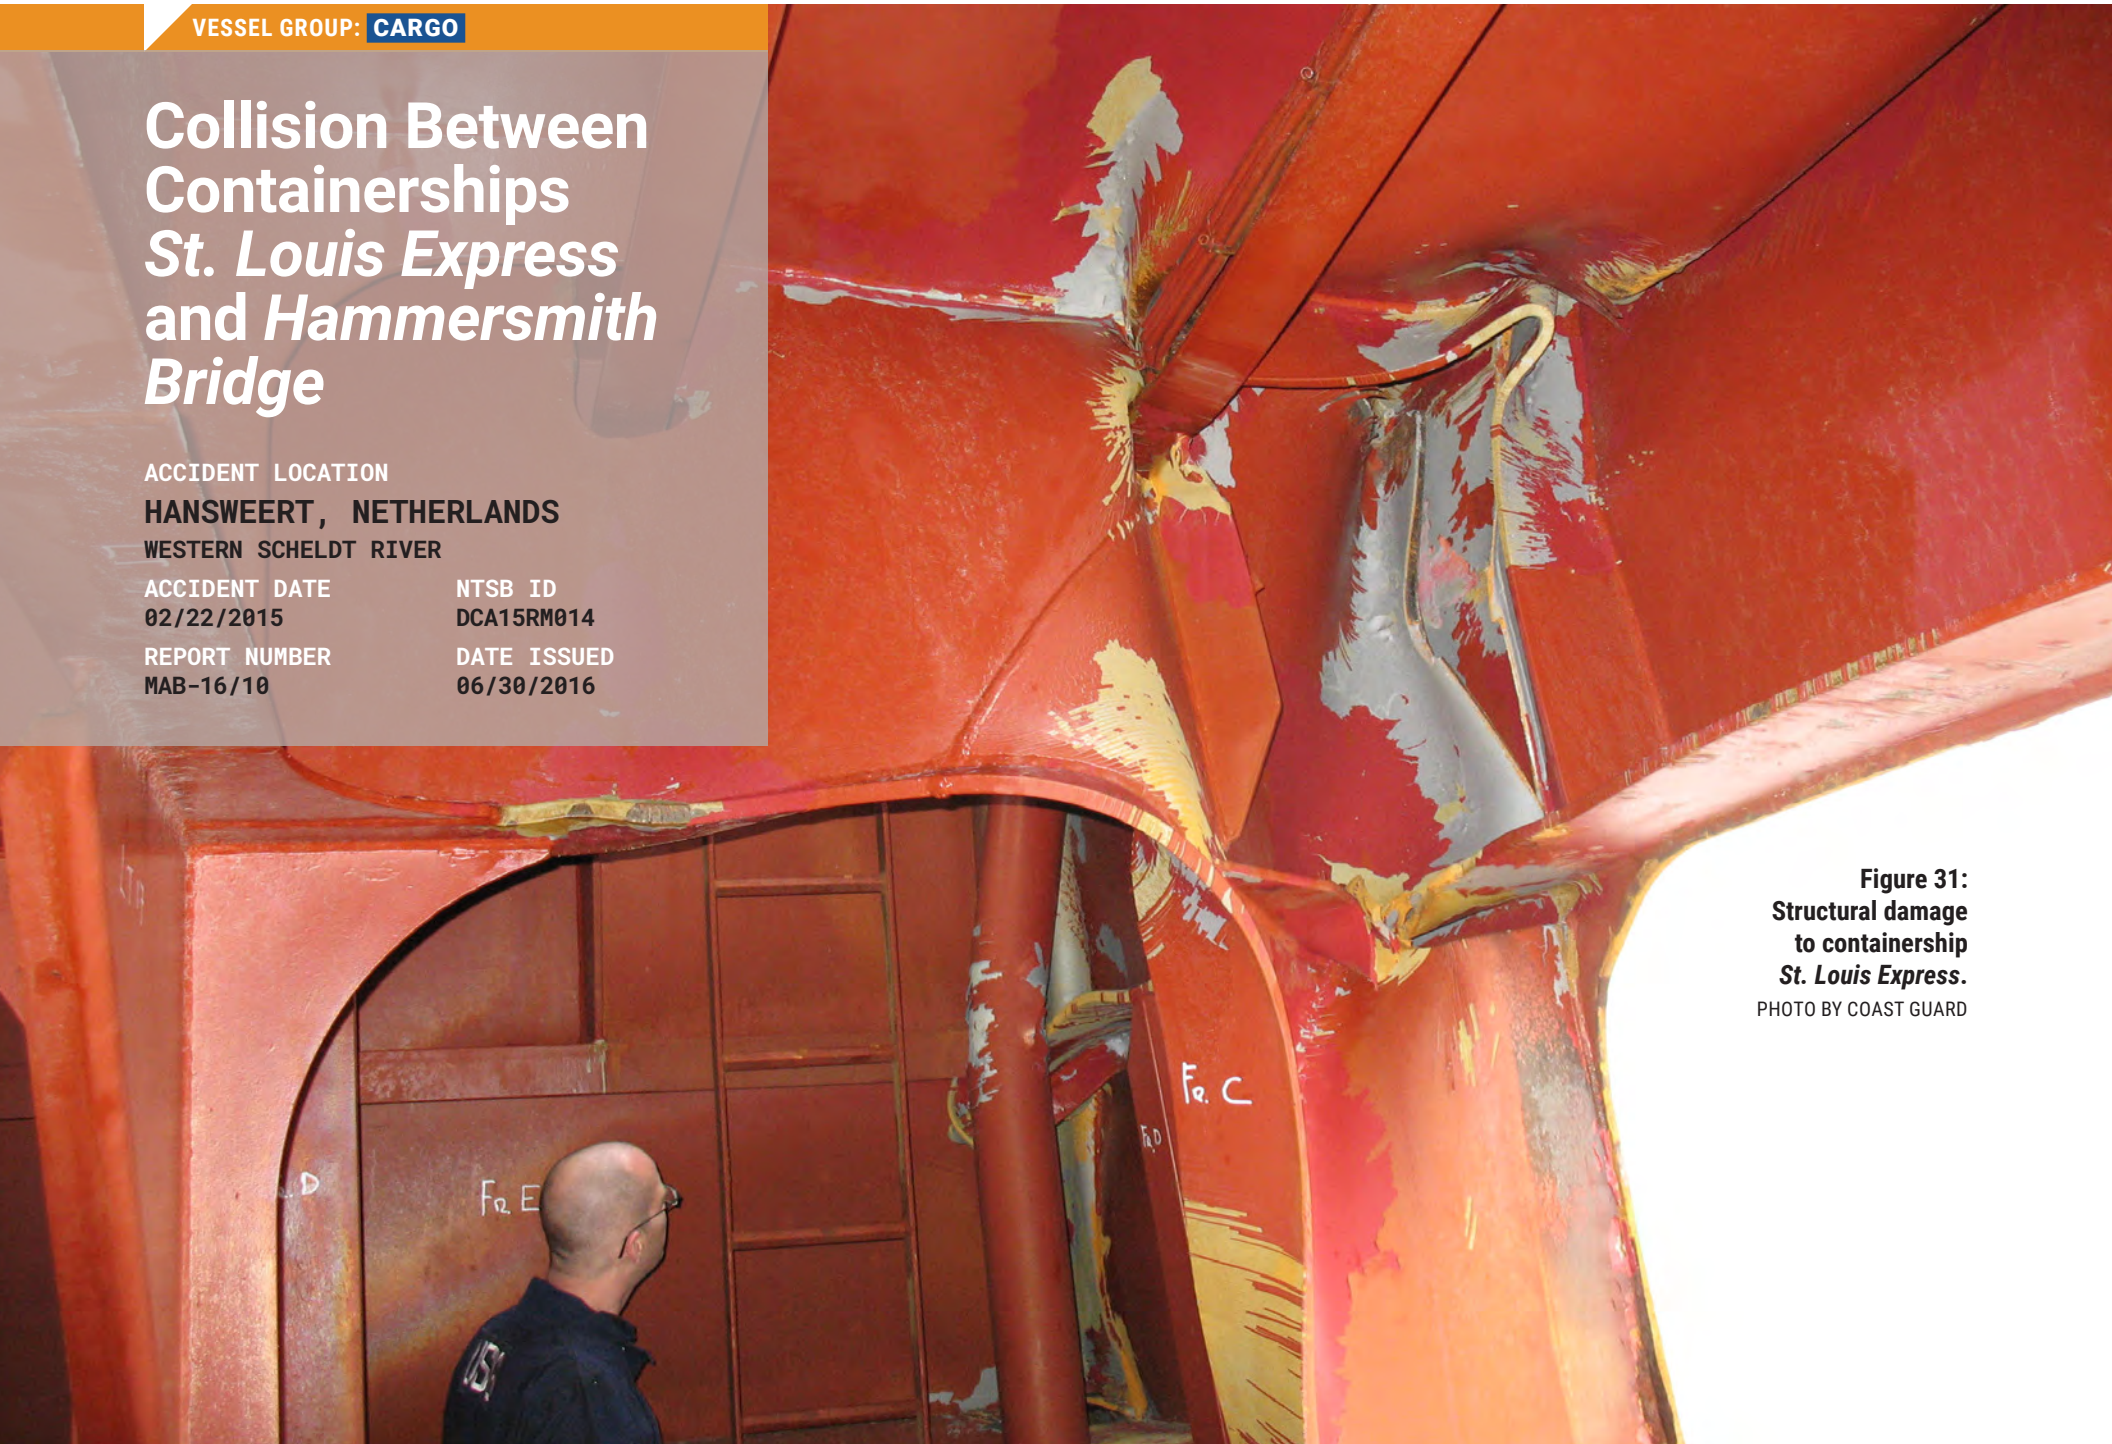
Figure 31:
Structural damage
to containership
St. Louis Express.

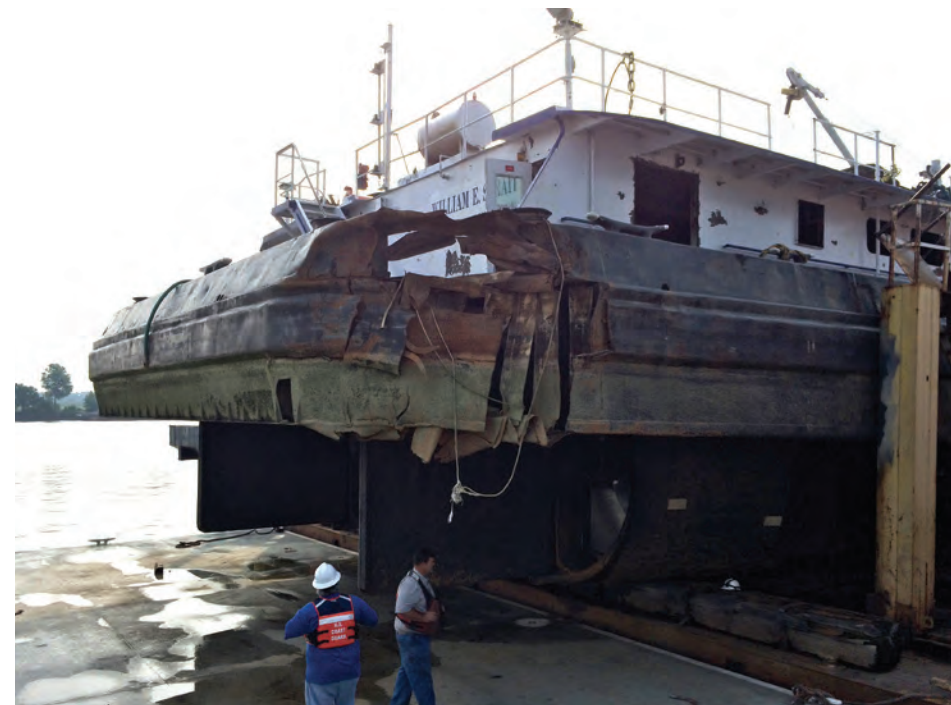
Figure 35: Damaged hull near the starboard stern of the towing vessel *William E Strait*. Photo taken after the vessel was salvaged.

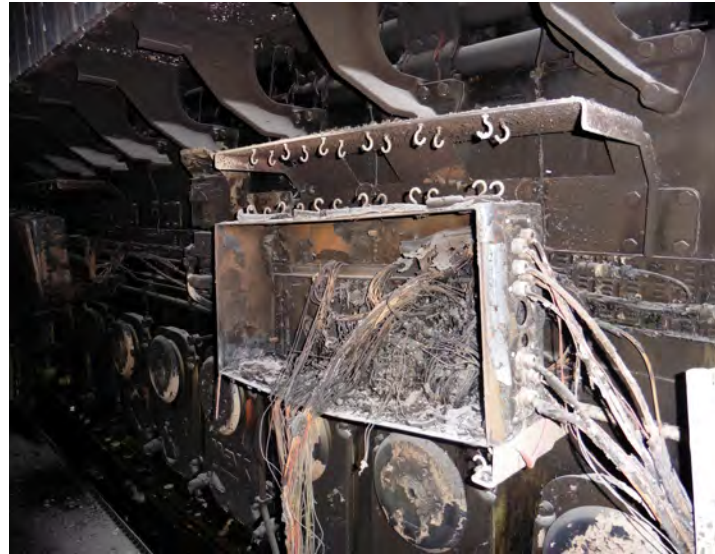
Figure 39: Fire damage to containership *Gunde Maersk*'s auxiliary engine no. 1 inboard side, looking forward.

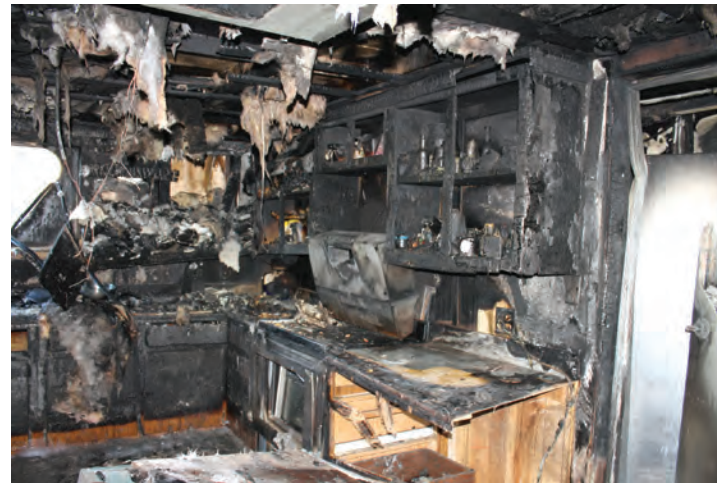
Figure 47: Fire damage to the towing vessel *San Gabriel* galley located on the main deck. PHOTO BY COAST GUARD

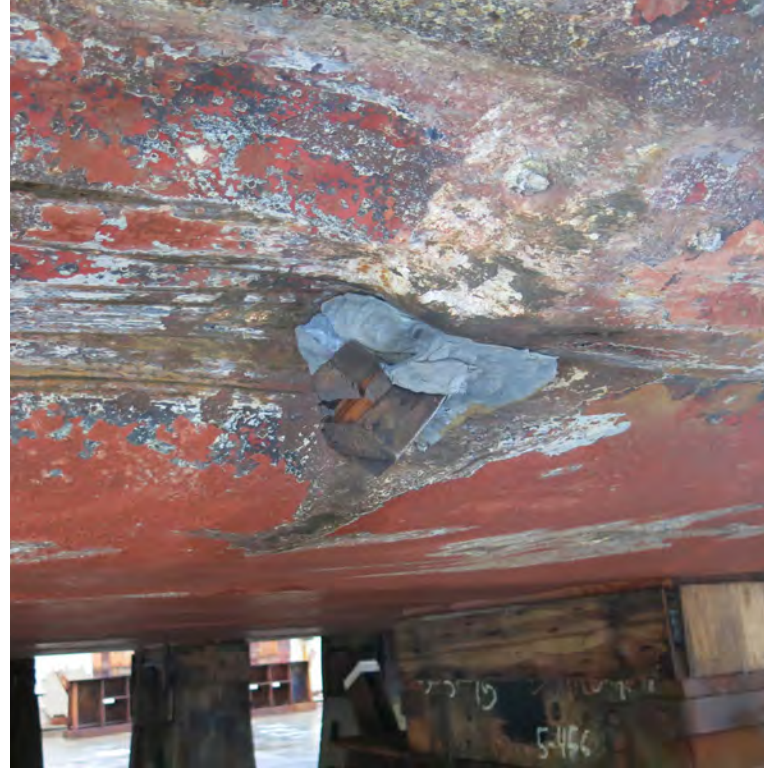
Figure 57: Breached hull on the fish-processing vessel *Gordon Jensen*'s port side.
