-- STILLWATER RESERVOIR DAM --
VISUAL
INSPECTION / EVALUATION REPORT

Dam Name: *Stillwater Reservoir Dam*

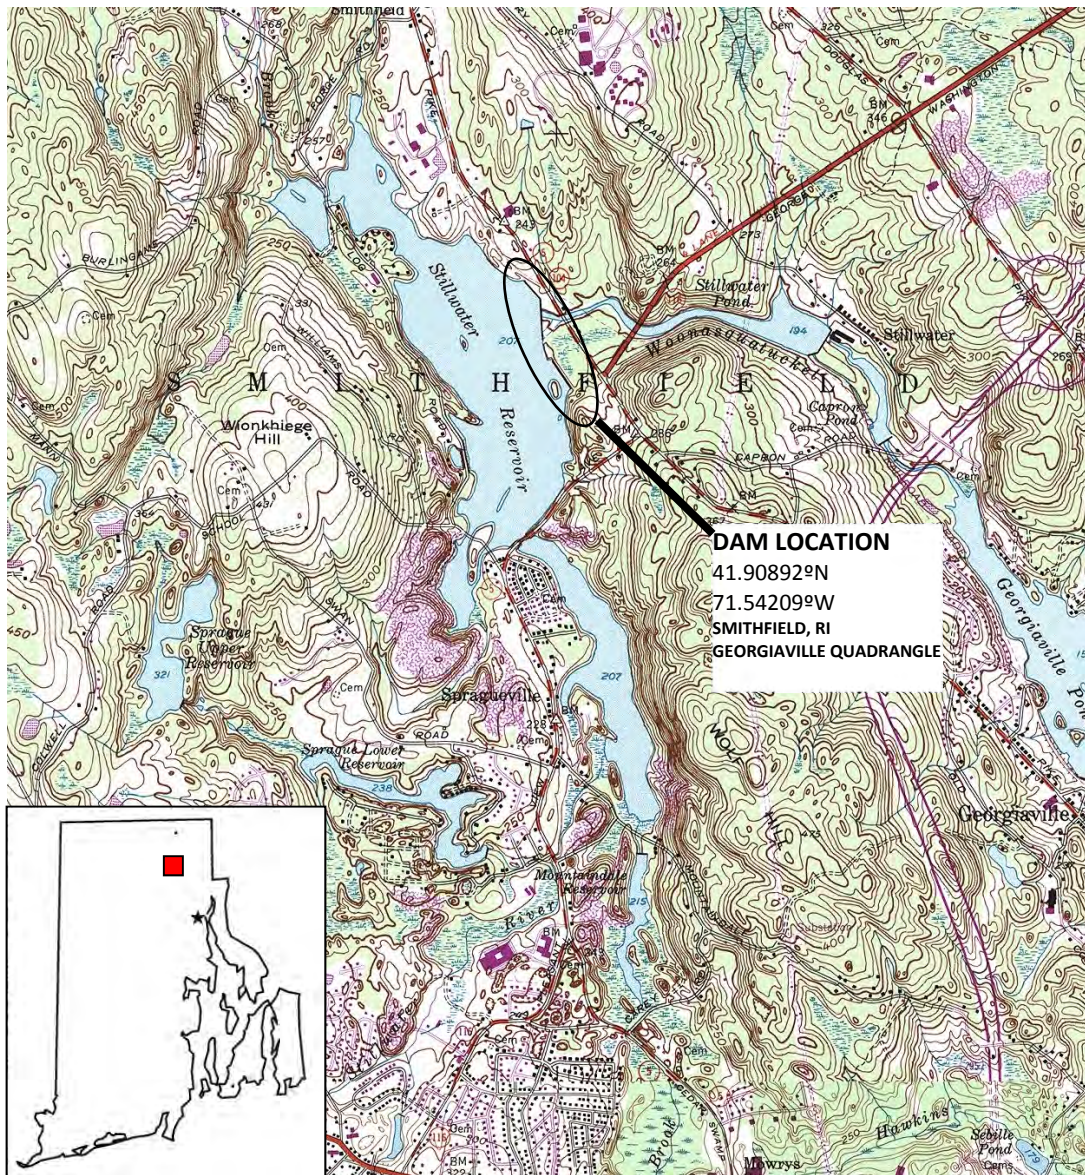
When describing the dam, “left” and “right” refer to the respective sides of the dam as viewed when facing downstream (with normal flow of water).

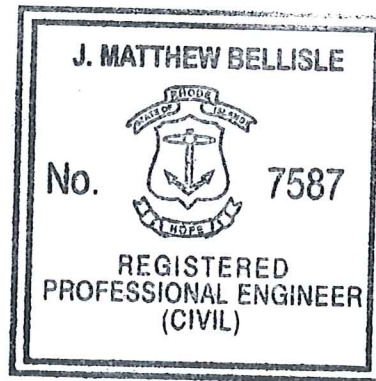
J. Matthew Bellisle, P.E.
PARE CORPORATION
Senior Vice President

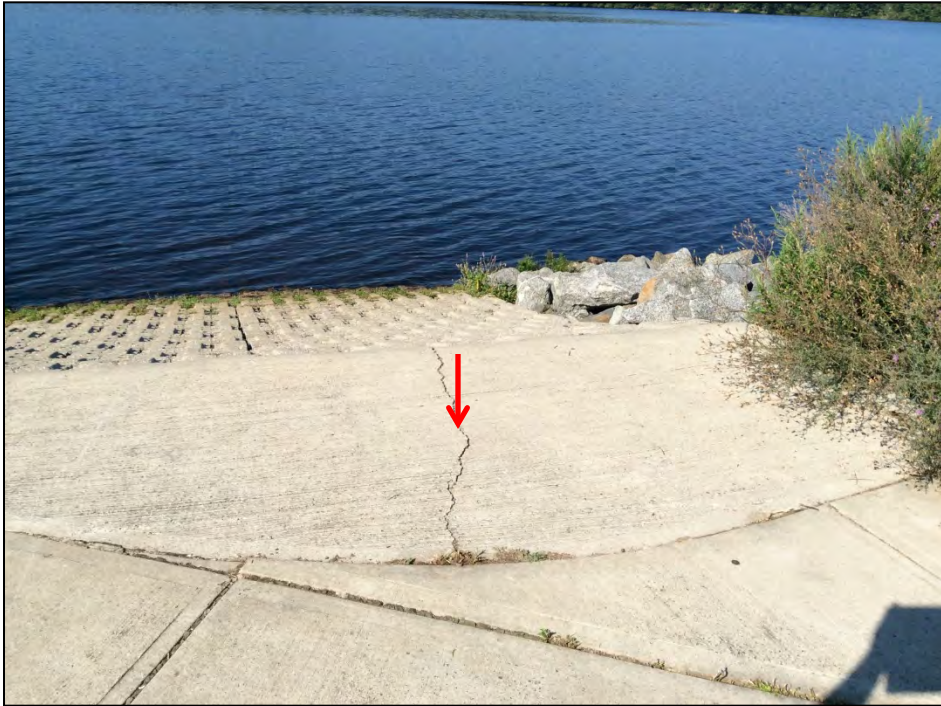
Photo No. 3: A crack within the concrete at the top of the boat ramp located near the left abutment. The width of the crack was measured at 1/4 inch wide.

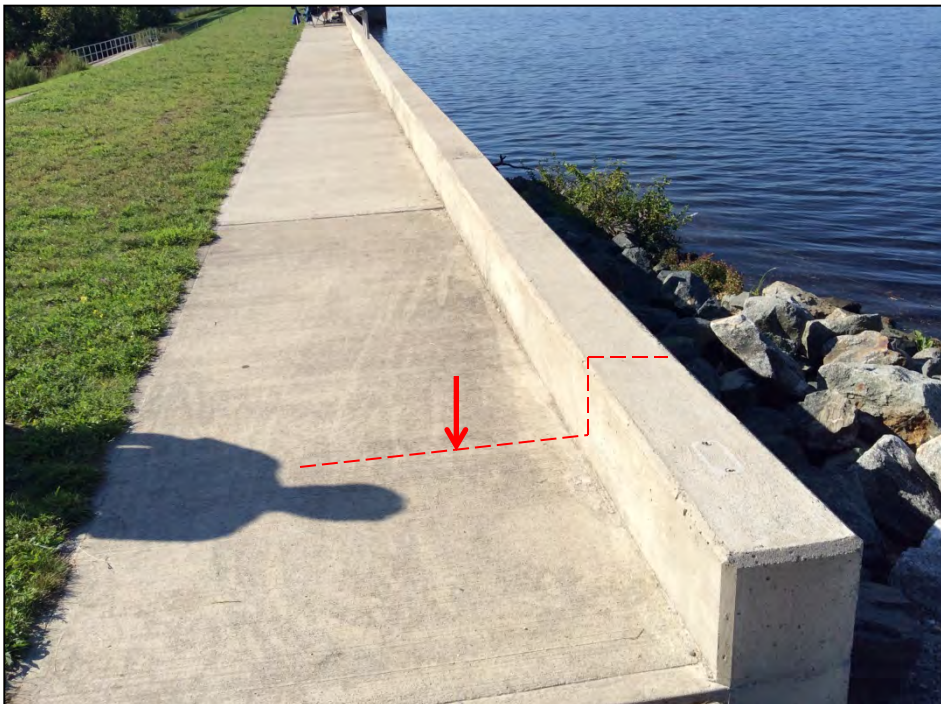
Photo No. 4: Continuous hairline crack along the sidewalk and through the upstream wall as viewed from the left abutment looking right.

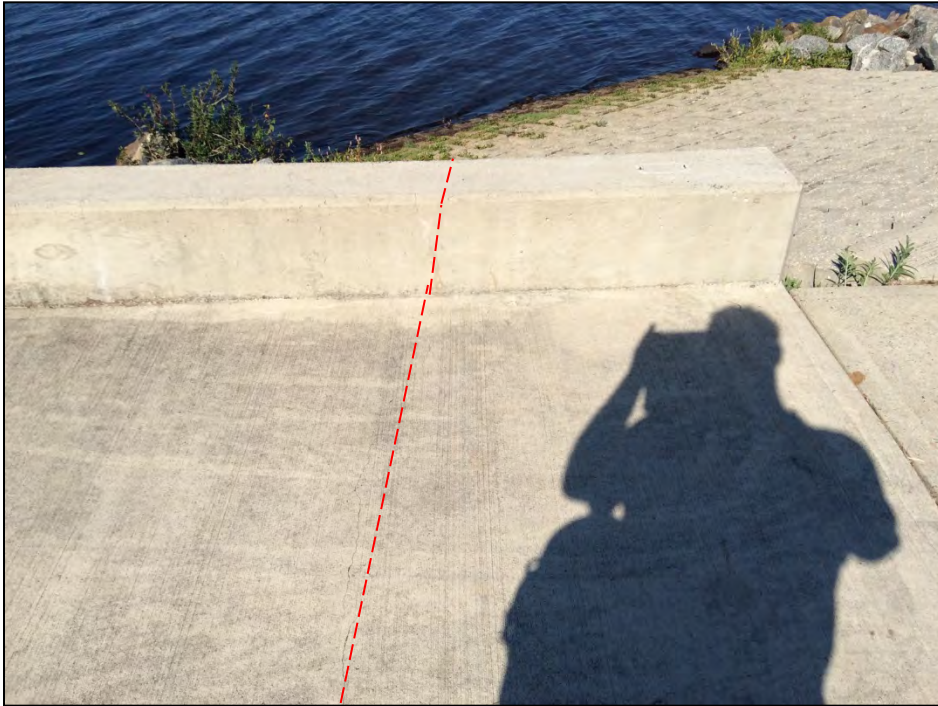
Photo No. 5: View of the cracks along the sidewalk and upstream wall at the left-most wall section (near the left abutment) looking upstream.

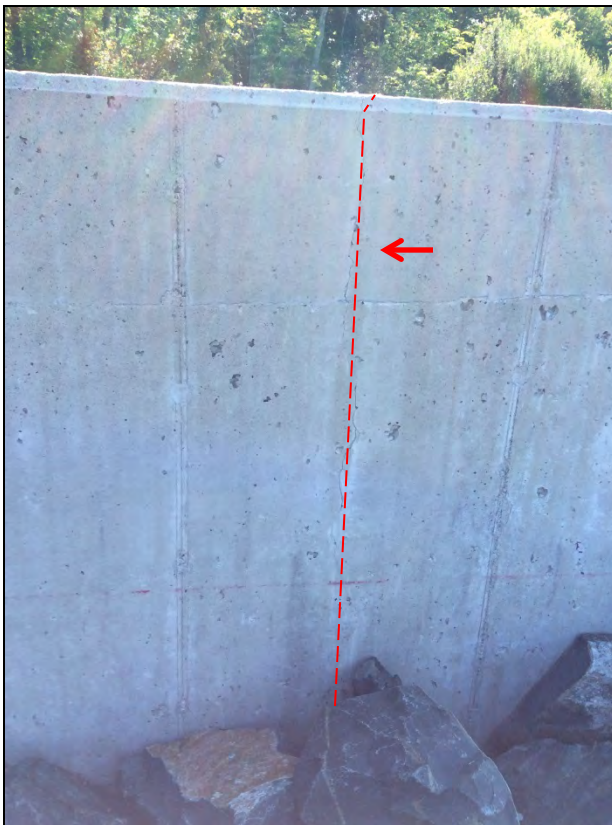
Photo No. 6: Typical cracks along the upstream wall extend through the wall. This is a photo of the upstream face at the second wall section from the left abutment.

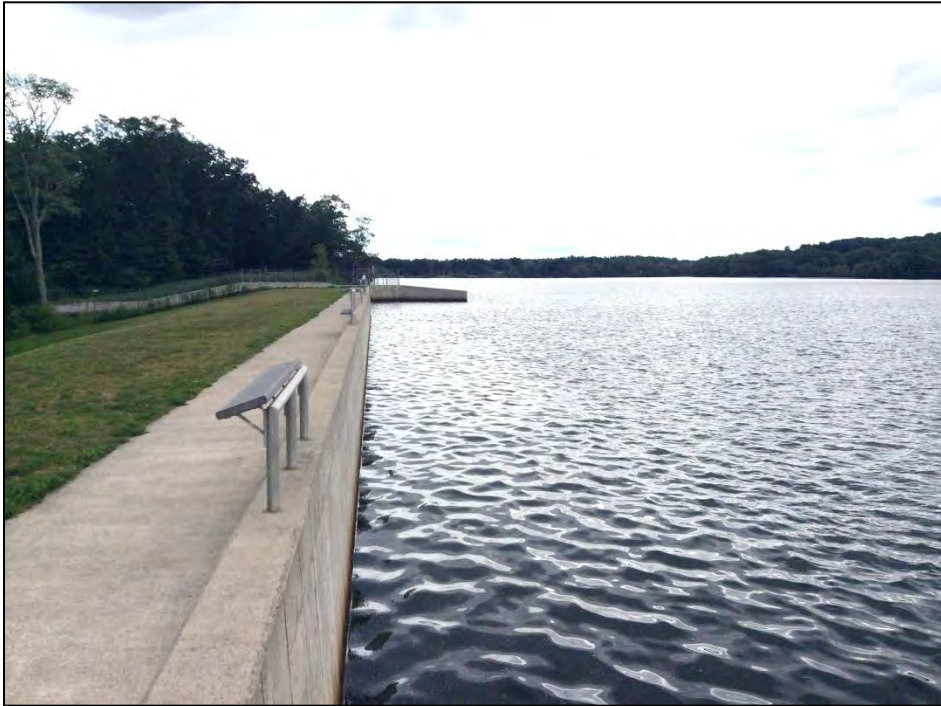
Photo No. 7: The upstream side as seen from right of the gatehouse looking right.

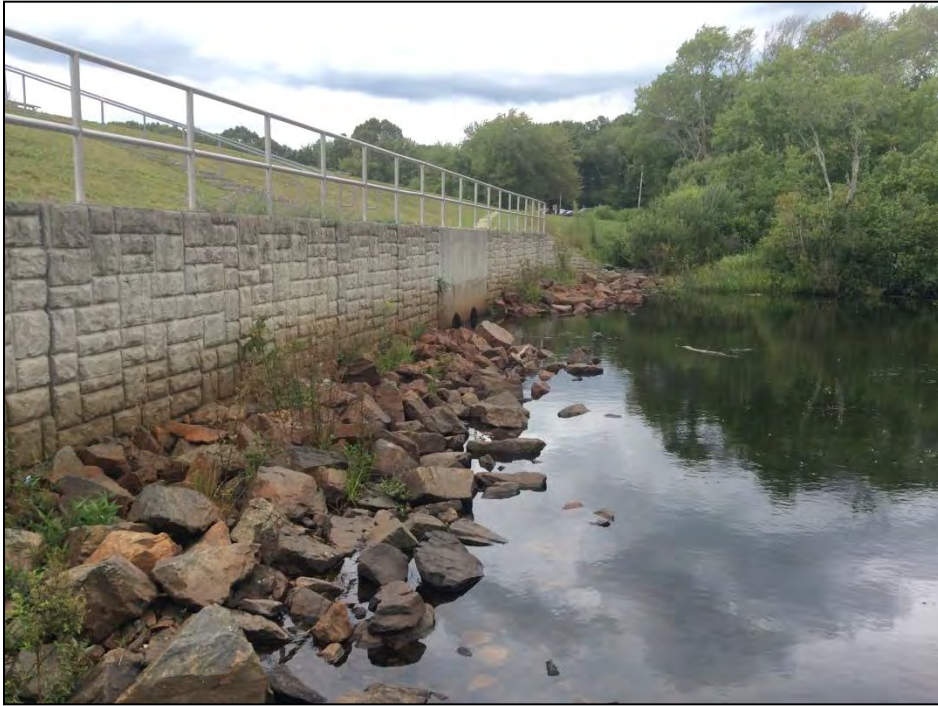
Photo No. 57: The low level outlet downstream headwall as viewed from the right. Note the staining within the riprap and along the wall.

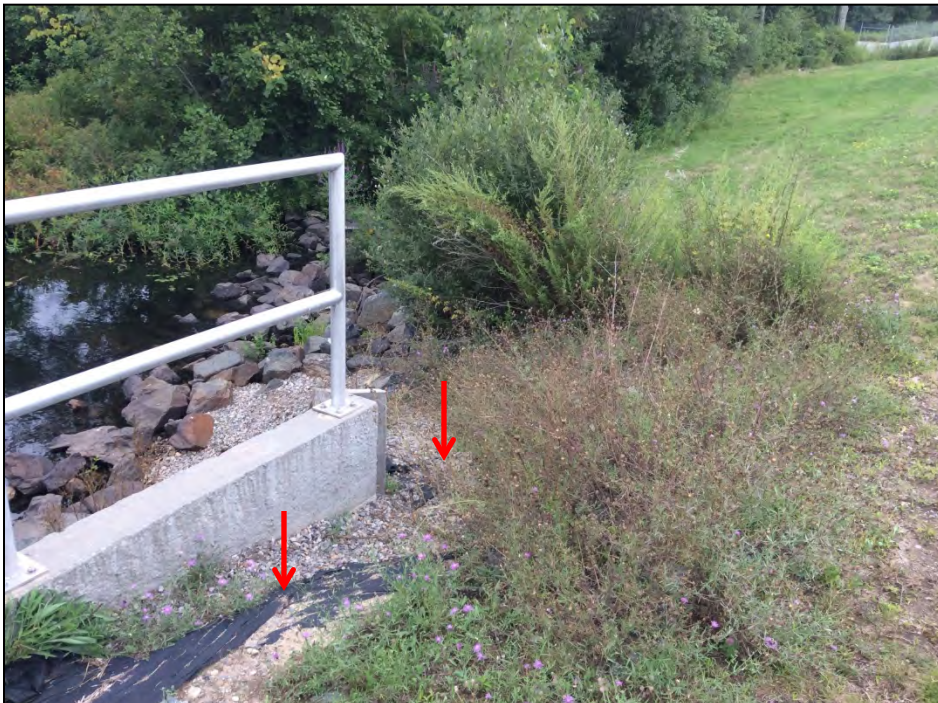
Photo No. 58: Erosion behind the right side of the low level outlet downstream headwall. Photo looking right and slightly downstream. Erosion is typical along both sides except there is more bare ground on the left side.
