Re: Sanitary Sewer and Process Wastewater Cross-Connection Repair
Charbert, Division of NFA Corp.
Alton, Rhode Island

**CHARBERT BUILDING SEWER MAIN REPAIR
ALTON, RHODE ISLAND**

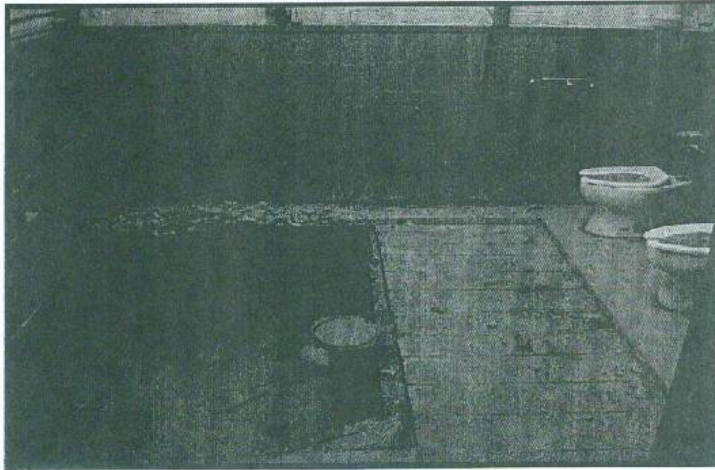
Photo No. 1 - Men's Room in Center of Building where New Sewer Main begins.

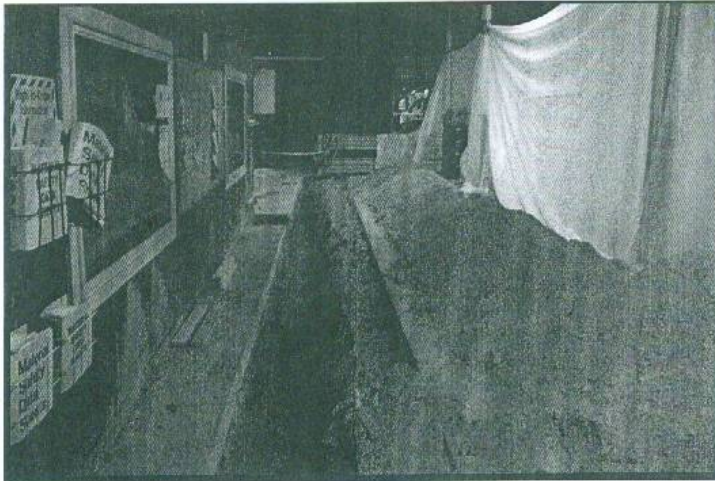
Photo No. 2 - New Sewer Main Trench through Facility.

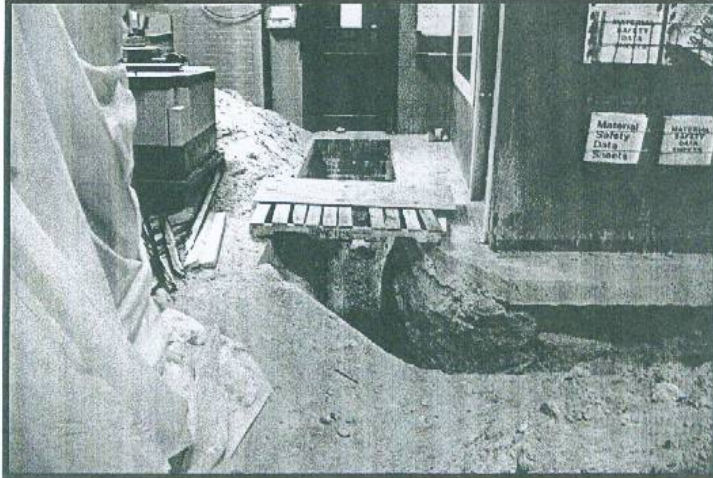
Photo No. 3 - New Sewer Main Trench approaching Basement under Dye Laboratory.

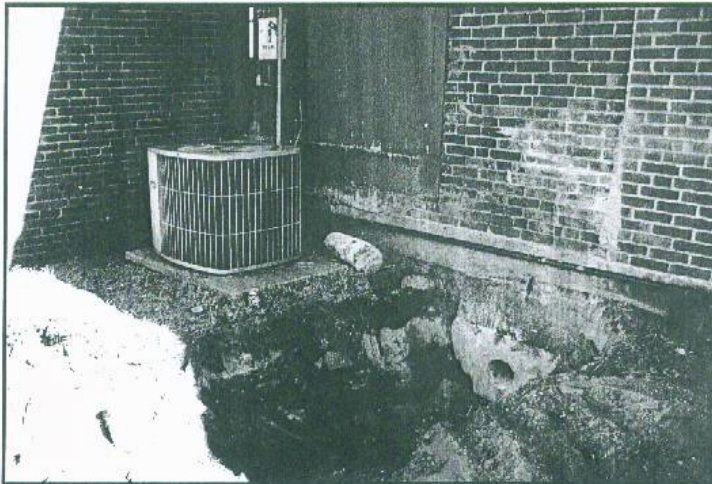
Photo No. 4 - New Sewer Main Location in rear Maintenance Area.

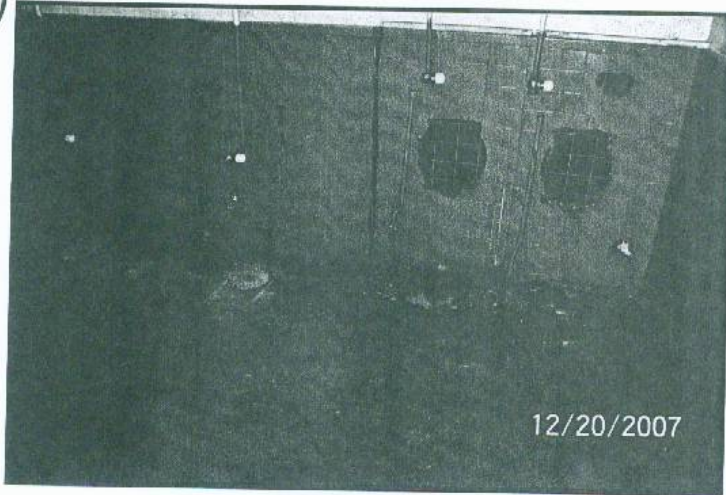
Photo No. 5 - Closed Men's Room in Maintenance Area.

After the completion of the new sewer main installation, an existing men's bathroom located in the maintenance area and a lady's room in the center of the building that could not reasonably be connected to the new main, were closed as part of this work, see Photos 5 and 6. Once the new sewer main was operable and all sanitary sewer flow were connected, the old sewer main was connected to an industrial waste water manhole in the rear of the facility to allow any waste water flows connected to that line to flow to the industrial waste water pump house.

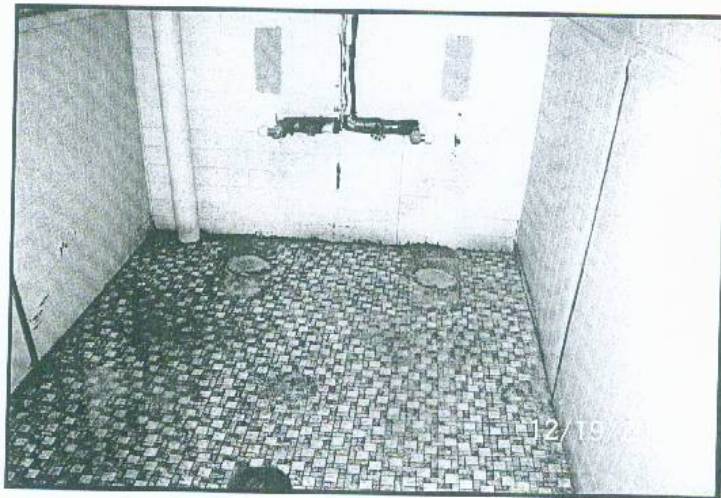
Photo No. 6 - Closed Ladies Room in Center of Building.
