Re: *Short-Term Response Action Plan*
Former Tidewater Facility
Pawtucket, Rhode Island
RIDEM Case No. 95-022

FORMER TIDEWATER MANUFACTURED GAS PLANT PAWTUCKET, RHODE ISLAND

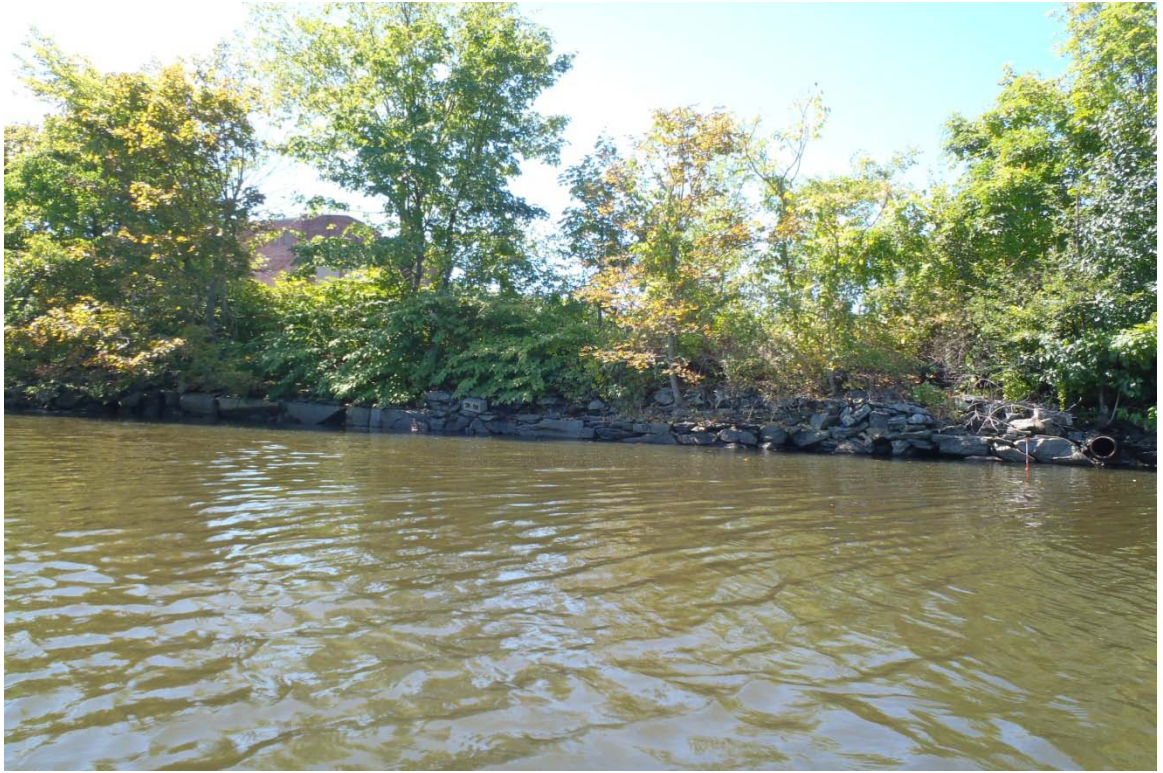
A multi-colored sheen has been periodically observed since approximately [month] 2010 on the water surface of the Seekonk River adjacent to the FGPA, approximately 150 feet north of the existing temporary cap area (installed in December 2009 to mitigate a sheen area migrating from a portion of the riverbank, as described in a *Short Term Response Summary Report* dated February 1, 2010), as shown on Figure 2. National Grid responded by placing oil snares along the area of this newer sheen area; however a specific source of the sheen was not initially identified. During a waterfront survey conducted on August 30, 2010, an approximately 150-foot long above ground steel pipe, varying in diameter from 4 to 6 inches, was observed running parallel to the Seekonk River, approximately 150 feet north of the existing temporary cap area, as shown on Figure 2. The northern end of the pipe was observed to be capped above grade and the southern end terminates below grade. Upon further inspection, certain sections of this piping were noted to be in disrepair and coal-tar like materials were observed on the ground surface and river embankment beneath the piping. As described above, the presence of this piping and coal tar residuals may be contributing to the intermittent sheens observed in adjacent portions of the Seekonk River.

Photo 1: Shoreline area along FGPA where intermittent sheen is observed.

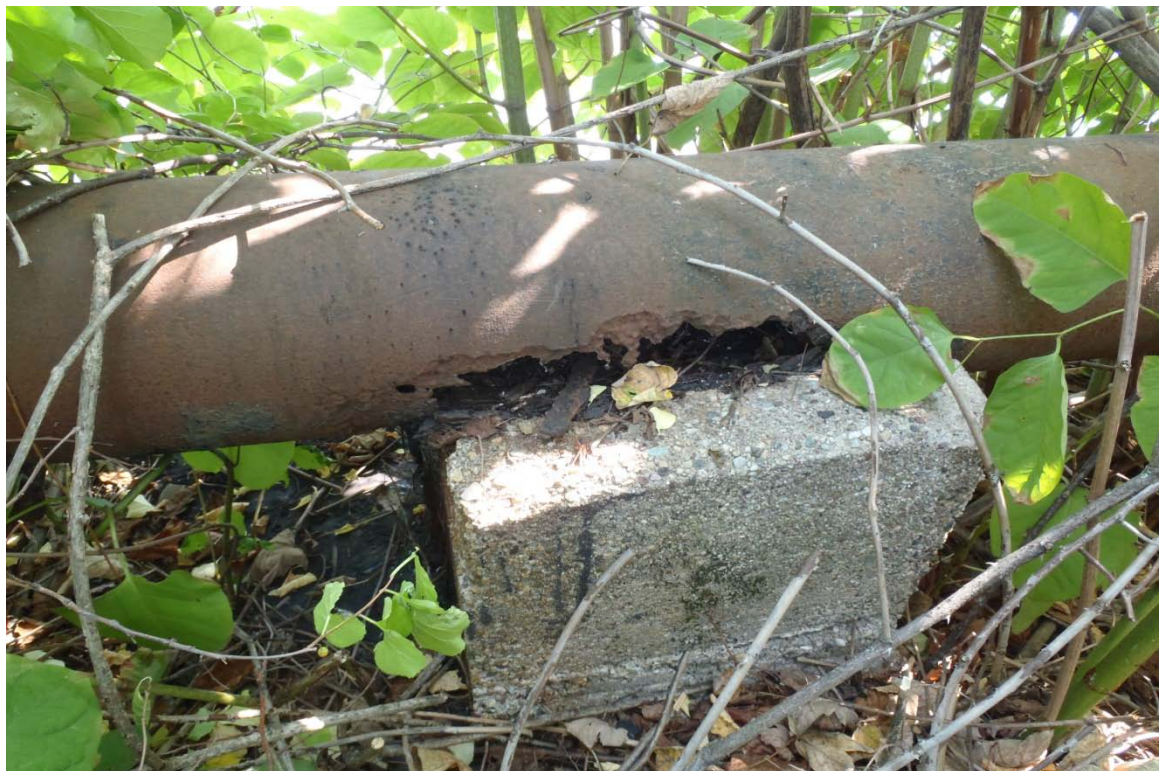
Photo 2: Broken pipe along riverbank. Pipe leak of apparent coal tar-like material.

The above ground sections of pipe will be removed and disposed off-Site at a licensed disposal facility; the underground section of pipe on the southern end will be capped above grade with a blind flange. An approximately 5 square foot area of coal tar-impacted surface material observed in the vicinity of the damaged pipe will be removed and disposed off-Site at a licensed disposal facility. A non-woven geotextile will be placed over the removal area and the area will be backfilled to match surrounding grade with engineered material designed to stabilize the slope. In addition, residual, hardened coal tar-like material located on the river embankment will be manually removed and containerized with the removed surface soil described above and transported off-Site to a licensed receiving facility for thermal treatment or disposal.

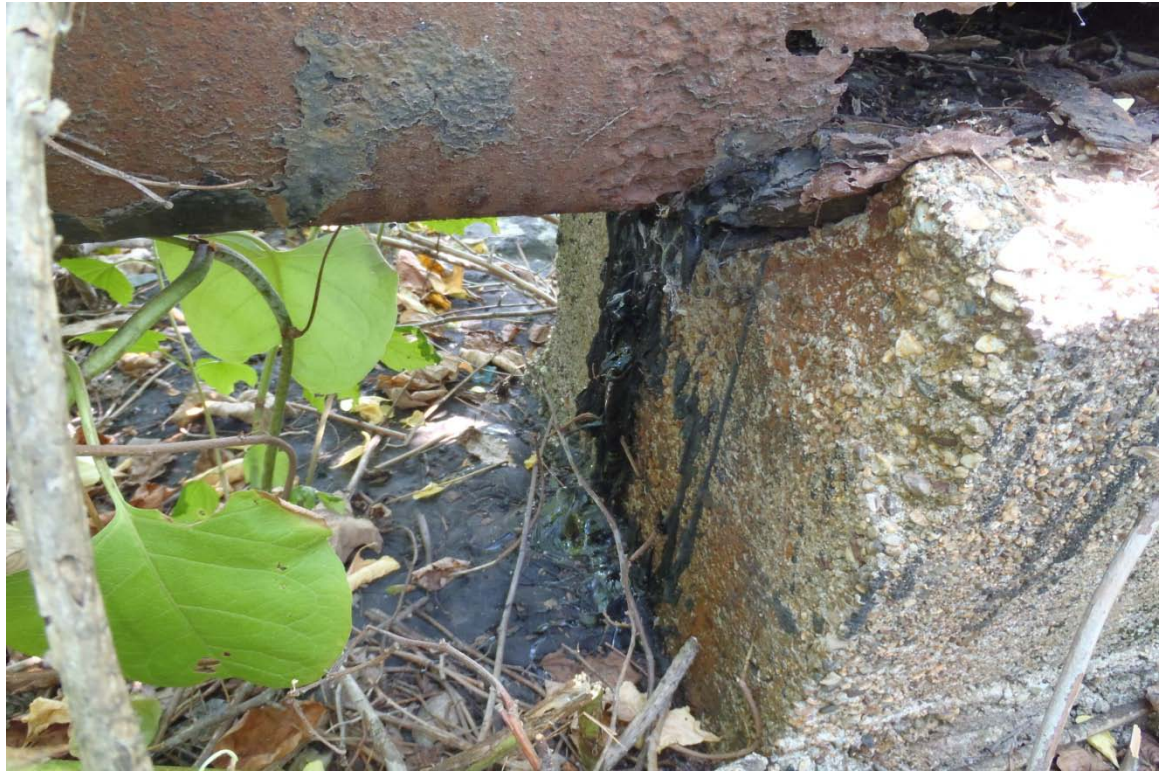
Photo 3: Close-up of damaged pipe and associated pipe leak.
