**-- OLNEY POND DAM --  
VISUAL  
INSPECTION / EVALUATION REPORT**

Dam Name: *Olney Pond Dam*

State Dam ID#: *102*

Date of Inspection: *March 28, 2022*

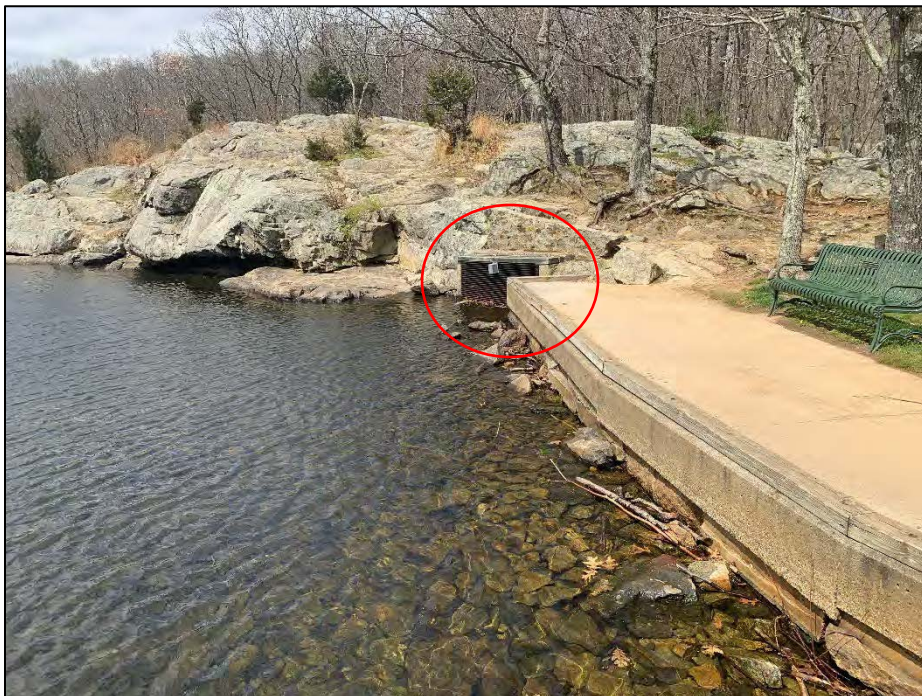
- The upstream side consists of a concrete and mortared wall. The following was noted during the inspection:
  - From the historic water line downward, the face of the wall is deteriorated with scoured concrete surfaces, missing and/or broken mortar, and shifted concrete wall blocks.
  - The horizontal and vertical wall alignments appear normal.
  - Both the spillway and right abutment contact points appear normal with no separations or unusual movement observed.
- The outer edges of the concrete for the low level outlet platform, near the center of the dam, appears in satisfactory condition with minor scour and exposed aggregate at and below the historic normal pool line.

Photo No. 2.: Upstream side of dam as viewed from the bend near the left abutment looking left. Note the deteriorated and shifted concrete wall sections above the waterline. Circled is the primary spillway.

5. Fill cracks, spalls, and expansion joints along the upstream wall face. Cracks should be filled with a pressure injected epoxy, while spalls should be filled with a mortar patch.

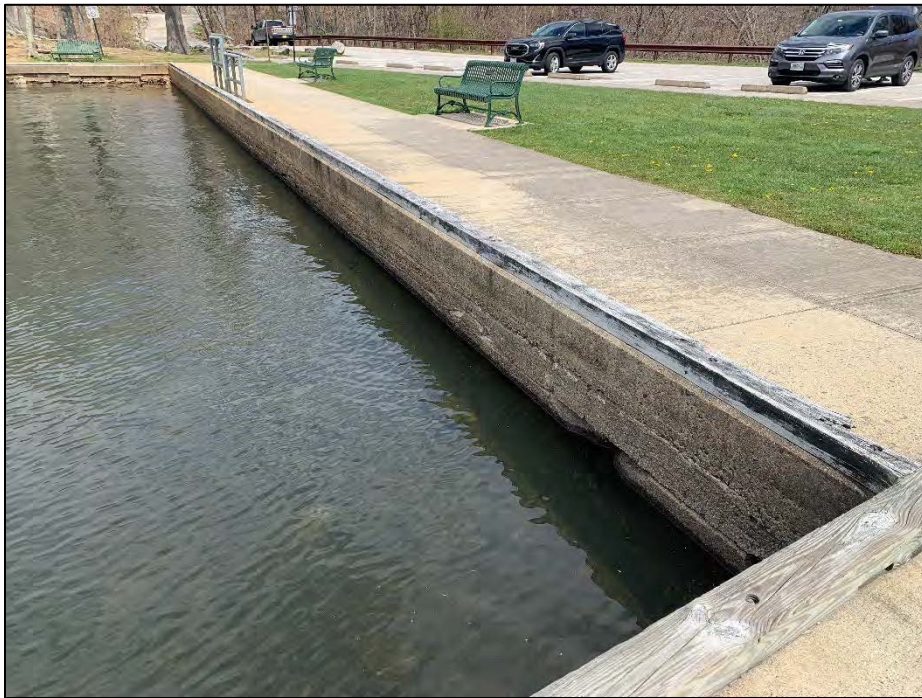
Photo No. 3.: Upstream side as viewed from low level outlet platform looking left. Note concrete spalling along waterline.

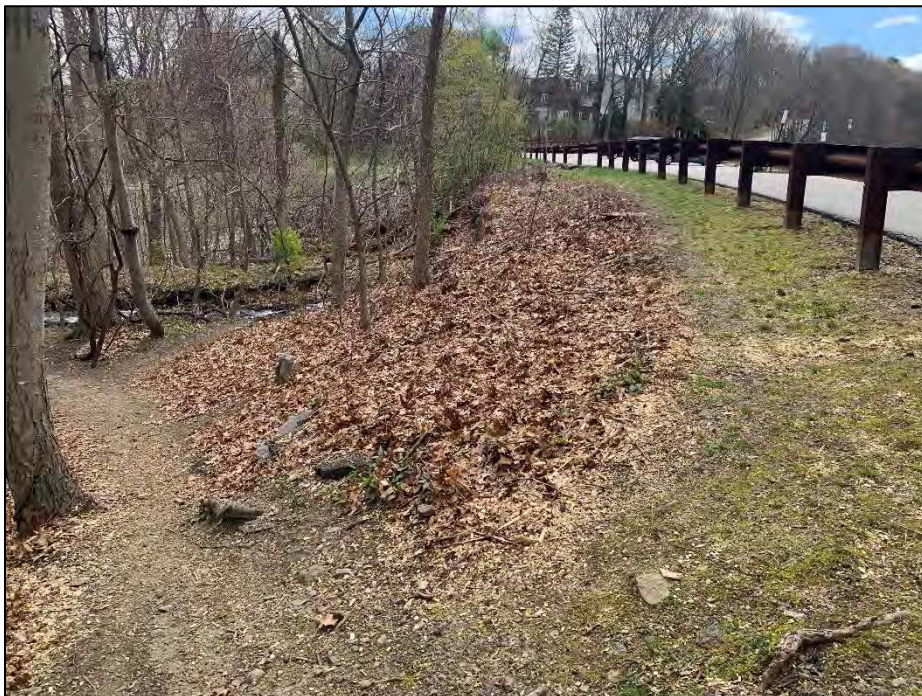
Photo No. 12.: Downstream slope from the left abutment looking right. Note the deadfall cover and tree growth.

- Clearing the downstream groins and areas of small trees and brush within 15 feet of the dam. *Note that the downstream right groin has been cleared of trees; however, stumps remain.*
- Clear the small trees and brush from within 15 feet of the toe of the dam.
- If not already done so, if dye testing was performed on the previously filled holes over the spillway culvert alignment in conjunction with an internal video inspection, and the holes are connected to the culvert, develop and initiate a cementitious repair patching program on the culvert. If the holes are not connected to the culvert, monitor the development of holes in these locations.

2. Post tree clearing grub root systems larger than 0.5 inches from the embankments and fill the resulting holes with suitable compacted material. Depending upon the type of stumps to be removed, the procedure for removing the root system may vary. Some trees have taproots while others have a shallow network of roots that cover a large area. Impacts to the embankments should be evaluated by an engineer prior to grubbing roots from the dam. Given the location of the stumps on the embankment and the conditions prevalent at the time of the work, instability, seepage, or piping conditions could develop if not undertaken in a controlled manner. Clearing should extend a minimum of 15-feet from all embankment and other structures associated with the dam and include.

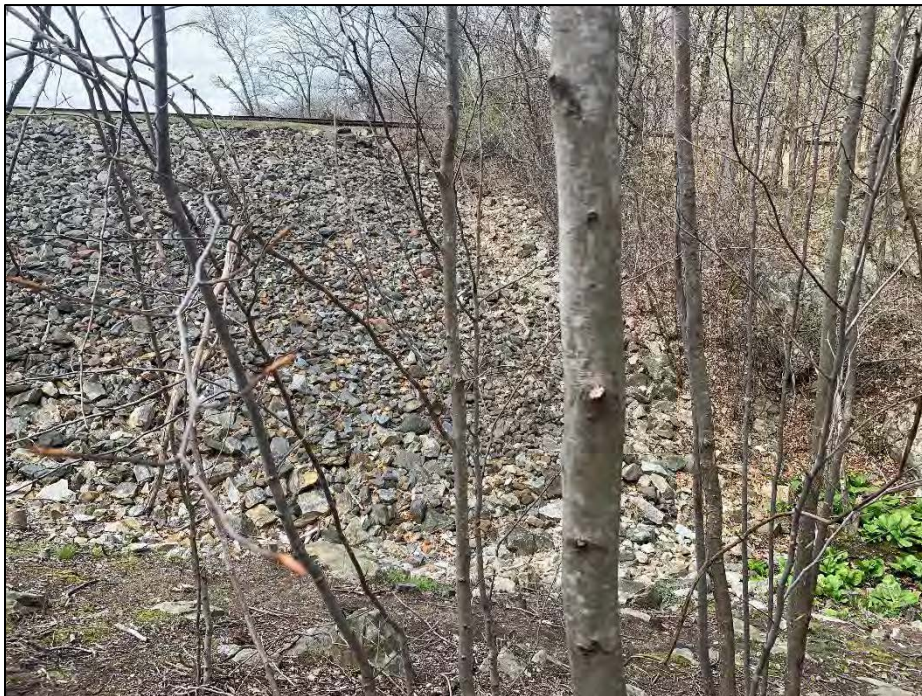
Photo No. 18.: Downstream slope as viewed from beyond the right groin looking upstream and slightly left. Note the wetland vegetatoin along the toe.

7. If not already done so, develop and initiate a program for monitoring the seepage along the toe of the dam. Seepage rates should be recorded through the use of V-notched weirs installed within formed channel(s). The seepage areas should also be monitored for boils and for signs of iron flocculate and/or sediment transport. If conditions advance, the Owner is recommended to retain the services of a registered professional engineer experienced in dam repair to further evaluate the situation.

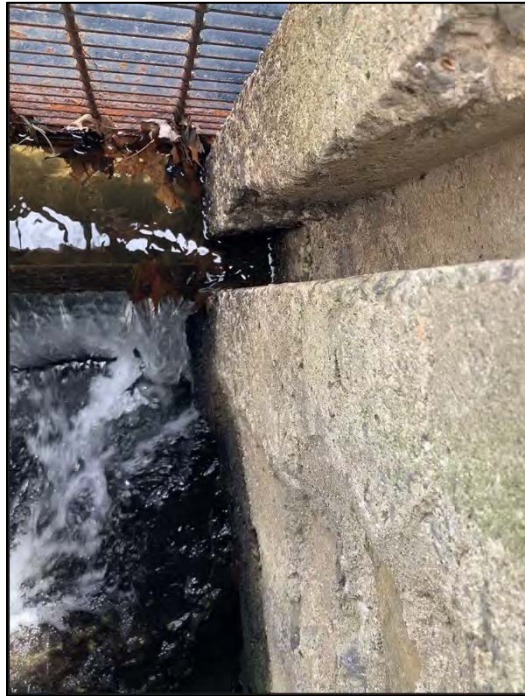
- Spalled concrete along the top of the right stop log slot was observed. The condition of the left stop log slot was viewed due to the presence/location of the trash rack.

- Leakage estimated to be less than 3 gpm was noted between the stop log and the stop log slot on the right side.
- Leakage estimated to be less than 5 gpm was noted to be passing through the joint between the culvert wall and the base slab just past the stop log section.

Photo No. 21.: Primary spillway stop log weir section right side looking down stop log slot. Note spalling within stop log slot and leakage under wall downstream of stop logs.

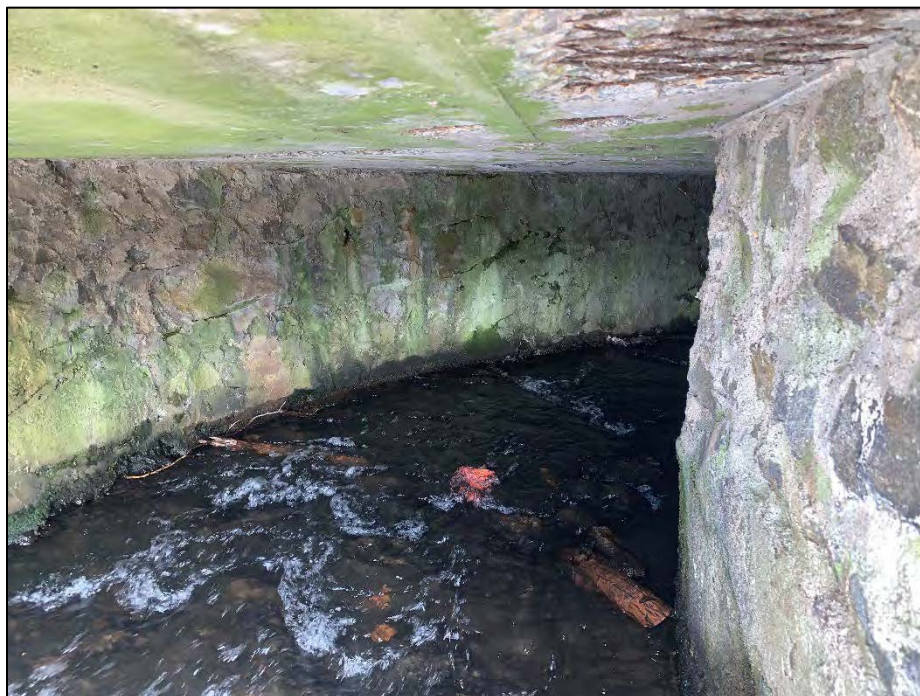
- Spalled concrete was observed along the culvert ceiling about 8 feet downstream of the intake with the spalled area about 18 inches in diameter. The depth of spalling is about 1 inch deep with exposed reinforcement observed.

Photo No. 22.: Primary spillway culvert as viewed from the intake. Note the spalled areas along the ceiling with exposed reinforcement.

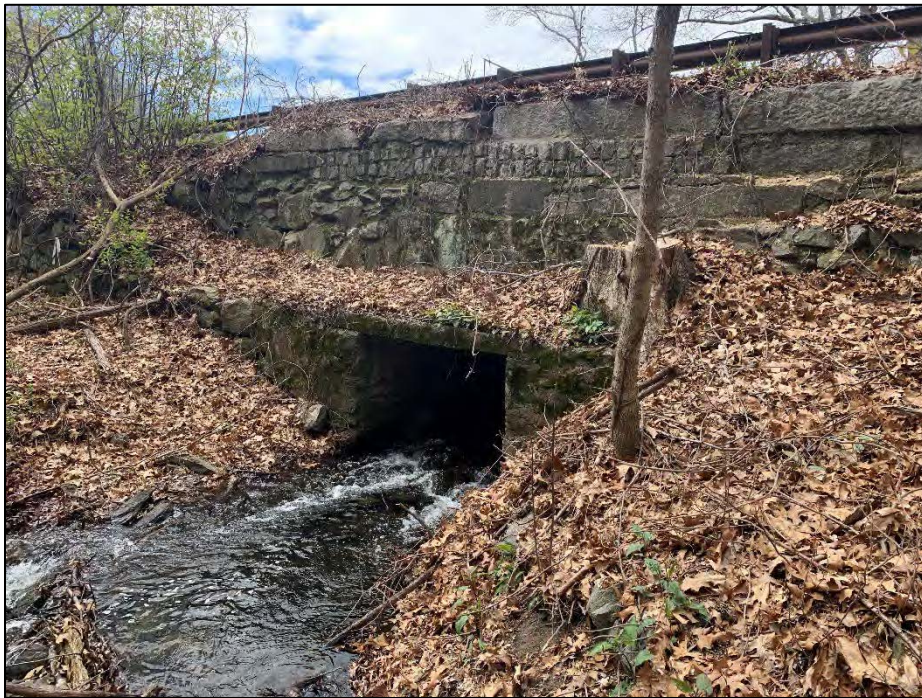
- Left of the riprap slope is a stone wall that supports the roadway and also functions as the downstream headwall for the spillway discharge.
  - The wall appears in satisfactory condition with normal alignments and tight joints.
  - A tree stump is present behind the left side of the wall. The Owner's representative stated that the tree associated with the stump was cut down recently.
  - The slope downstream of the dam is earthen and is covered with leaf and woody debris limiting the inspection to general review of alignment. The slope appears even at about 3H:1V.
- The contact points with both the left and right abutments appear normal with no cracks, separations, or signs of unusual movement.

Photo No. 23.: Primary spillway discharge opening. Note tree trunk above the headwall.

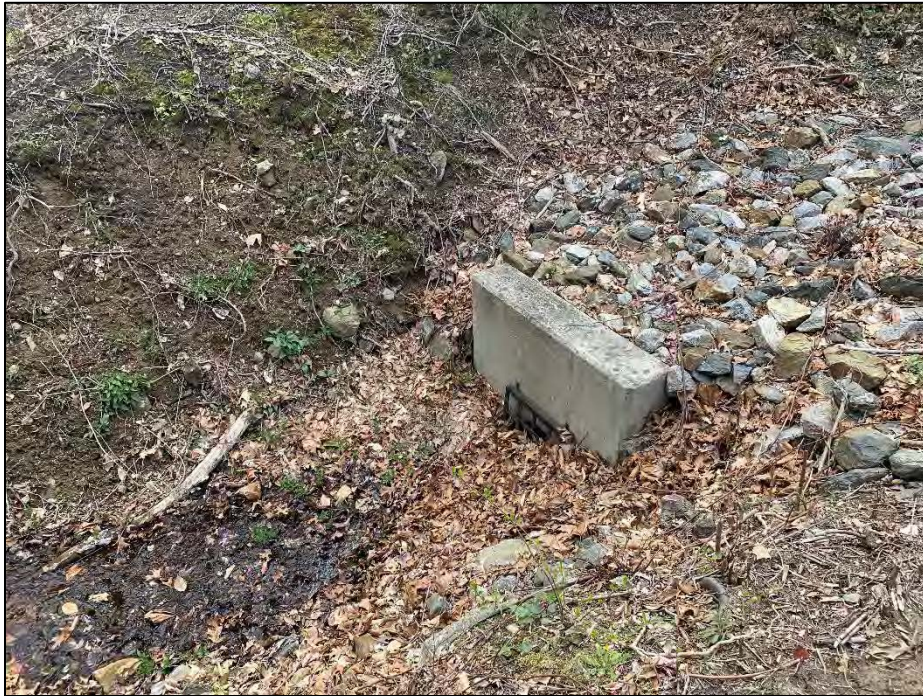
Photo No. 27.: Low level outlet discharge opening. Note buildup of leaves against opening.

8. Remove the existing animal guard at the low-level outlet discharge and replace it with a guard that is designed such that full flow can be discharged from the low-level outlet.

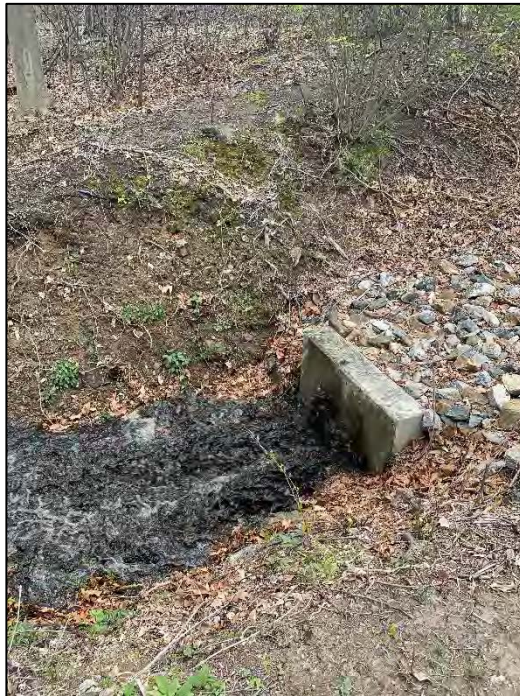
- The approach was below water therefore an inspection was not completed to assess the condition of the intake, trash rack, or accumulated sediment buildup.
- The gate stem was broken during the previous 2019 inspection. Since that inspection, this has been repaired and the gate is now fully functional.
- The gate operator is housed within a locked vault near the center of the dam on the upstream side.
- The Owner's representative demonstrated the gate's operation.
  - Prior to operation, the low level outlet discharge channel was covered with accumulated leaves which covered almost 2/3rds of the discharge opening.
  - The gate opened with ease. The reaction time for outflow was about 5 seconds. The flow from the discharge opening was muddy indicating a heavy sediment buildup at the

Photo No. 28.: Low level outlet discharge opening following initial gate opening. Note the muddy flow likely from one year of sediment buildup at the intake.

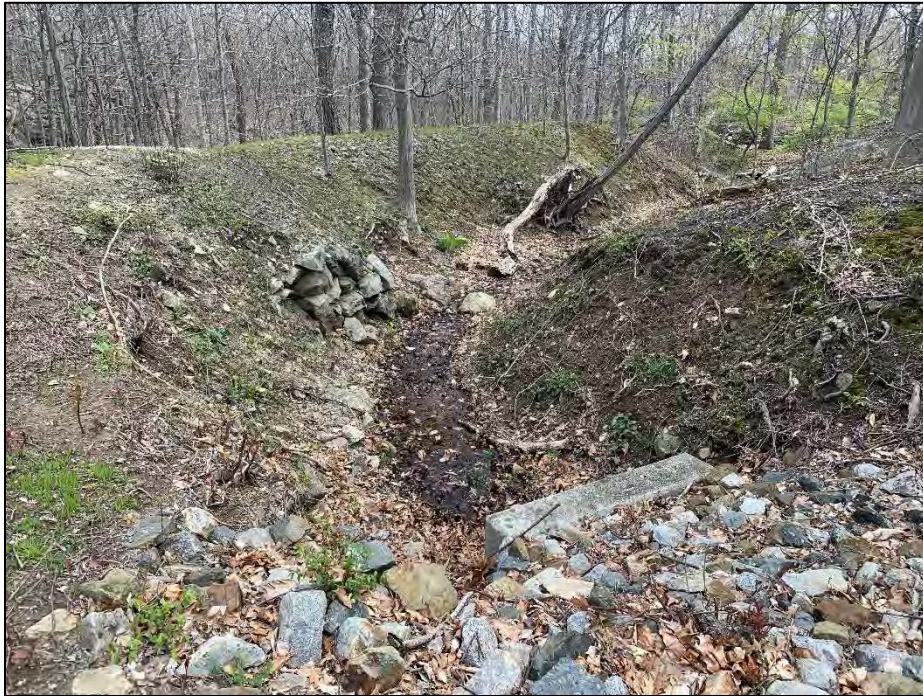
Photo No. 29.: Low level outlet discharge channel. Note deadfall cover within channel bottom.
