PASCOAG RESERVOIR UPPER DAM, BURRILLVILLE (016)

Pascoag Reservoir Upper Dam (**Figure 1**) has been classified by DEM as having a **High Hazard** potential. The following report summarizes GZA's evaluation of the dam's potential impact area due to failure of the dam.

1.00 SUMMARY OF SITE AND POTENTIAL DOWNSTREAM IMPACT AREA

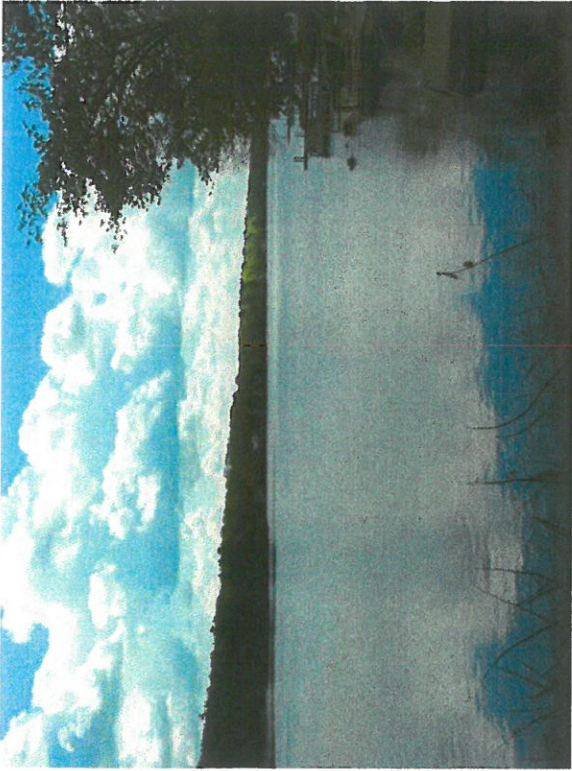
Photo 1. View of Pascoag Reservoir from embankment

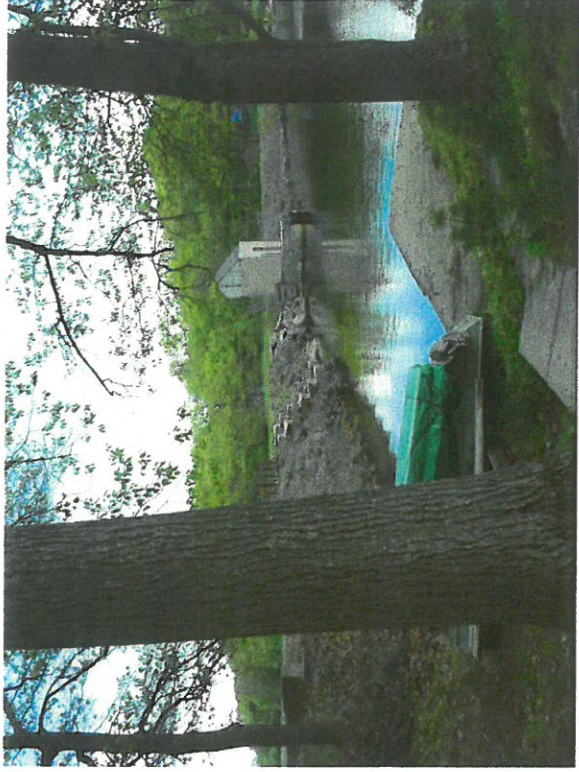
Photo 2. View of upstream face of the dam and spillway.

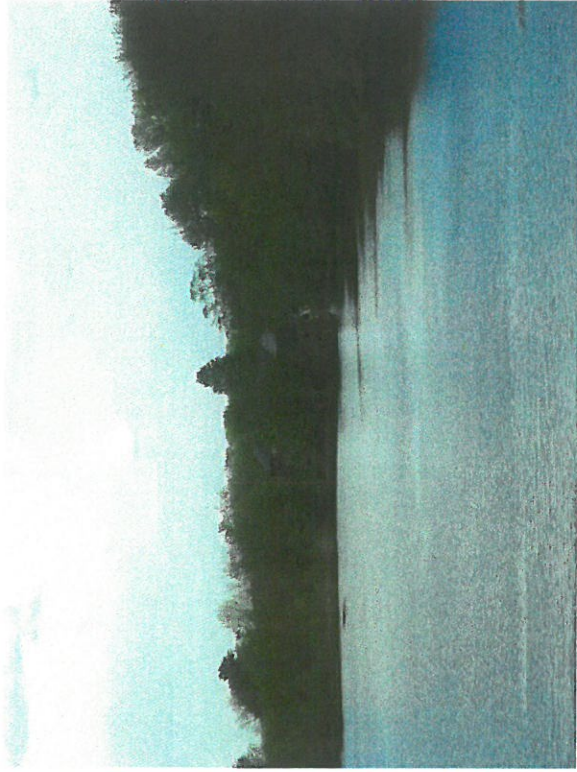
Photo 4. View along left side Pascoag Reservoir.

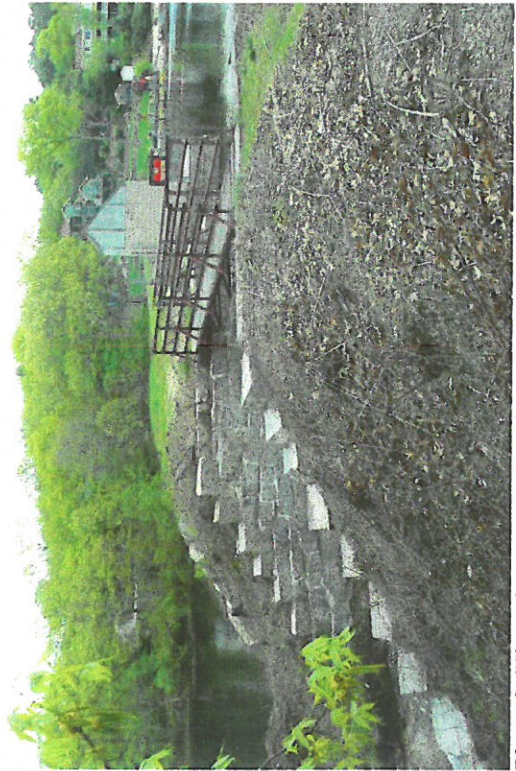
Photo 3. View along crest of spillway from left side of dam.

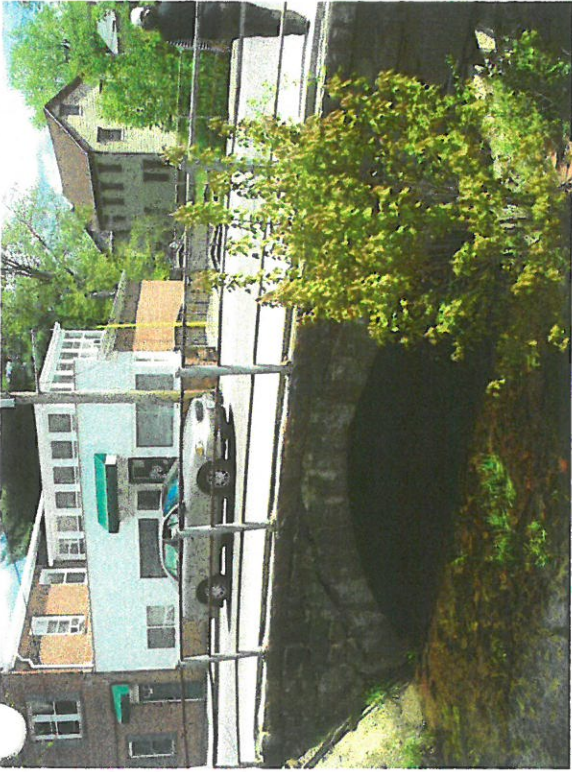
Photo 5. Sayles Av crossing.

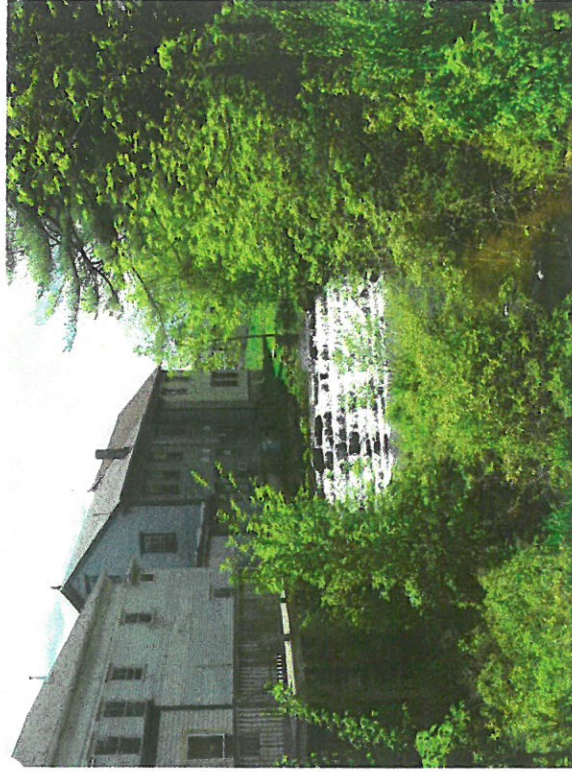
Photo 6. Akela Pond Dam. Note the building close to the bank of Pascoag River.

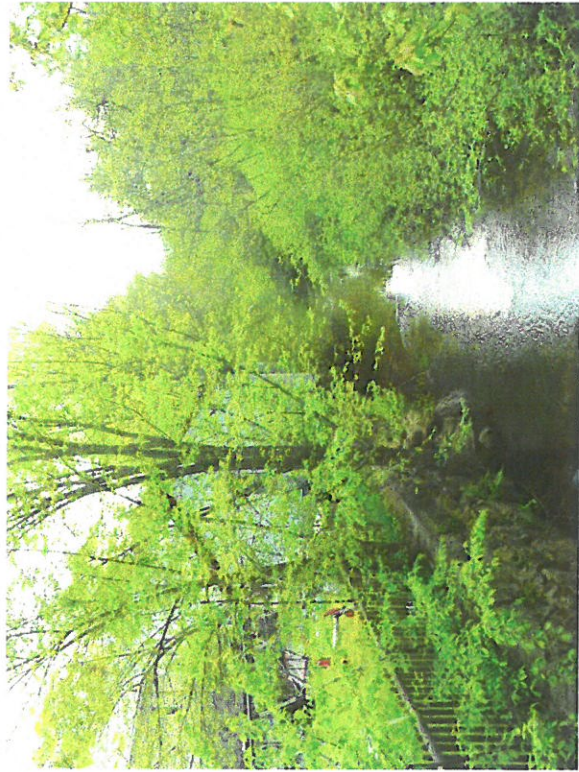
Photo 7. View of downstream channel from Sayles Av.

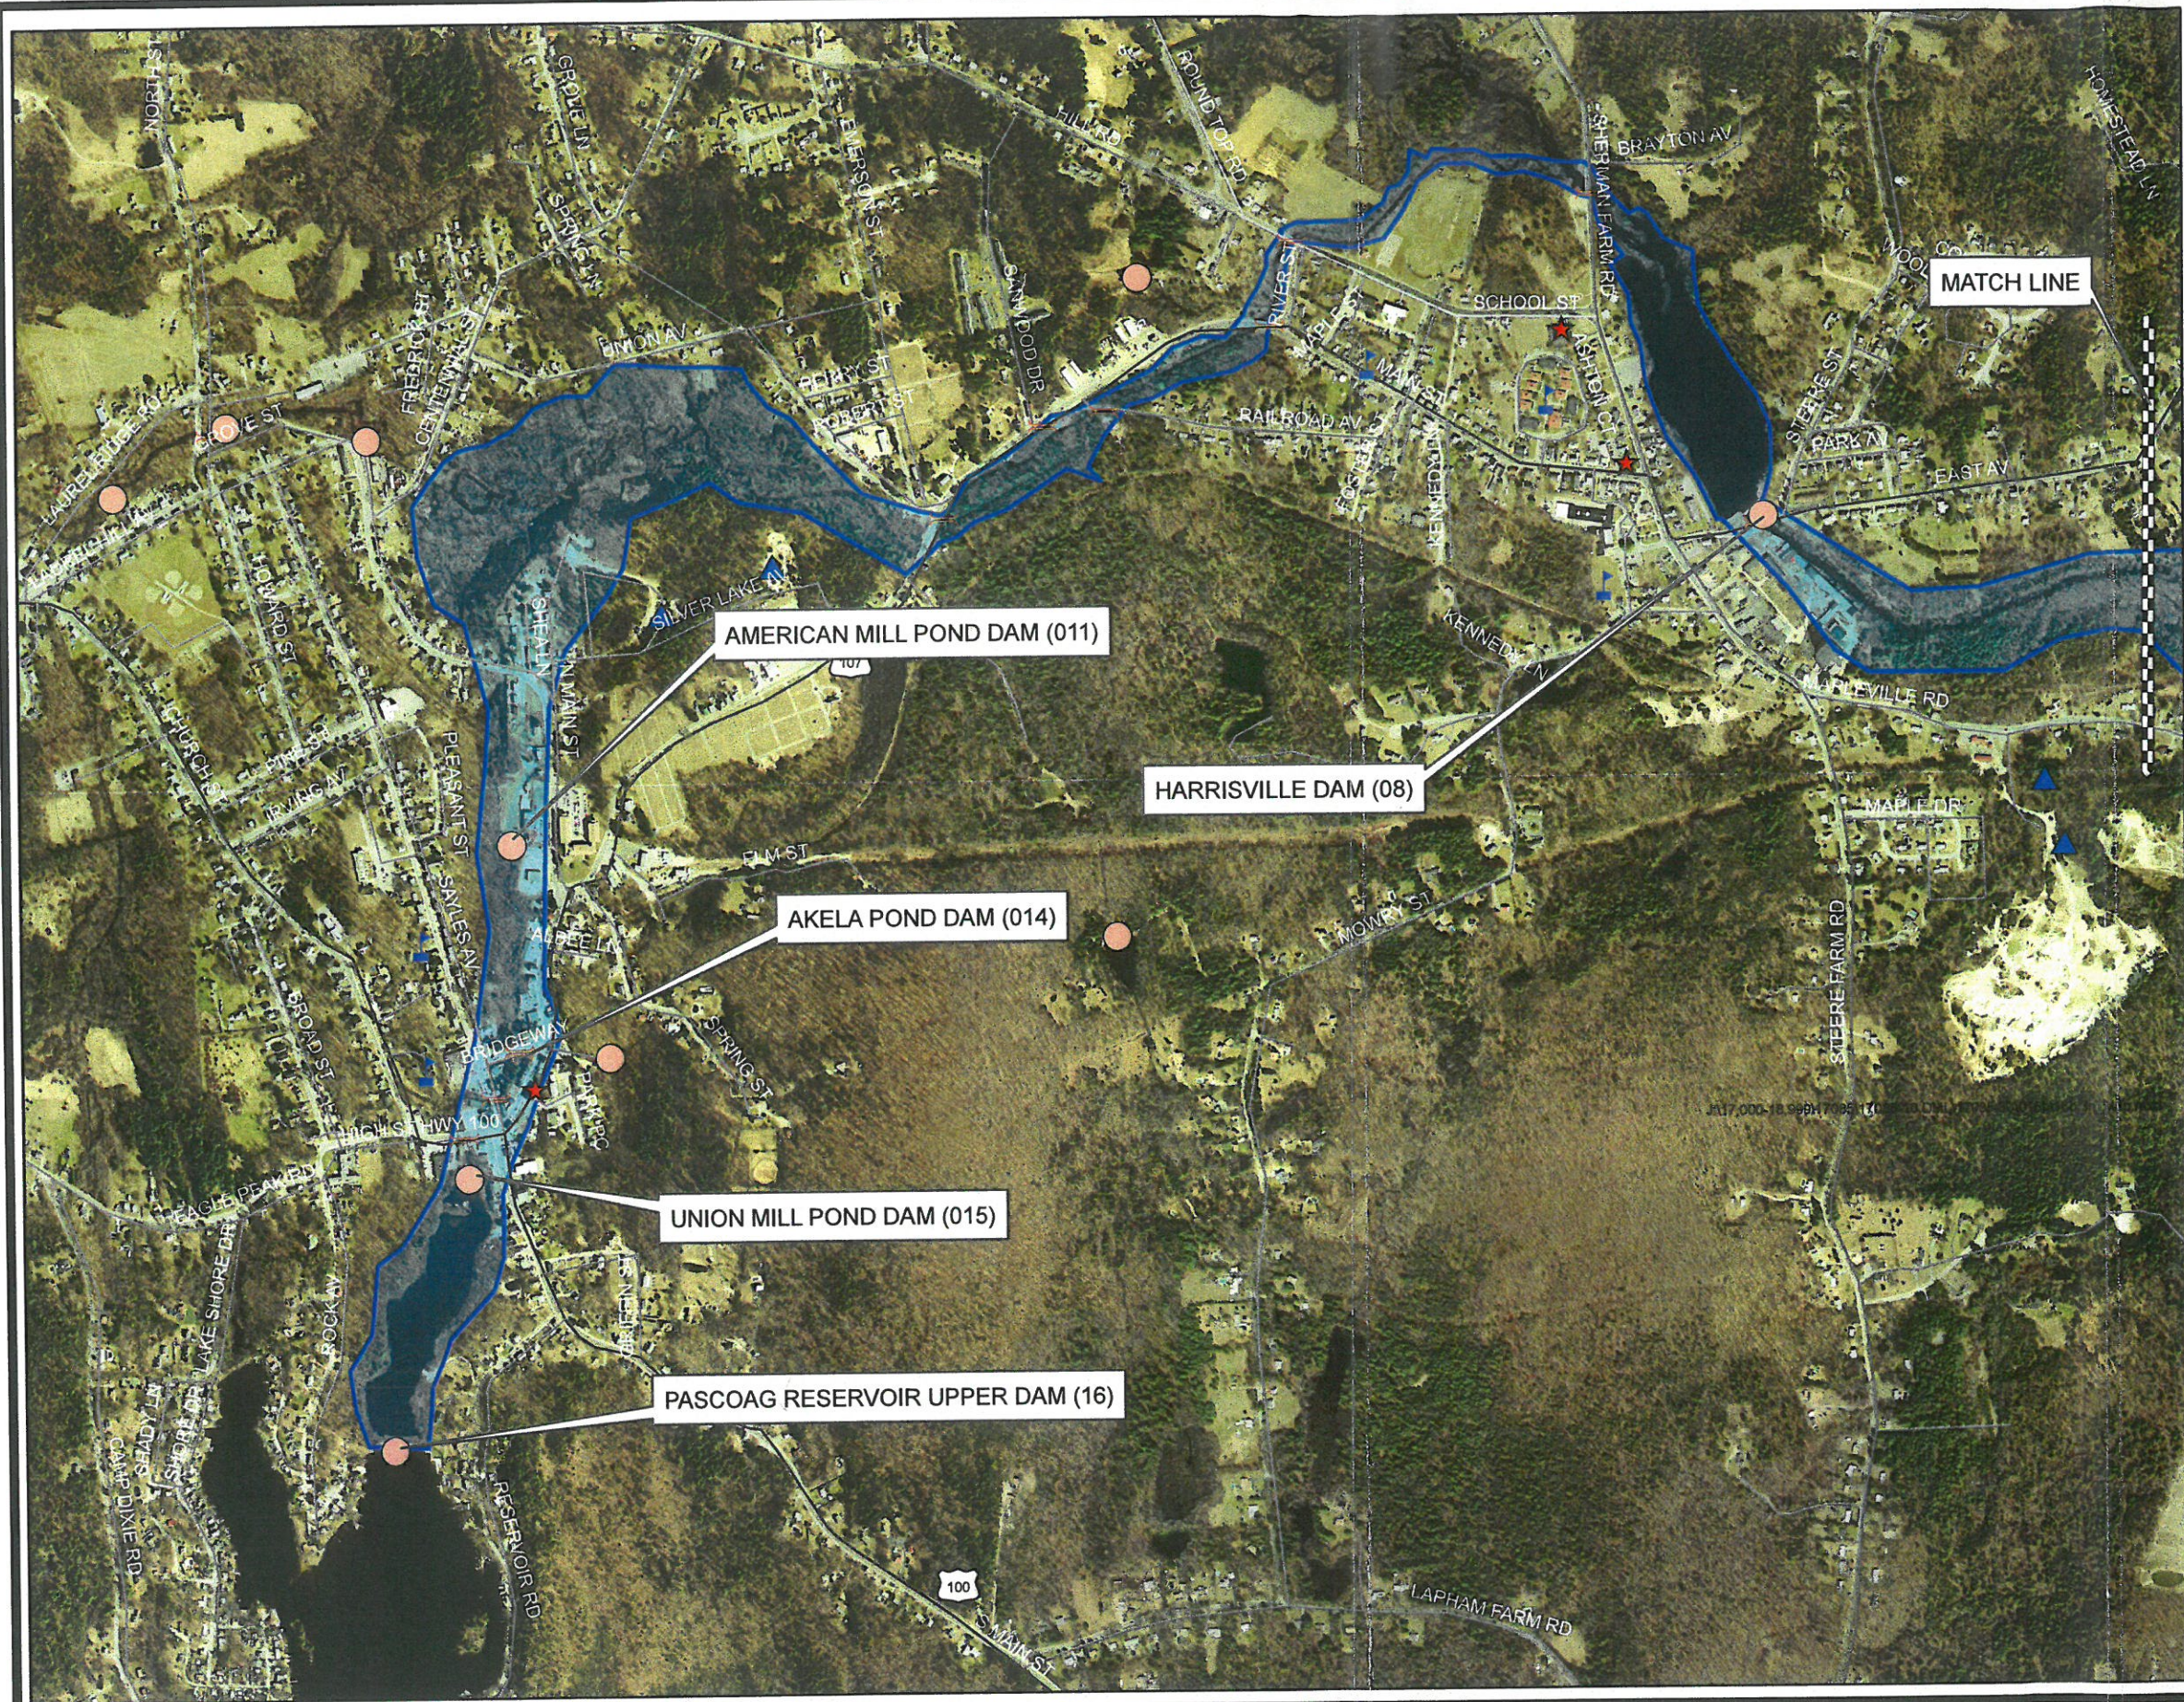
Proj. Mgr.: DML Designed By: DDR Reviewed By: PHB Operator: DDR	Dwg. Date: 07-13-09 Job No.: 17085.40	Figure No.: 2
--	--	-------------------------

Several riverine cross sections, developed by GZA from USGS 7.5 minute quadrangle maps and RIGIS mapping data, were input into the SMPDBK model to preliminarily estimate approximate peak water surface elevations. The results of the analysis are provided as the approximate inundation area depicted in **Figures 2, 3 and 4**.

Results of the analysis indicate a peak flood depth at the immediate toe of the dam of about 23 ft. The flood wave from a hypothetical dam failure at Pascoag Reservoir Upper Dam is expected to cause the failure of many downstream dams and bridges on the Pascoag River, the Clear River and the Branch River. The dam break flood wave is anticipated to inundate many structures and result in the loss of lives. The resulting dam break flood wave is anticipated to be several times larger than the 500-year flood and lead to widespread flooding along the Pascoag River, the Clear River and the Branch River.

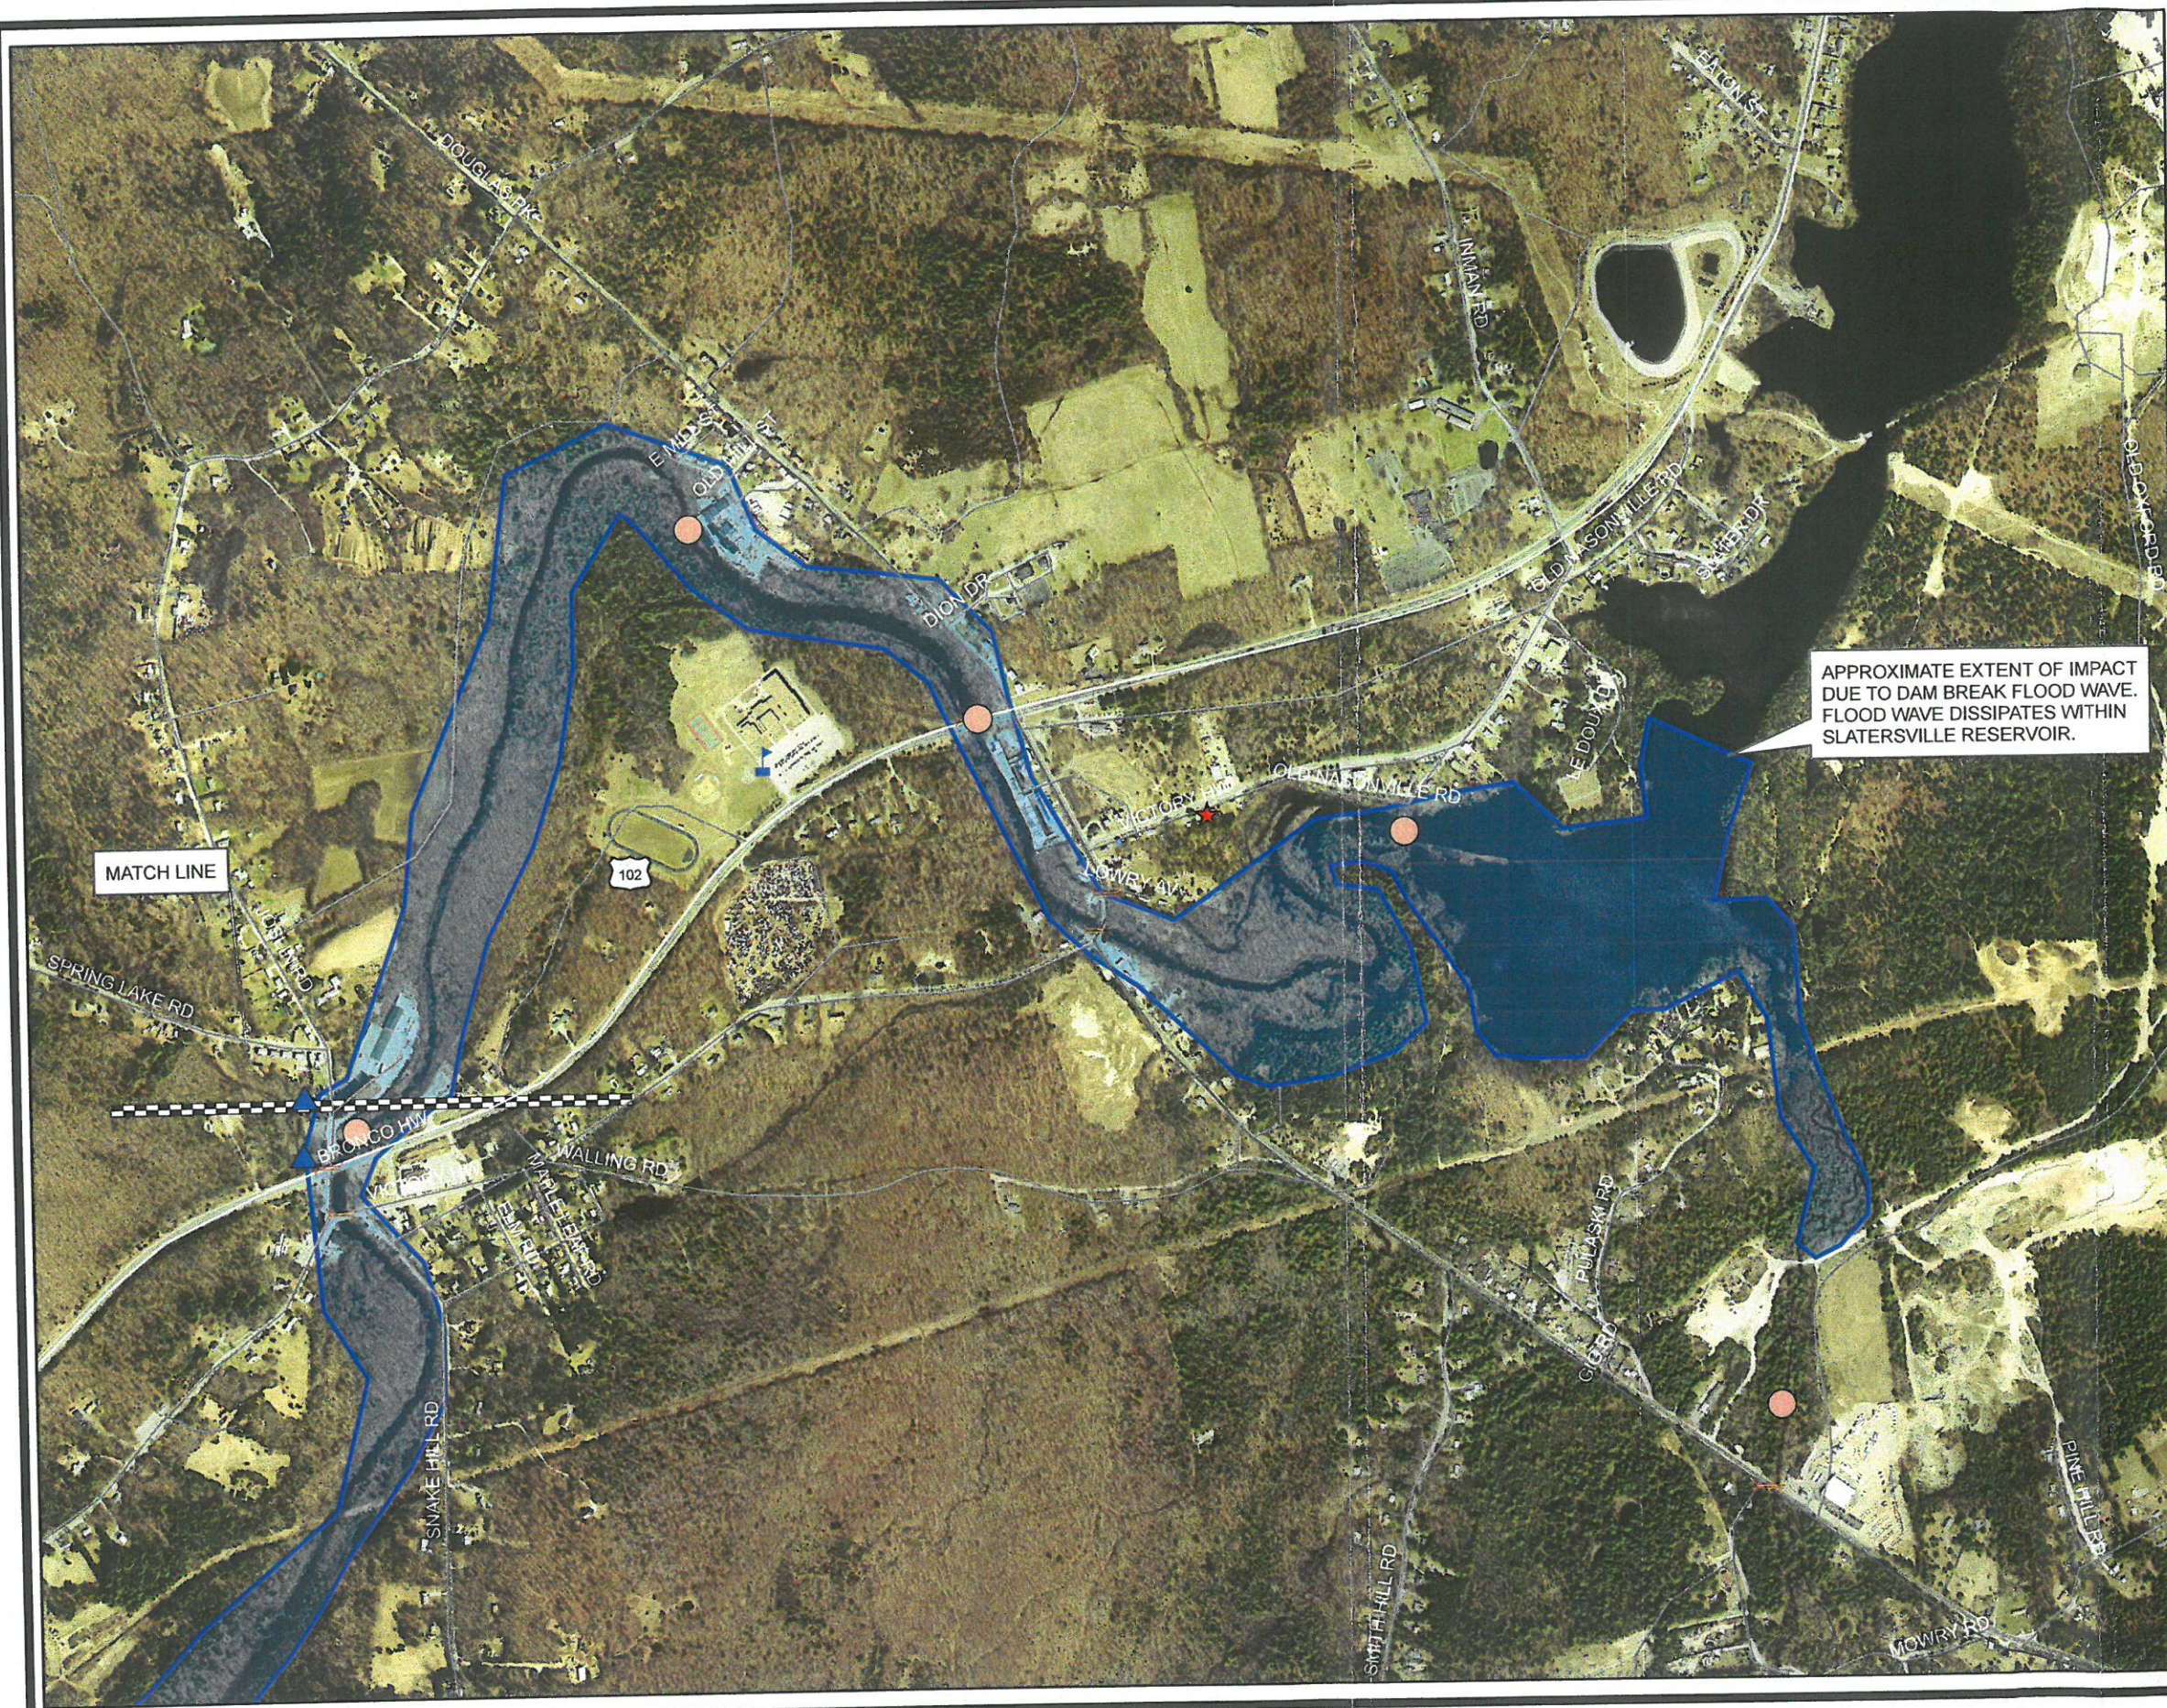
Proj. Mgr.: DML	Dwg. Date: 08-13-00	Figure No.:
Designed By: DDR		4
Reviewed By: PHB	Job No.: 17085.40	
Operator: DDR

APPROXIMATE EXTENT OF IMPACT DUE TO DAM BREAK FLOOD WAVE. FLOOD WAVE DISSIPATES WITHIN SLATERSVILLE RESERVOIR.
