**-- WYOMING UPPER DAM --
VISUAL
INSPECTION / EVALUATION REPORT**

Dam Name: *Wyoming Upper Dam*

Date of Inspection: *June 5, 2014*

INSPECTION SUMMARY

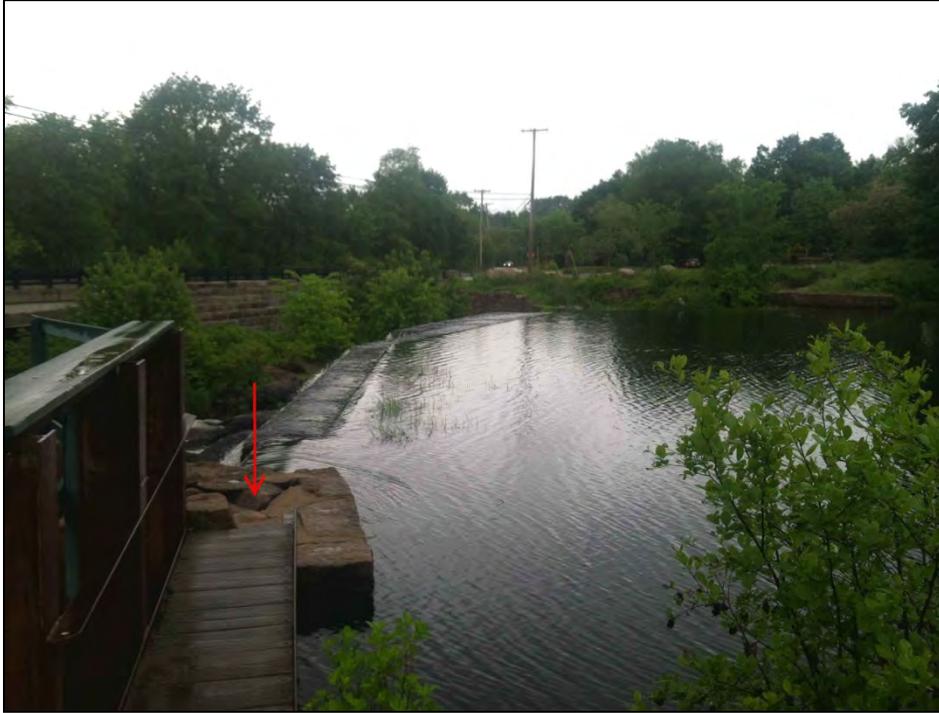
Photo No. 1: Overview of the primary spillway from the left. Note the sunken areas of stone along the left training wall (See Photo No. 2).

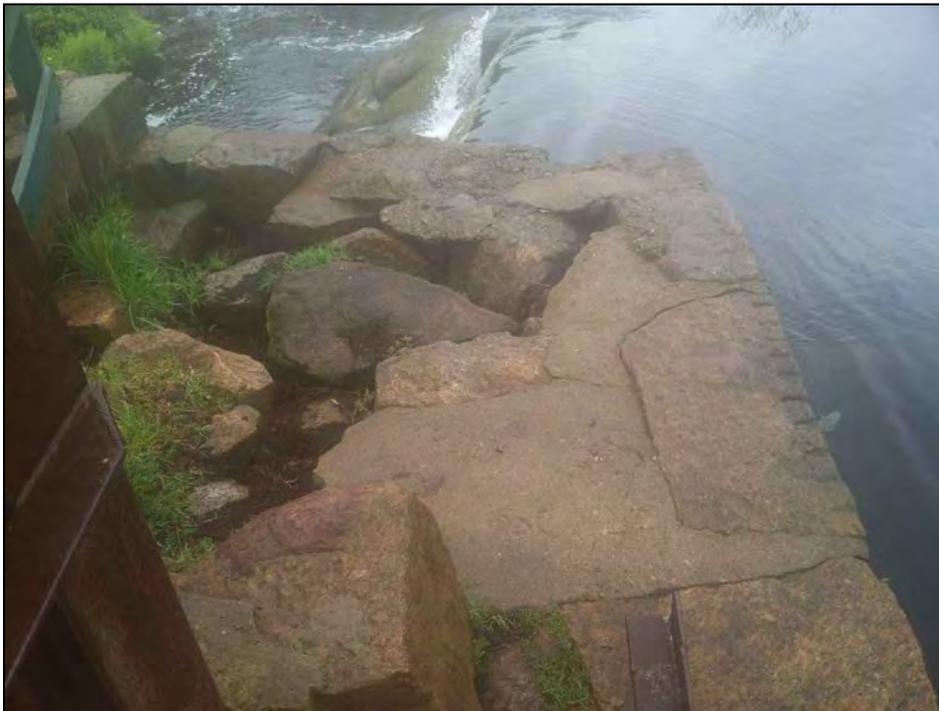
Photo No. 2: Sunken stone areas along the top of the primary spillway's left training wall as pointed out in Photo No. 1.

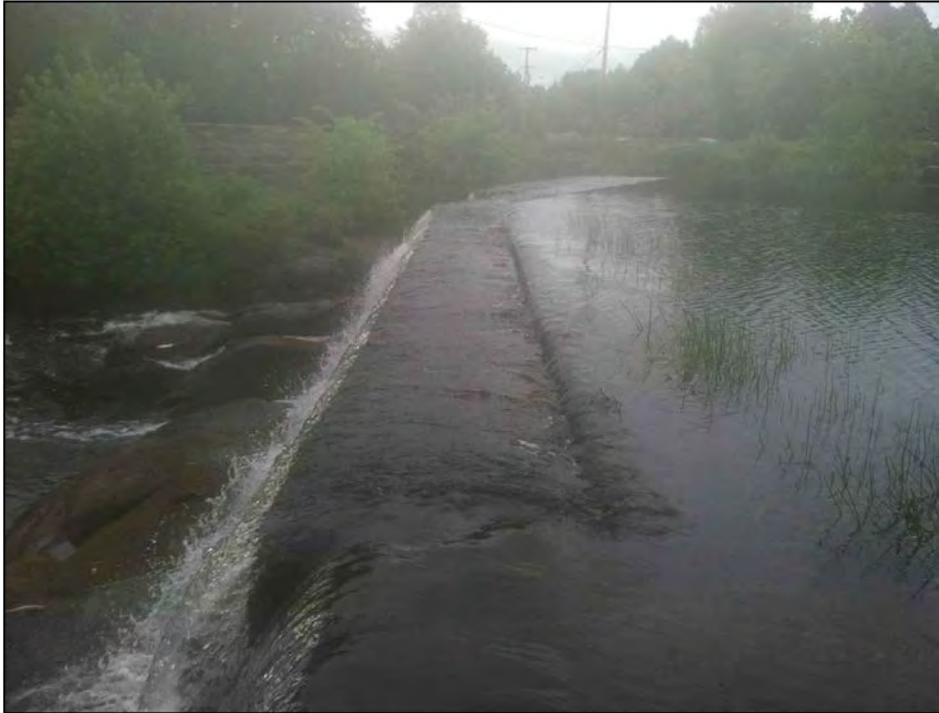
- The flow pattern over the control section is uneven, which may be indicative of missing and/or displaced weir stones.
- The approach channel is clear of debris.

Photo No. 3: The control section at the primary spillway as viewed from the left.

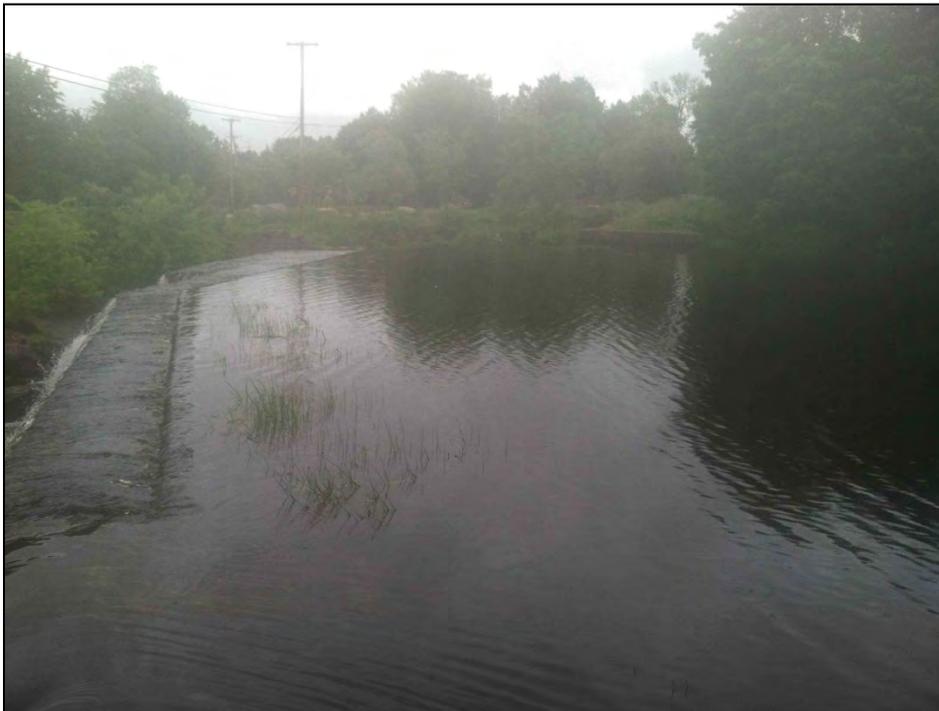
Photo No. 4: Overview of the approach to the primary spillway as viewed from the left.

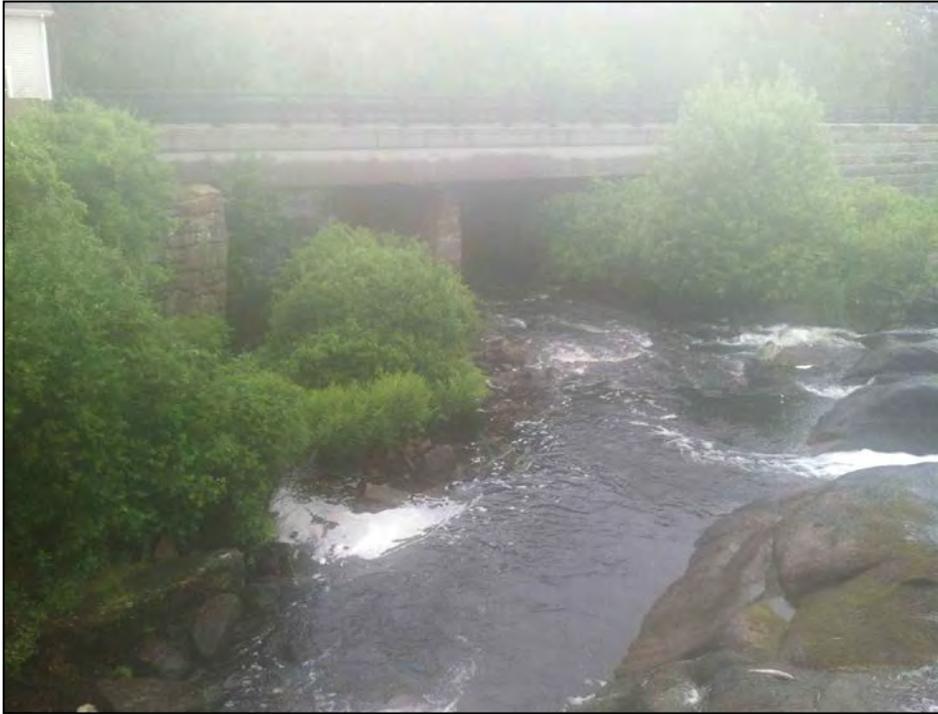
Photo No. 5: The discharge channel as viewed from left of the primary spillway. Note the overgrowth within the channel.

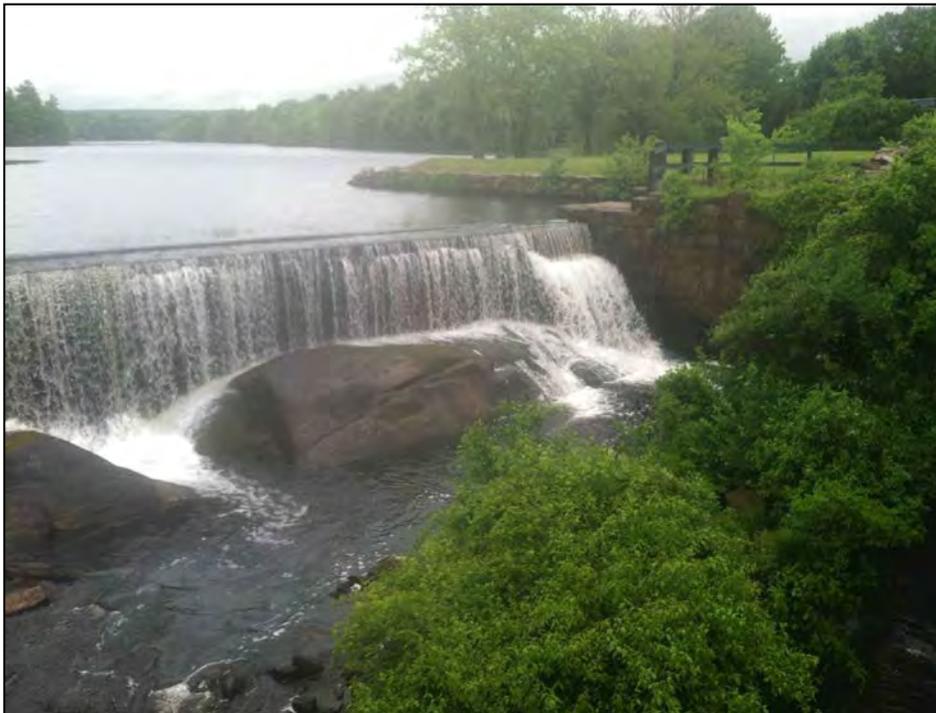
Photo No. 6: Downstream face of the primary spillway as viewed from the bridge over the downstream channel looking left.

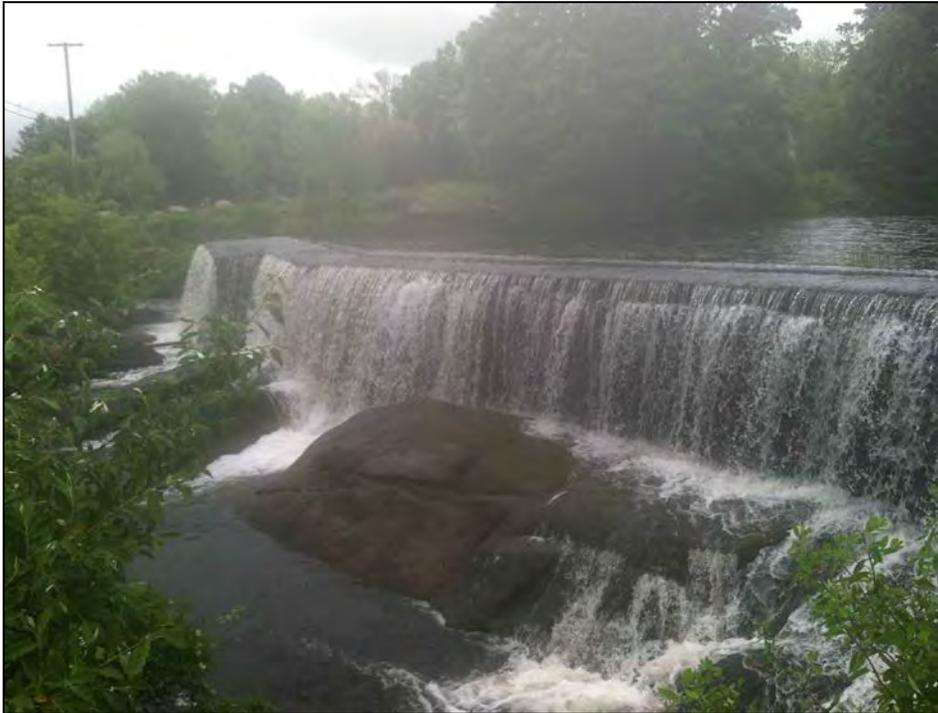
Photo No. 7: Downstream face of the primary spillway as viewed from the left side of the downstream channel looking right.

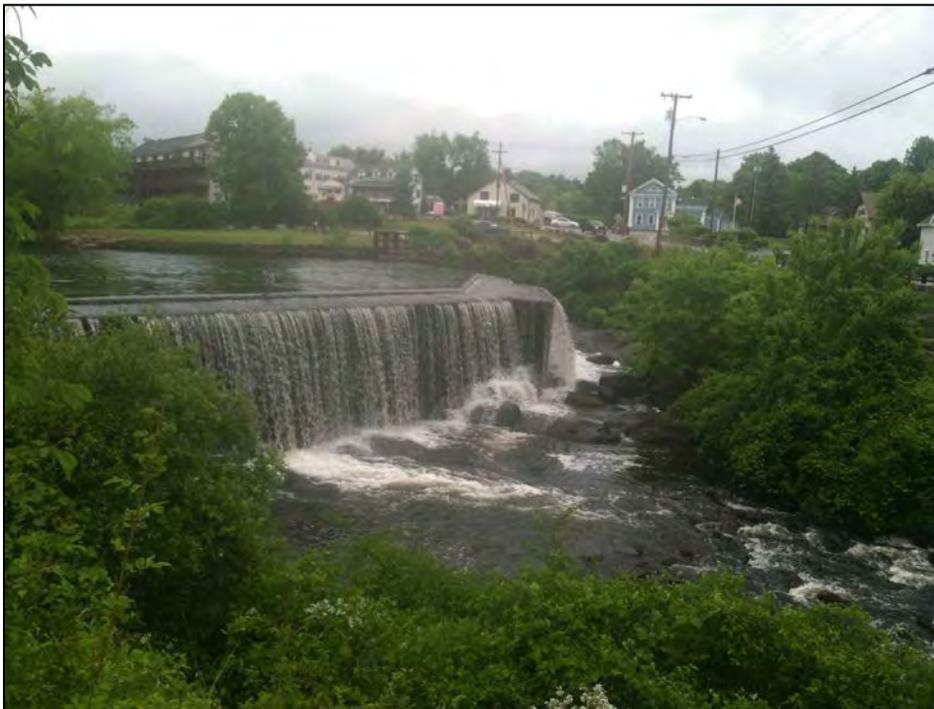
Photo No. 8: Downstream face of the primary spillway as viewed from the right side of the downstream channel looking left.

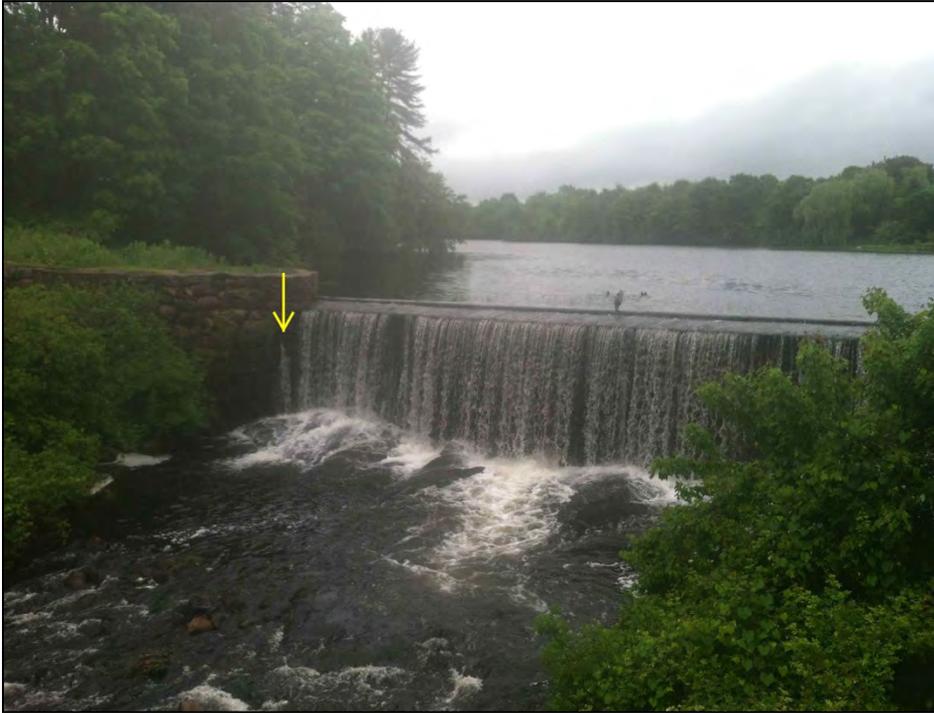
Photo No. 9: Right downstream face of the primary spillway as viewed from the bridge over the downstream channel. Note the leakage at its connection with the right embankment.

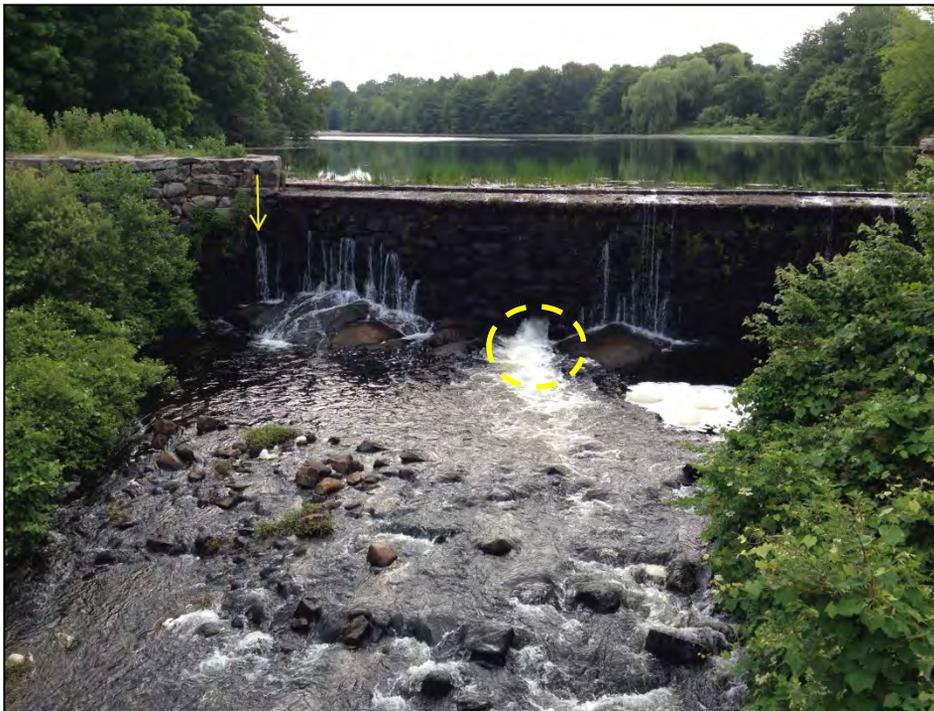
- As indicated on the photo taken by RIDEM personnel (Photo No. 10), several clusters of thin leakage streams are present along the spillway's downstream face along its right-most third.

- The leakage appears to be concentrated along the mid-height of the wall.
 - During the time of the inspection, access to this area to look for signs of sediment transport downstream of the spillway and/or soil loss and/or undermining along the approach was limited due to its location within the submerged flow areas.

- The leakage appears to be running clear at roughly 5-10 GPM per location with no iron oxide staining noted along each exit point.
- The stone masonry across the full downstream face has many open joints that are in need of repointing and chinking.

Photo No. 10: This photo location is similar to Photo No. 9, except during low flow conditions (taken at the end of June 2014 by RIDEM). Note the leakage areas along the downstream spillway face. Arrow points to the leakage shown in Photo No. 9. Also note the flow through the low level outlet discharge.

7. Complete an inspection of the downstream face of the spillway under low flow conditions to assess the spillway for indications of problematic leakage or stone loss. Develop and implement a repair program to address deficiencies.

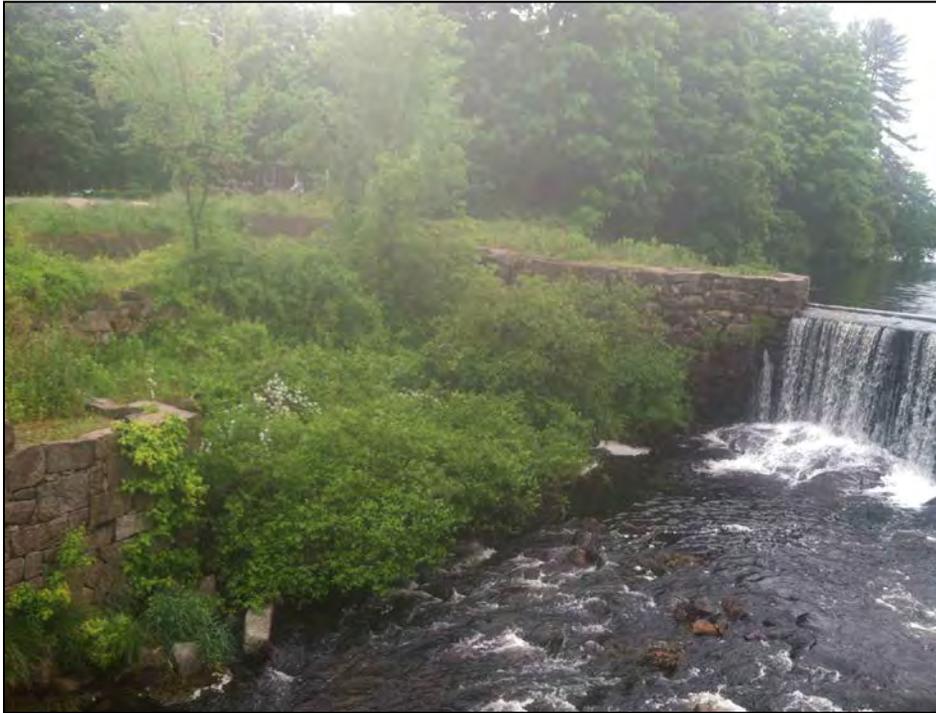
Photo No. 11: The area downstream of the right embankment as viewed from the bridge over the downstream channel looking right. Note the overgrowth in the downstream area.

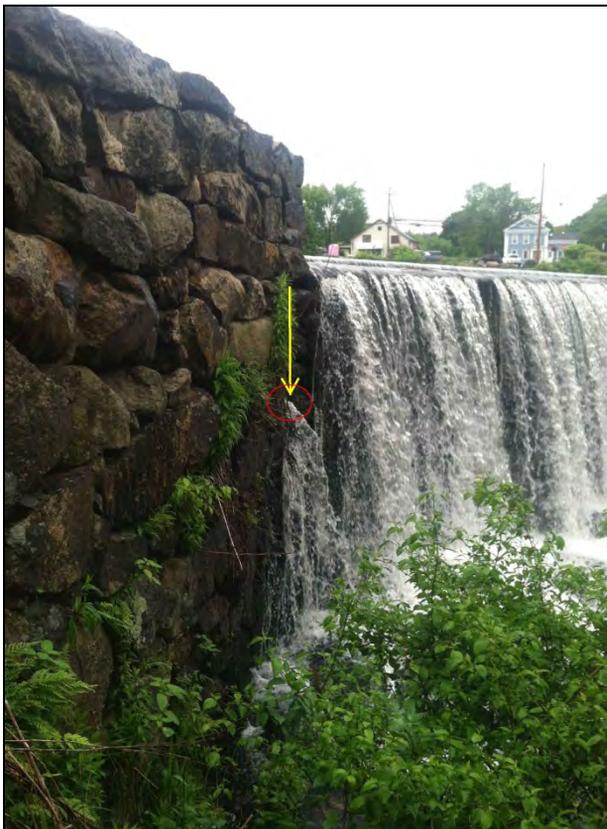
Photo No. 12: A closer view of the leakage shown in Photo No. 9. Photo taken from the downstream toe of the right embankment.

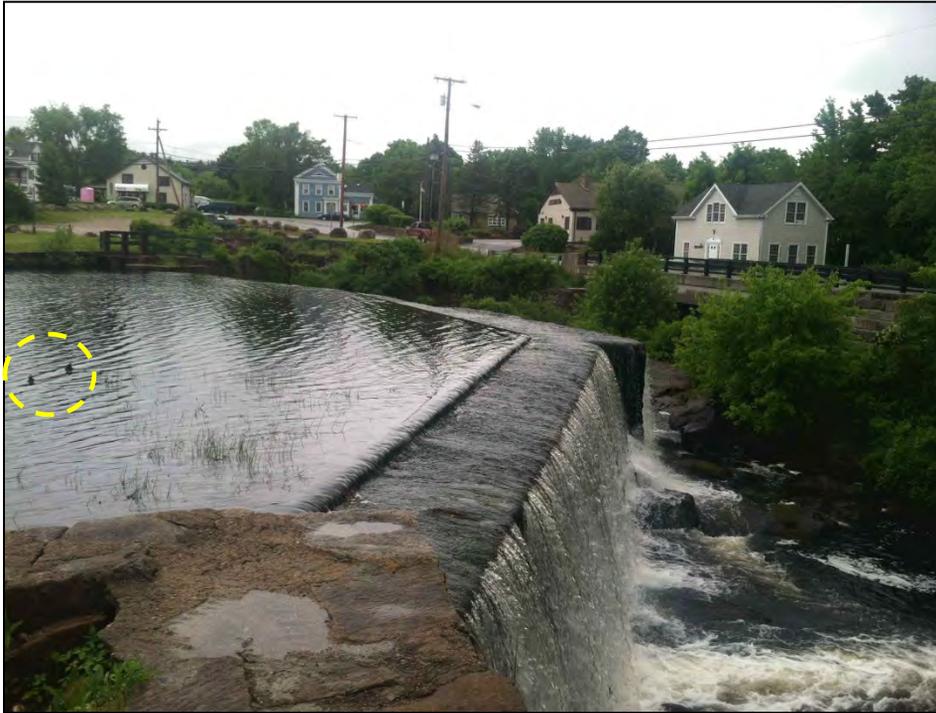
Photo No. 13: The control section at the primary spillway as viewed from the right. Note the location of the former low level outlet controls.

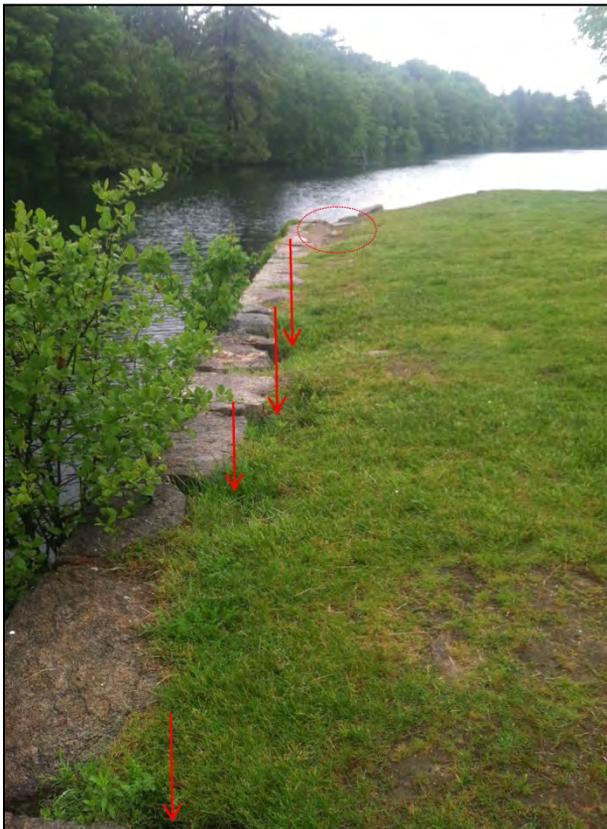
Photo No. 14: Overview of the wall at the left side of the spillway approach, which also supports the left embankment. Photo taken from the sluiceway looking upstream. Note the numerous sinkholes behind the wall and the erosion along its upstream side.

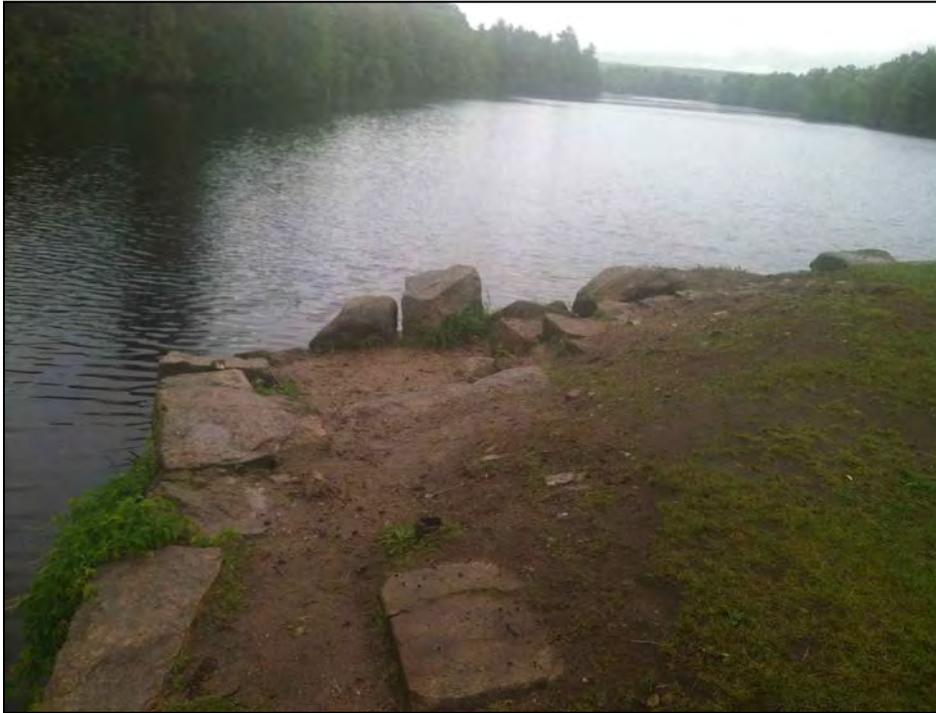
Photo No. 15: Close-up of the erosion circled in Photo No. 14.

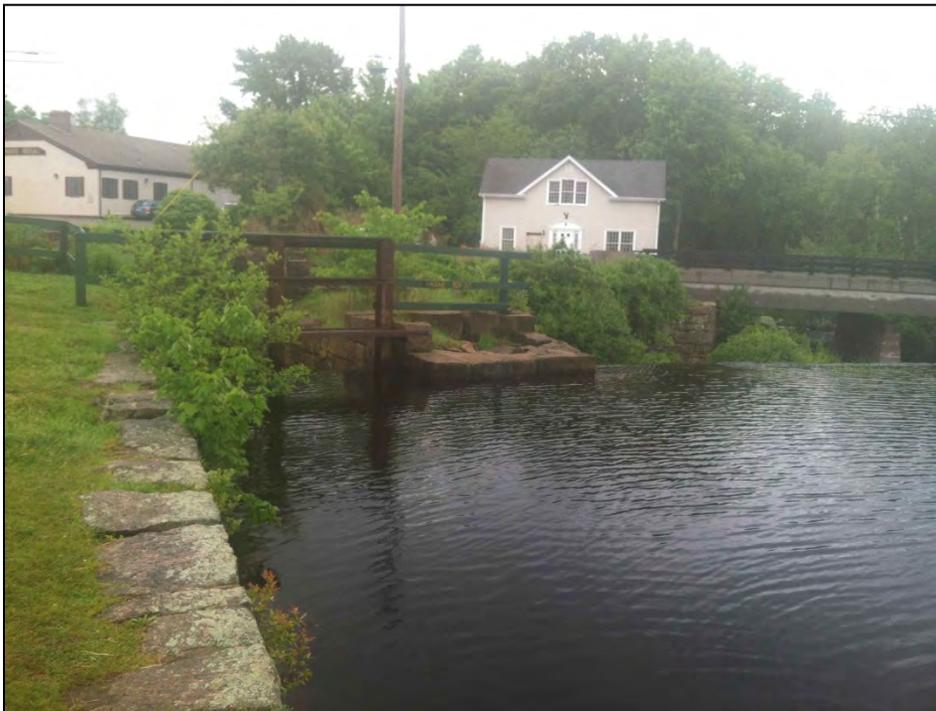
Photo No. 16: Overview of the sluiceway as viewed from upstream.

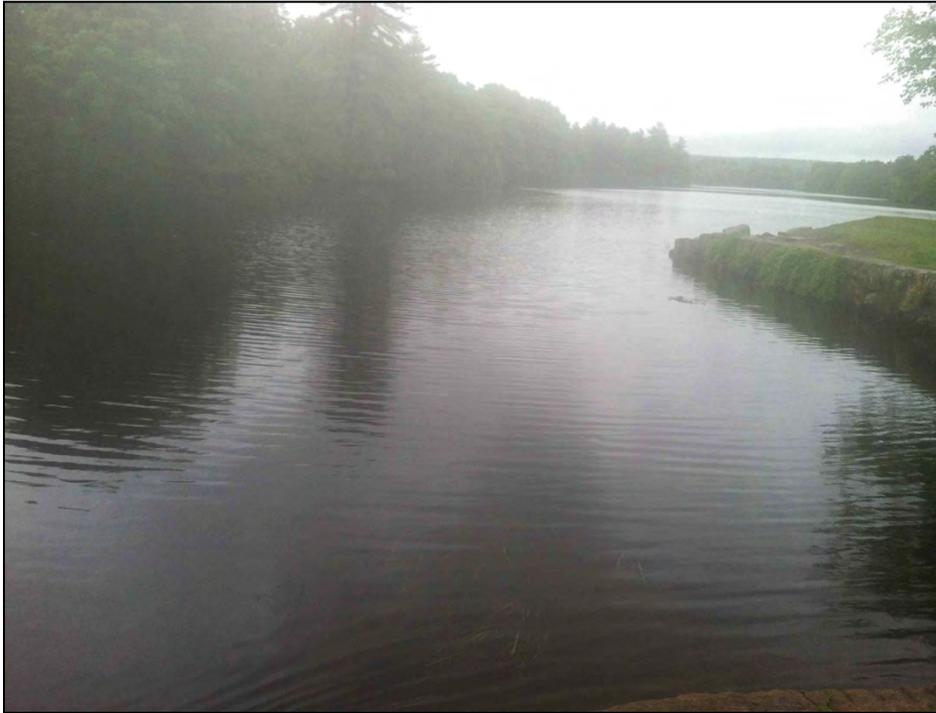
Photo No. 17: Overview of the sluiceway's approach area and view into the impoundment as viewed from the sluiceway.

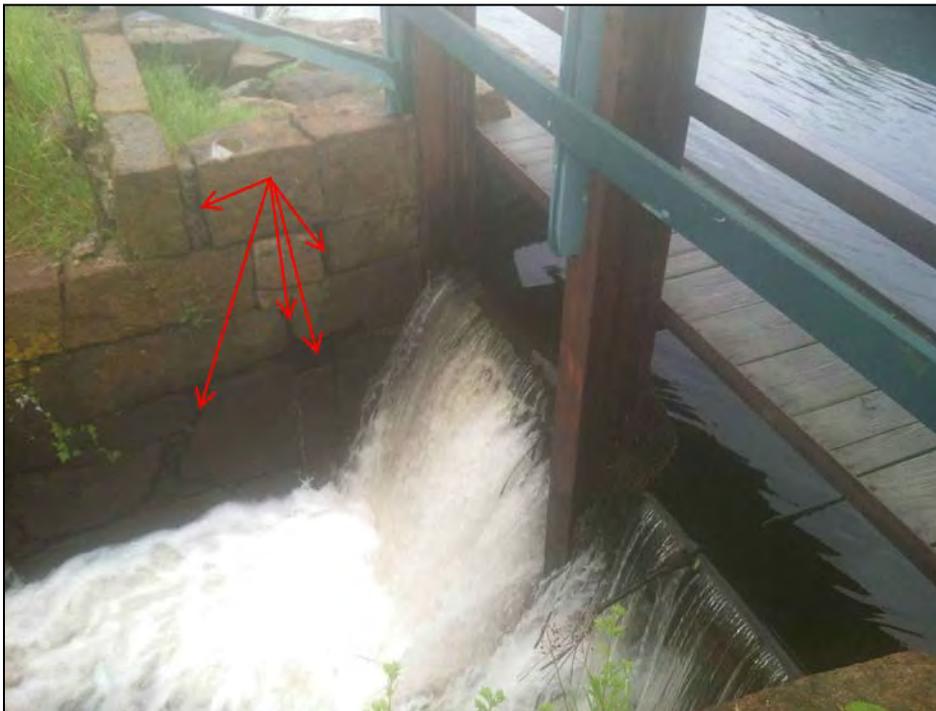
Photo No. 18: Stop log controls at the sluiceway as viewed from the left. Note the poor jointing along the channel's right wall.

10. Seal leakage around the stop log slots at the sluiceway.
11. Modify the existing controls at the sluiceway to provide an operable outlet structure. This could include removing and installing new stop logs fitted with steel lifting eyes to allow the stop logs to be installed and removed manually with one or two pole-mounted hooks.

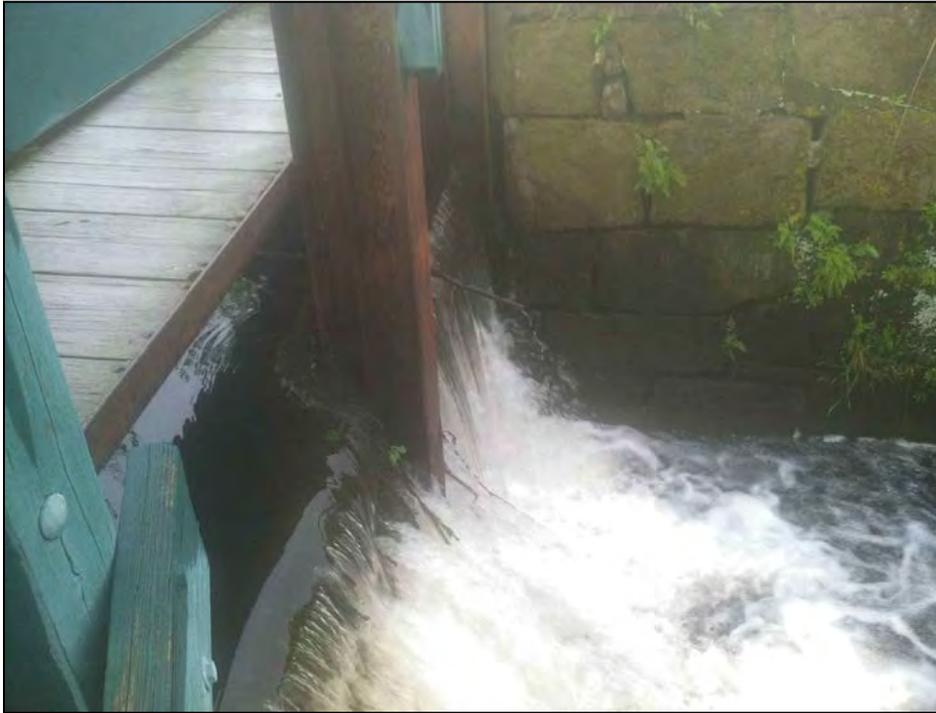
Photo No. 19: Stop log controls at the sluiceway as viewed from the right. The channels' left wall joints are in a similar condition to that noted along the right wall (Photo No. 18).

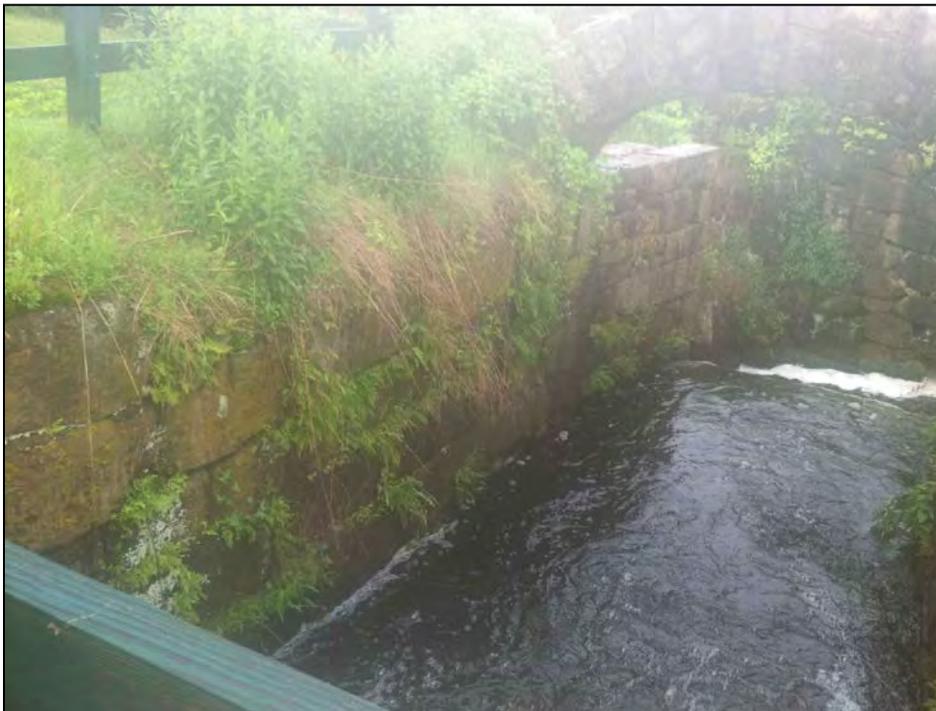
Photo No. 20: The sluiceway's left downstream channel wall as viewed from its control section. Note the poorly defined joints and unwanted vegetation growth through the joints.

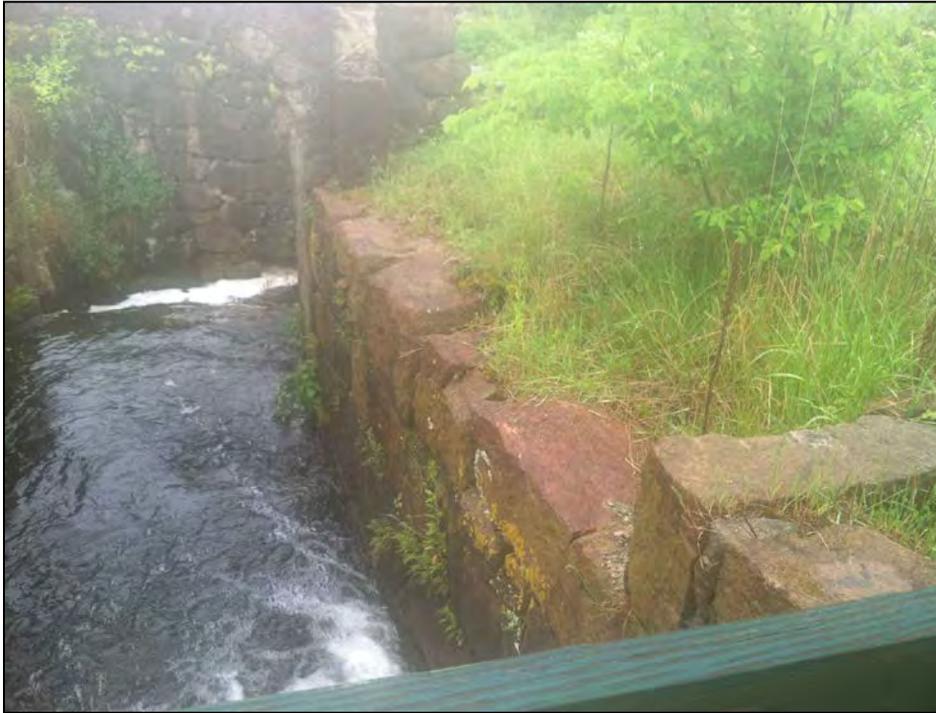
Photo No. 21: The sluiceway's right downstream channel wall as viewed from its control section.

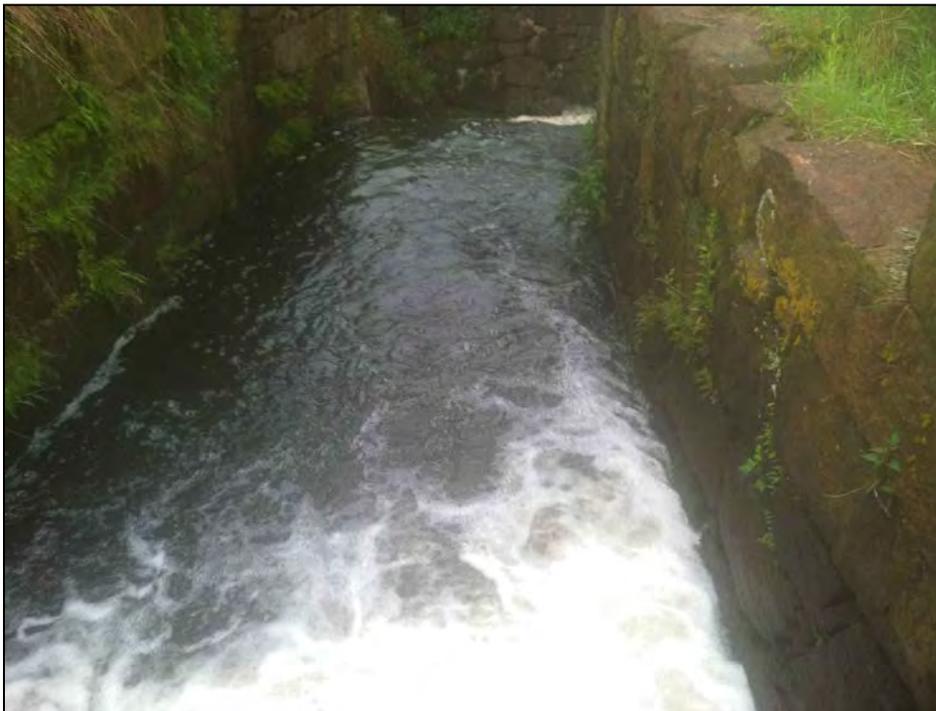
Photo No. 22: The sluiceway's downstream channel as viewed from its control section.

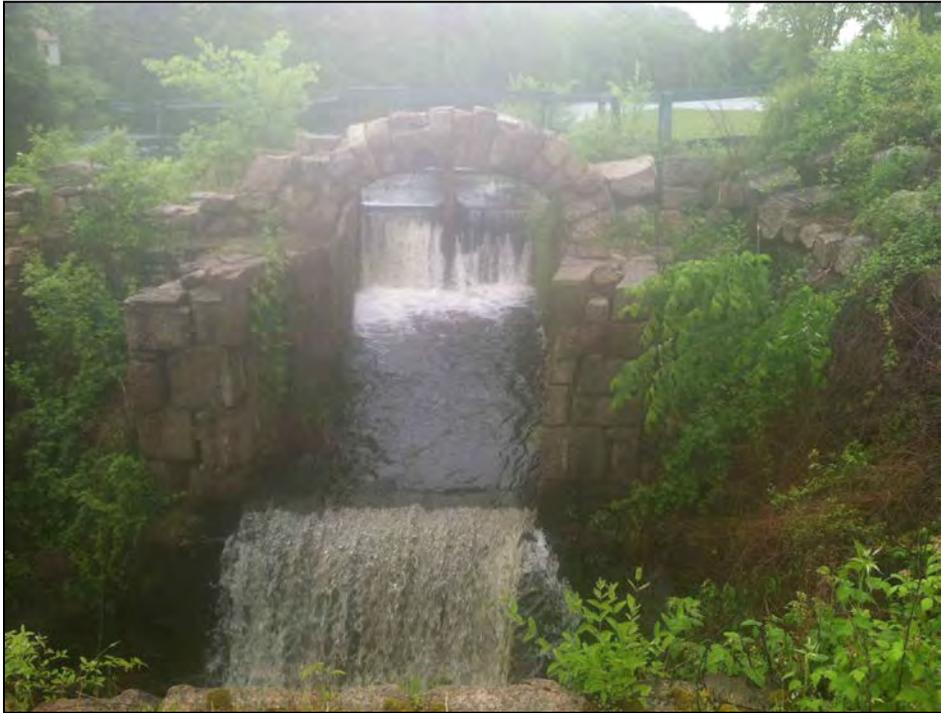
Photo No. 23: Overview of the sluiceway's stepped discharge area as viewed from downstream.

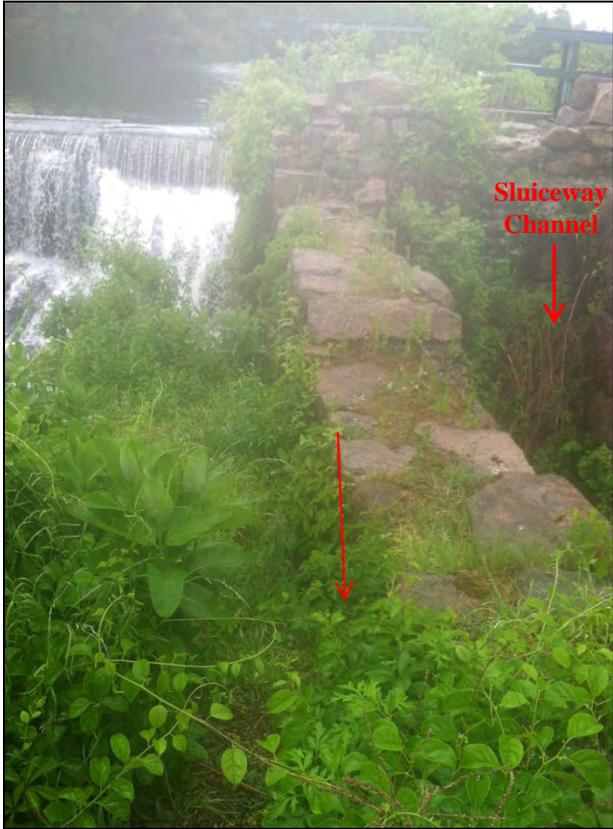
Photo No. 24: Back side of the sluiceway's right channel wall looking upstream. Note the location of the observed undermining.

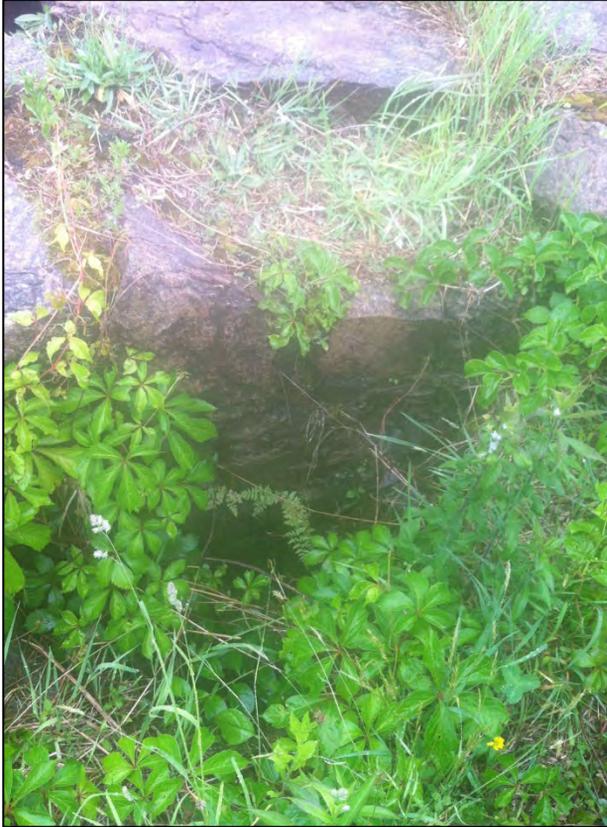
Photo No. 25: A view into the undermined wall section pointed out in Photo No. 24. Though not distinguishable from this photo, the discharge channel can be viewed through this hole.

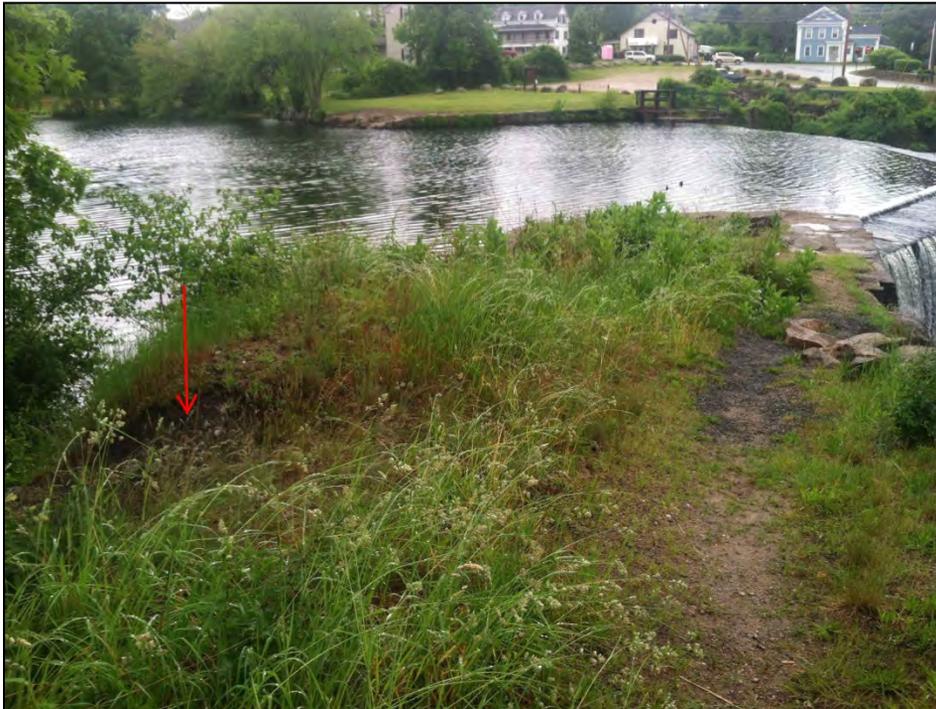
Photo No. 26: The upstream side of the right embankment as viewed from the crest near the embankment center. Note the eroded and/or sloughed area.

12. Trap and remove burrowing animals and promptly fill the resulting holes with compacted structural fill.
13. Rehabilitate the right embankment's upstream side. The rehabilitation program should include reconstruction of the upstream wall, replacement of apparently dumped fill in the apparent former flume approach, and regrading the upstream slope right of the former flume followed by the installation of a rip rap erosion control system to protect the slope from wave action.

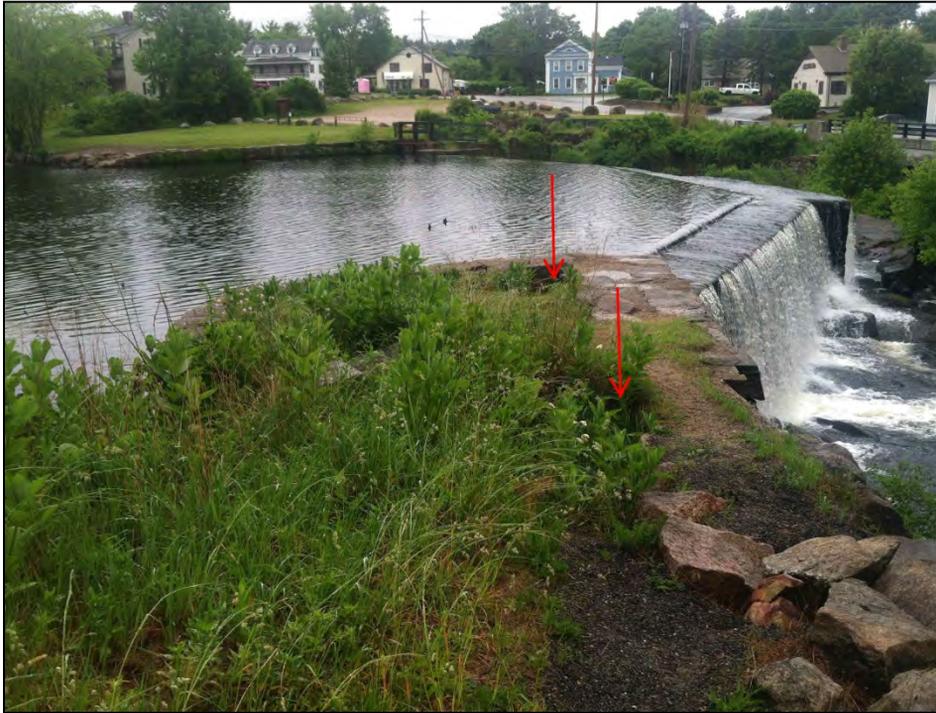
Photo No. 27: Overview of the crest of the right embankment as viewed from near the right abutment looking left. Note the depressions behind the abandoned flume discharge and near the spillway.

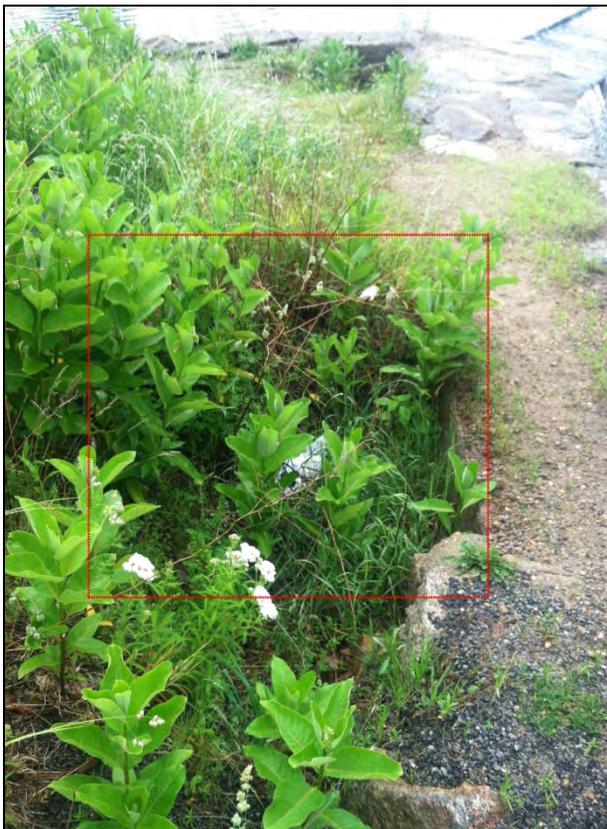
Photo No. 28: Close-up of the depression behind the flume's discharge headwall as pointed out in Photo No. 27. Photo is looking to the left.

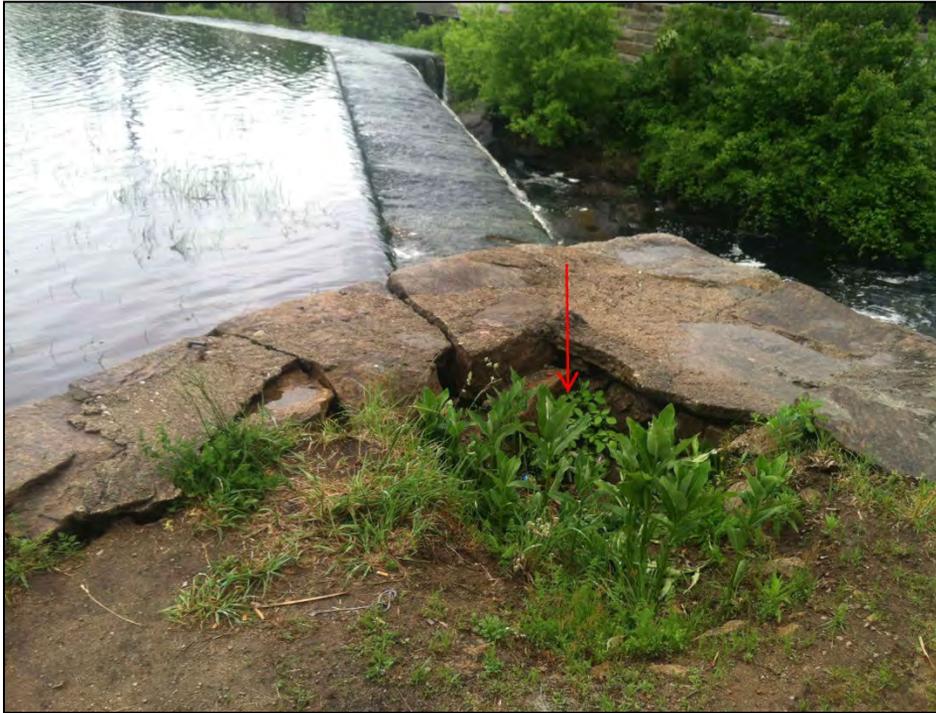
- In the area of the sinkhole mentioned above, there is a roughly 0.5 inch wide crack through the top of the wall (Photo No. 29).
- Clear leakage was observed about half-way up the downstream wall and aligns with the above-mentioned sink hole. The leakage is flowing at about 15 GPM.

Photo No. 29: Close-up of the depression behind the spillway's right training wall as pointed out in Photo No. 27. Photo is looking to the left.

1. Fill the two sinkholes right of the spillway and the depressions behind wall sections at the left and right embankments with compacted engineered fill. Monitor for continued settlement.
2. To help reduce leakage through the embankment sections, clear vegetation from, re-chink, and repoint stone masonry joints along the following areas:
 - a. Walls that support the three embankments (both above and below the normal pool level)
 - b. Along the right channel wall at the sluiceway's discharge, and
 - c. Along the downstream face of the spillway.

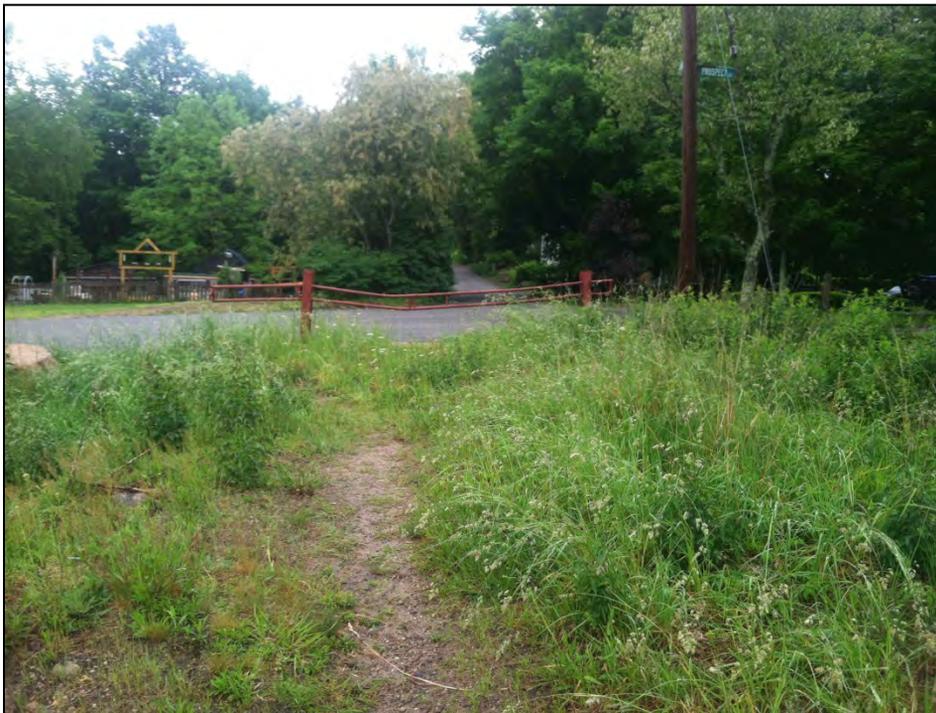
Photo No. 30: Overview of the right abutment.

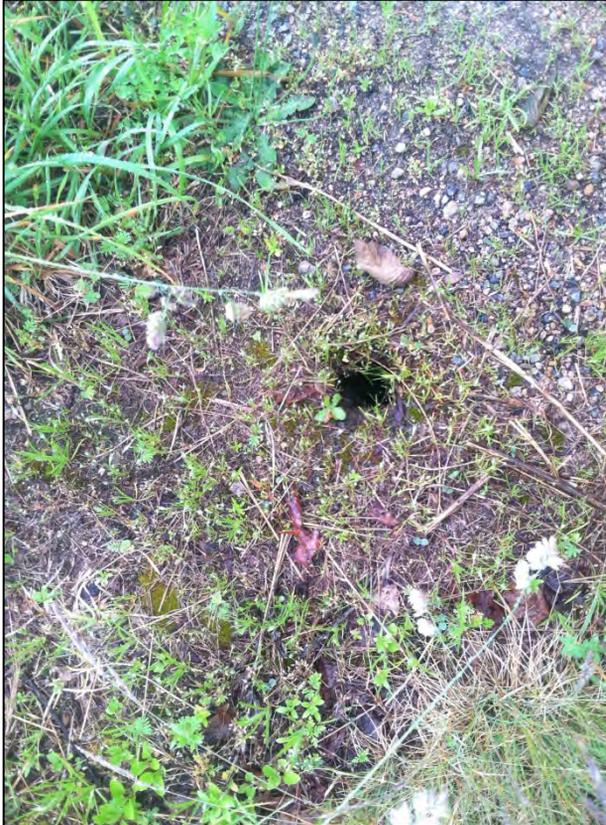
Photo No. 31: Animal burrow near the center of the right embankment.

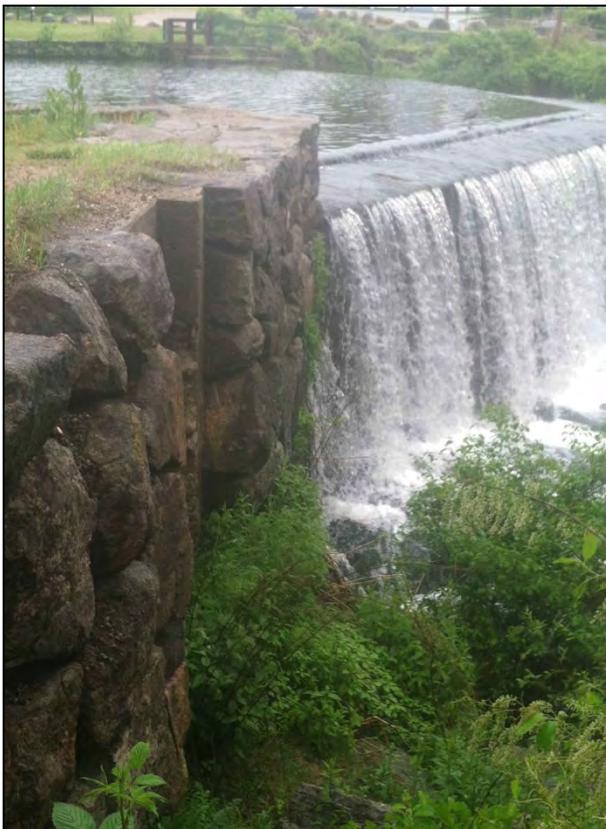
Photo No. 32: Overview of the downstream wall supporting the right embankment as viewed from the right looking left.

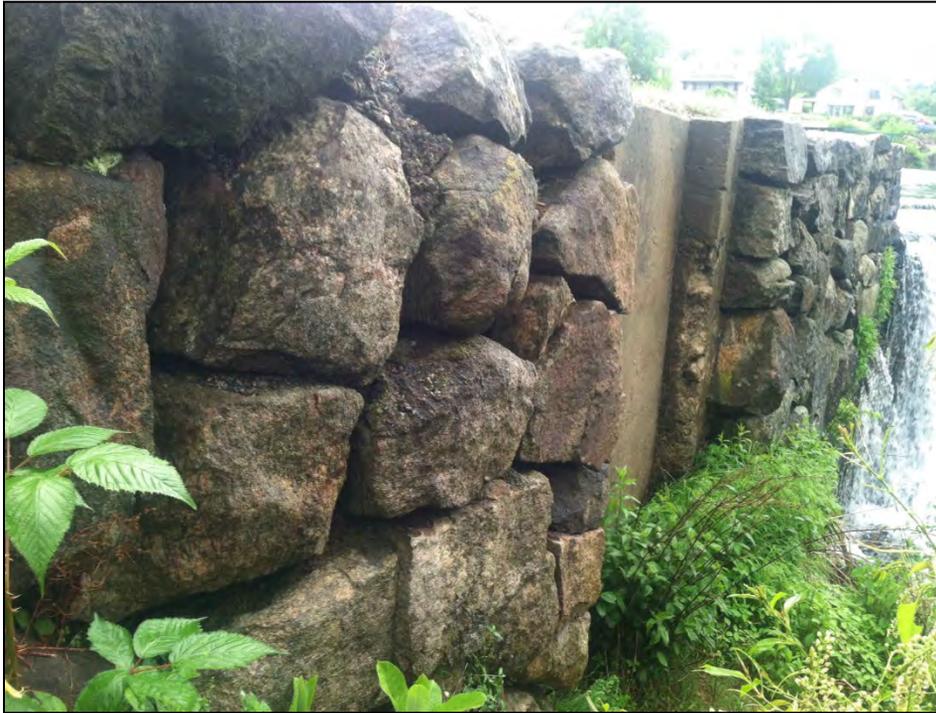
Photo No. 33: The downstream wall supporting the right embankment. Note the joints typically in poor condition with missing chinking stones and the apparently shifted wall stones.
