**-- WYOMING UPPER DAM --
VISUAL
INSPECTION / EVALUATION REPORT**

Dam Name: *Wyoming Upper Dam*

Date of Inspection: *June 5, 2014*

INSPECTION SUMMARY

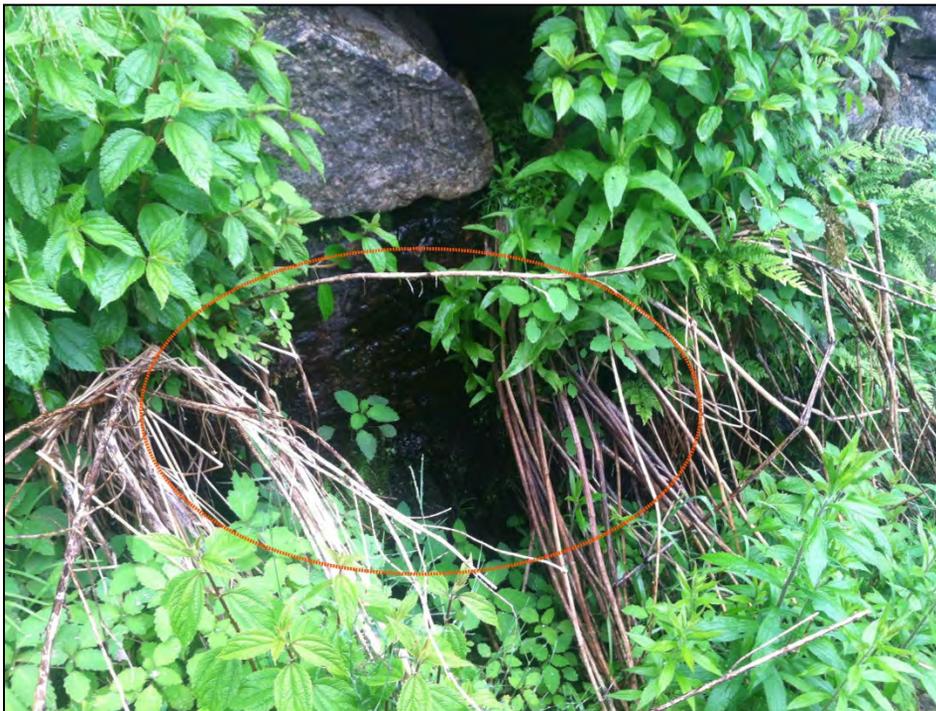
Photo No. 34: Typical seepage along the bottom of the right embankment's downstream wall between the abandoned flume and the primary spillway.

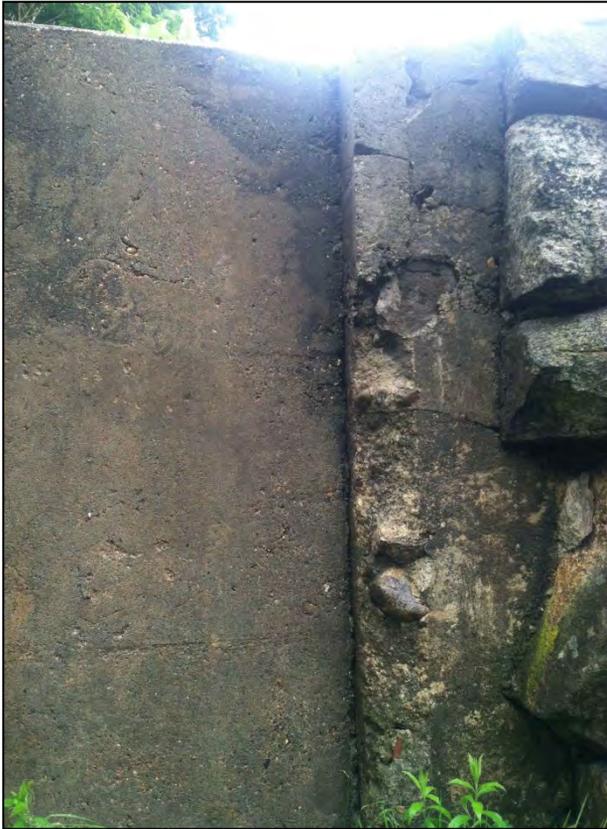
- The concrete section appears to have good alignment. However, the left and right edges are cracked (Photos Nos. 35 and 36) with a void below each (Photo No. 37). No leakage was observed.

Photo No. 35: Left side of the flume's abandoned discharge. Note the spalled areas of concrete.

9. Evaluate the abandonment procedures utilized at the flume. Complete additional evaluations to determine if repairs are necessary to cut-off the flow or properly abandon the former flume structure.

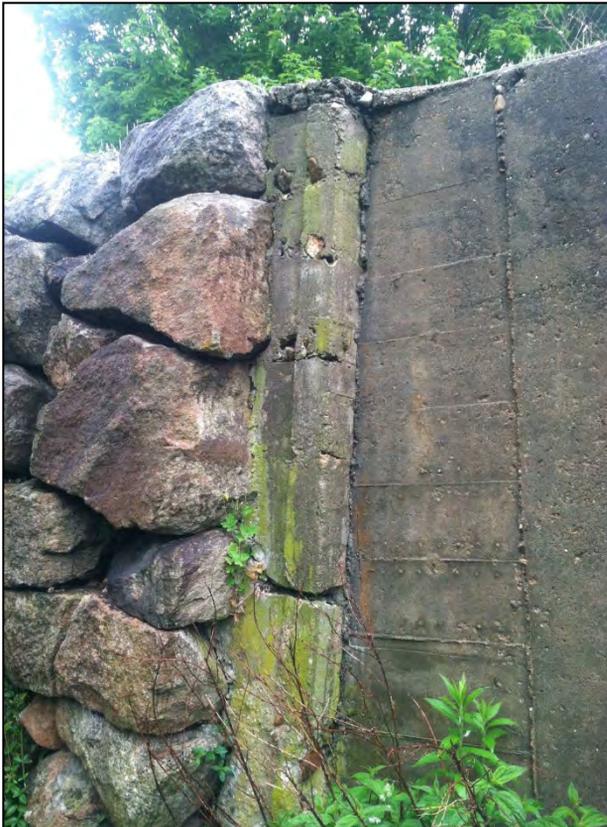
Photo No. 36: Right side of the flume's abandoned discharge. Note the spalled areas of concrete.

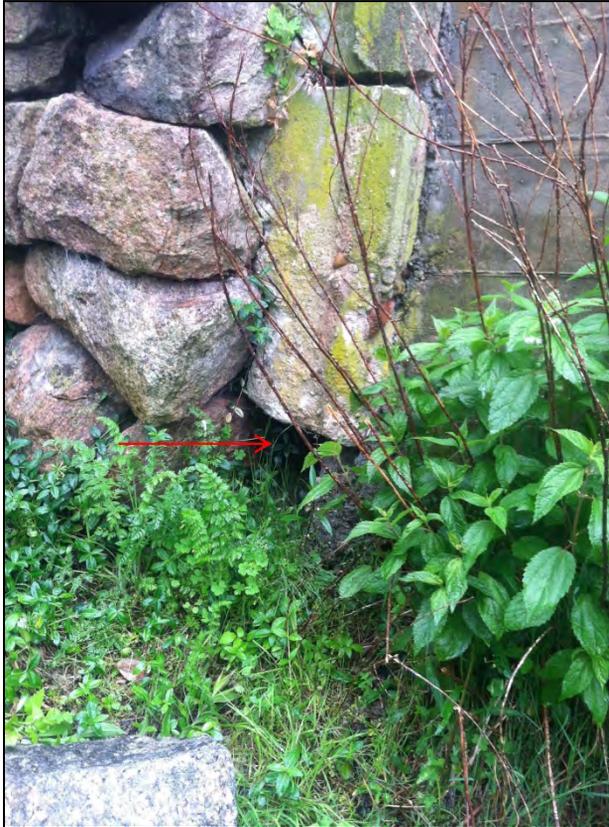
Photo No. 37: A void along the base of the right side of the abandoned flume's discharge. A similar void is present at the base of the left side of flume's discharge as well.

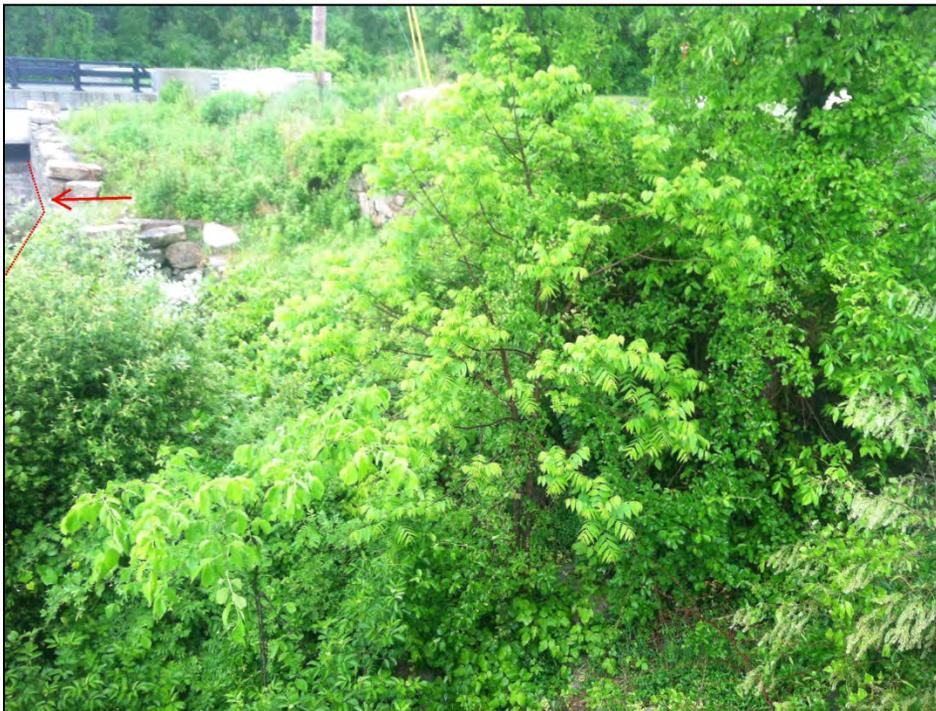
Photo No. 38: View of the downstream area as seen from the crest of the right embankment. Note the heavy overgrowth. Arrow indicates edge of discharge channel.

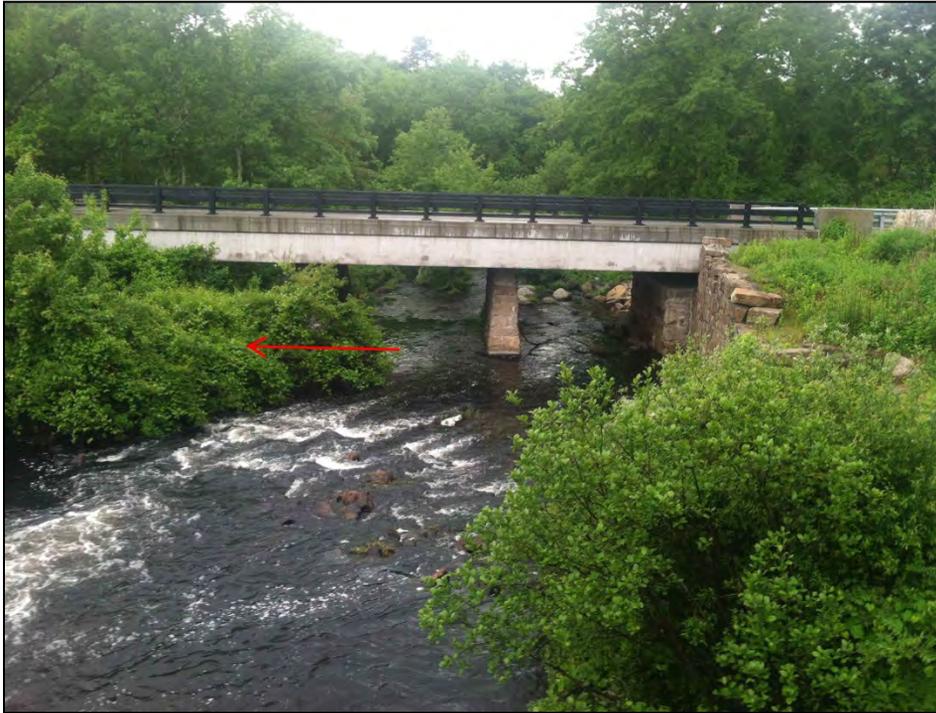
Photo No. 39: The discharge channel as viewed from right of the primary spillway. Note the overgrowth within the center of the channel.
