REMEDIAL ACTION REPORT FOR

SHORT TERM MEASURE

PROVIDENCE GAS COMPANY

JUNE 14, 1996

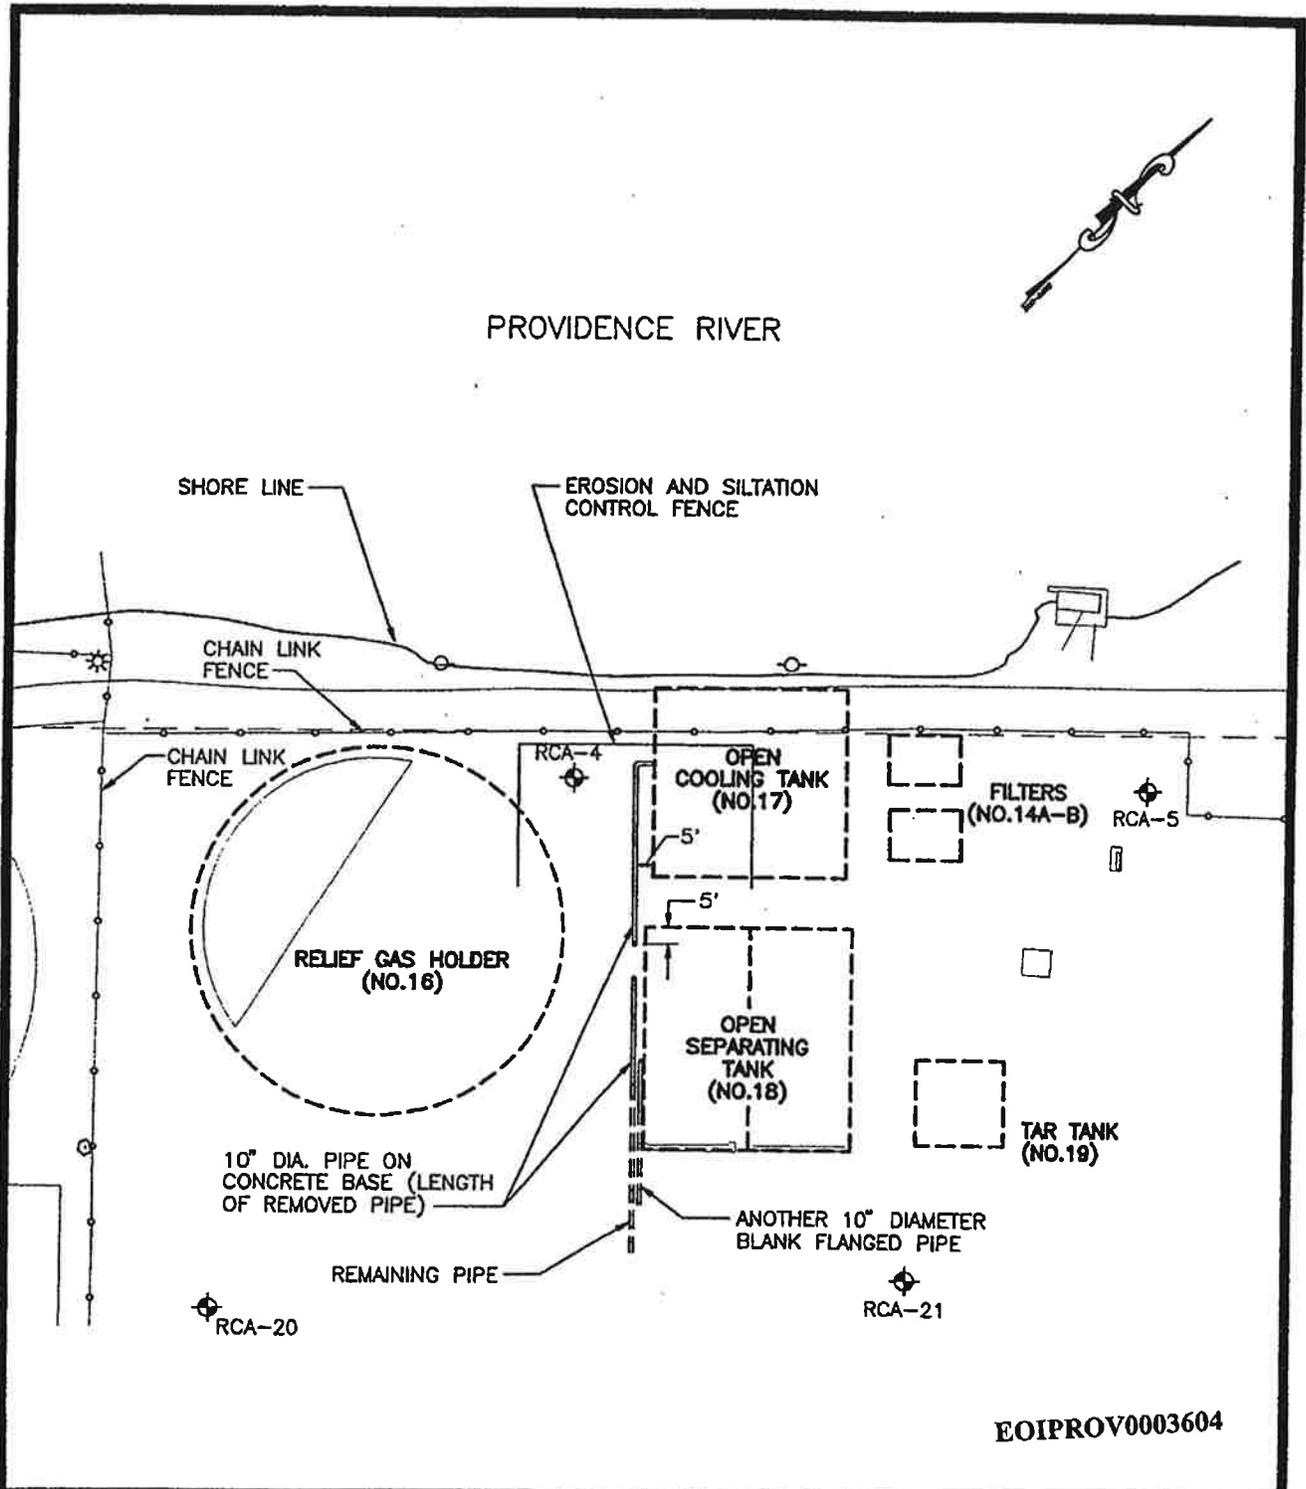
SHORT TERM MEASURE PLAN

An erosion/siltation control fence was installed around the perimeter of the work area prior to excavation, as required in the CRMC Assent Permit (see Figure 1, Short Term Measure Plan in Appendix A). Hay bales were toed into the ground and staked. The excavation was initiated approximately 18 feet south of the northern fence line using an excavator. The 10-inch diameter steel pipe was encountered at approximately five feet deep in a north to south orientation. The excavation was extended north following the pipe which was expected to extend towards the river. However, at approximately 13 feet south of the fence line, the pipe ended with a swing joint connecting to Cooling Tank (No. 17) at approximately four feet below grade. Further exploratory excavation to the north and west confirmed that the pipe ended at the tank.
