Draft Five-Year Review Report

Anthony Carnevale Elementary School and Del Sesto Middle School

50-152 Springfield Street, Providence, Rhode Island

November 2011

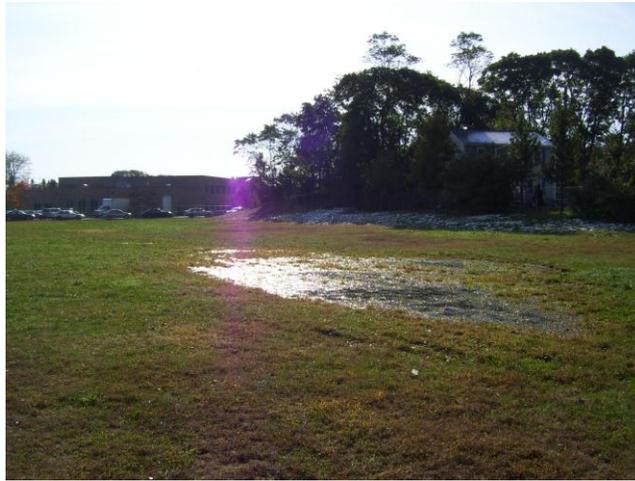
Areas of standing water demarcating shallow depressions in the cap were observed at multiple locations throughout the site. These included several wet areas in the grassy area behind the middle school, one wet area near Springfield St in the grassy area between the two schools, and

Standing water in shallow depression in grassy area behind middle school

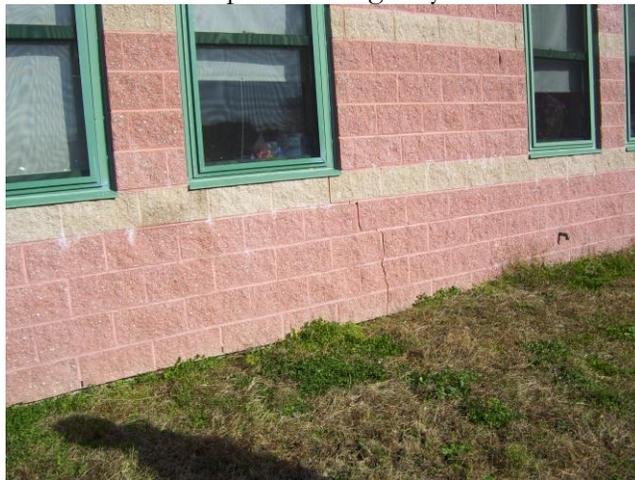
Evidence of subsurface settling was observed during the inspection of the site grounds. This evidence included the cavities observed along the middle school foundation, visible cracks in the exterior building façade and foundation, minor cracks in asphalt pavement, and a gap in a joint in the concrete sidewalk along the middle school. In particular, a large vertical gap (i.e. several inches wide) was observed at the junction of the blower shed of the elementary school and the main building. A cinder block wall between transformers behind the middle school also appeared to be leaning slightly. These observations could be indicative of decomposition of buried solid waste and resulting subsurface settling causing uneven movement of the ground surface (i.e. development of deeper cavities and shallow depressions) and shifting of surface improvements.

Cracking in middle school façade

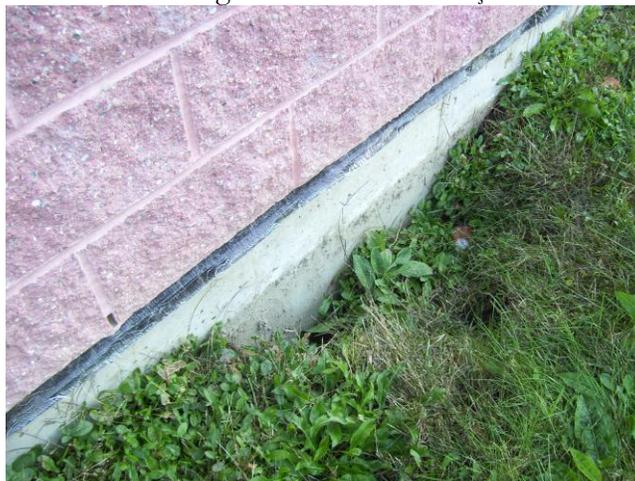
Concerns observed by Fuss & O'Neill during the inspection included several cavities within the cap thickness at observed grassy areas immediately adjacent to the middle school foundation. These included cavities observed near the electrical transformers behind the middle school and in the courtyard area at the northern end of the middle school. Several areas where cavities had recently been repaired by filling with soil were also observed in these areas. The orange snow fence placed at the interface of the soil cap and underlying existing soil was not observed at any location during the inspection.

Cavity within cap thickness adjacent to middle school foundation

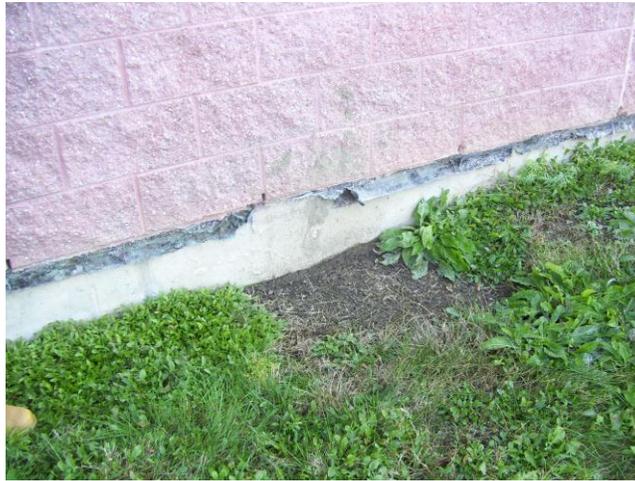
In response to observations of cavities within the cap thickness, maintenance personnel typically make the repairs themselves by filling the cavity with soil and applying grass seed. However, soil which is added to the cavities reportedly often settles out and the cavities develop again and require repeated repairs. Messrs. Burtan, Setts, and Conti agreed that the development of cavities and depressions in the ground surface is likely indicative of decomposition of solid waste in the subsurface and subsequent settling of overlying materials. With the exception of those pavement repairs discussed in *Section 2.4*, response actions performed to repair areas impacted by settling have reportedly been limited to landscaped areas.

Repaired cavity adjacent to middle school foundation

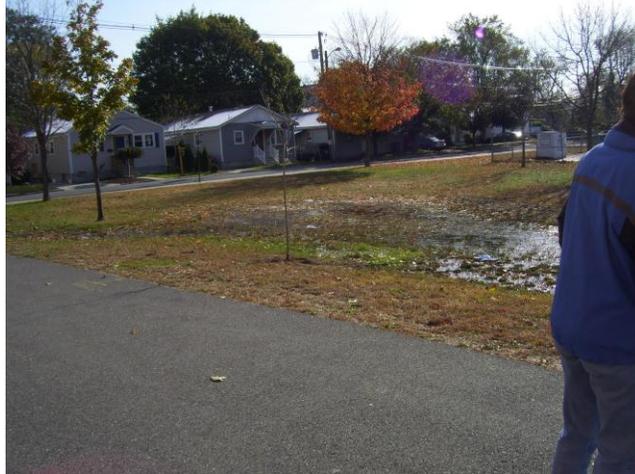
Response: With the exception of one sapling which had no leaves, no additional evidence of dying or distressed trees and shrubs was noted during the inspection conducted as part of the Five-Year Review. While a forensic evaluation of the potential causes of stress to the sapling was not performed by Fuss & O'Neill as part of the Five-Year Review, the following observations and feedback from maintenance personnel were noted. No evidence of deep openings in the cap thickness or exposure of soil or solid waste materials

Distressed sapling and standing water in depression in grassy area between schools

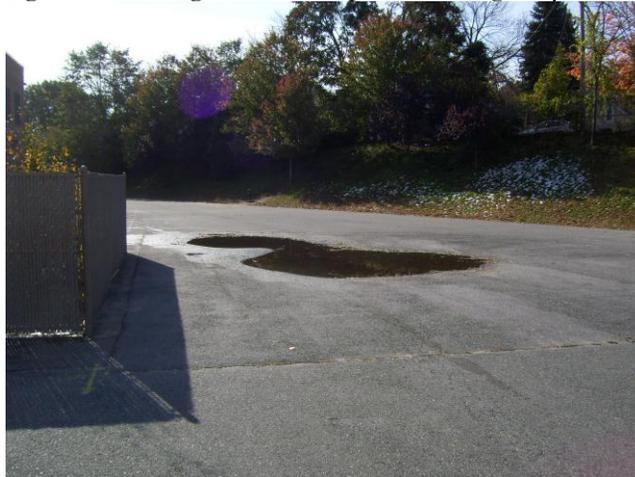
several puddles observed on the asphalt pavement behind the elementary school. The standing water was indicative of saturated or poorly drained soil at landscaped areas and depressions in the surface topography at grassy or paved areas. Additionally, several areas of poor grass cover or dead grass were observed in the grassy area behind the middle school.

Standing water on pavement behind elementary school

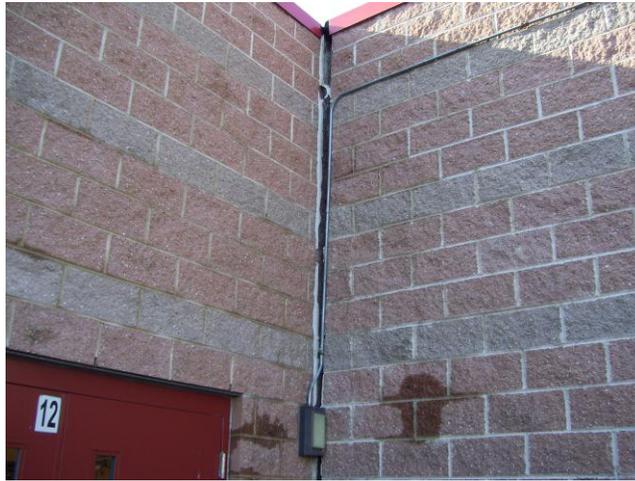
Gap between blower shed and main elementary school building

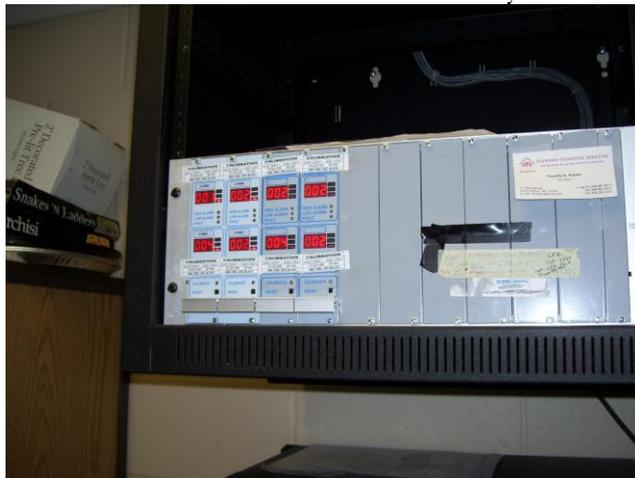
The inspection also included observation of the methane sensor display panels in each of the main offices of the schools. Labels on the panels indicated that they had been calibrated on October 24, 2011. Additionally, the sensors were reading 1 to 4% of the lower explosive limit at the time of the inspection. According to quarterly monitoring reports reviewed as part of the Five-Year Review, the sensors are set to read above zero when calibrated using a zero methane gas. This calibration technique prevents the sensors from going into an alarm condition due to sudden temperature drop, while still providing a conservative level of protection because the alarm limit does not change. One of the wall-mounted methane sensors was observed in each of the schools as well. The sensors were mounted a few inches above the floor.

Methane sensor panel

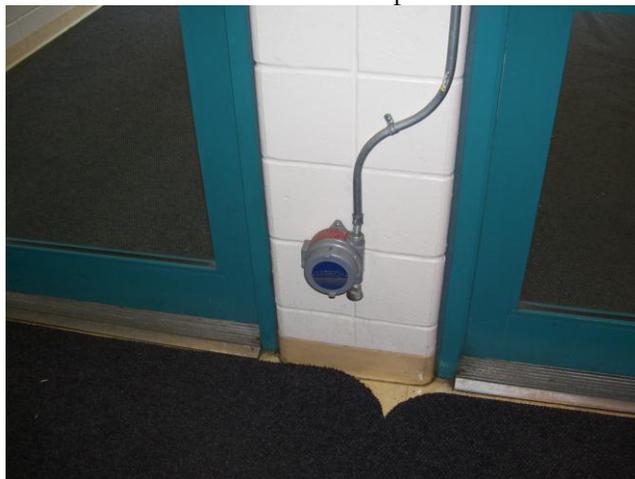
Methane sensor

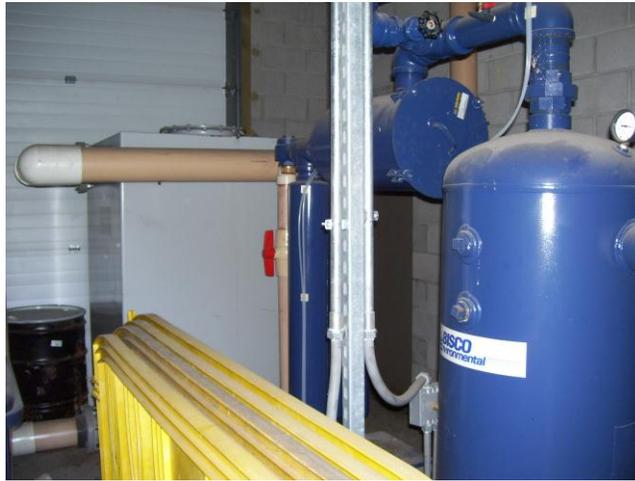
Each of the sub-slab ventilation system blower sheds was inspected. The blowers were observed to be operating at the time of the inspection. Carbon vessels, blowers, and moisture separator tanks were observed in each shed. Monitoring components observed on this equipment included a vacuum gauge, pressure gauge, temperature gauge, multiple sampling ports, and a viewing window for water inside the moisture separator tank. Several 55-gallon drums reportedly used for storage of water drained from the moisture separator tanks or monitoring well installation soil cuttings were also observed in the sheds.

Water tank, blower, carbon vessel of sub-slab ventilation system

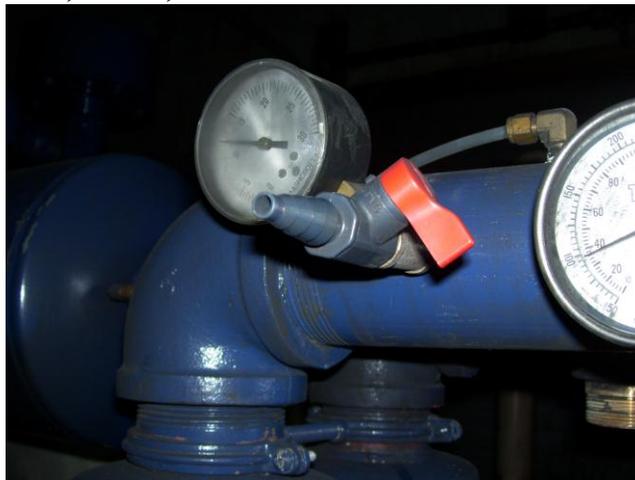
Influent sample port of sub-slab ventilation system

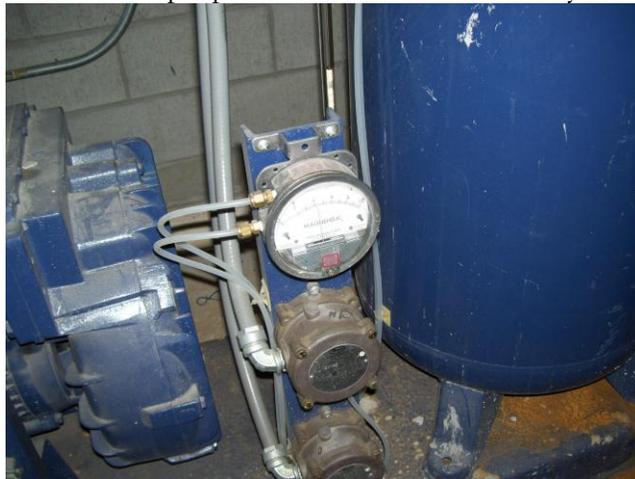
Even though the data is not reported in the quarterly monitoring reports, Ms. Pallister stated that Arcadis checks the vacuum readings of each sub-slab ventilation system leg during the quarterly monitoring events. When the blowers are operative, a vacuum level of approximately 3.5 to 4 inches of water reportedly persists inside the piping of each leg. The vacuum levels observed by Mr. Clinton of Fuss & O'Neill during the inspection were consistent with this statement.

Vacuum gauge of sub-slab ventilation system
