**Maidford River and Paradise Brook**  
**Water Quality Study and Pollutant Source Identification**  
**National Water Quality Initiative**

**Prepared By: Office of Water Resources**  
**Rhode Island Department of Environmental Management**  
**235 Promenade St. Providence, RI 02908**  
**February 2017**

## **1. Problem Definition/Background**

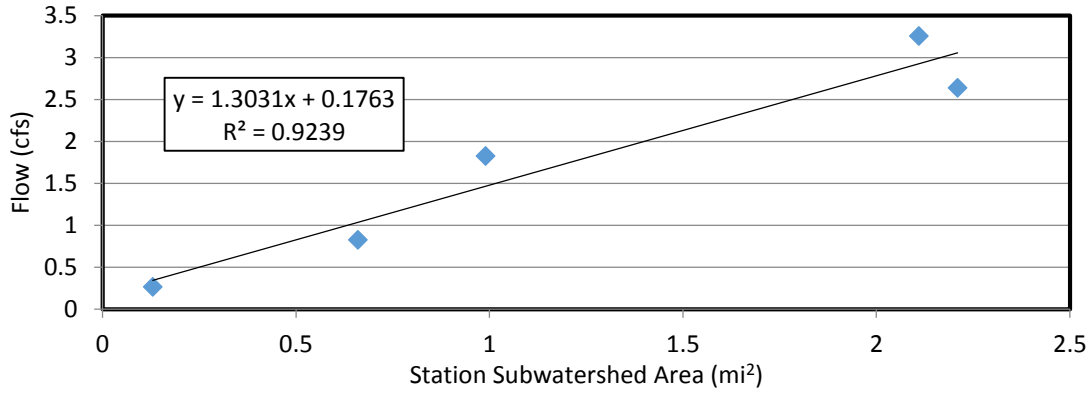
Figure 3. Maidford River Dy-Weather Flow vs. Station Subwatershed Area (4/2/15).

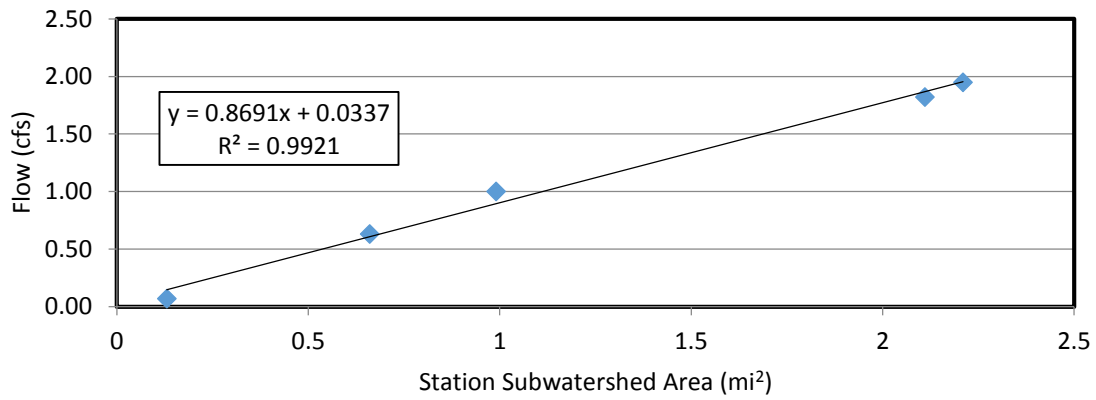
Figure 4. Maidford River Dry-Weather Flow vs. Station Subwatershed Area (4/15/15).

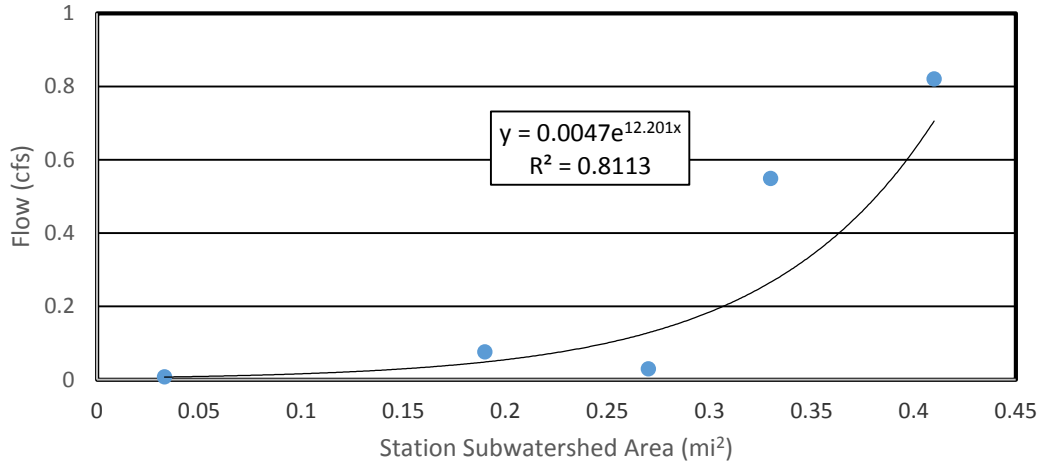
Unlike the Maidford River, there is not a linear relationship between flow and drainage area. There is very little flow, at the first three stations, north of Green End Avenue. The amount of flow, relative to the contributing drainage area, increases significantly south of Green End Avenue. Dry-weather flow generally increases about four-fold from Green End Avenue to Third Beach Road. Flow increases again by about 50% from Third Beach Avenue to the terminal station (PDS-OCI-6A). It therefore appears that groundwater is preferentially discharging to the stream south of Green End Avenue (PDS-SW-2). North of this station, the streambed lies in compact till, a relatively impermeable material. From Green End Avenue to Third Beach Road the streambed elevation drops approximately 65 feet. Since the surficial layer of till is only about 20 feet thick in the general area, it appears that the streambed has incised through the till and into much more porous fractured bedrock. Much of the groundwater discharging into the stream, south of Green End Avenue, may be from areas far upstream, including the headwaters area. Therefore, any changes in dry-weather water quality, in the lower portion of the river, may be at least partially caused by polluted areas in the upper reaches of the stream.

Figure 6. Paradise Brook Dry-Weather Flow vs. Station Subwatershed Area (4/2/15)

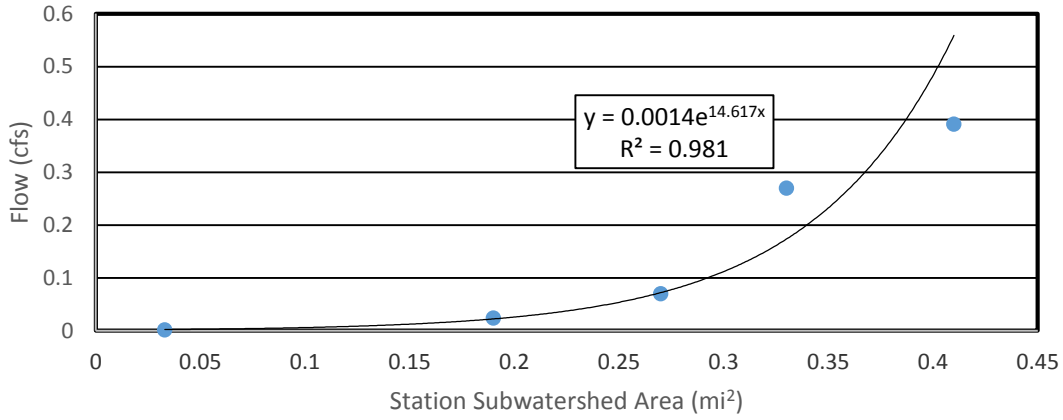
Figure 7. Paradise Brook Dry-Weather Flow vs. Station Subwatershed Area (4/15/15).

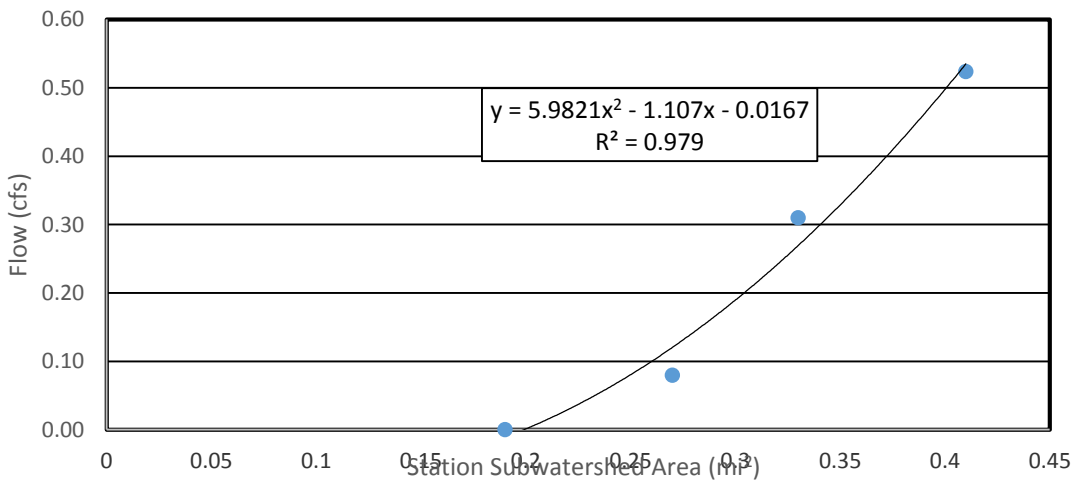
Figure 8. Paradise Brook Dry-Weather Flow vs. Station Subwatershed Area (1/5/16).

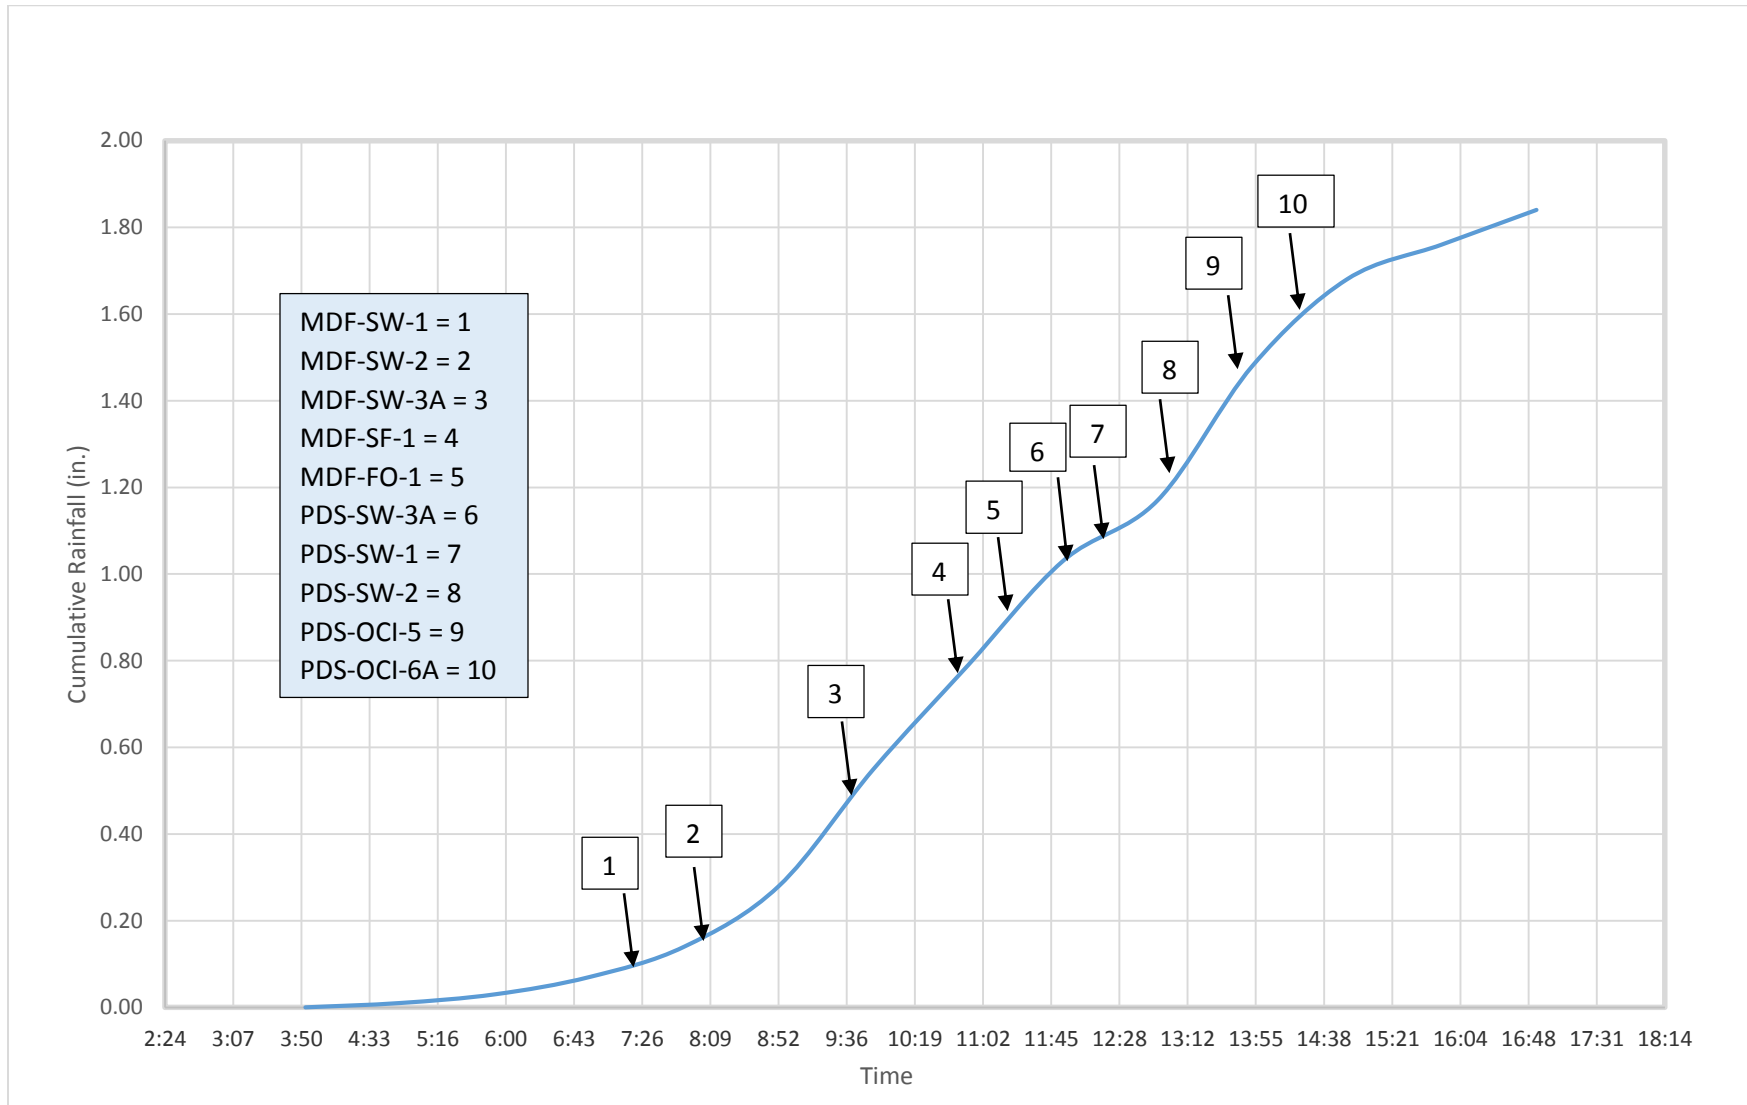
During the first wet-weather event, on December 9, 2014, sampling of the Maidford River was initiated near the beginning of the rain event (Figure 9). Paradise Brook was sampled during the second half of the rain event. Sampling was concluded while it was still raining. The rainfall rate was very steady, during the entire storm.

Figure 9. Cumulative Rainfall and Station Sampling Times. December 9, 2014.

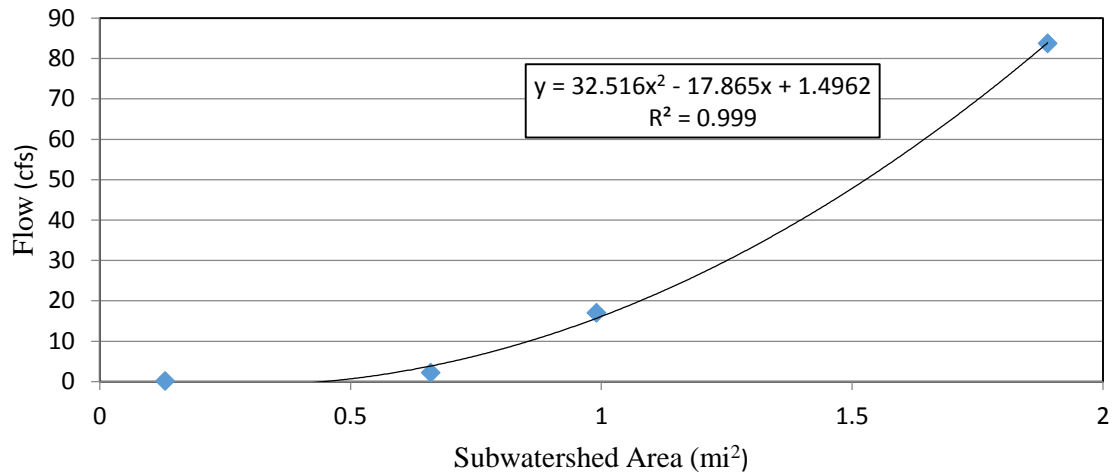
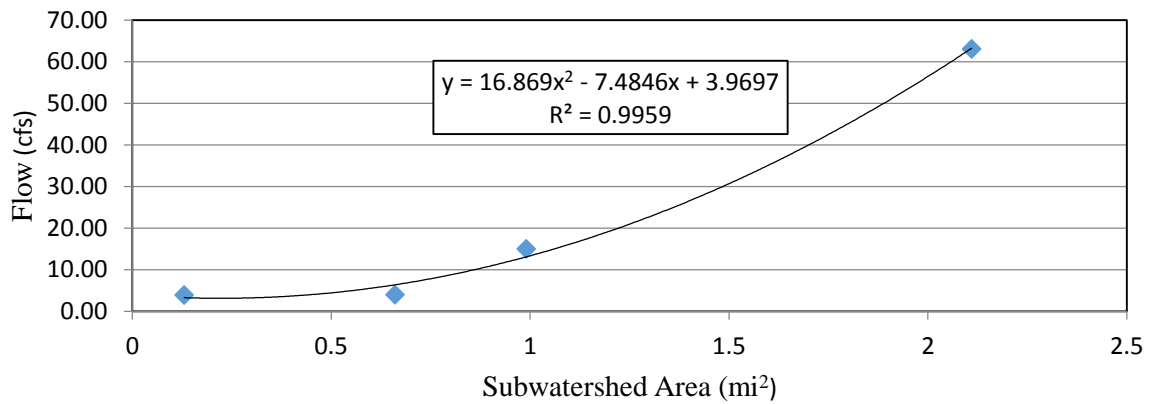
Unlike dry-weather flow, the wet-weather flow vs. contributing drainage area is not a linear relationship (Figures 12-14). A hydrological study, performed by Fuss & O'Neil, determined that the culvert at the Berkeley Avenue spur (aka Whitehall Museum) is undersized, resulting in flooding of Berkeley Avenue. The undersized culvert causes flooding of a hay field on the north side of the Berkeley Avenue Spur. Floodwaters are culverted to a stormwater trench on the opposite (eastern) side of Berkeley Avenue, eventually rejoining the stream well south of the Berkeley Avenue spur. The undersized culvert at the spur can also slow flow velocities down enough to back up flow at the Berkeley Avenue culvert, causing that culvert to reach capacity and causing more flooding of Berkeley Avenue. Under these conditions, some of the flow upstream of Berkeley Avenue, enters the stormwater trench on the east side of Berkeley Avenue, re-entering the river well south of the Berkeley Avenue spur (Photo M32). Therefore a significant portion of the flow in the Berkeley Avenue area appears to bypass the spur, during high flow conditions. Figures 12-14 show evidence of the bottleneck at the Berkeley Avenue spur. Regardless of precipitation conditions, and flow levels at the downstream staions, the flow at the spur is approximaely 16 cfs (apparently the maximum capacity of the culvert). It is anticipated that, without the bottleneck at the Berkeley spur, the relationship between flow and contributing drainage area would have been much more linear.

Figure 12. Maidford River Wet-Weather Flow vs. Station Subwatershed Area (12/9/14).

Figure 13. Maidford River Wet-Weather Flow vs. Station Subwatershed Area (9/30/15).

Figure 14. Maidford River Wet-Weather Flow vs. Station Subwatershed Area (10/29/15).

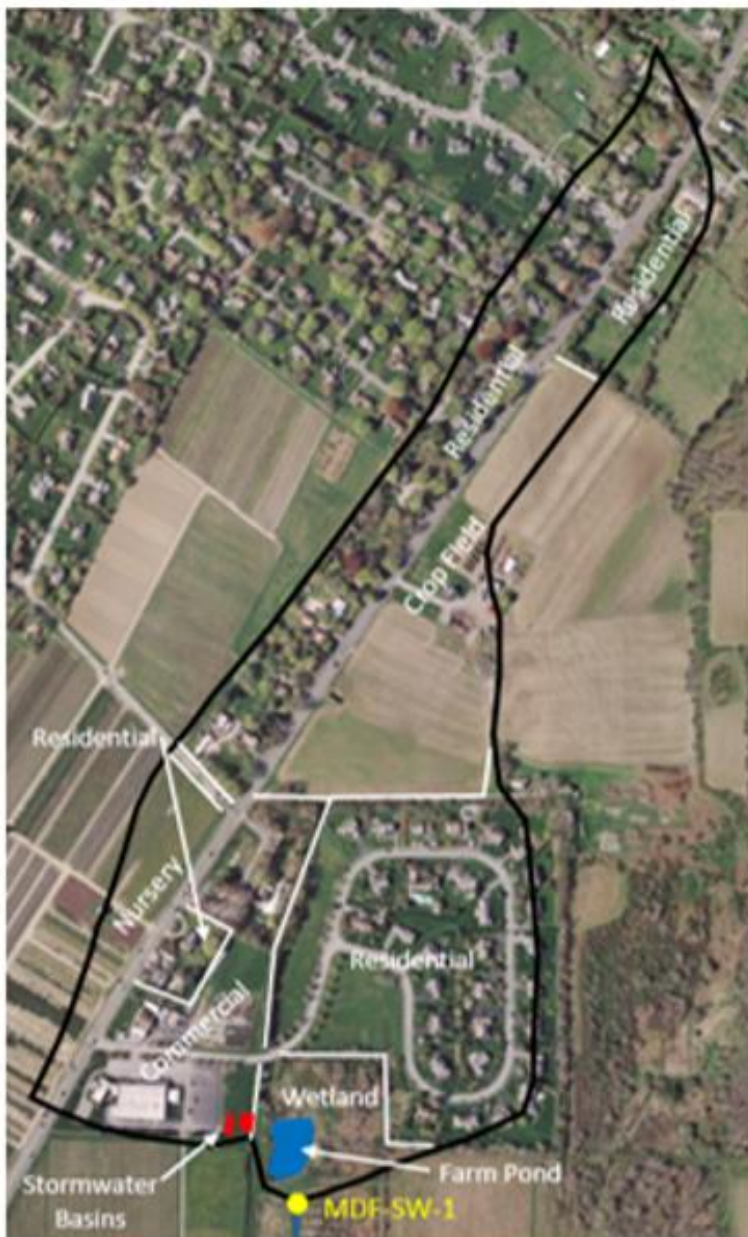
Figure 18. Maidford Subwatershed 1. (Upgradient of MDF-SW-1; Meadow Lane)

Elevated phosphorus and TKN levels were recorded during the 4/15/2016 dry-weather sampling event. Elevated TKN was also recorded, during the 1/2/2016 event. Nitrate was elevated during all dry-weather three events. Since there was no dry-weather flow into the farm pond at the headwaters of the Maidford River, the pond and contiguous wetlands are probably the source area, resulting in the elevated phosphorus and TKN, and to a lesser extent nitrate levels. Potential sources, common to all three pollutants, include decaying plant material, wildlife waste, leaky sanitary sewers, and bioturbation (waterfowl or other wildlife disturbing pond sediments). There is a sanitary sewer and pump station, serving a nearby subdivision on Meadow Ln, but there have been no recent reports of leaks and there was no evidence of such on the ground. Stormwater runoff, from nearby Meadow Ln., may be the ultimate source of nutrients in the pond sediment. Since nitrate dissolves and is transported readily in groundwater, the main potential source of nitrate may have been contaminated groundwater from the upper reaches of the watershed. Groundwater may have been contaminated by any of the following: fertilizers (including manure) applied to cropfields, residential lawns, and perhaps fertilizer application related to small nursery operations with plants in containers. Nitrate levels were extremely elevated. Since river baseflow, during dry weather, is the result of groundwater discharging into the stream, the high dry-weather nitrate levels were an indication of high levels of nitrate in groundwater in this uppermost portion of the watershed.

Stormwater from Meadow Ln. is a potential source common to all the above pollutants. A roadway culvert on Meadow Ln. drains to a wetland at the head of the small farm pond that forms the headwaters of the Maidford River. A significant amount of roadway sediment was observed in the wetland (Photo M4). In addition to sediment, other potential sources of pollutants in stormwater are pet and wildlife waste, leaky sanitary sewers, and lawn fertilizers. Wildlife waste and plant detritus from wetlands adjacent to the pond, are also potential sources of pollutants (Photo M5).

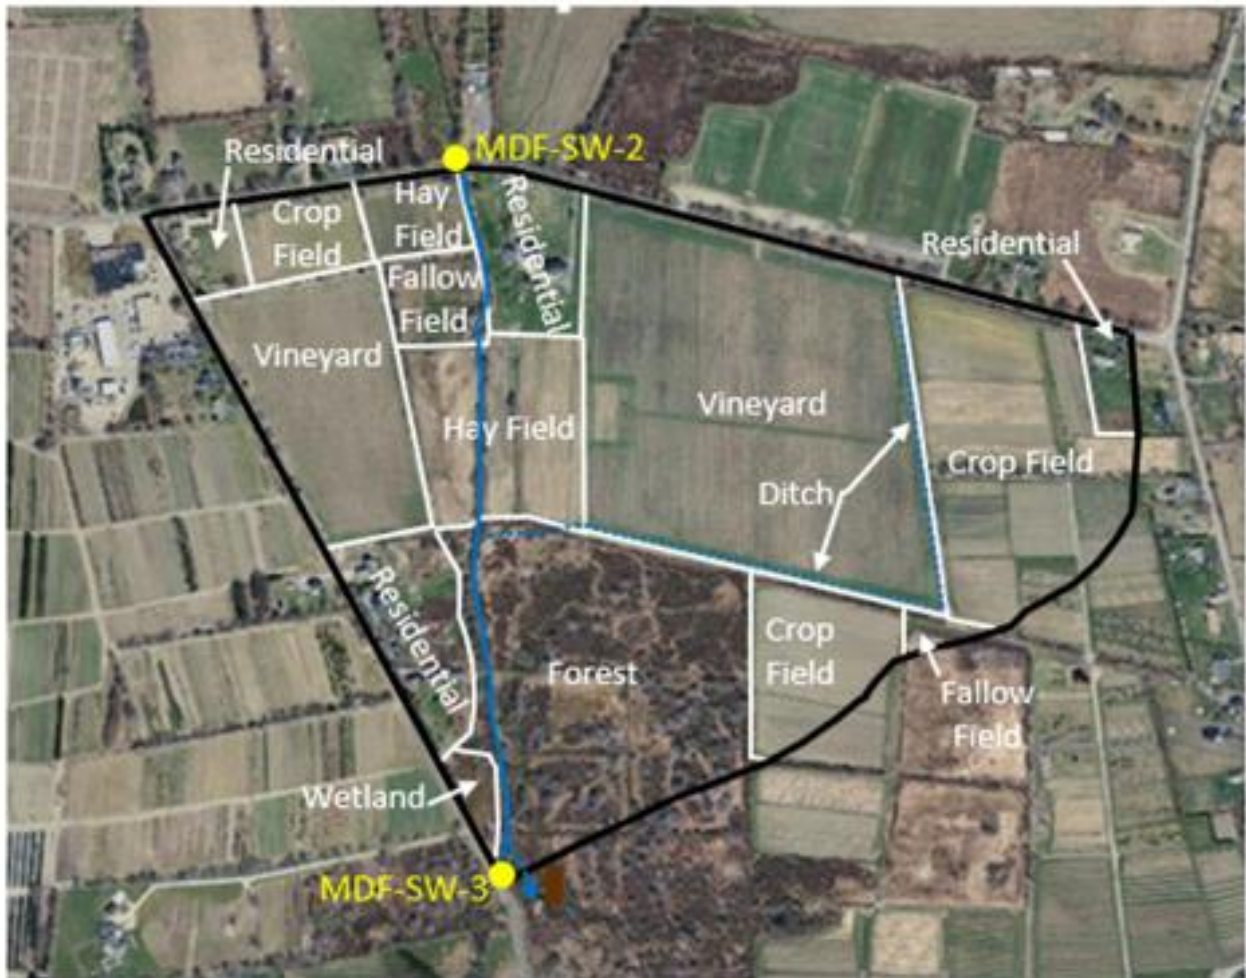
Figure 20. Maidford Subwatershed 3 (in part). (MDF-SW-2 to MDF-SW-3; Wyatt Road to Berkeley Avenue).

This station, located on Berkeley Av., was not sampled during dry weather.

This station was sampled only once, hours after the end of a wet-weather event. There was a six-fold increase in fecal coliform bacteria, and more modest increases in TKN, nitrate and ammonia. Animal and human waste are potential sources, common to all three pollutants. Potential sources include manure applied to the hayfields, crop fields, and vineyards, located between Wyatt Rd. and Berkeley Av., in addition to a crop field to the north of Wyatt Rd. These agricultural areas will be discussed in greater detail in the section below. Wildlife waste from nearby agricultural, wetland, and forested areas are an additional possible source. Finally, stormwater from Wyatt Rd. and contaminated by pet and wildlife waste and septic systems associated with a few houses on Berkeley Av., are also potential waste-related sources. Additional potential sources of ammonia, TKN, and nitrate include decaying plant material. Fertilizers are another potential source of ammonia and nitrate.

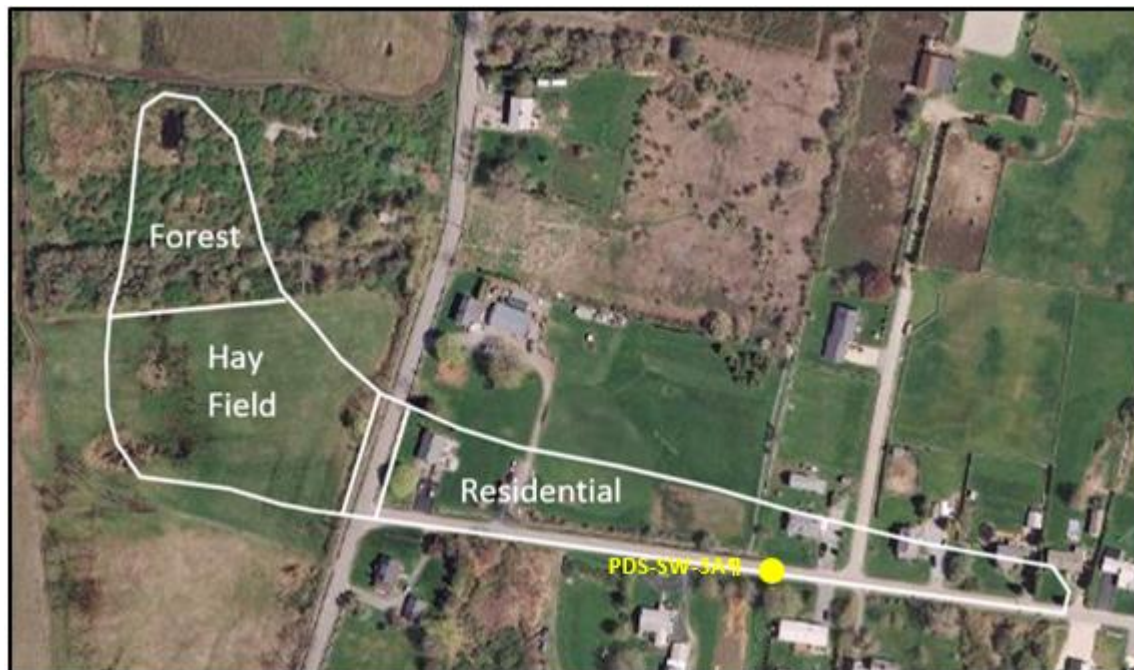
Figure 24. Paradise Subwatershed 1. (Up-Gradient of PDS-SW-3A; Fayal Lane).

EPA suggested guidelines for total phosphorus, TKN, and nitrate were exceeded at the headwater station, during dry weather. This was also the only station where the geometric mean criteria for fecal coliform (200 CFU/100 ml) was exceeded, during dry weather. The sampling station (PDS-SW-3A) was located close to the head of the watershed boundary, so the contributing source area is very limited. Potential sources, common to all pollutant exceedances, include septic systems and pet and wildlife waste. Additional potential sources of phosphorus and nitrate include lawn fertilizers.

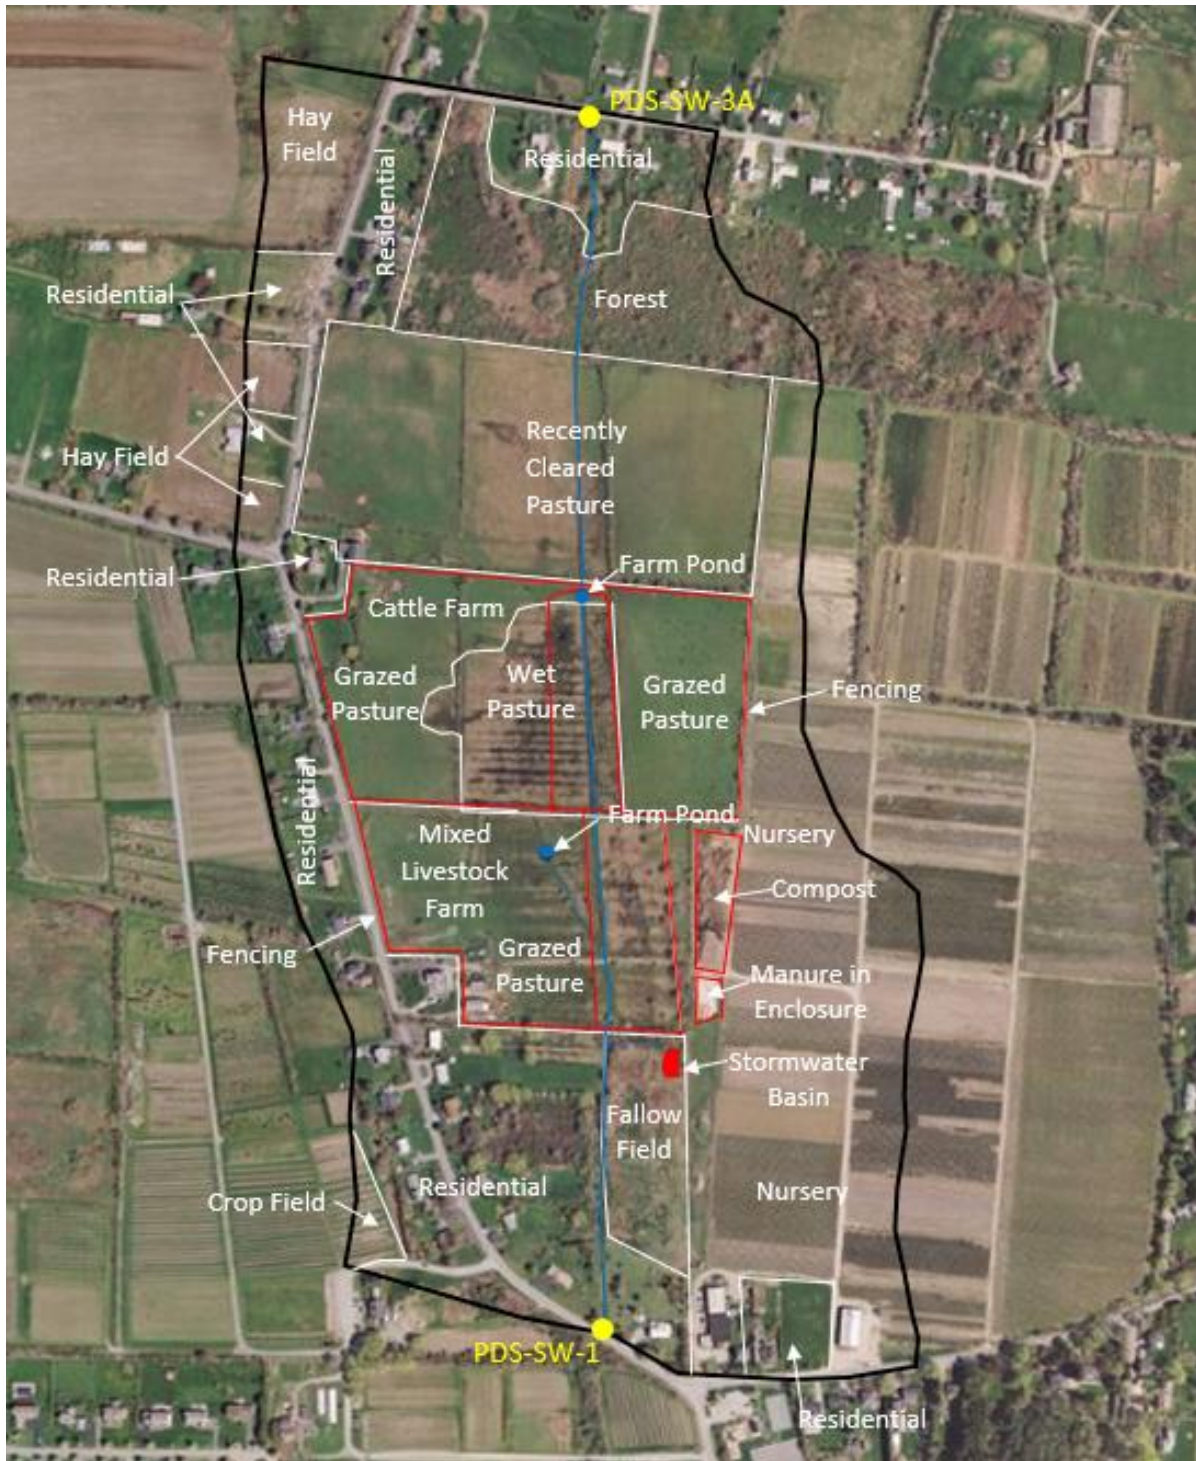
Figure 25. Paradise Subwatershed 2. (PDS-SW-3A to PDS-SW-1; Fayal Lane to Mitchell's Lane).

The highest dry-weather total phosphorus, TKN values, and enterococci concentrations, recorded at either the Maidford River or Paradise Brook, were recorded at Mitchell's Ln. (PDS-SW-1). Nitrogen from animal feces and urine is initially in the organic form (TKN). In time, the organic nitrogen is transformed to ammonia and nitrate. The presence of TKN may indicate that a waste source is close to the stream, and there has not been sufficient time for the breakdown of organic nitrogen to other forms of nitrogen. A common source of all three pollutants is animal waste associated with a mixed-livestock operation and a cattle farm.

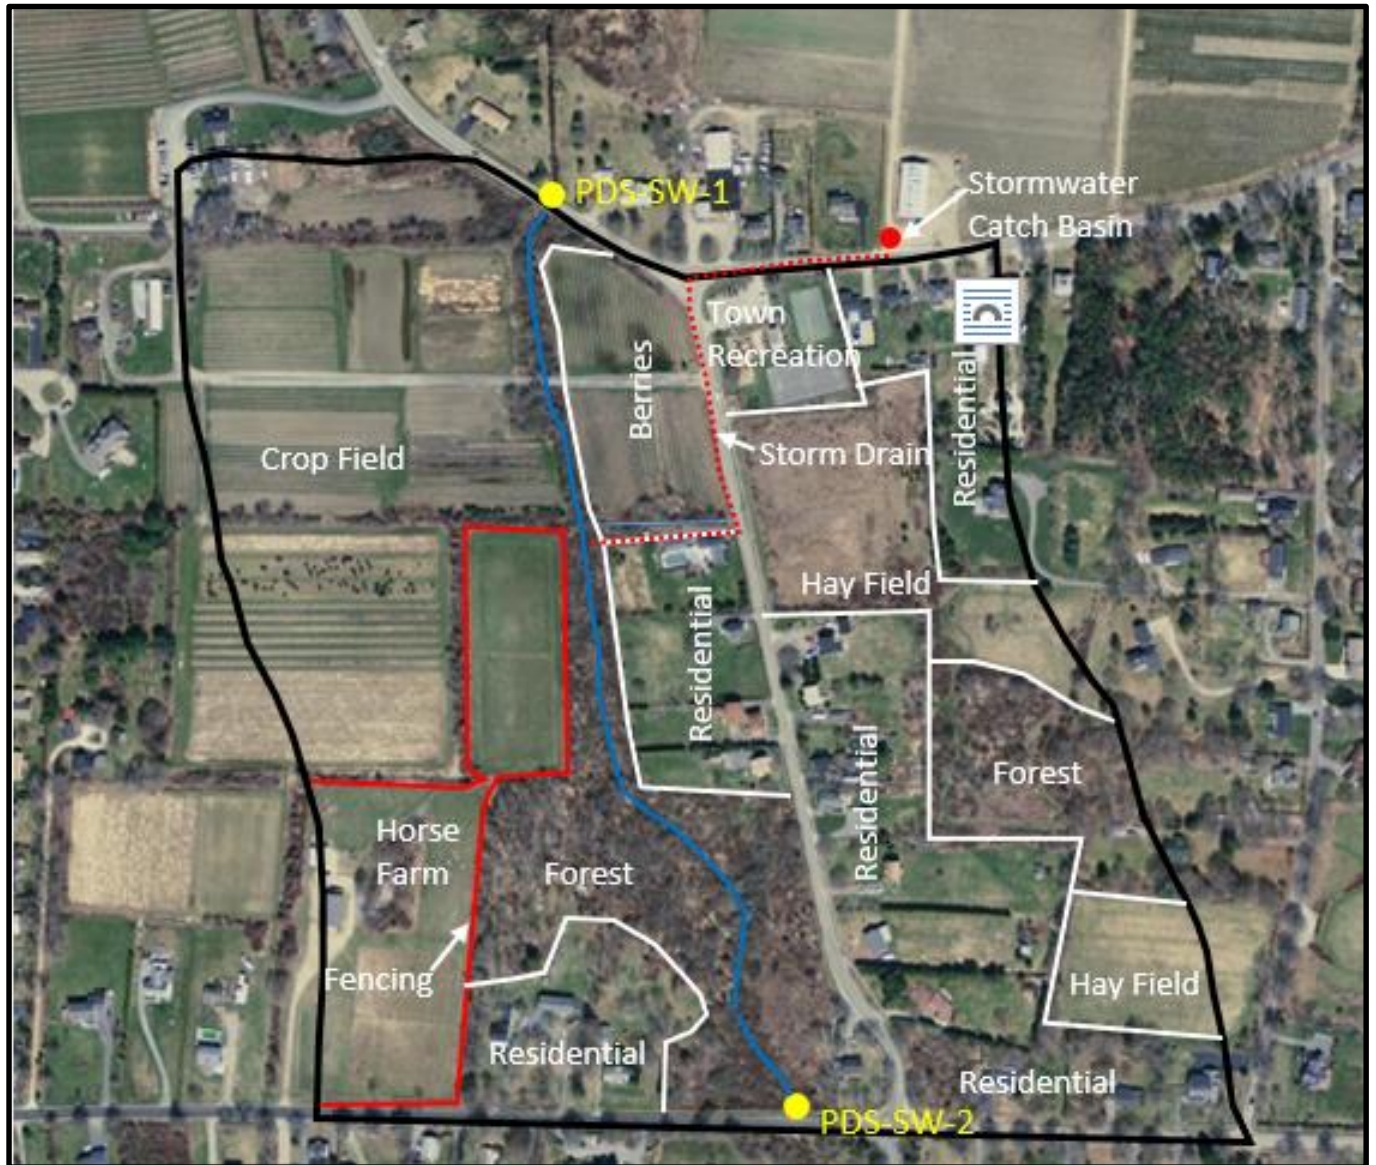
Figure 26. Paradise Subwatershed 3: (PDS-SW-1 to PDS-SW-2; Mitchell's Lane to Green End Avenue).

Dry-weather total phosphorus, TKN, nitrate, and enterococci bacteria levels at Green End Av. (PDS-SW-2) were elevated on 1/5/2016, despite the fact that there was no flow at the upstream station at Mitchell's Ln. An increase in nitrate was also recorded at this station, during the previous two dry-weather events. A common potential source of all the above pollutants, could be manure applied to a mixed orchard/crop operation, located to the west of the intersection of Third Beach Rd. and Mitchell's Ln. Other potential sources, common to all pollutants include septic systems and pet waste from the few houses on Third Beach Rd that border the stream in this reach, or wildlife waste along the forested riparian corridor. Decaying plant material, within the cropfields at the northern end of the reach or the forested riparian

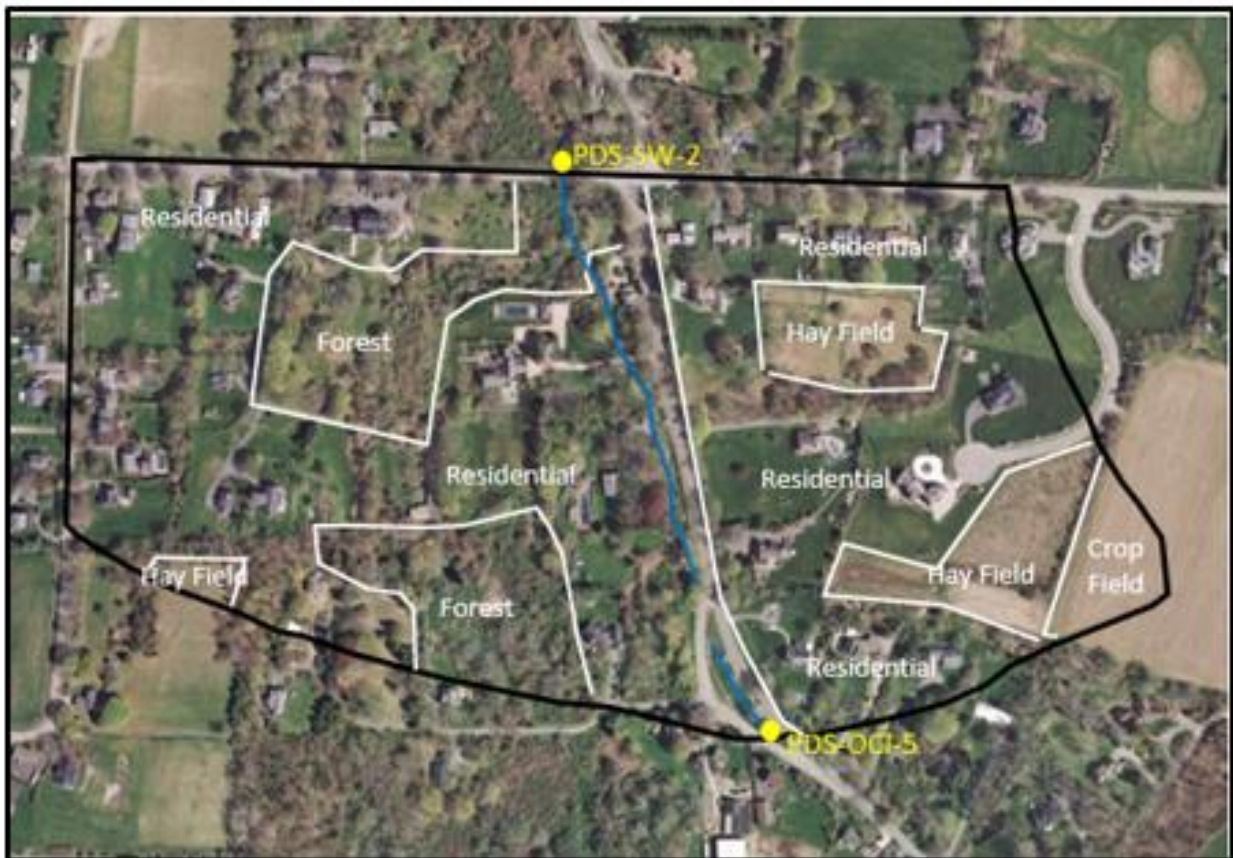
Figure 27. Paradise Subwatershed 4. (PDS-SW-2 to PDS-OCI-5; Green End Avenue to Third Beach Road).

The mean dry-weather nitrate concentration more than doubles at Third Beach Rd, relative to the upstream station at Green End Av. The subwatershed, associated with this reach, is characterized mostly by low-density residential development. Two hay fields and a portion of a crop field are also located within the subwatershed. Potential dry-weather nitrate sources, exclusive to this reach, include septic systems, pet and wildlife waste, lawn fertilizers, and manure and fertilizer applied to farm fields. However, at least some of the increase in nitrate levels recorded in this reach, probably resulted from sources areas upstream of this reach, including sources in the headwaters region.

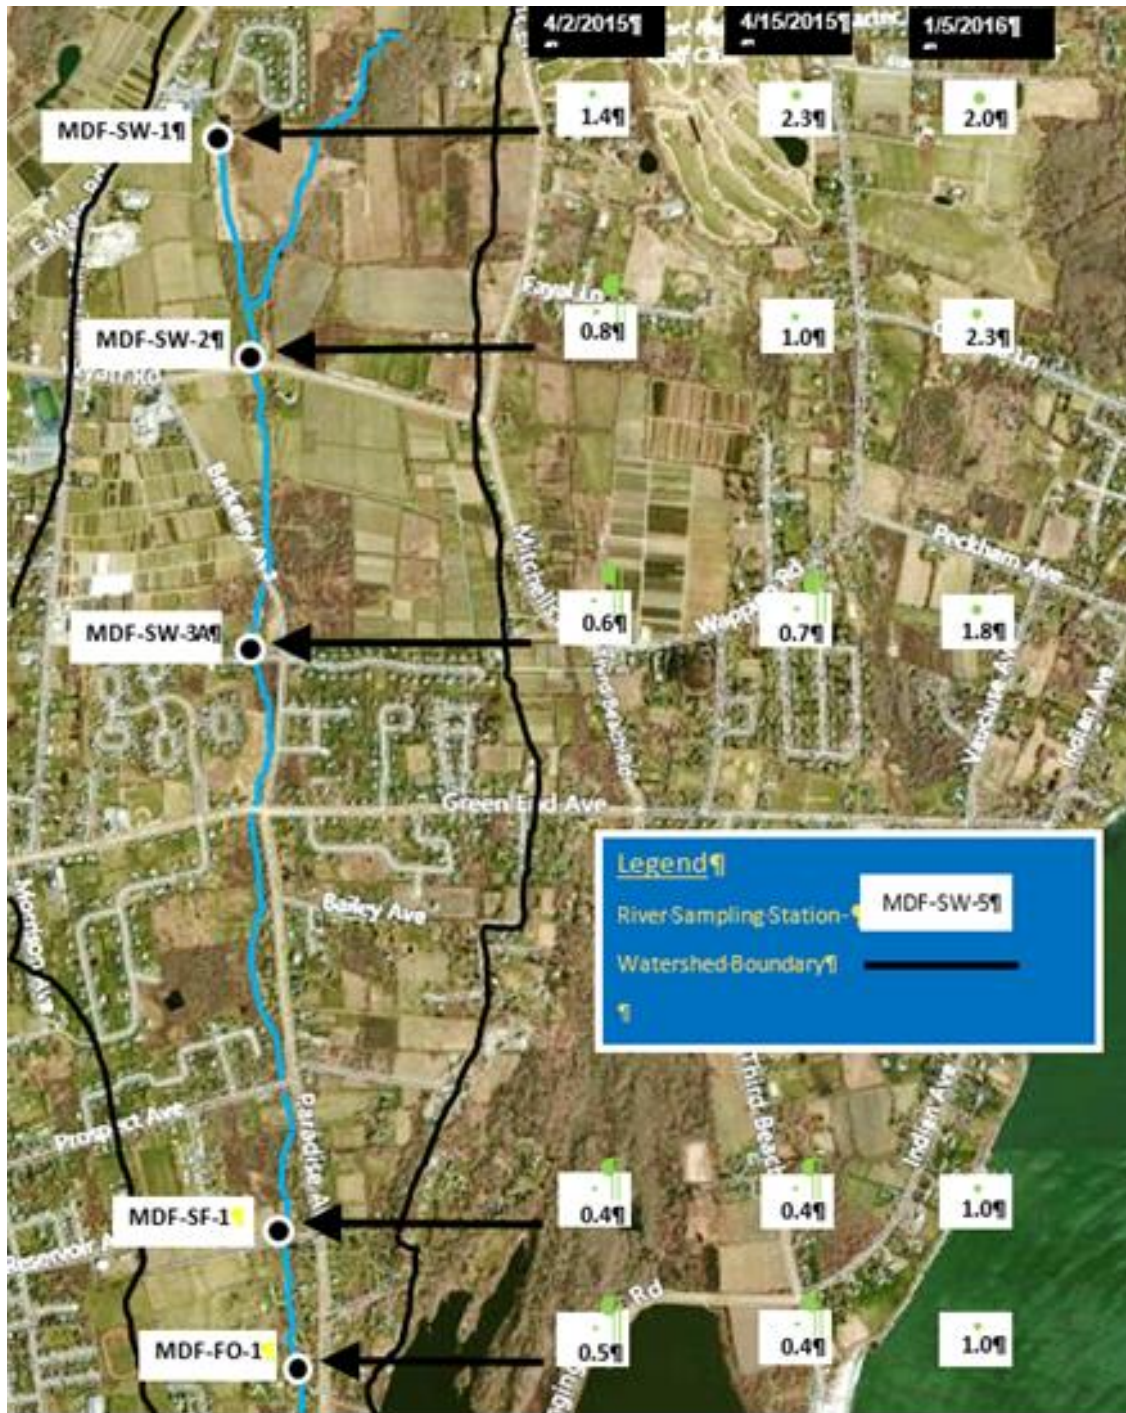
The dry-weather turbidity values were low, with a mean and maximum value of 1.1 and 2.3 NTU, respectively (Figure M1). RIDEM water quality criteria for turbidity is based on exceedances above the background level. For the Maidford River, background is interpreted as “naturally” occurring conditions, as found at the most upstream two stations, where the riparian corridor is naturalized. Dry weather values for both stations were averaged together to determine the background level for dry weather of 1.6 NTU. Comparing average values against this background level, no downstream station exceeds by more than 5 NTU.

Figure M1. Maidford River Dry –Weather Turbidity (ug/l).

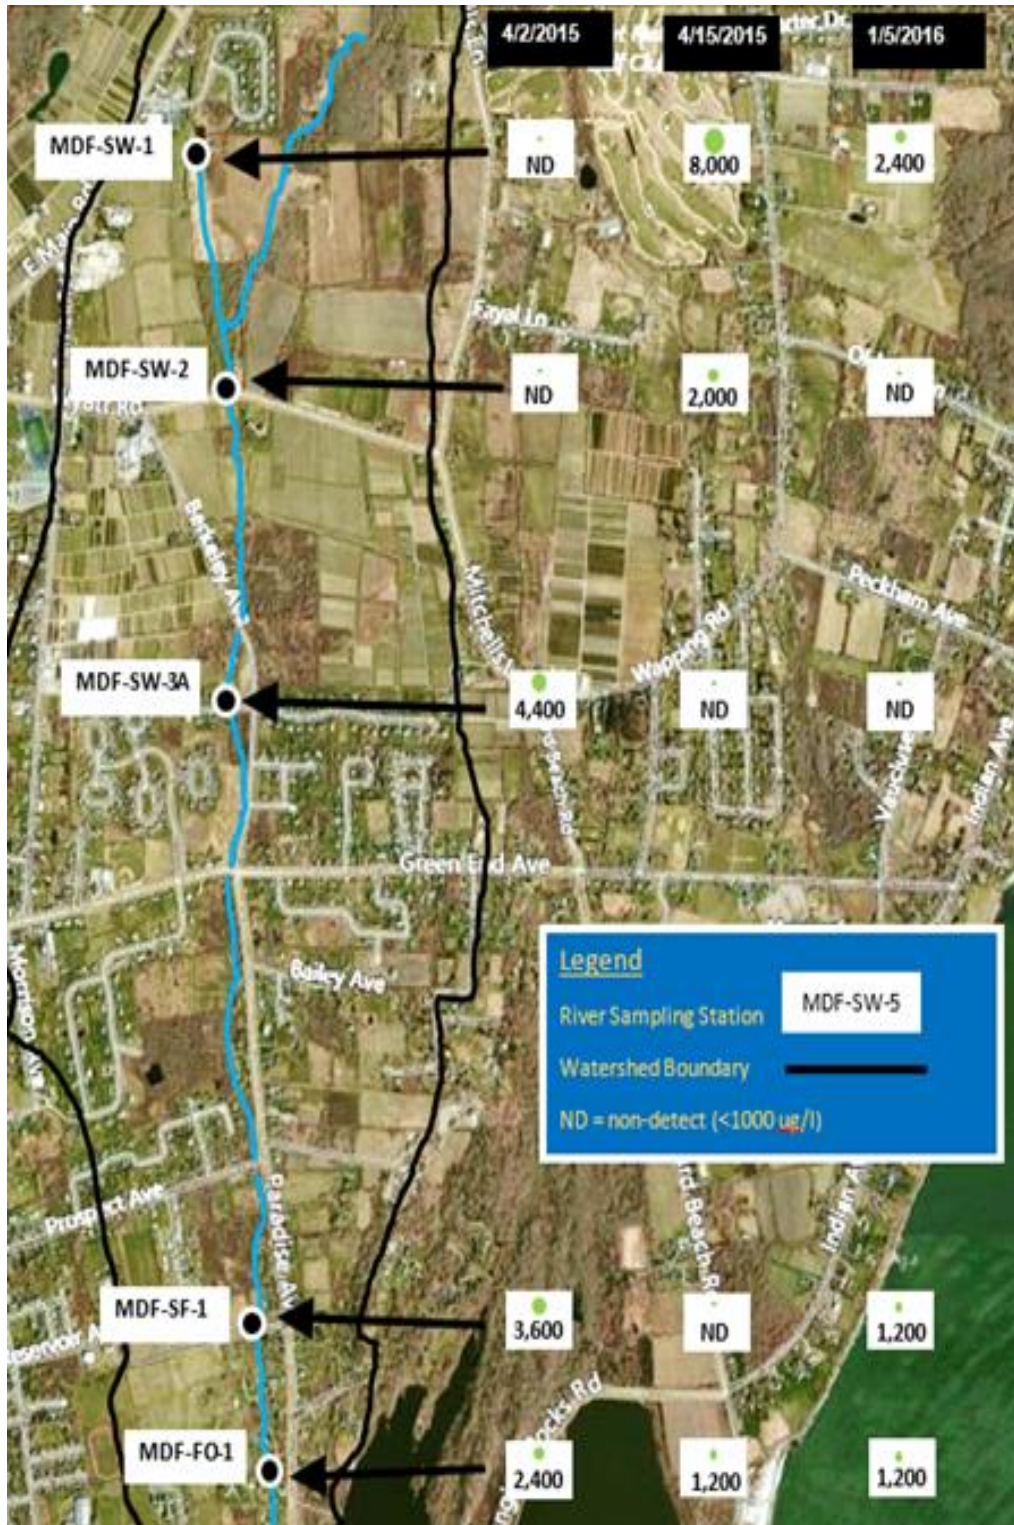
Like turbidity, the dry-weather TSS values are low, with a mean and maximum value of 2,000 and 8,000 ug/l, respectively (Figure M3). Many TSS results were below the detection limit (1,000 ug/l). EPA guidance for TSS is 25,000 ug/l for protection of juvenile fish, larvae, and eggs. Suspended solids are mainly sediment. Decaying organic material may be a minor constituent of TSS, especially during low flow periods. Flow velocities during dry weather are not sufficient to cause significant streambank erosion or resuspension of streambed sediments.

Figure M3. Maidford River Dry-Weather Total Suspended Solids (ug/l).
