Remedial Action Closure Report

*Former Manufactured Gas Plant
642 Allens Avenue*

Providence,
Rhode Island

Prepared for: **New England Gas Company**

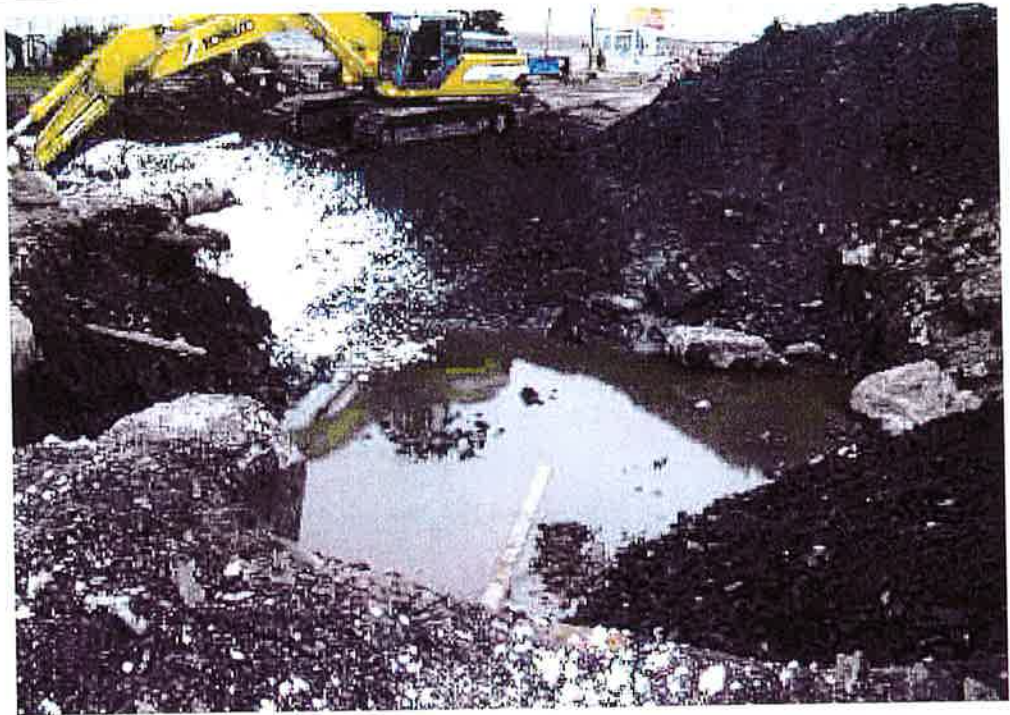
View of Area 2 excavation from west side.

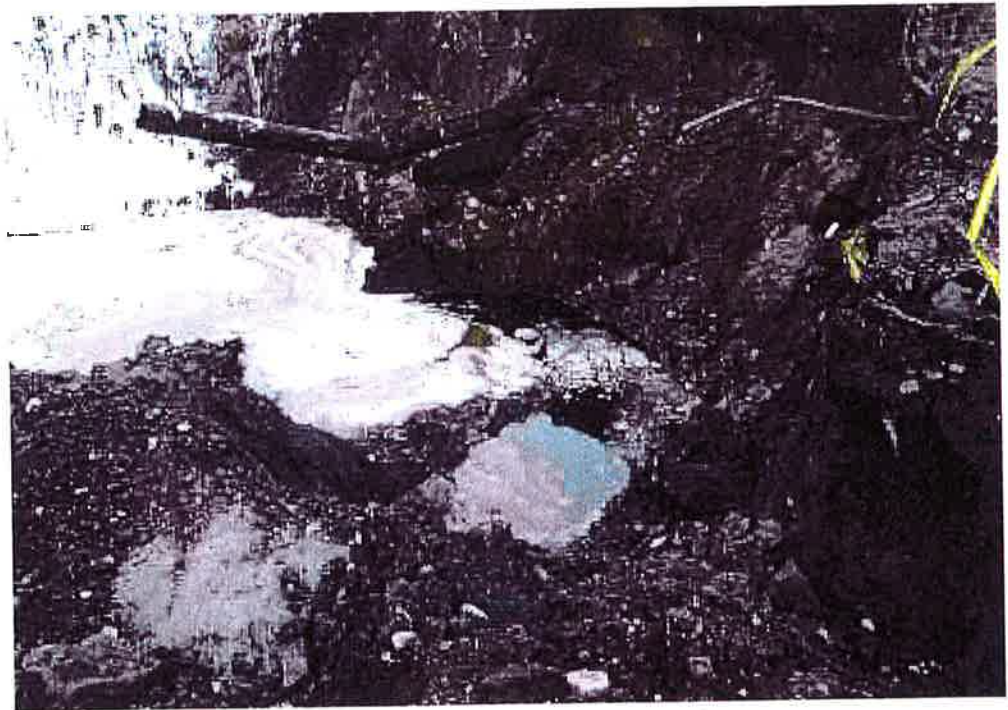
LNAPL from north wall of Area 2 excavation.

The excavation was advanced in a north/northeasterly direction and brought to the approximate edge of the paved access road north of Structure 3B and continued east along the road. Proximate to confirmation sample point EXA2-12, a light non-aqueous phase liquid (LNAPL) was observed to be weeping into the excavation from the north excavation wall at the water table. The LNAPL appeared to be brown in color and appeared to be isolated to a small area.

The excavation was left open overnight and LNAPL was observed to have collected in the excavation. The LNAPL appeared to be from the same area that was observed the day before and as the excavation had already been brought to the northern limits, the project team decided to place a 12-inch diameter recovery well to facilitate future LNAPL recovery. Recovery well specifications are detailed in Appendix E. A trash pump equipped with a 3-inch hose was used to remove LNAPL from the excavations.

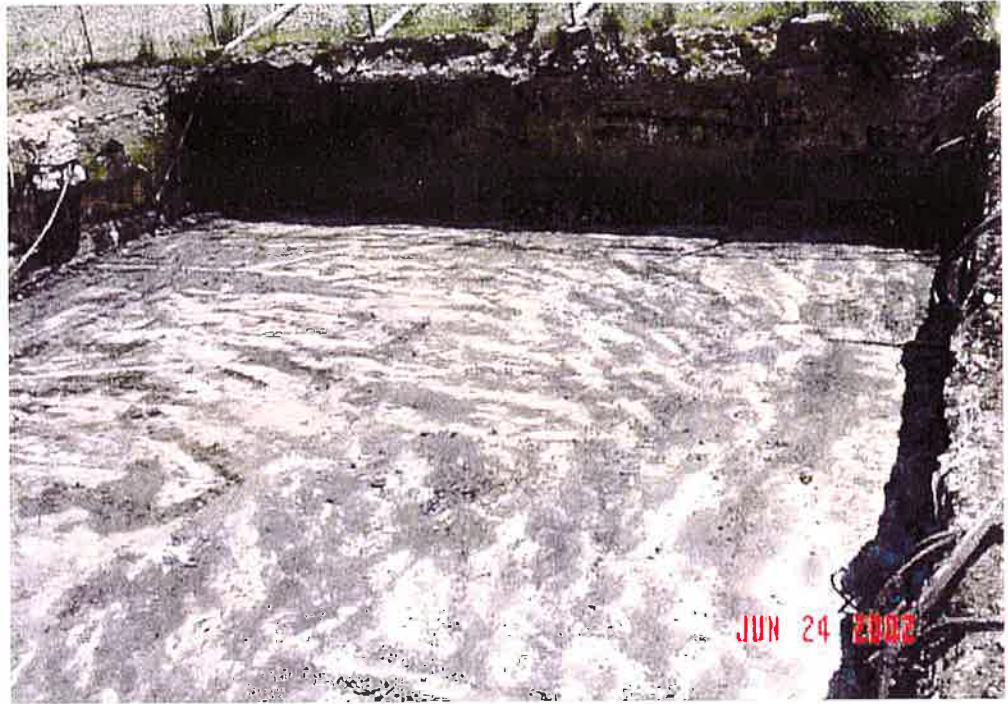
Western cell of Structure 3B after excavation/cleaning.

Once stabilized, the material was transferred to the center section of Structure 3B, since stabilization was conducted from east to west. There were three pipes observed in the northeast corner of the eastern cell at approximately three feet below surface grade (BSG). These pipes were traced back to two small structures located east of Structure 3B. These structures were subsequently identified as Structure 3B Northeast (NE) and Structure 3B Southeast (SE). The pipes were removed and the pipe outlets into the structure were sealed with concrete, once the structure was partially backfilled, allowing access to the outlets. When excavation and scraping of the eastern cell with a smooth-edged excavator bucket was completed, it was inspected by Mr. Joseph Martella of RIDEM's Office of Waste Management on May 28, 2002 and approval was granted to backfill this portion of the structure. Mr. Martella visited the Site again on June 24, 2002 to observe the cleaning of the western and final cell in the structure and approved the backfilling of the structure.

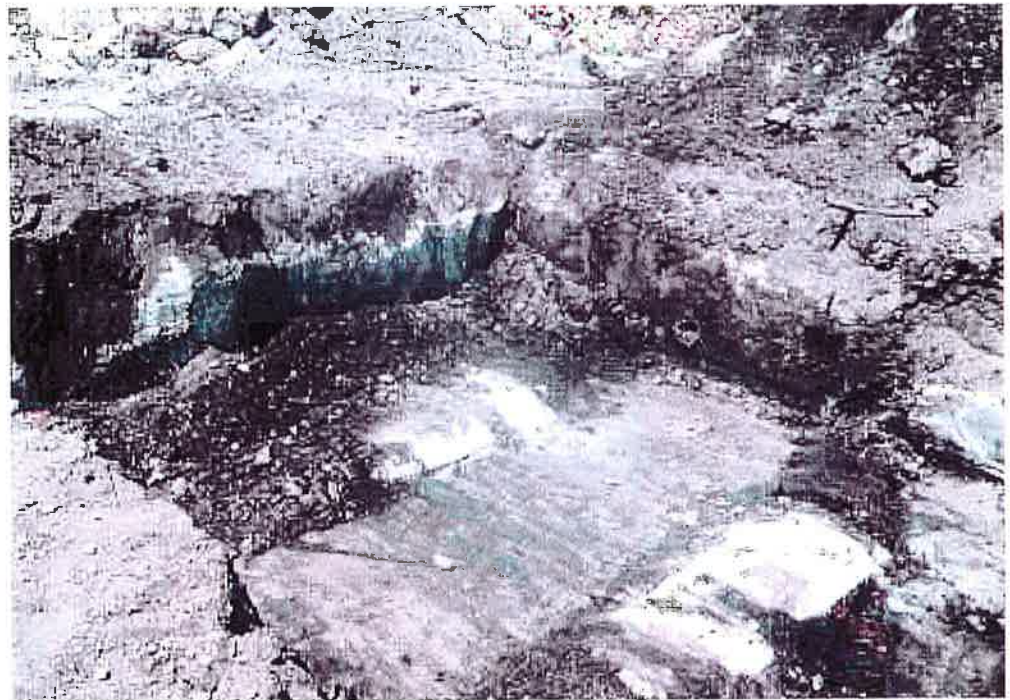
Structure 3B NE.

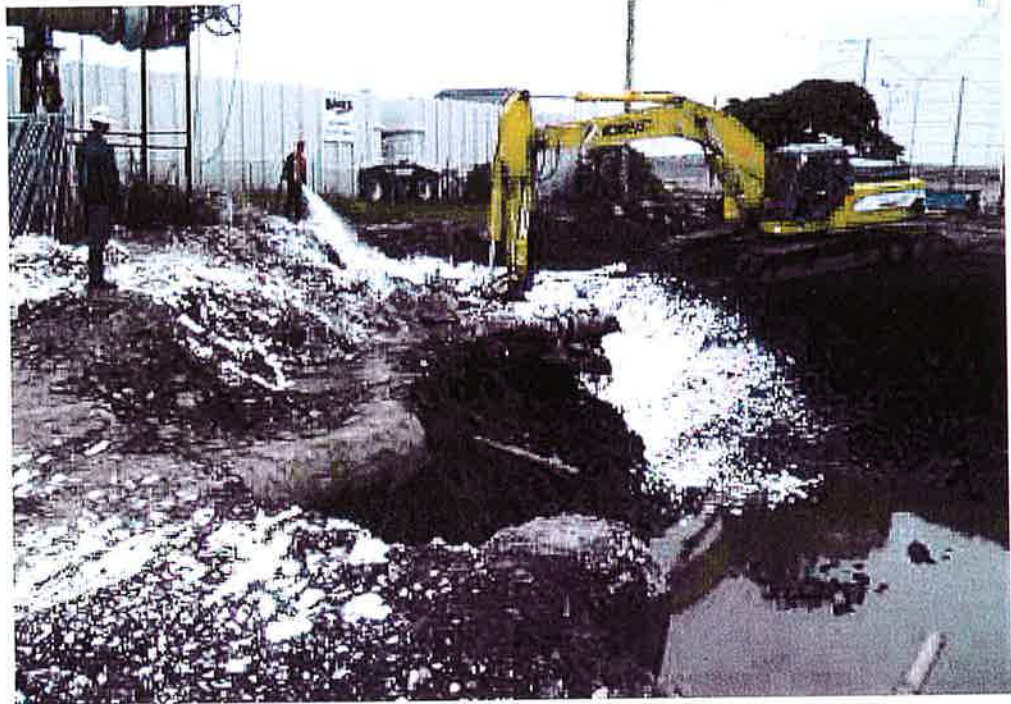
Area 2 excavation with CHES applying odor-suppressing foam.

Odor-suppressing foam was used during the remedial excavations to manage odors and fugitive emissions emanating from excavations and stockpiles. Dust suppression was achieved through the use of a watering truck when Site conditions warranted its use. Refer to the Photographs section to see this equipment in use.

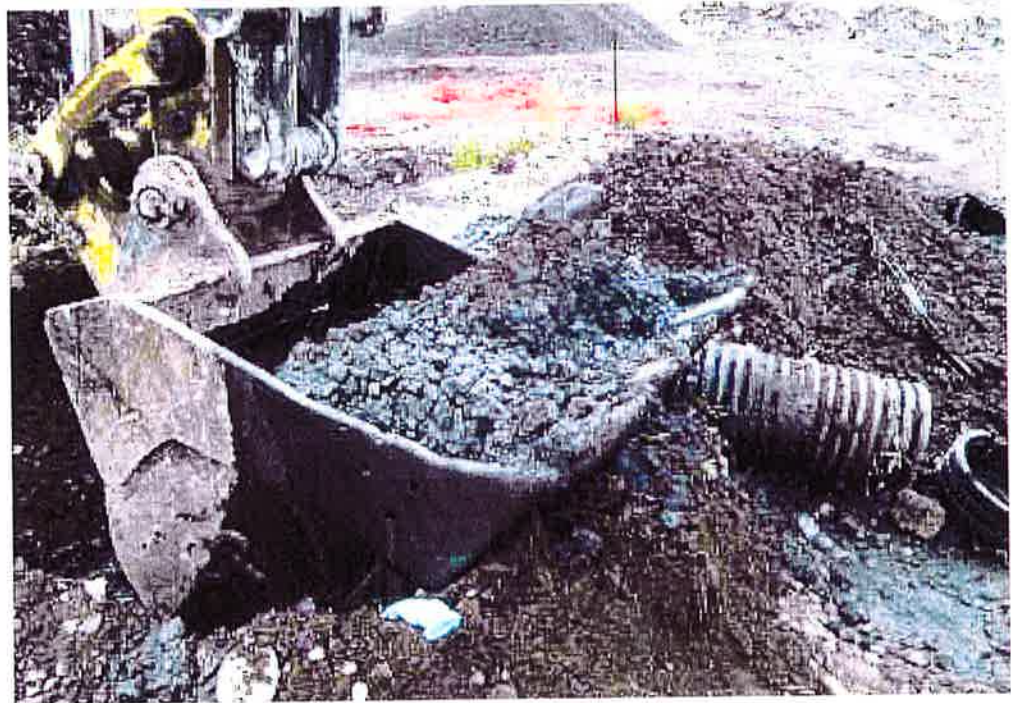
View of contents of Structure 14A.

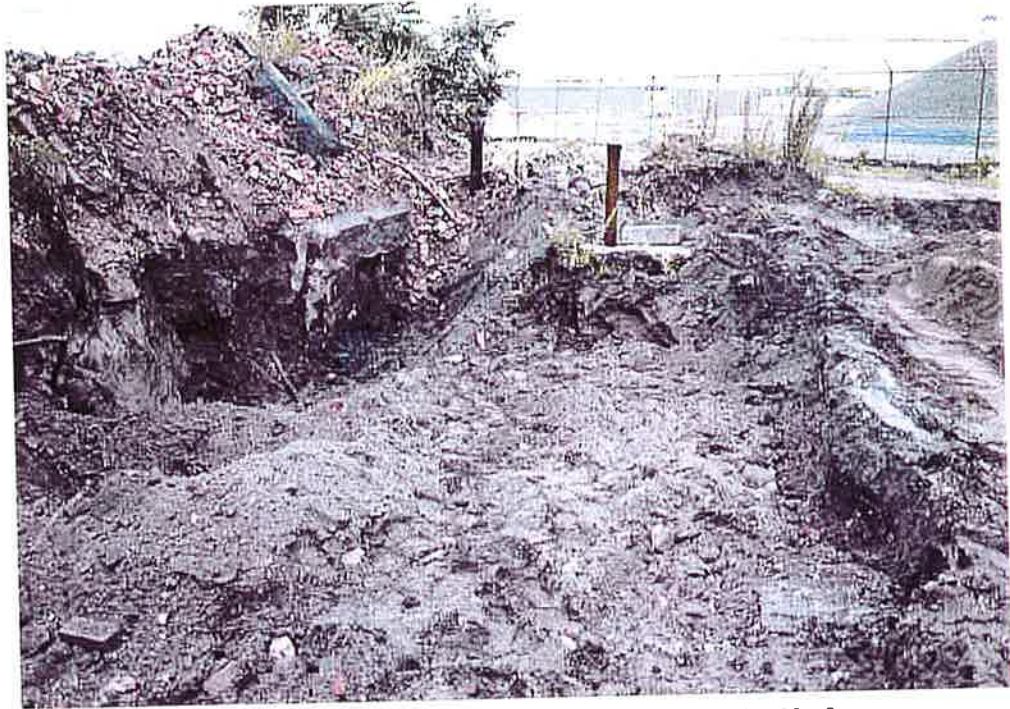
View of surficial excavation completed south of Building No. 9.

A surficial soil excavation was begun on August 29, 2002 south of Building No. 9. Due to the presence of a Duke Energy dike located south of the excavation area, a 20-foot no dig zone was established between the excavation and the dike. Soils were excavated to a depth of 2 feet BSG. The excavation started proximate to an ESS boring that indicated a soil sample at 0-2 feet exceeded surficial soil ROs. The excavation proceeded westerly to the 3B Northeast and Southeast structures which had previously been excavated. A concrete foundation slab was encountered along the southern portion of the excavation and a cement "trough" was observed running approximately the entire length of the excavation. The excavation was advanced northerly to the concrete foundation of Building No. 9.

Table 11 (see Tables section) summarizes the sidewall confirmatory samples collected from the surficial excavation conducted south of Building No. 9. As shown, there were compounds that exceeded the surface soil ROs. Confirmatory sample points EXA2-23, 24, and 25 were located along the eastern sidewall. Additional excavations were conducted to the east and samples were collected from the northern and southern sidewalls. Collection of eastern confirmation samples was not possible due to the presence of a concrete foundation. Confirmatory sample EXA2-33 was collected from the north wall of the additional excavation and laboratory analysis indicated concentrations of Benzo (a) pyrene, Benzo (a) anthracene, and Benzo (b) fluoranthene that exceed the ROs. Further excavation to the north of EXA2-33 was not practical due to the presence of a partially demolished building (Building No. 9) and several rubble piles surrounding the building footprint.

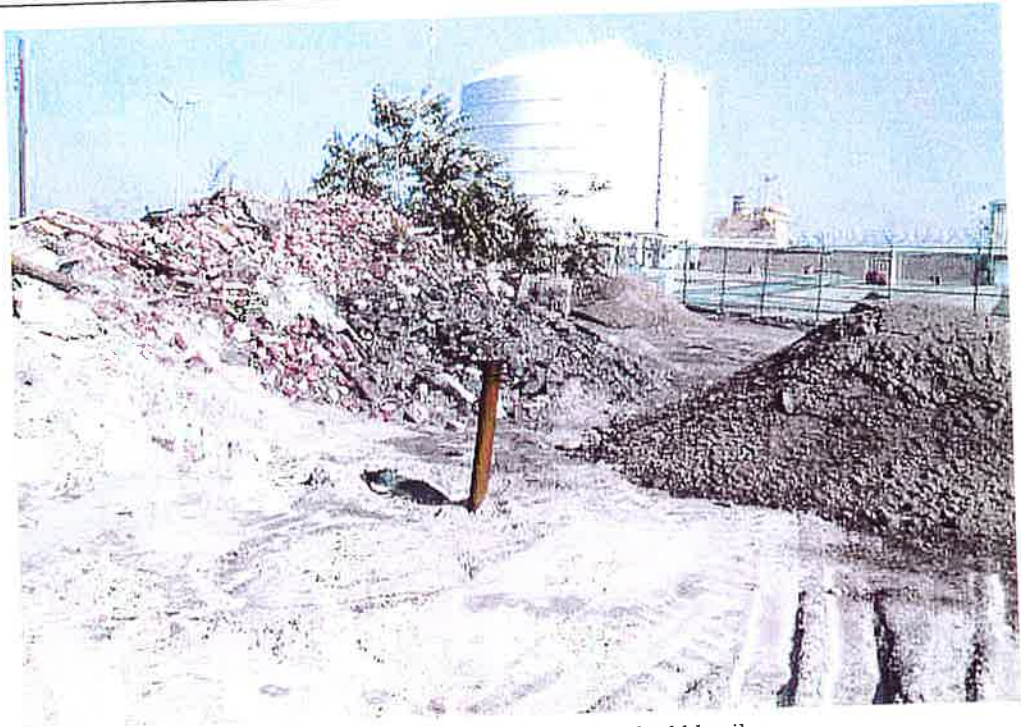
Partially demolished Building 9 and rubble piles.

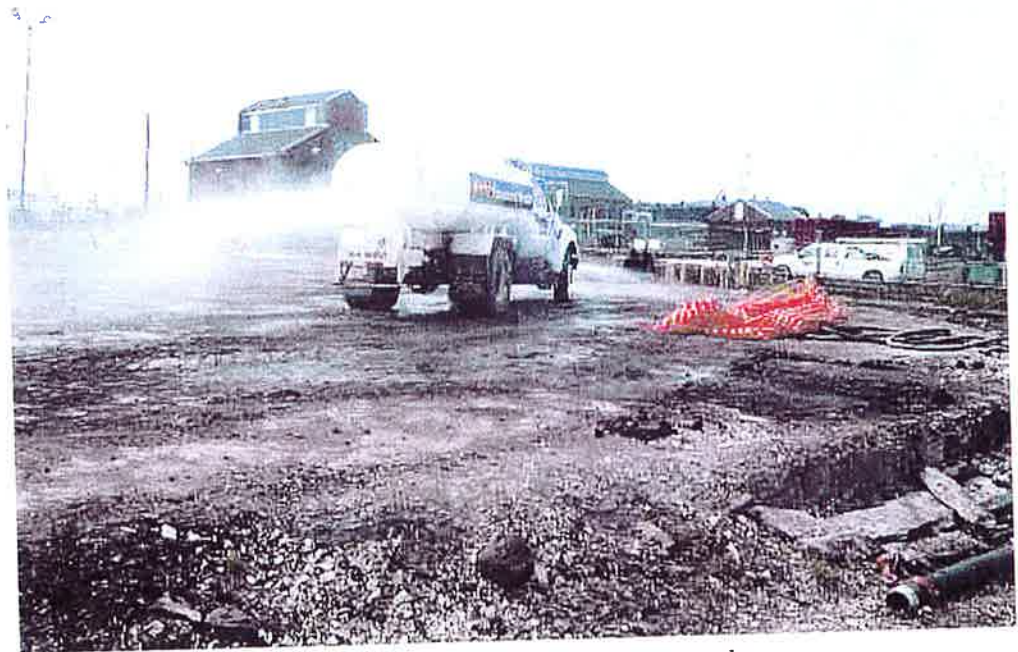
On Site dust suppression using water truck.

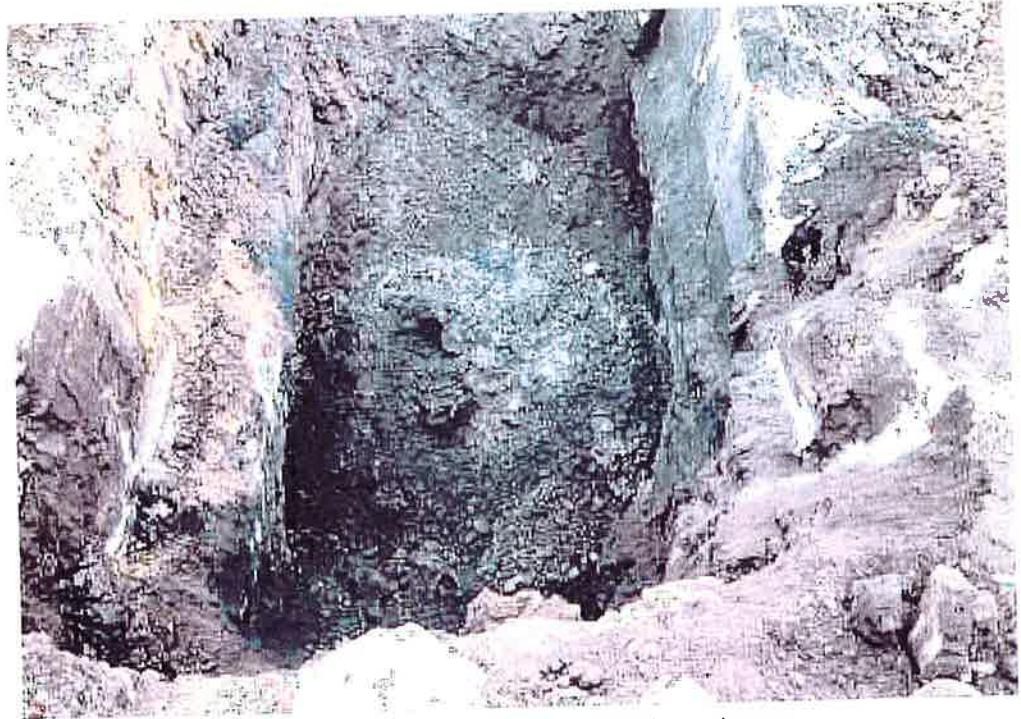
Soil conditions proximate to knockdown pipe.

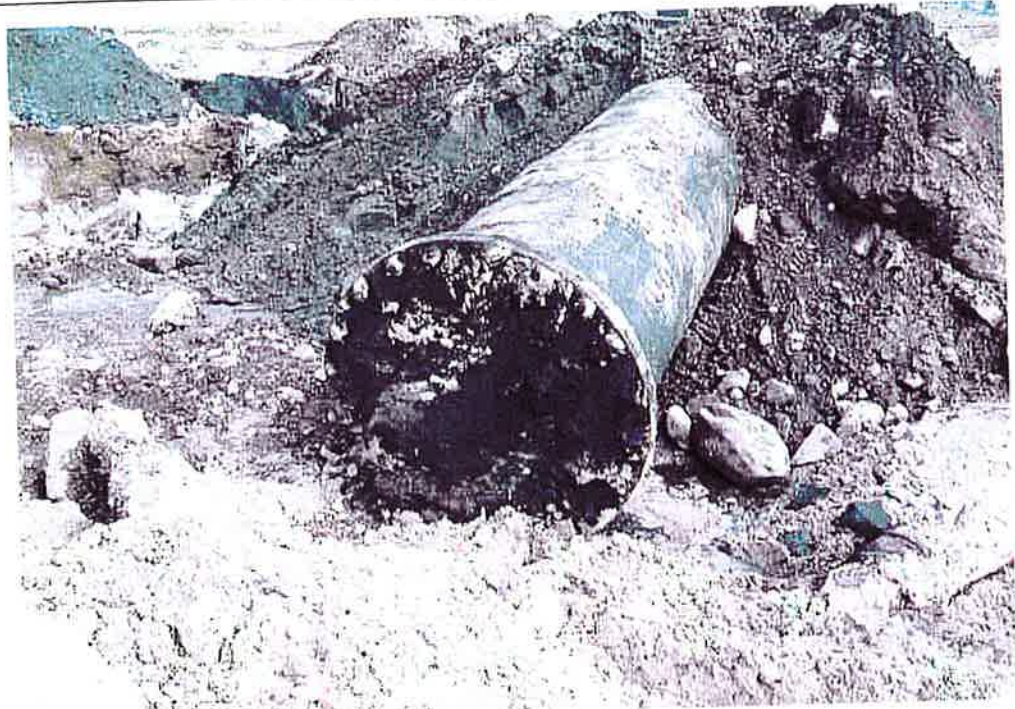
View of knockdown pipe after removed. (Note flanged bottom and rivets).

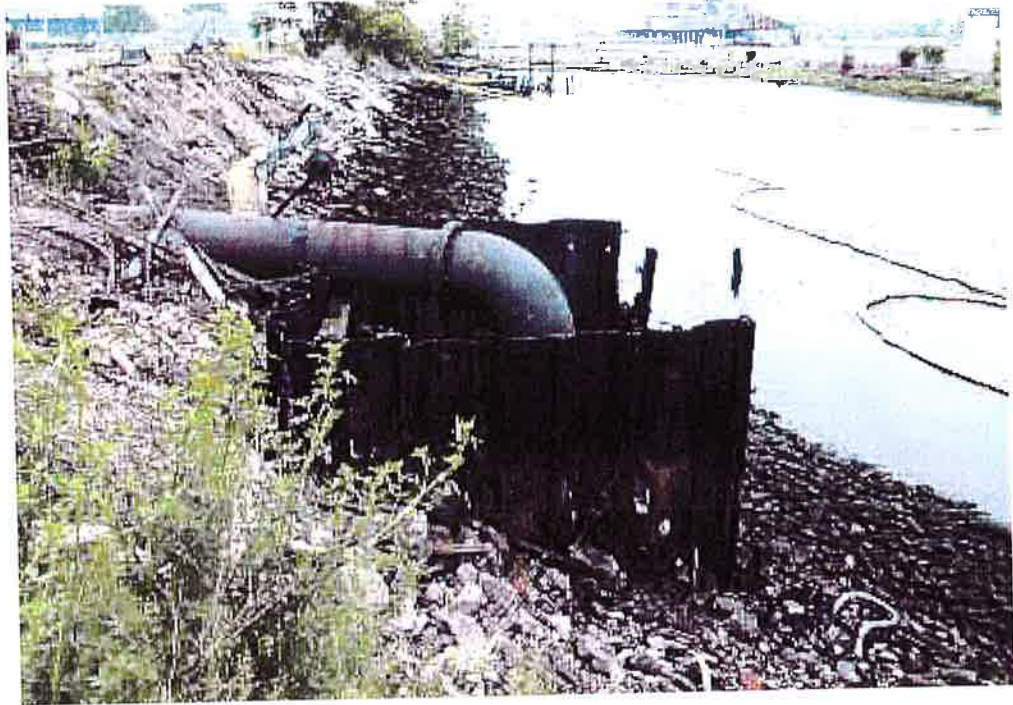
Salt-water intake structure before removal.

Removal of the salt-water intake structure began on June 11, 2002 and these activities were conducted during low tide conditions. Removal was accomplished by excavating approximately 1.5 feet BSG of the surrounding sheet piling and the sheet piling was cut with an acetylene torch. The piping associated with the structure was removed and stockpiled on the MHA for recycling. LNAPL was observed on the water surface during the removal activities within the structure and additional absorbent booms were placed around the former structure for containment and collection. Removal of the salt-water intake was completed on June 14, 2002.

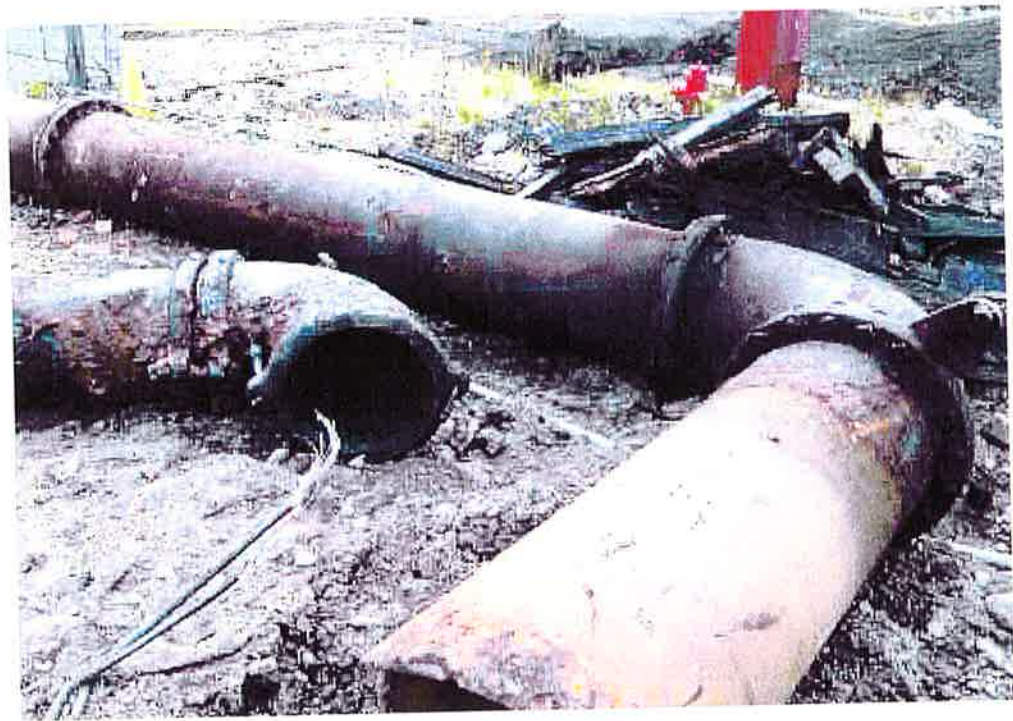
Salt-water intake structure piping after removal.

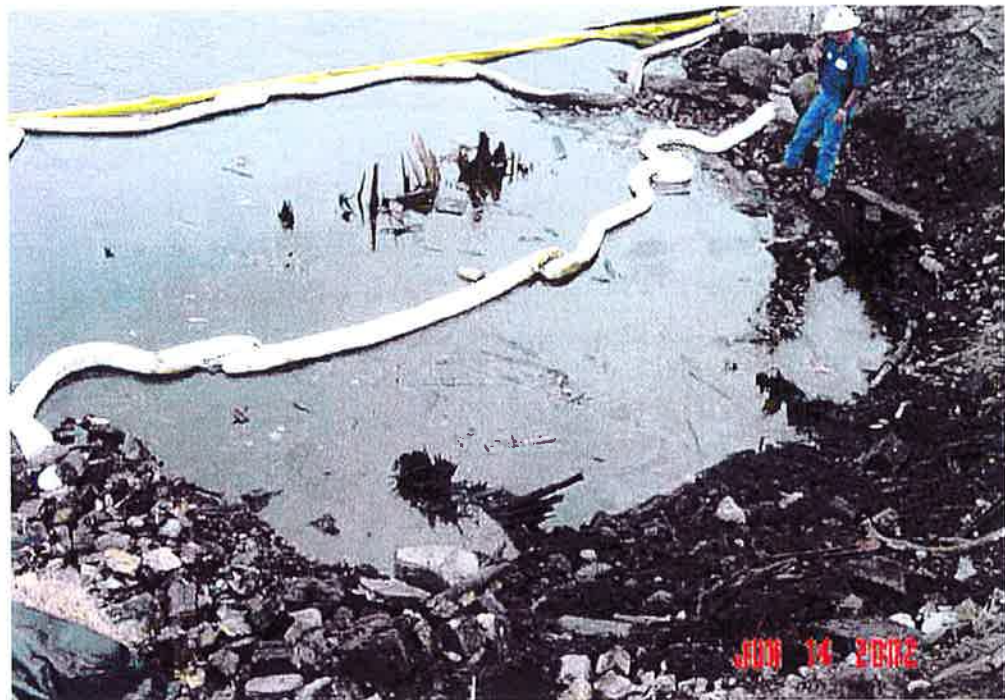
LNAPL recovery following removal of saltwater intake structure.

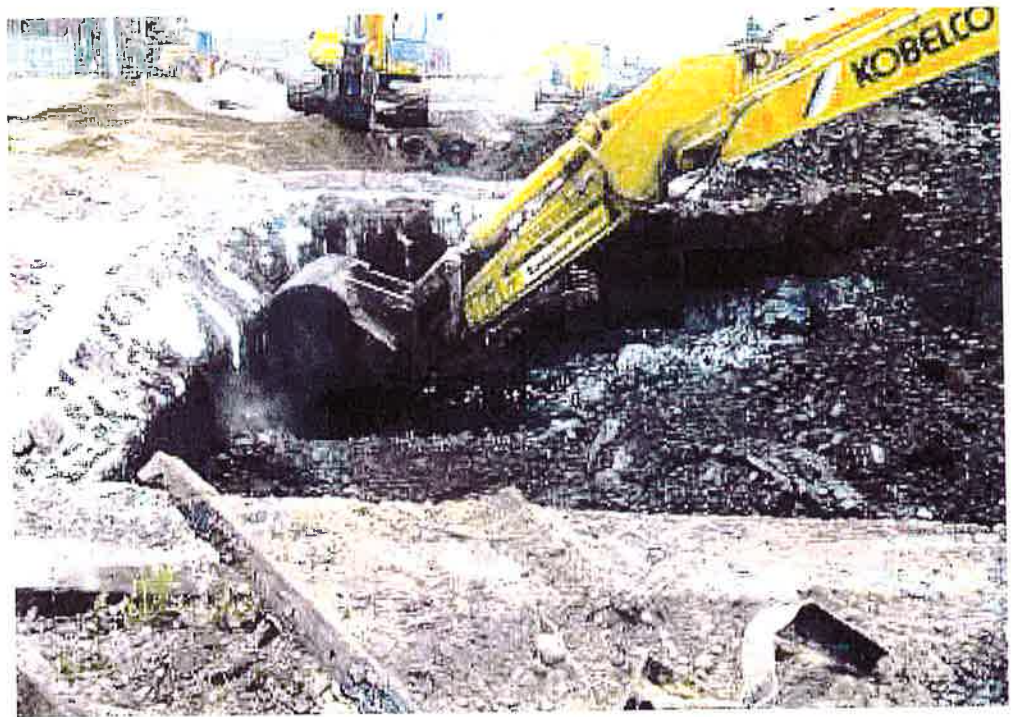
Excavation and stabilization of contents of Structure 18.

Once excavation started, it became evident that the structure was made up of six cells with concrete dividing walls. There was also a gap observed in the middle of the structure that ran the length of the structure, was oriented in a north/south direction and divided the three east and three west cells. This gap did not have a concrete bottom and the soil which filled the gap was excavated to an approximate maximum depth of 14 feet BSG. There were several pipes connecting the east and west cells that were removed and stockpiled for disposal.

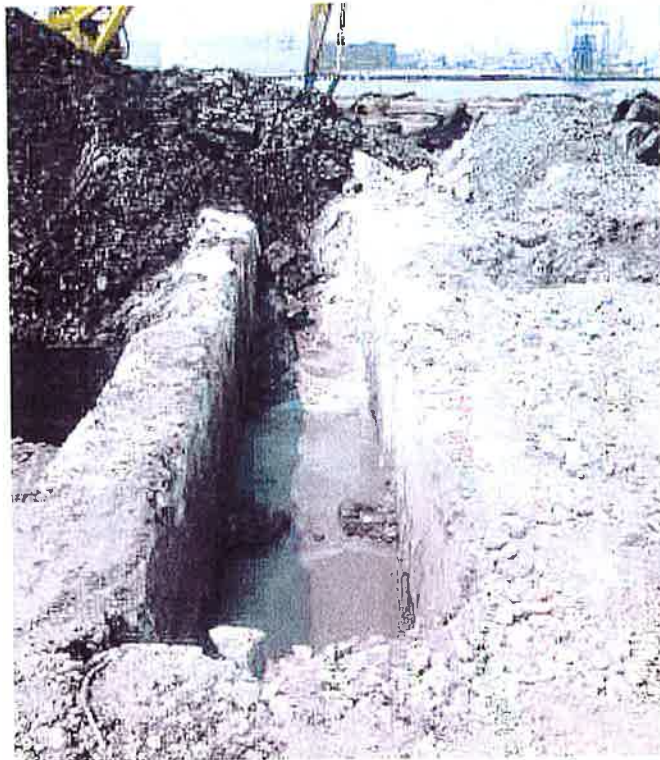
View of gap in Structure 18 separating eastern and western cells.

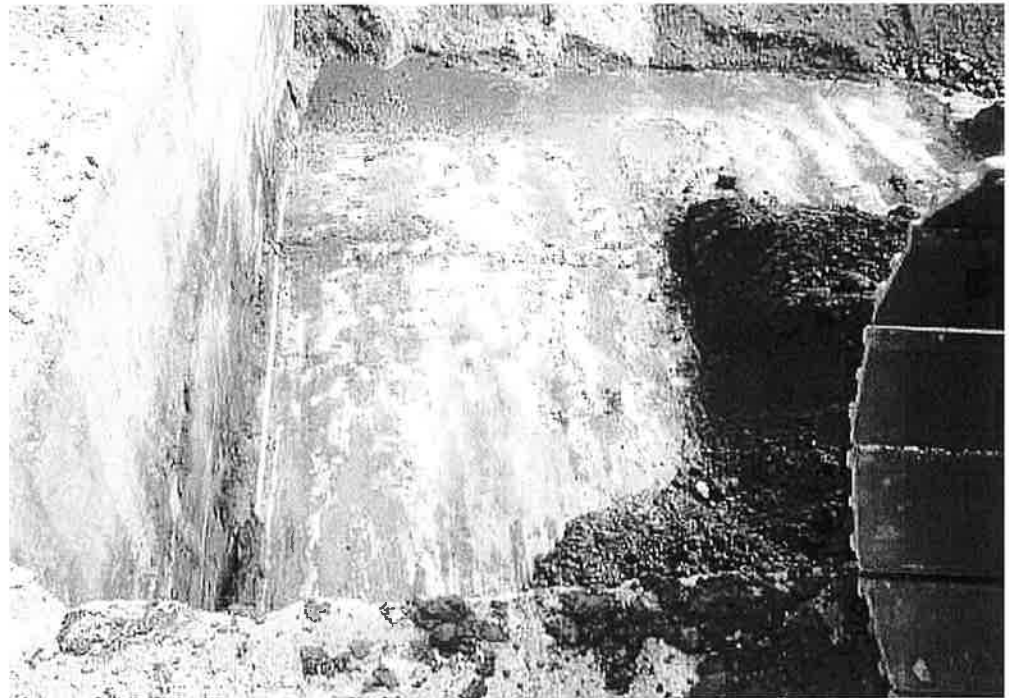
View of portion of bottom of Structure 17.

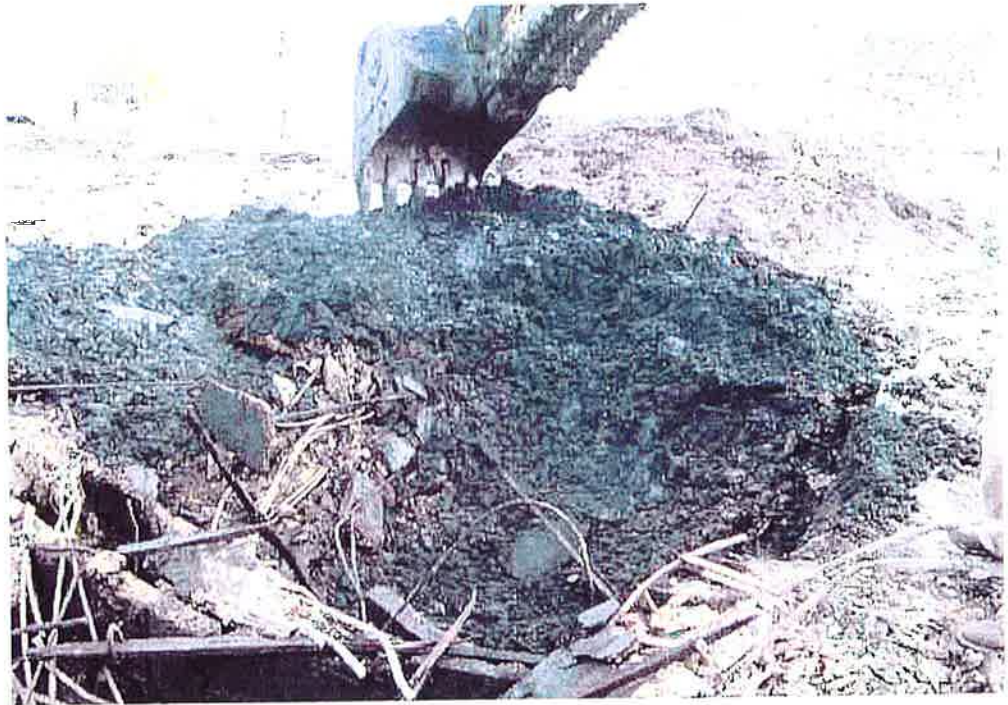
Stabilization of contents of Structure 19 using "speedi-dry".

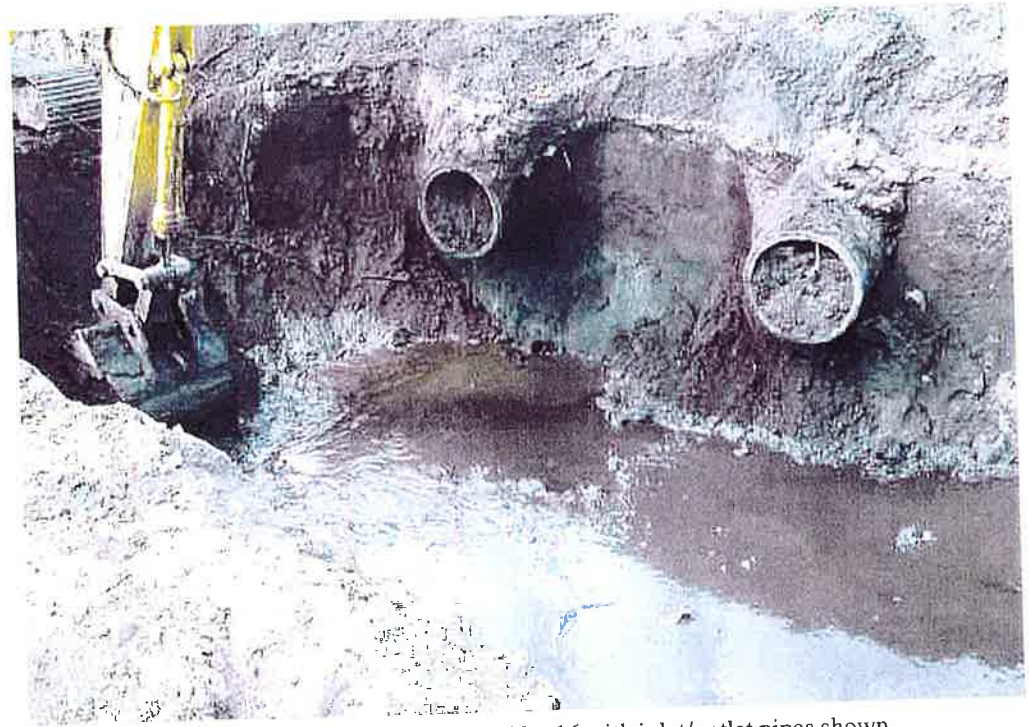
Excavation next to base of Gasholder 16 with inlet/outlet pipes shown.

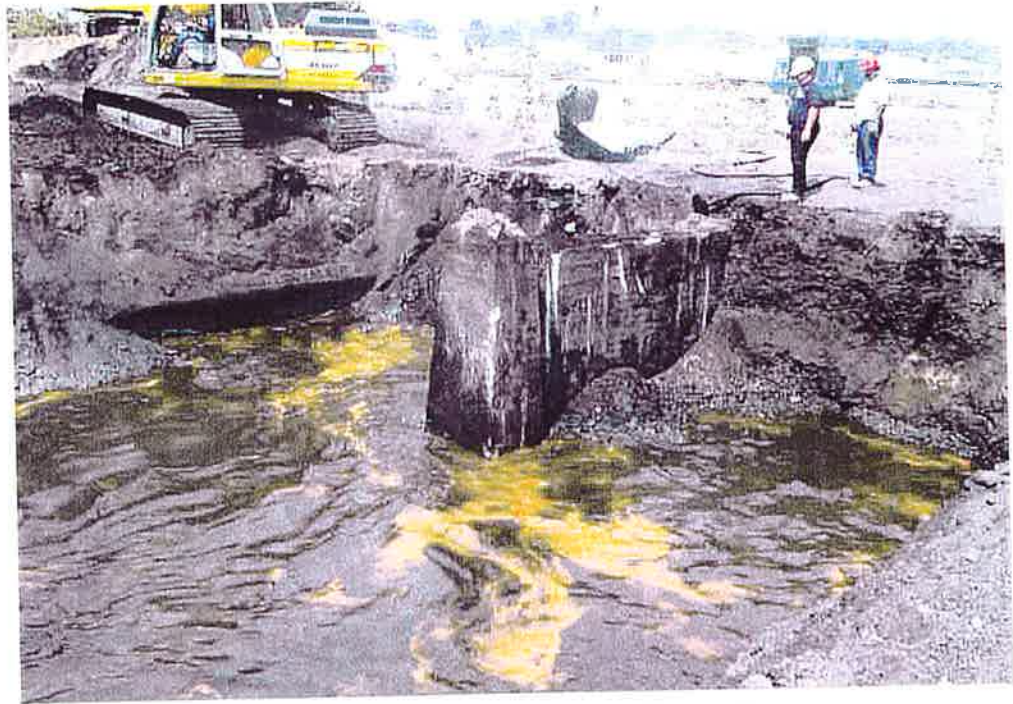
Northeast wall of Area 3 subsurface soil excavation.
Note approximately 12 inch pipe below excavator, presumed to be a water pipe.

Several remnant subsurface footings were uncovered in this excavation south of Structure 14B. LNAPL observed in this portion of the excavation appeared to be greenish in color. An approximately 12-inch pipe was observed running parallel to the eastern sides of Structures 17 and 18. The pipe was believed to be a water main and was left intact in the excavation. This pipe did not appear to be a source of subsurface impacts.

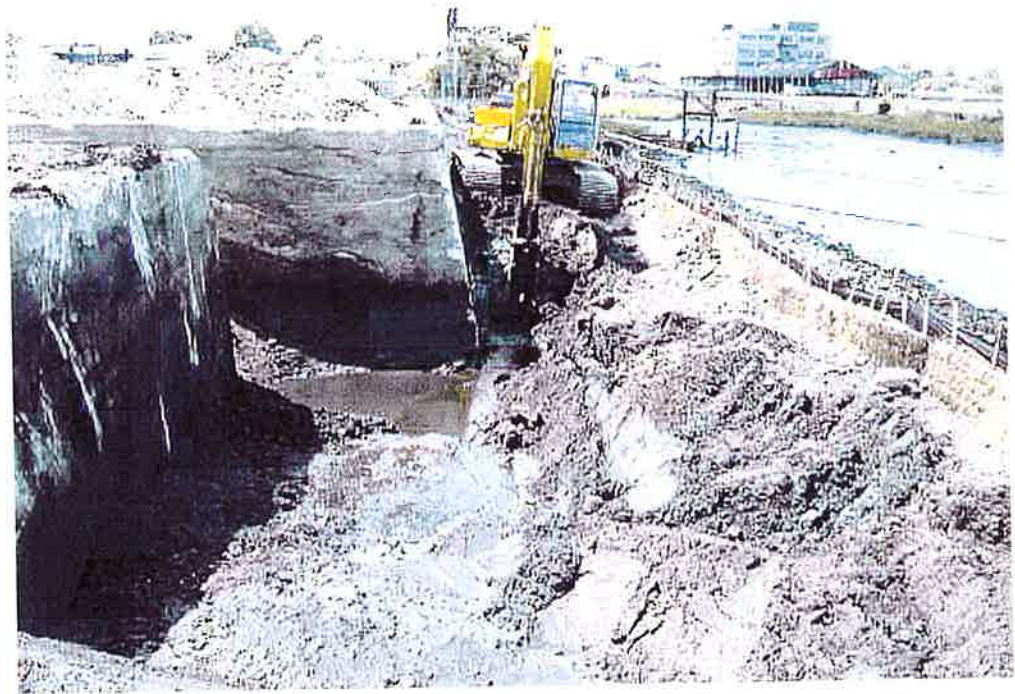
Seep area excavation with north sides of Structure 14A in foreground and Structure 17 next to excavator.

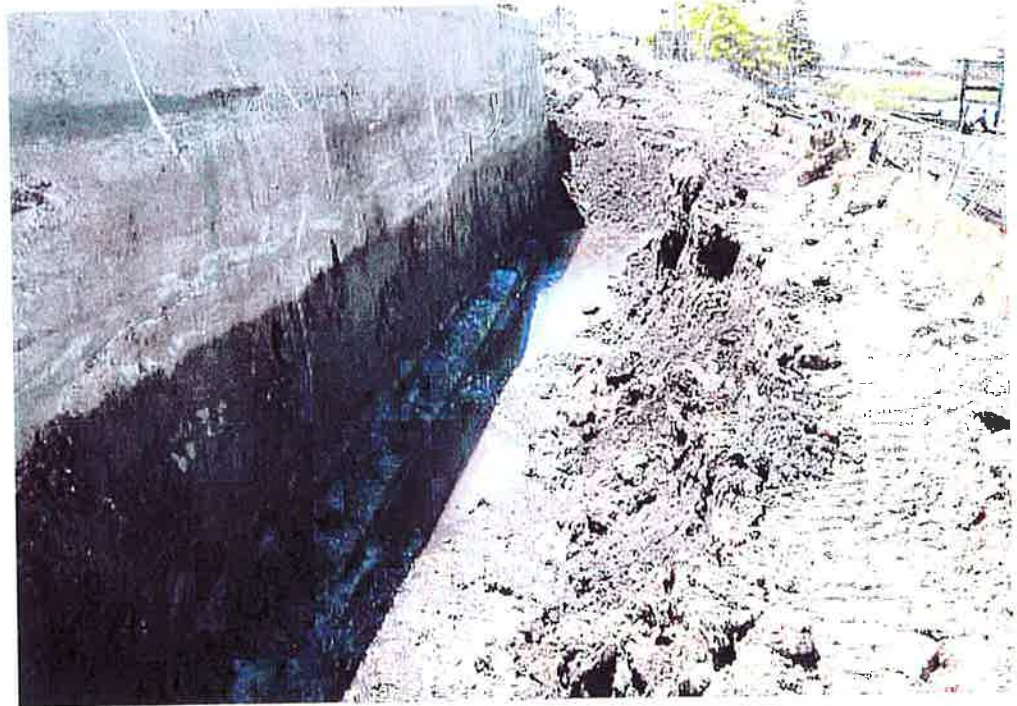
Seep trench excavated in front of Structure 17.

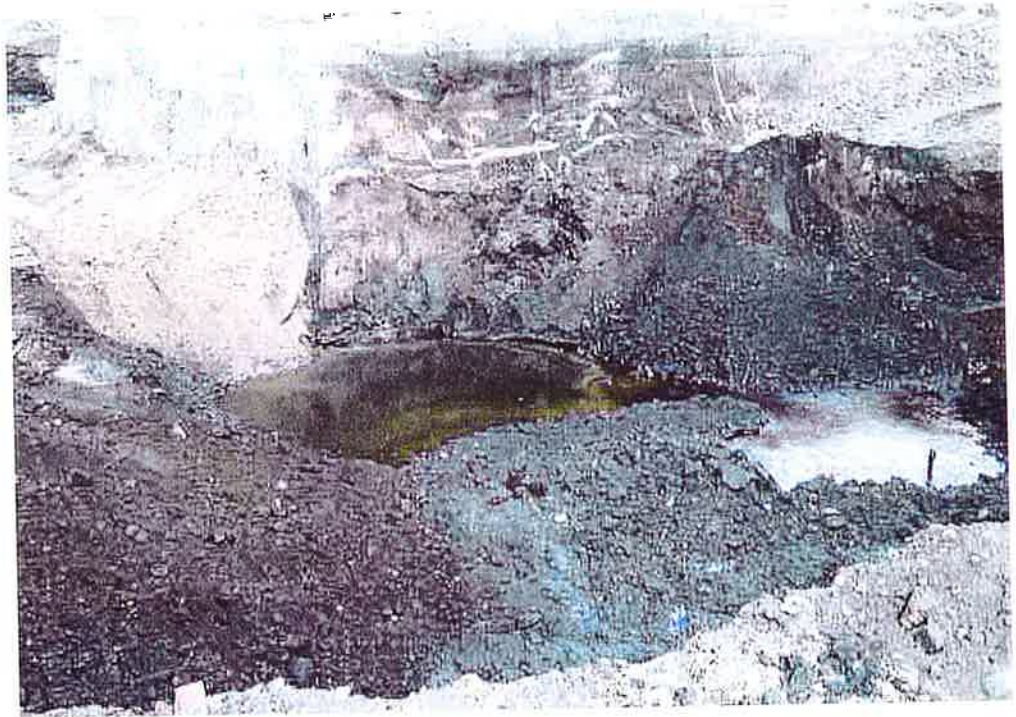
Clay backfill placed in front of Structure 17.

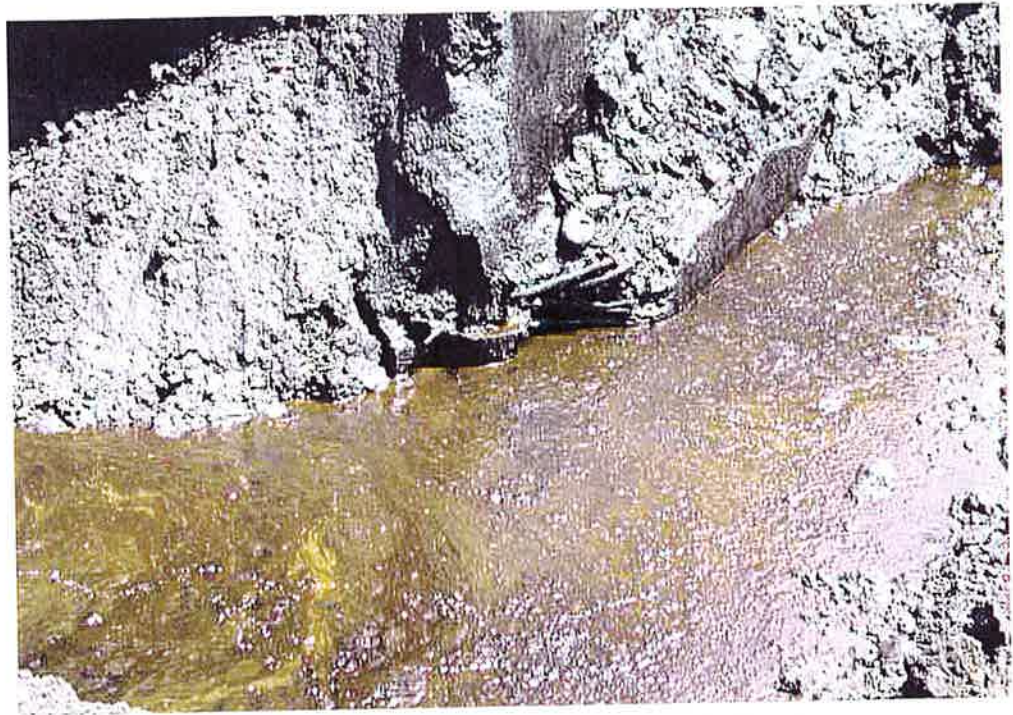
Accumulated groundwater and SPP at west end of trench.
