**Re: Status Report: September 2015 Remedial Action Work Plan (RAWP) Activities**

Former Gorham Manufacturing Facility  
333 Adelaide Avenue, Providence, RI  
File No.: SR-28-0549D

### **Air Monitoring Station Locations**

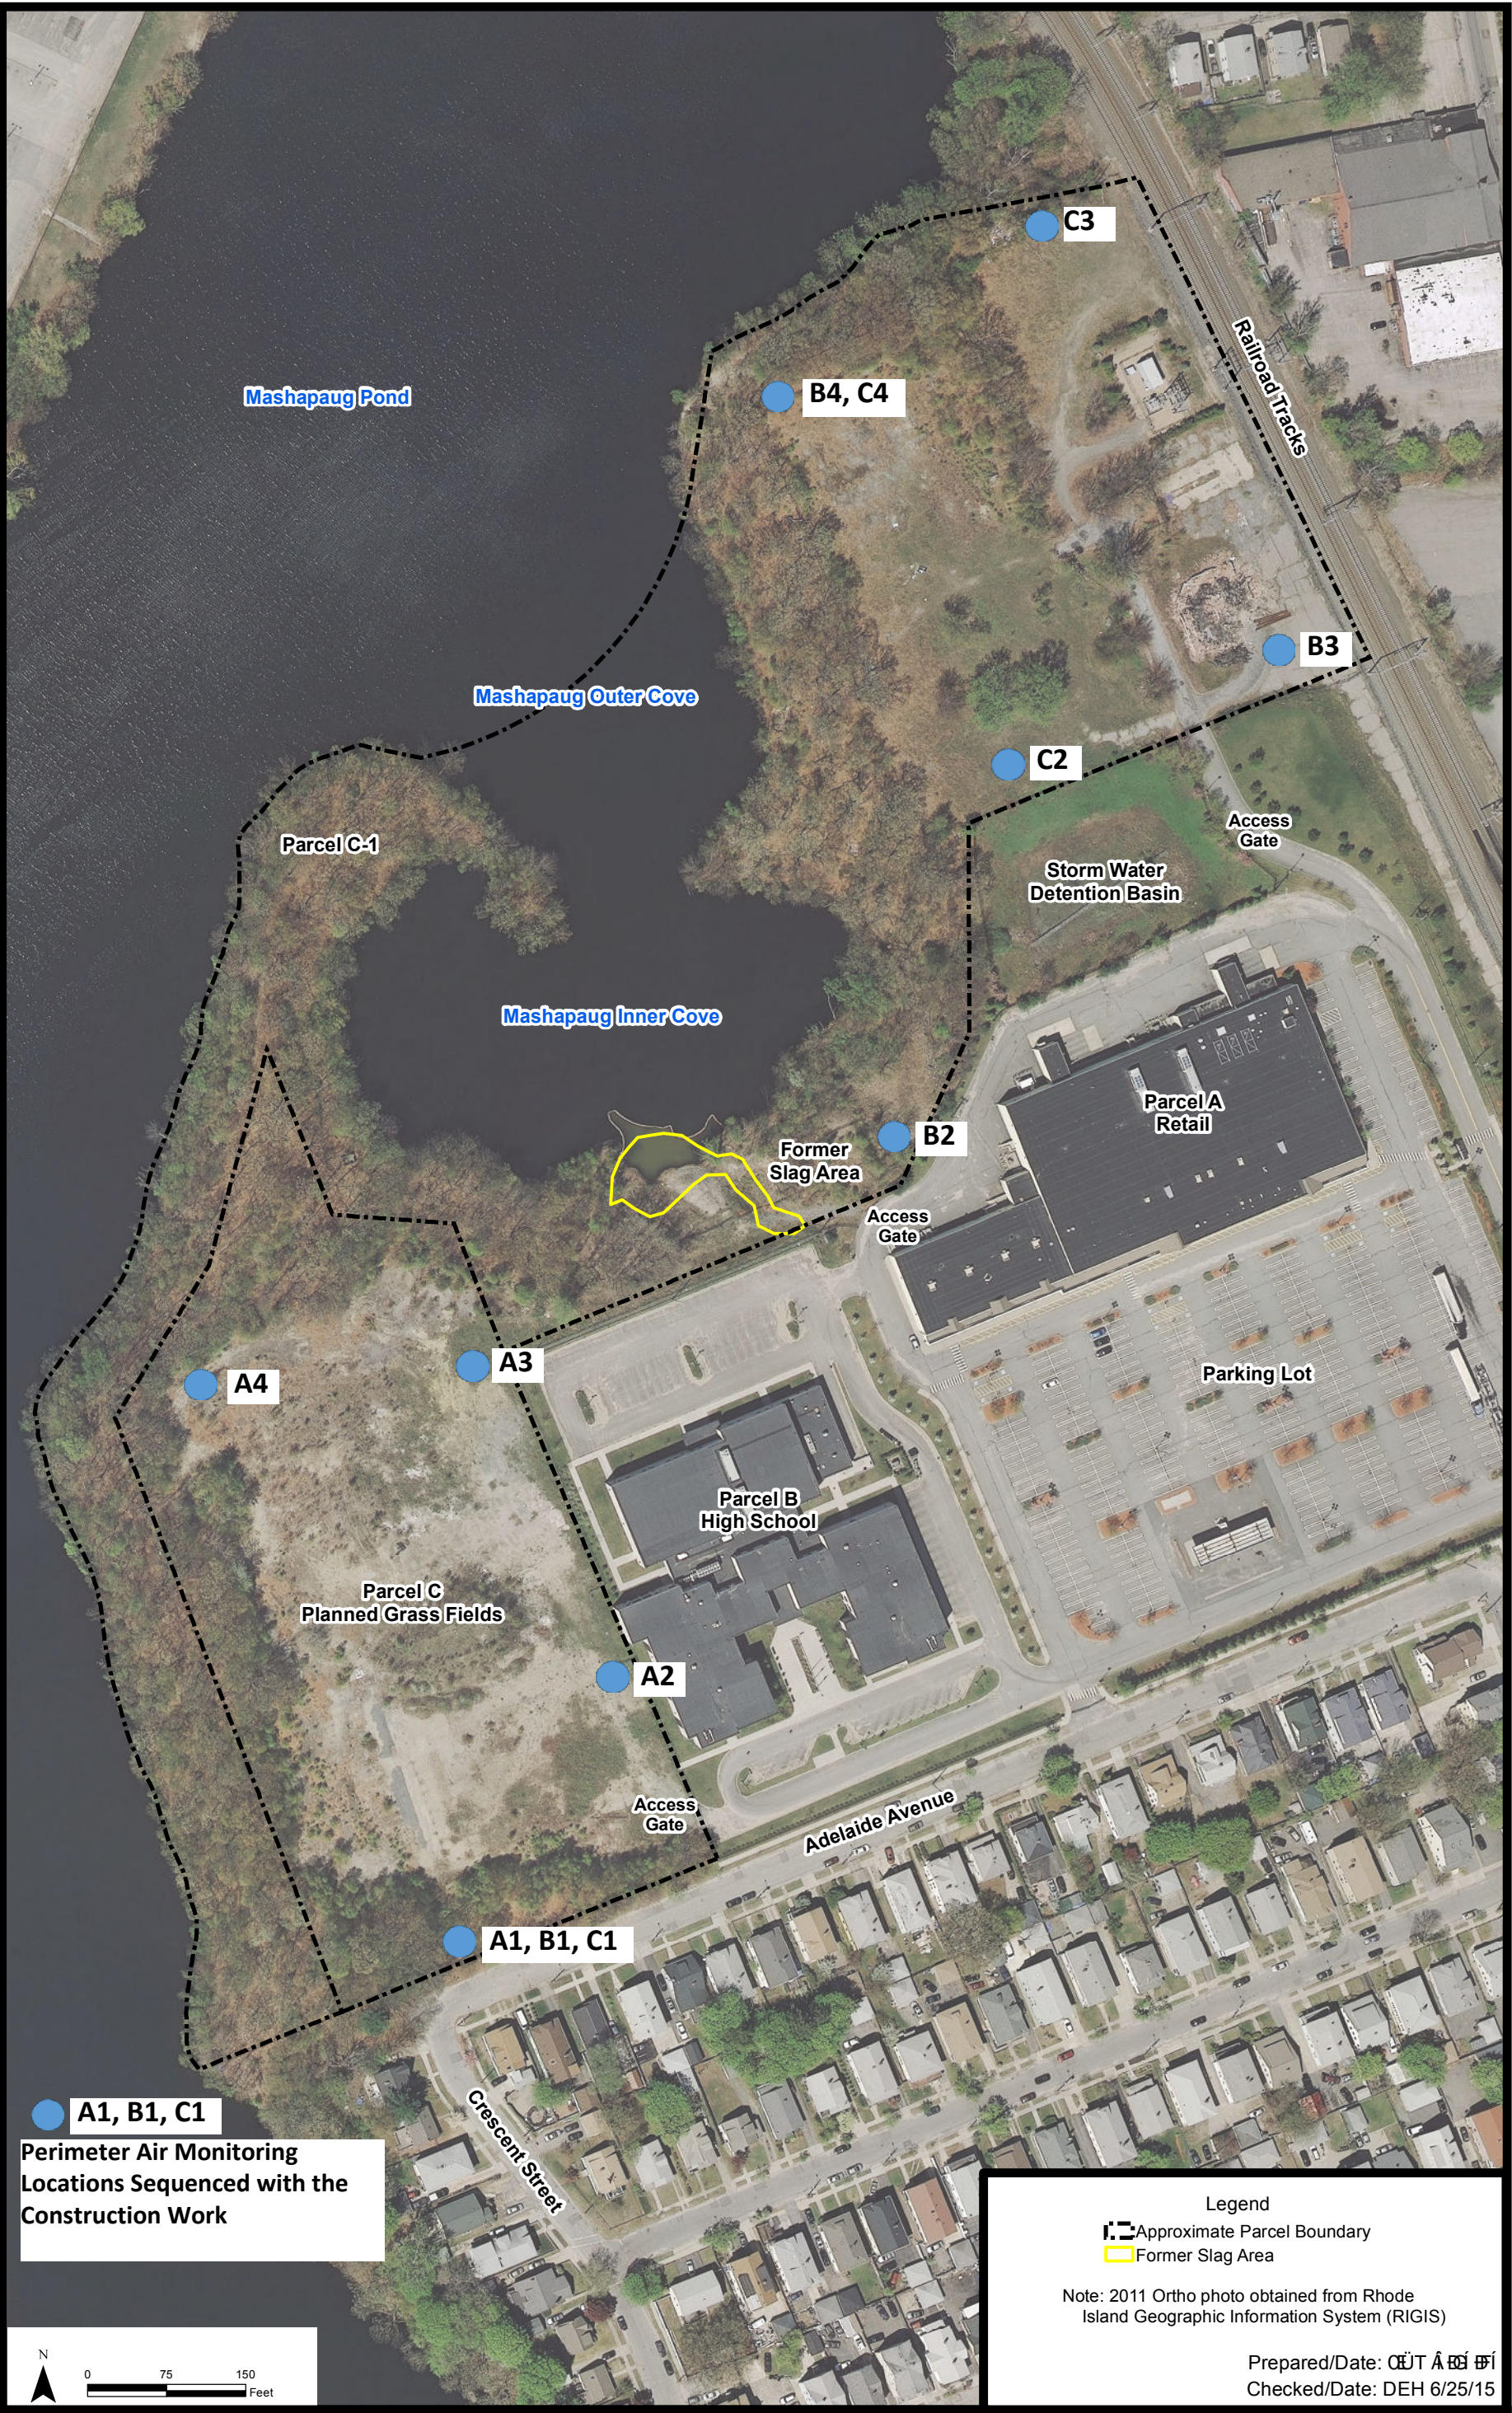
**Perimeter Air Monitoring Locations**

**A1, B1, C1**

**Perimeter Air Monitoring Locations Sequenced with the Construction Work**

- ▶ Amec setup the four (4) perimeter air monitoring stations in the “B” positions as depicted on Fixed Air Perimeter Air Monitoring Locations (Attachment B). Additional wetting of the soil on the access road into the cove and across Parcel C was completed to manage the dust from the equipment. Air monitoring results of the previous week, along with 2-weeks of planned upcoming work were posted to the notification board.
- ▶ The Time Weighted Average (TWA) dust monitoring concentrations measured at the four fixed stations on the perimeter, and hand held dust monitoring concentrations measures in the work areas were all below 0.150 mg/m<sup>3</sup> limit.
