**Re: Status Report: October 2015 Remedial Action Work Plan (RAWP) Activities**

Former Gorham Manufacturing Facility  
333 Adelaide Avenue, Providence, RI  
File No.: SR-28-0549D

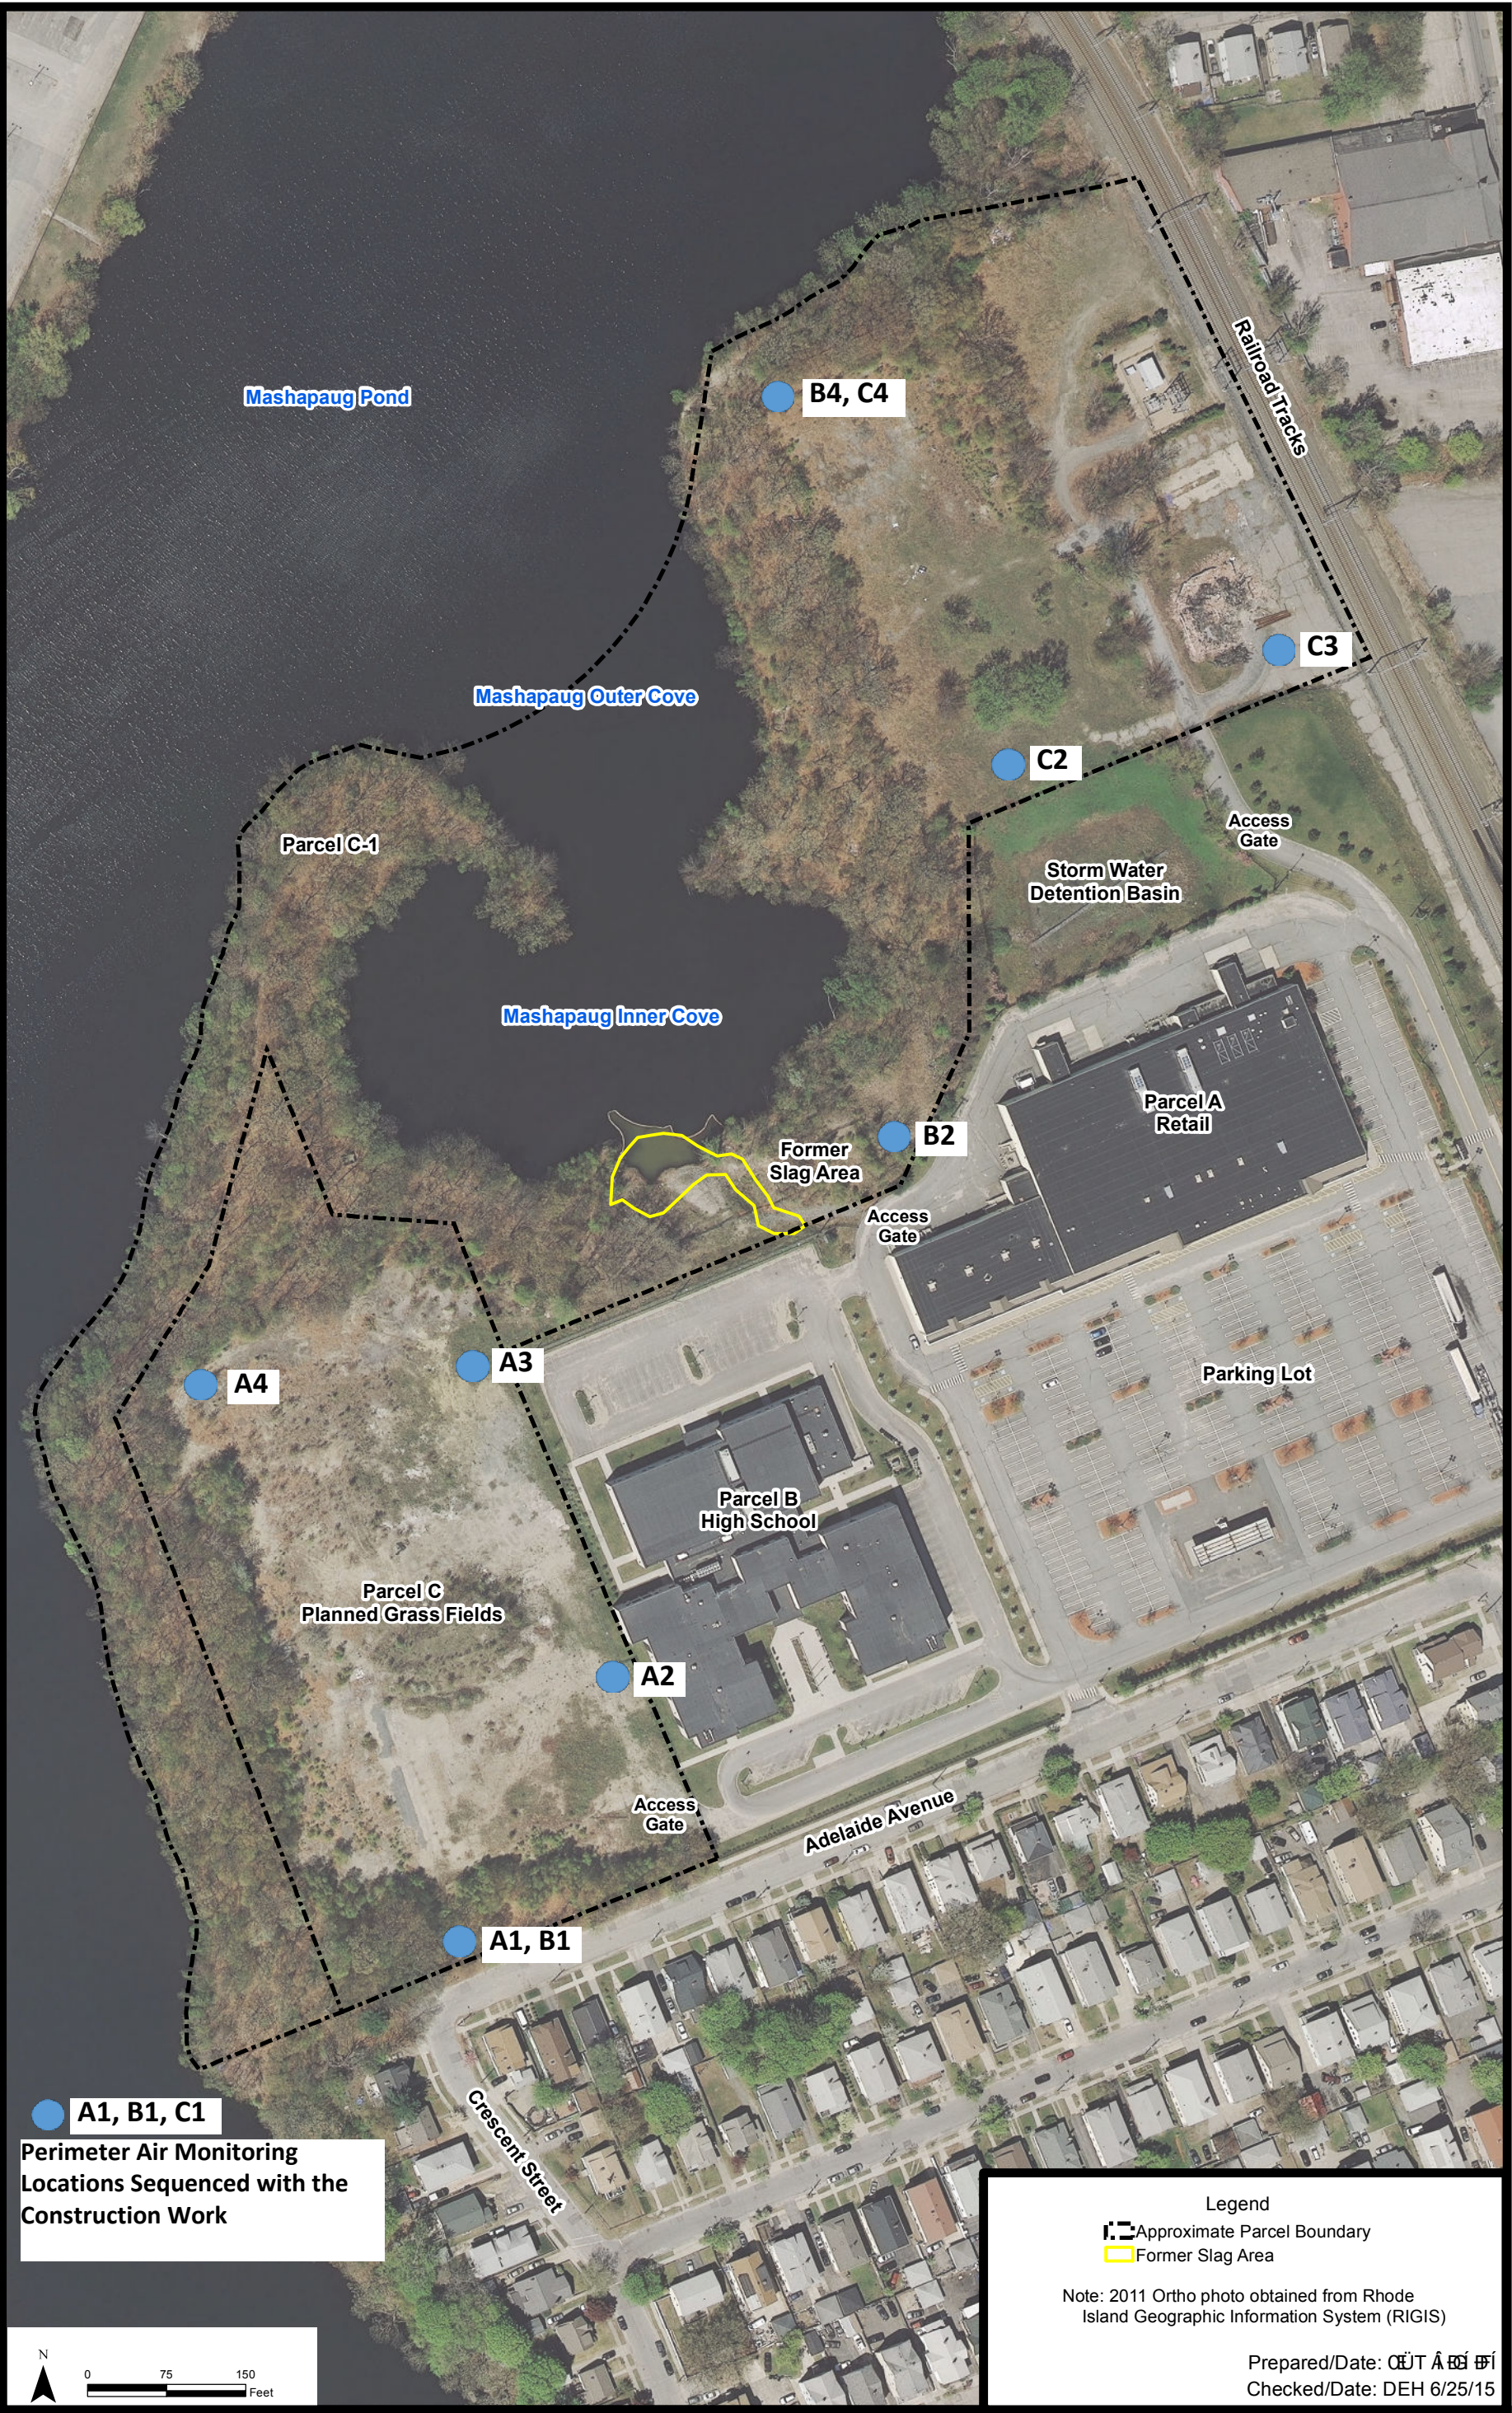
**Perimeter Air Monitoring Locations**  
 Project 3652-14-0032  
 Figure F

- ▶ Amec setup the four (4) perimeter air monitoring stations in the “B” positions as depicted on Fixed Air Perimeter Air Monitoring Locations (Attachment B). Additional wetting of the soil on the access road into the cove and across Parcel C was completed to manage the dust from the equipment. Air monitoring results of the previous week, along with 2-weeks of planned upcoming work were posted to the notification board.

- ▶ Following the 10/22/15 email to RIDEM, three (3) perimeter air monitoring stations were set up in the “C2-C4” positions depicted on the Fixed Perimeter Air Monitoring Locations Map at the completion of the Inner Cove restoration.

**● A1, B1, C1**  
**Perimeter Air Monitoring Locations Sequenced with the Construction Work**
