**Department of Environmental Management
Office of Waste Management**

FIELD INVESTIGATION REPORT

Facility Name: Portsmouth Town Dump
Date of Investigation: October 6, 2014
Facility Address: East Main Road, Portsmouth

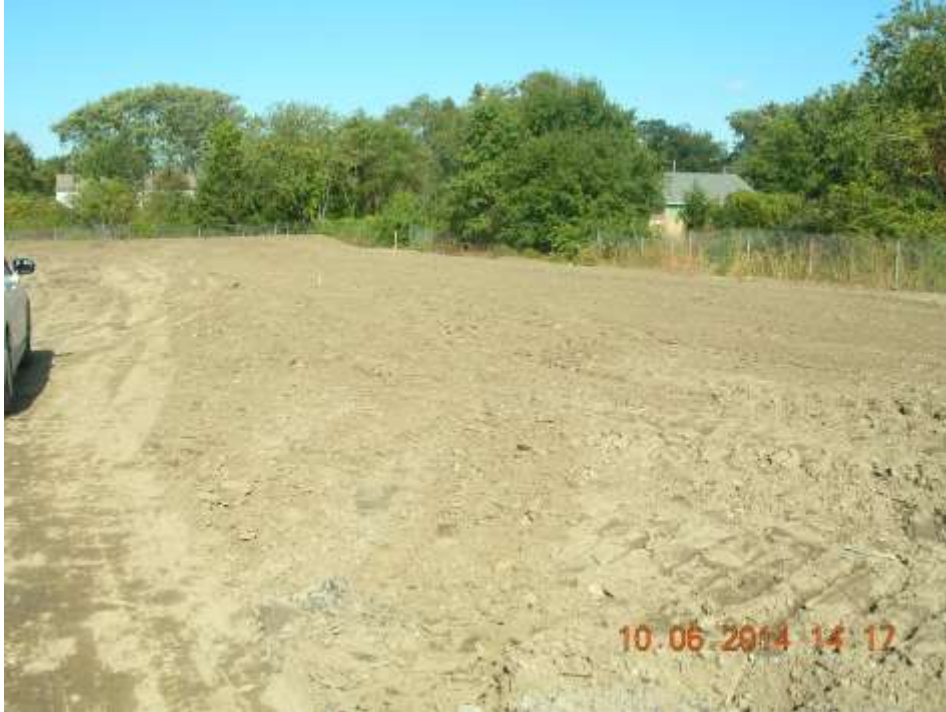
I arrived at the site at approximately 2:00 PM. Brian Oliveira was grading soils near the boundary with the Cardoza property that had been staked out. I asked if it was the final grade. He said no, it was subgrade material he received from a site in Newport and that later in the week, surveyors will come to stake out final grades and he will use stockpiled material for the 2 feet of cover. Dust control seemed to be effective.

Photo 1: Grading at property boundary.

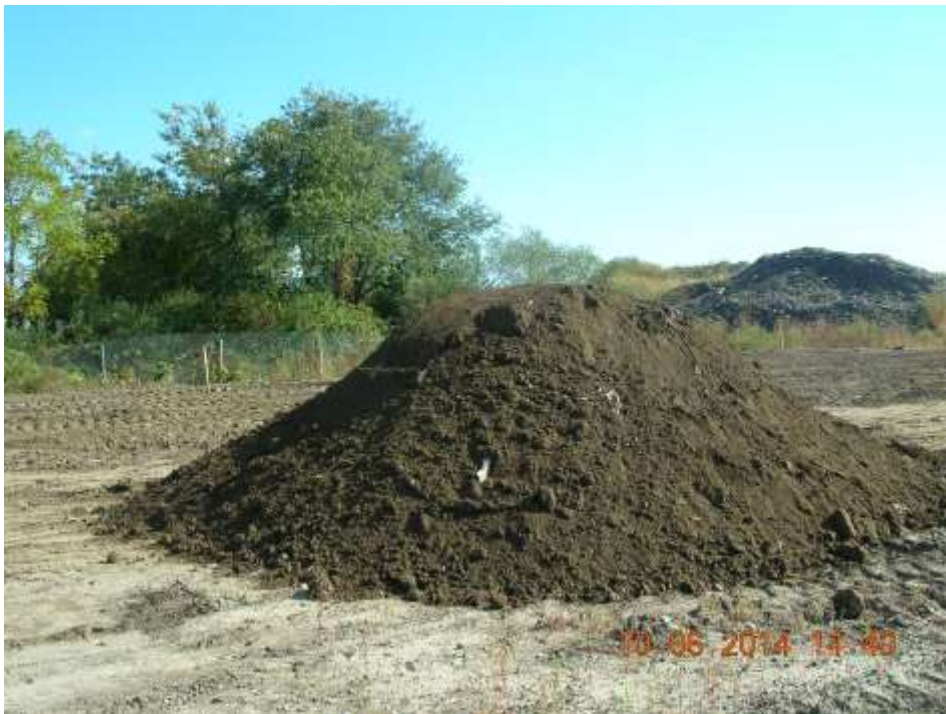
While I was there a truck came and dumped material. Documents in the vehicle show it came from 590 Bellevue Ave in Newport generated by SE Pacific LLC. It was a brown sandy loam with no odor. I took a grab sample directly from the pile (SS-12). I left the site at approximately 3:00 PM and delivered the samples to ESS Laboratories and asked they be analyzed for metals and SVOC's.

Photo 2: Pile from which SS-12 was taken.
