Re: *Short-Term Response Action Plan Closure Report*
MGP-Residuals Roadway Remediation
Former Tidewater Facility
Pawtucket, Rhode Island
RIDEM Case No. 95-022

FORMER TIDEWATER FACILITY			
PAWTUCKET, RHODE ISLAND			
SHORT-TERM RESPONSE ACTION PLAN CLOSURE REPORT MGP-RESIDUALS ROADWAY AND PARKING AREA			
PREPARED BY:

**Short-Term Response Action Plan Closure Report
MGP-Residuals Roadway Remediation
Former Tidewater Facility
Pawtucket, Rhode Island
RIDEM Case No. 95-022**

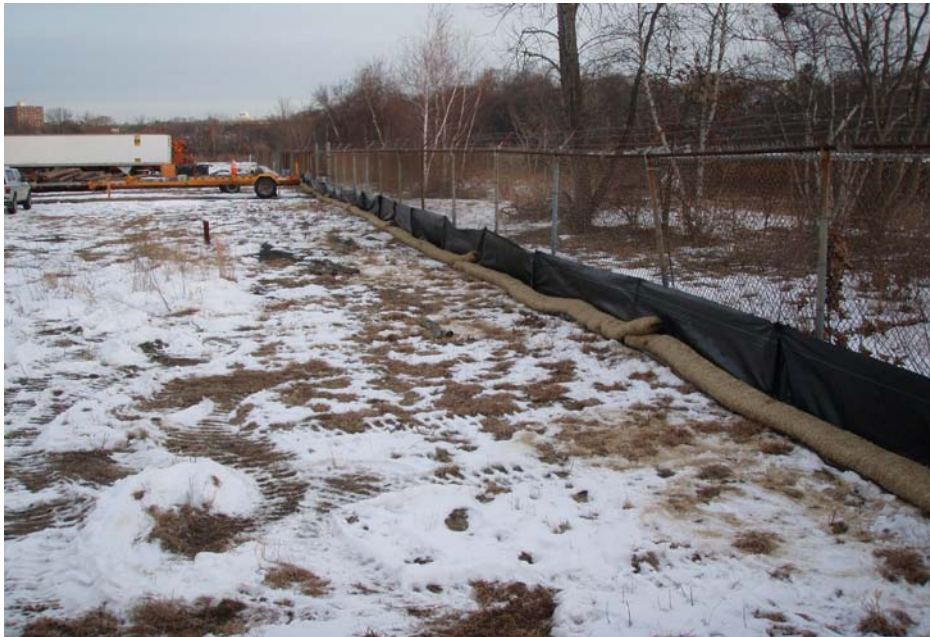
Photo No. 1 - Silt fence and hay bales installed down gradient of work area along fence adjacent to Seekonk River.

Prior to the start of excavation, erosion and sedimentation controls, consisting of hay bales and silt fence were installed along the fence line to the east of the work area, adjacent to the waterfront area, consistent with the January 2007 STRAP and CRMC Assent. Refer to Figure 2 for approximate location of the installed erosion controls.

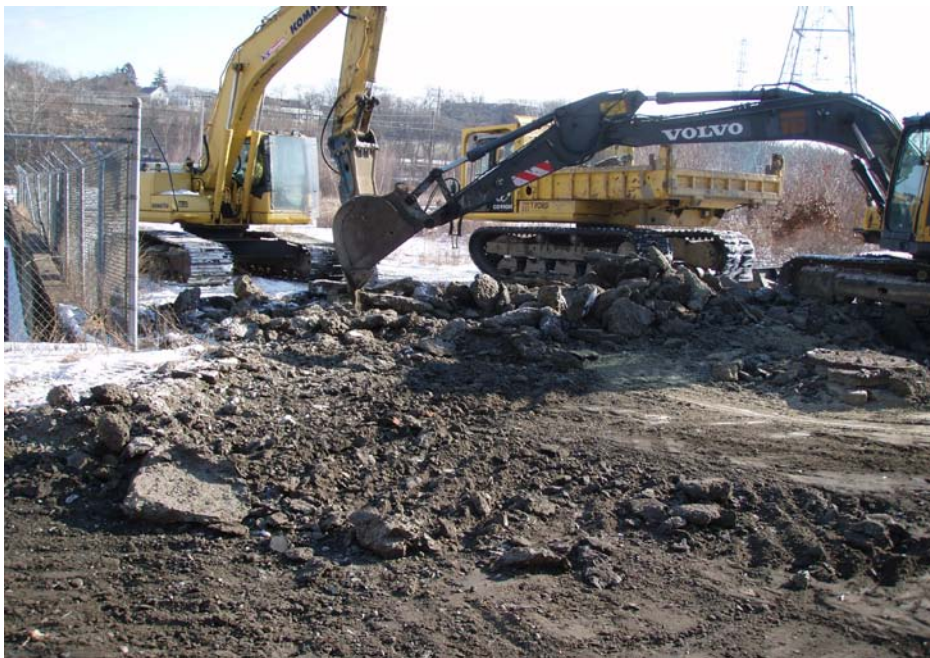
Photo No. 2 - T-Ford breaking up frost in roadway in western portion of work area (January 2010).

Due to the difficulties encountered in excavating the frozen roadway material to the appropriate depth, it was decided in January 2010 to suspend additional earthwork activities until the weather improved. The excavated area was lined with 20 mil polyethylene liner, and covered with an approximately 3-inch lift of bedding sand and an approximately 9-inch lift of processed material. Additional processed material was added to form a crown in the roadway to allow for proper runoff. All processed material was then

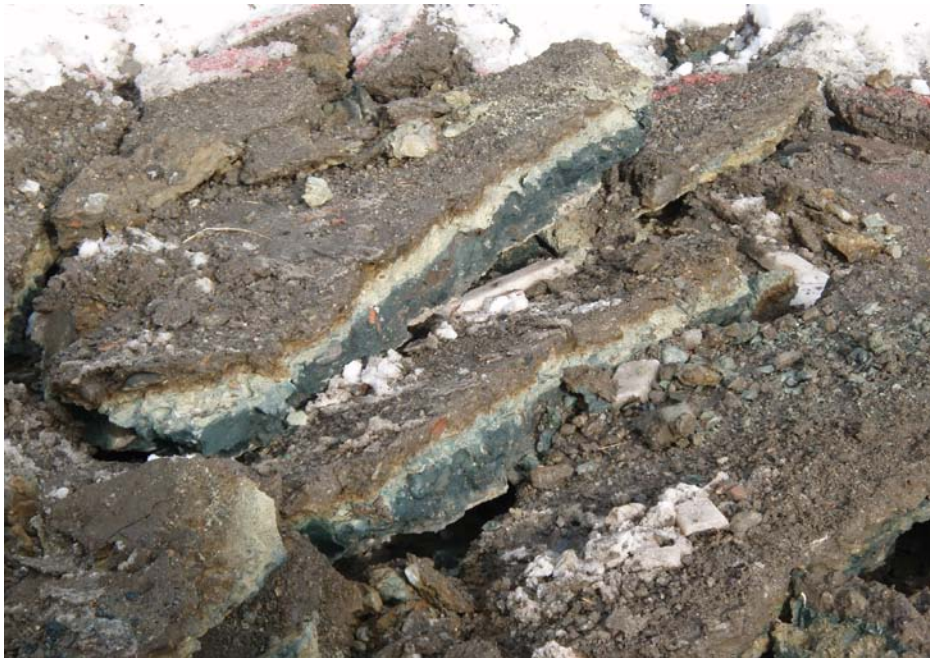
Photo No. 3 - Frost layer with blue-stained ash/organic like material encountered in January 2010.

- Partially frozen, blue stained ash/organic-like materials were disturbed and could not be used as backfill due to the winter conditions. These materials were stockpiled separately and subsequently disposed off-Site at ESMI.

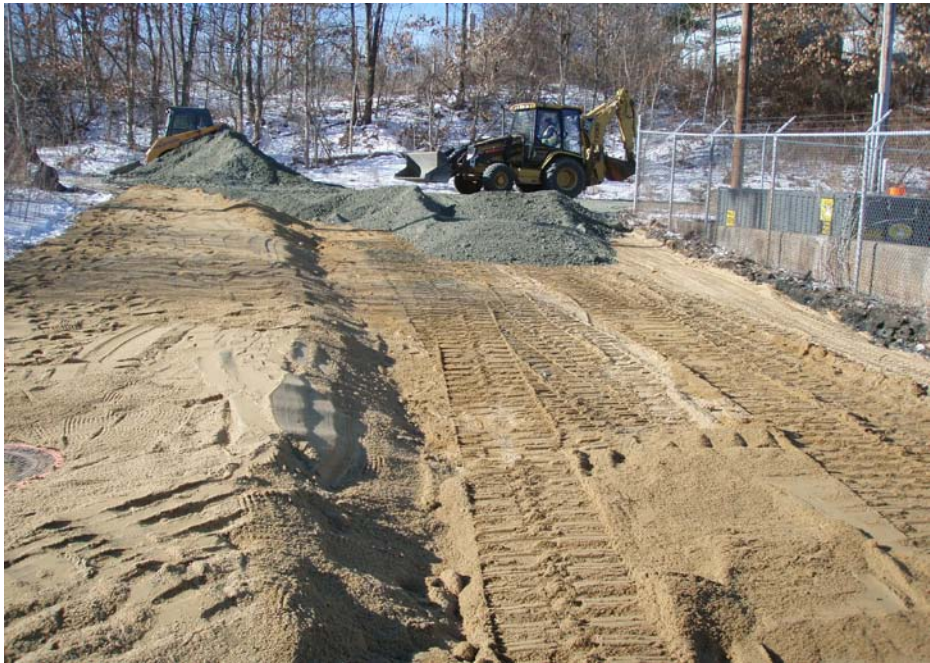
Photo No. 4 - T-Ford spreading out processed gravel layer above bedding sand (January 2010).

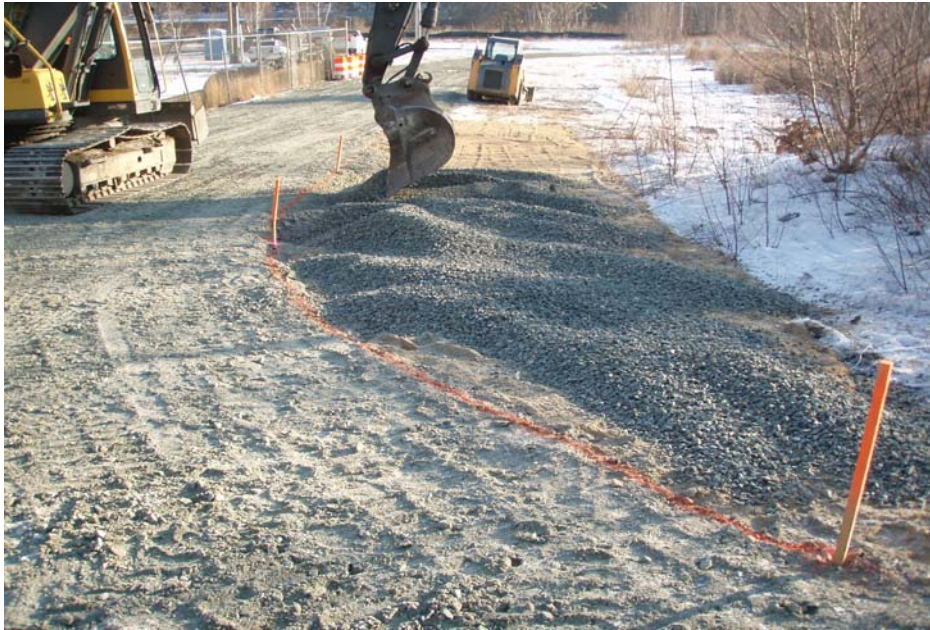
Photo No. 5 - T-Ford spreading lift of trap rock over the low lying area located on the southern side of the roadway (January 2010)

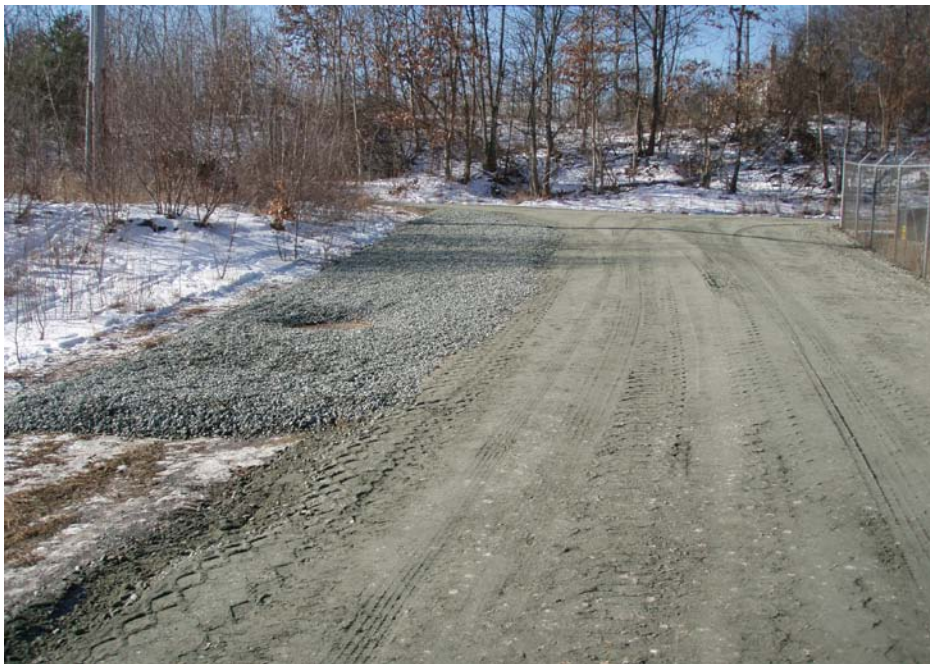
Photo No. 6 - Restored roadway and low lying cap area at completion of work in January 2010.

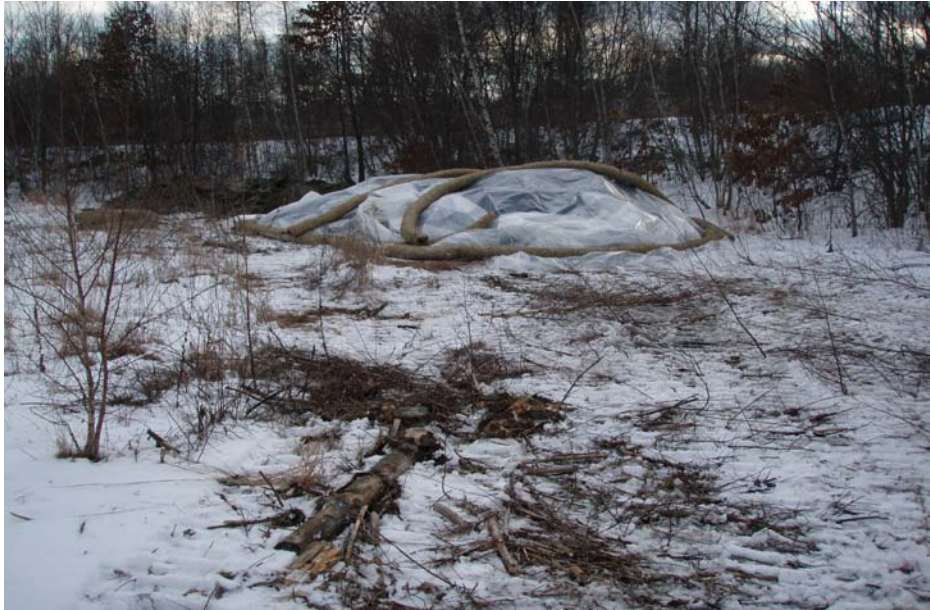
Photo No. 7 - Segregated stockpile of blue-stained material located in soil relocation area (January 2010). Material placed on and covered with polyethylene sheeting.

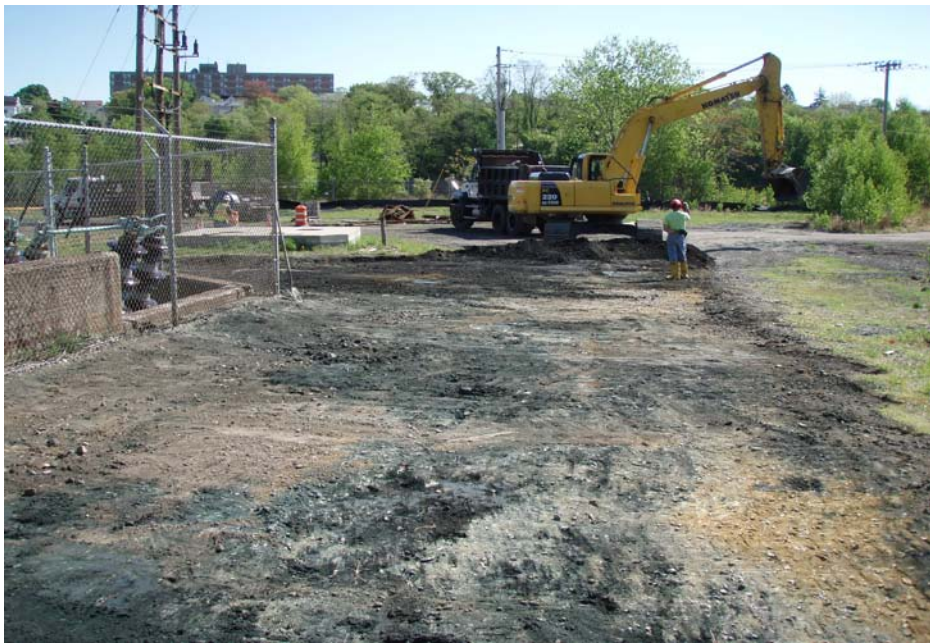
Photo No. 8 - T-Ford continues excavating roadway in May 2010. Blue stained ash-organic like material within 2 to 3 inches ground surface within roadway area.

With the exception of the limited areas where blue ash/organic material was encountered at depths of approximately 2 to 4-inches below grade, as depicted on Figure 2, excavation during the May 2010 Site work was extended down to approximately 1-foot below grade within the roadway and parking areas consistent with the January 2007 STRAP. The roadway cap was then installed as follows: placement of a 20 mil polyethylene liner, overlain with an approximate 3-inch thick lift of bedding sand and then an approximate 9-inch thick lift of processed material. In the area where only 2 to 4-inches of material excavated (Figure 2), the cap was modified to include the 20 mil polyethylene liner, an approximate 2-inch thick lift of bedding sand and an approximate 6-inch thick lift of processed material. Additional processed material was added to form a crown in the roadway to allow for proper runoff. All processed material was compacted using a vibratory compactor roller. In the low lying area to the south of the access road, a cap was placed over the existing surface soils consistent with the STRAP. This cap consisted of a 20 mil polyethylene liner, overlain with an approximately 3 inch lift of bedding sand and an approximately 3 inch lift of trap rock.

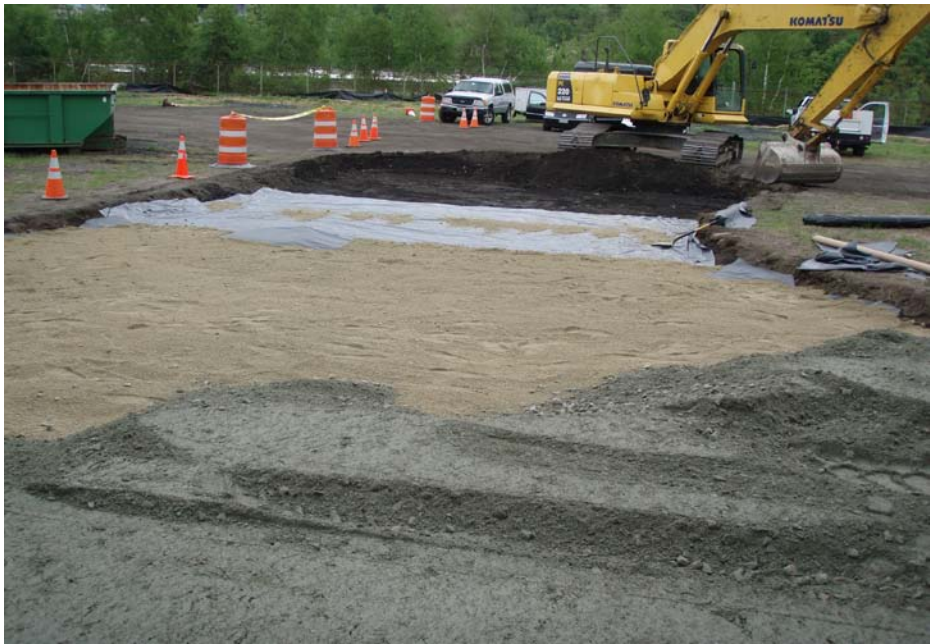
Photo No. 9 - T-Ford placing poly liner, bedding sand and processed material within eastern portion of work area in May 2010.

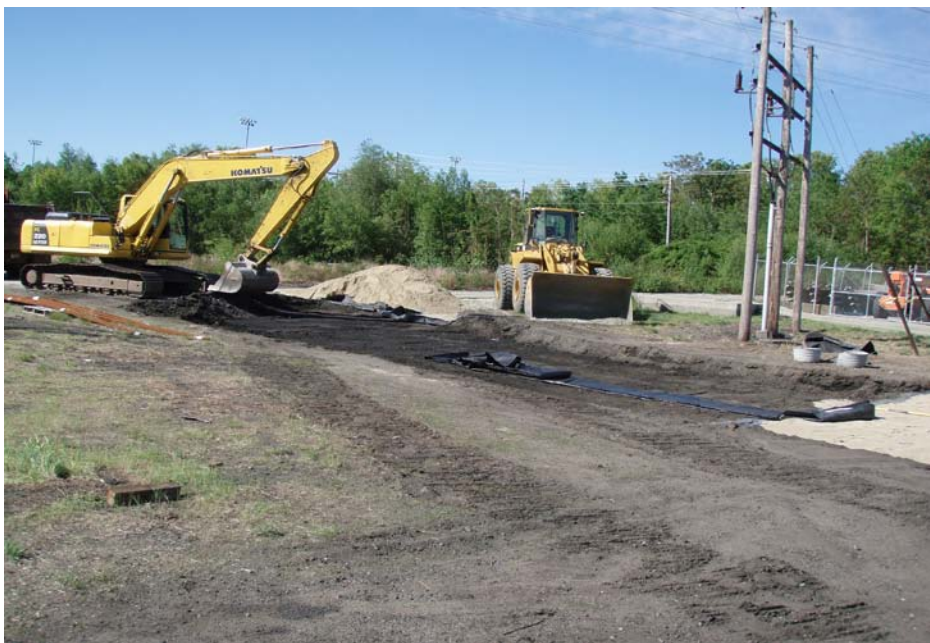
Photo No. 10 - T-Ford excavating roadway/parking areas in May 2010.

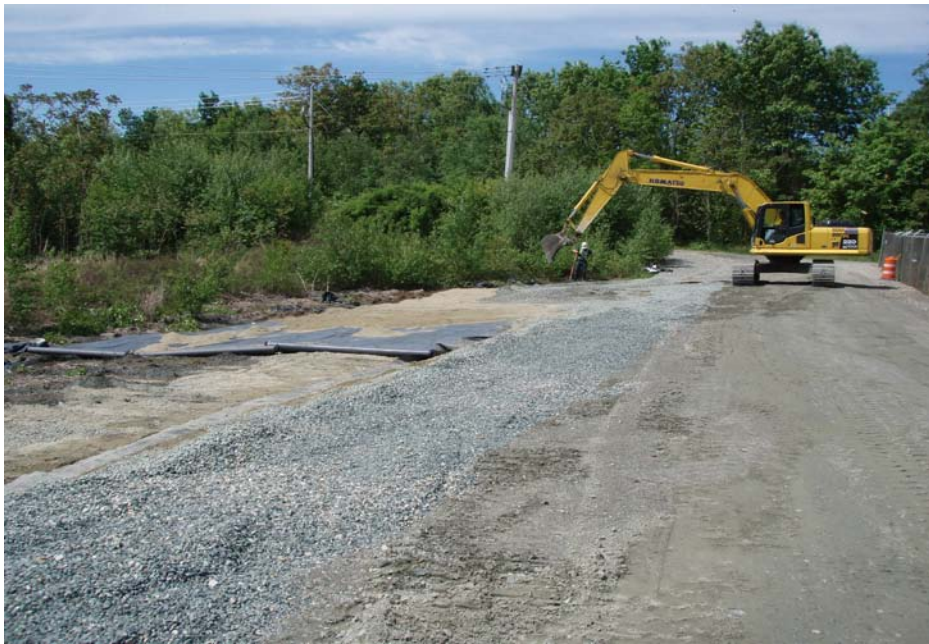
Photo No. 11 - T-Ford extending low lying area cap south and east of original work limits (May 2010).

During the May 2010 Site activities, it was noted that certain limited areas of the adjacent low lying area located to the south and east of the original STRAP work limits contained blue-stained surface soils. Based on these observations, the cap over the existing low lying area adjacent to the roadway was extended approximately 50 feet east and 20 feet south for a length approximately 150 feet along the roadway beyond what was originally proposed in January 2007 STRAP. This area of additional capping was installed consistent with the other capped areas. GZA verbally notified Mr. Thomas Medeiros of CRMC regarding this modification as the additional capped area is located within the 200 foot CRMC jurisdictional limit. Based on this communication, the modification was acceptable to CRMC. Mr. Medeiros requested a brief description and sketch showing the additional cap areas for CRMC files, which was emailed to his attention on April 30, 2010.

- The low lying cap located south of the roadway was extended approximately 50 feet east and 20 feet south for approximately 150 feet along the roadway to cover an additional approximate 4,550 square feet of observed blue stained materials.

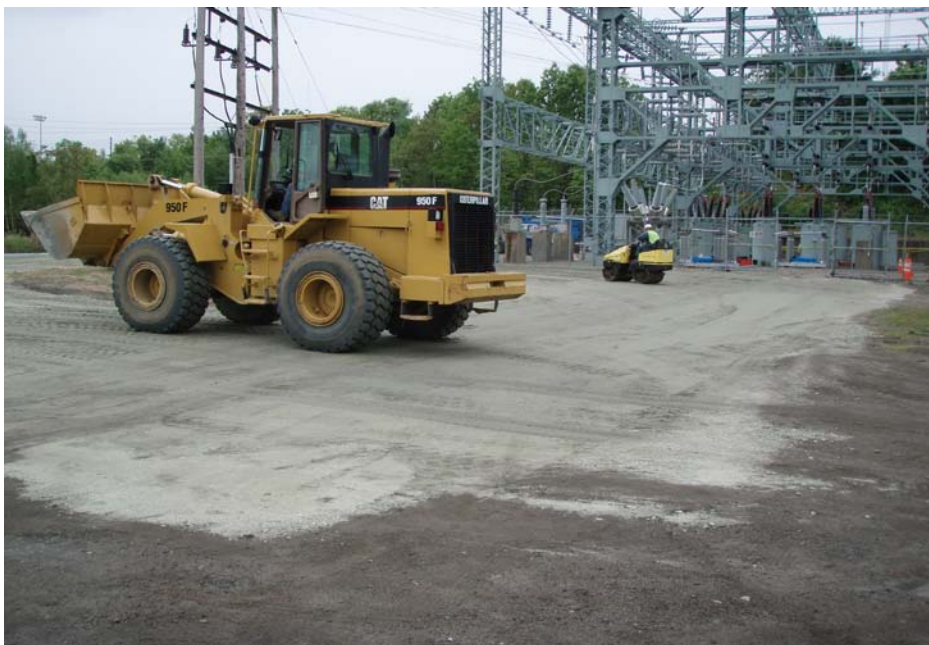
Photo No. 12 - T-Ford grading and compacting roadway (May 2010).

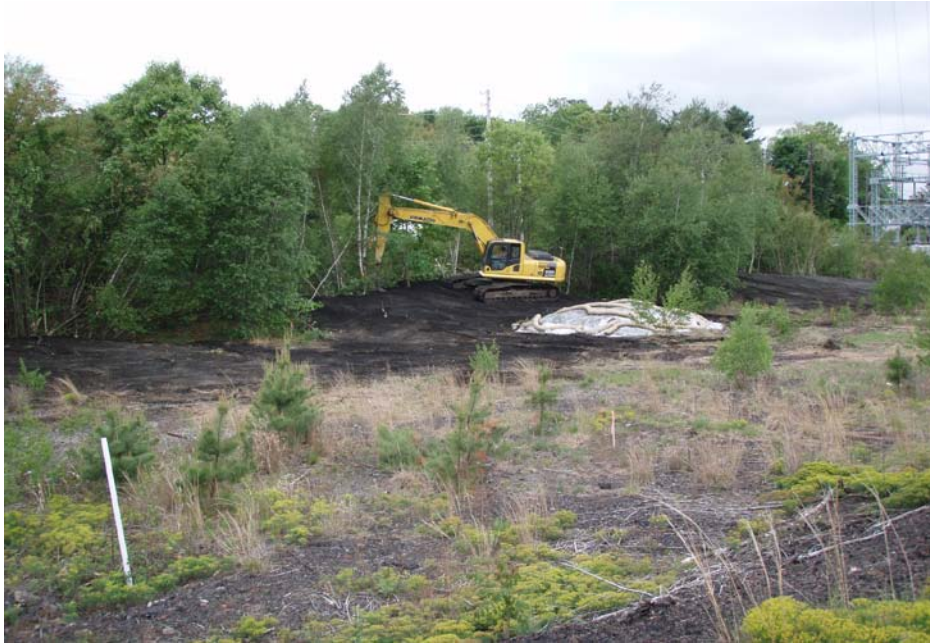
Photo No. 13 - T-Ford regrading excavated roadway and parking area material within relocation area (May 2010). Blue-stained material stockpile from January 2010 work is located in the foreground.

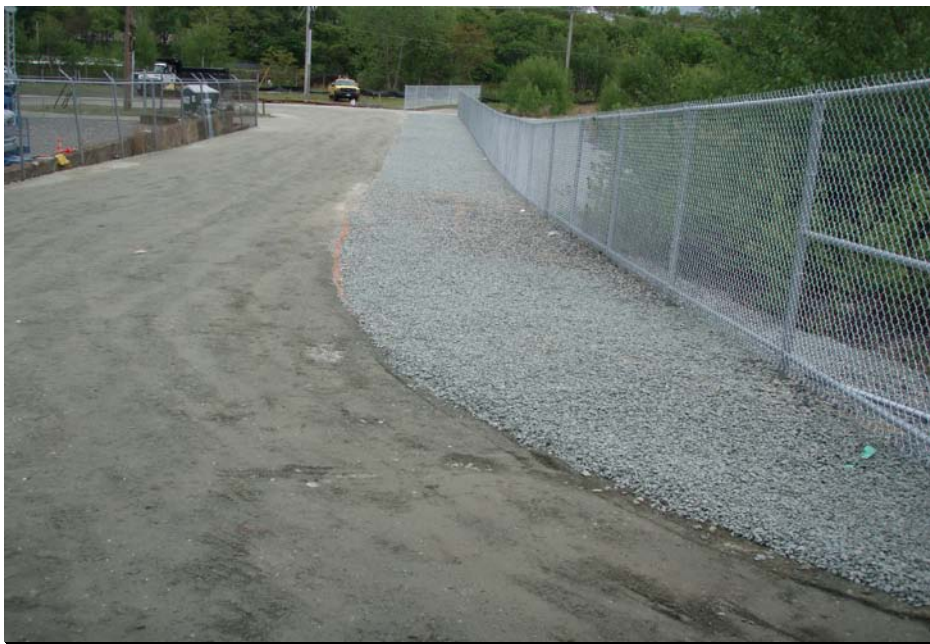
Photo No. 14 - Finished roadway and low lying area cap with fence.

Following completion of the earthwork activities, a 6-foot high chain-link fence, with gates, was installed parallel to the roadway and restored cap areas. The fence extends for approximately 350 feet from the south western corner of the roadway cap to the existing fence that is parallel to the Seekonk River, as depicted on Figure 2.

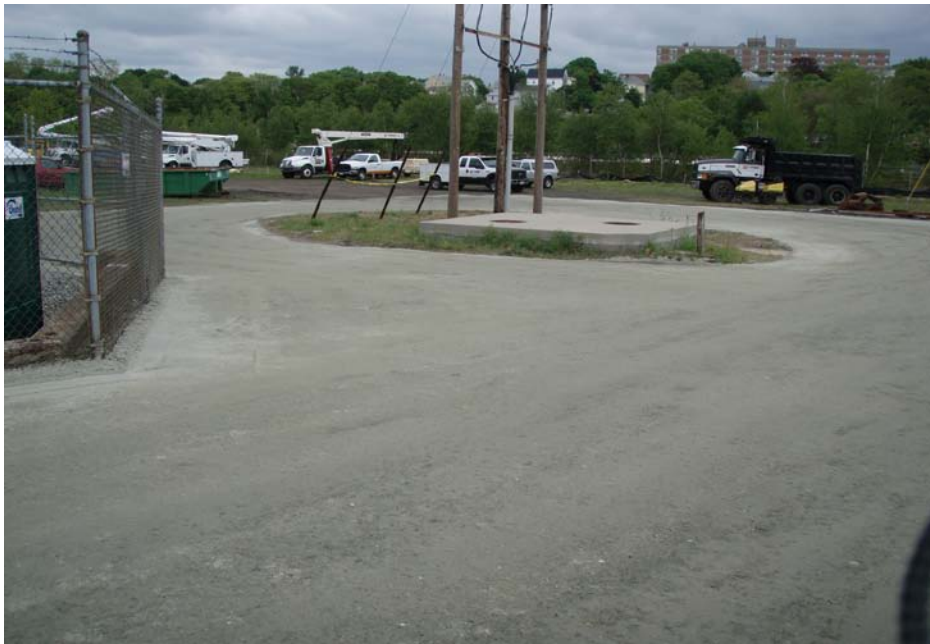
Photo No. 15 - Finished roadway and parking area cap.

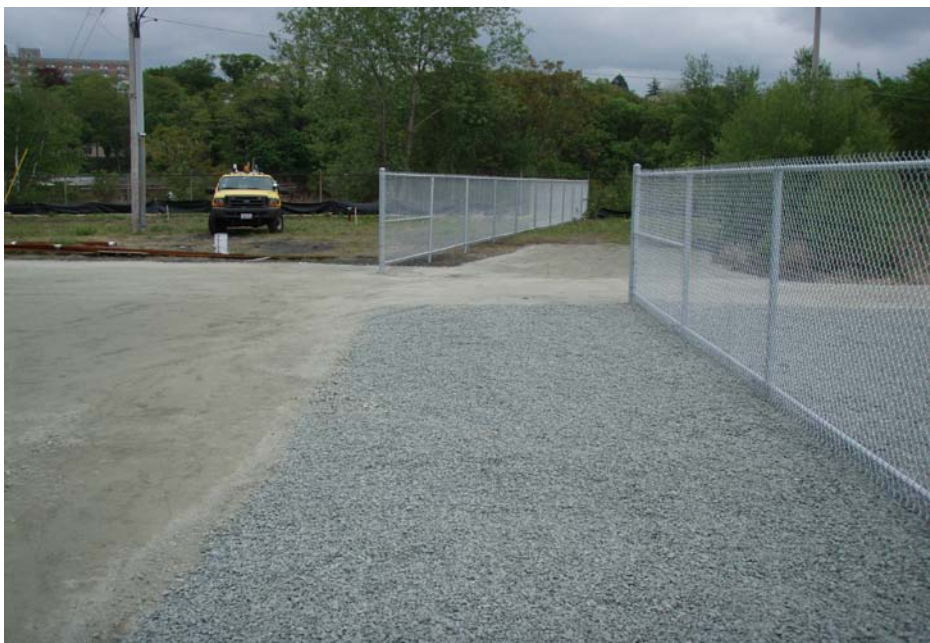
Photo No. 16 - Finished roadway and low lying area cap and fence.

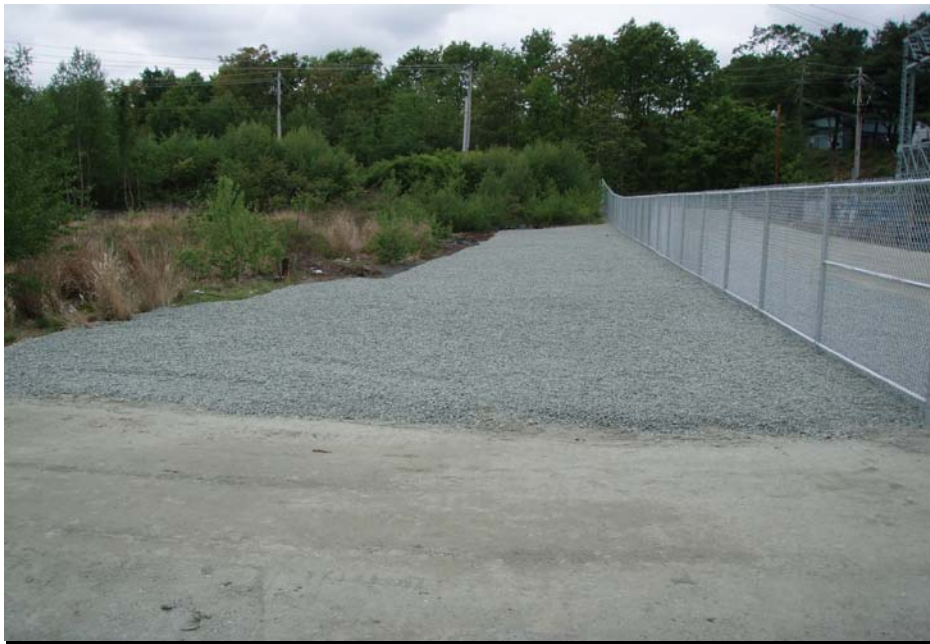
Photo No. 17 - Finished extended low lying area cap.
