Cutler Brook

Watershed Description

Assessment Unit Facts (RI0002007R-02)

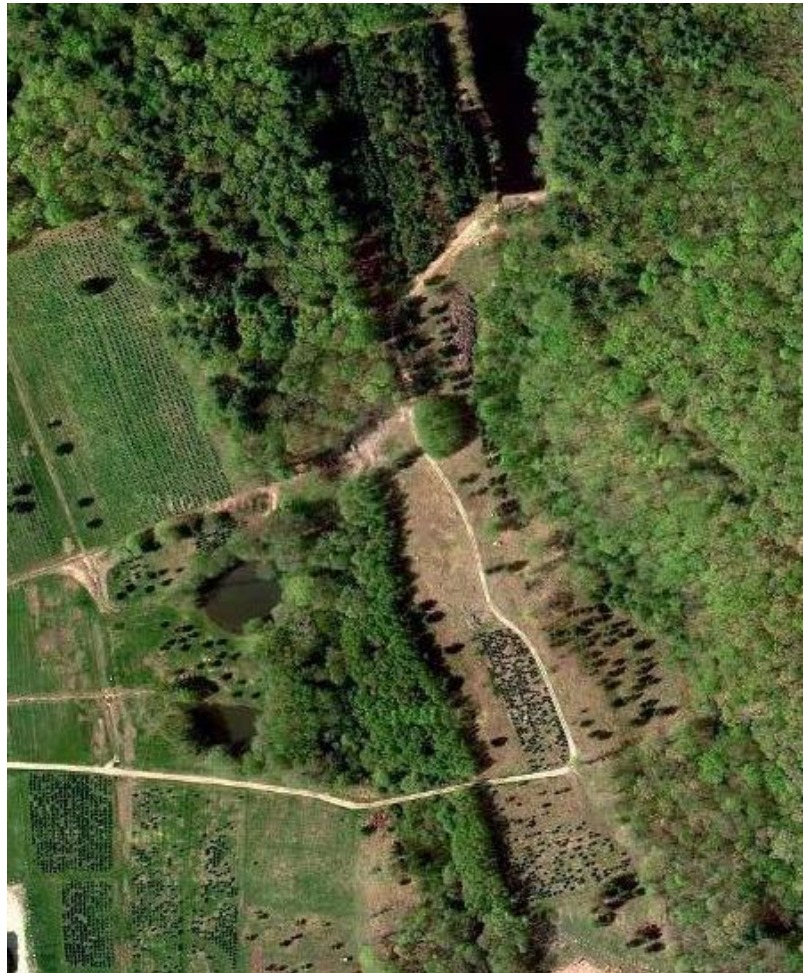
Figure 3: Partial aerial view of the Cutler Brook watershed (Source: Google Maps)

The Cutler Brook watershed covers 1.2 square miles. As shown in the aerial image of Figure 3, non-developed lands occupy a large portion (77%) of the watershed. Developed uses (including residential and commercial uses) cover 14% of the land area. Impervious surfaces cover 5.4% of the land within the watershed. Wetland and surface waters occupy 2%, and 7% of the lands within the watershed are used for agriculture.
