# Updates to the Rhode Island Statewide Total Maximum Daily Load (TMDL) for Bacteria Impaired Waters

**Final Report  
September 2023**

**RHODE ISLAND DEPARTMENT OF ENVIRONMENTAL MANAGEMENT  
OFFICE OF WATER RESOURCES  
235 PROMENADE STREET  
PROVIDENCE, RI 02908**

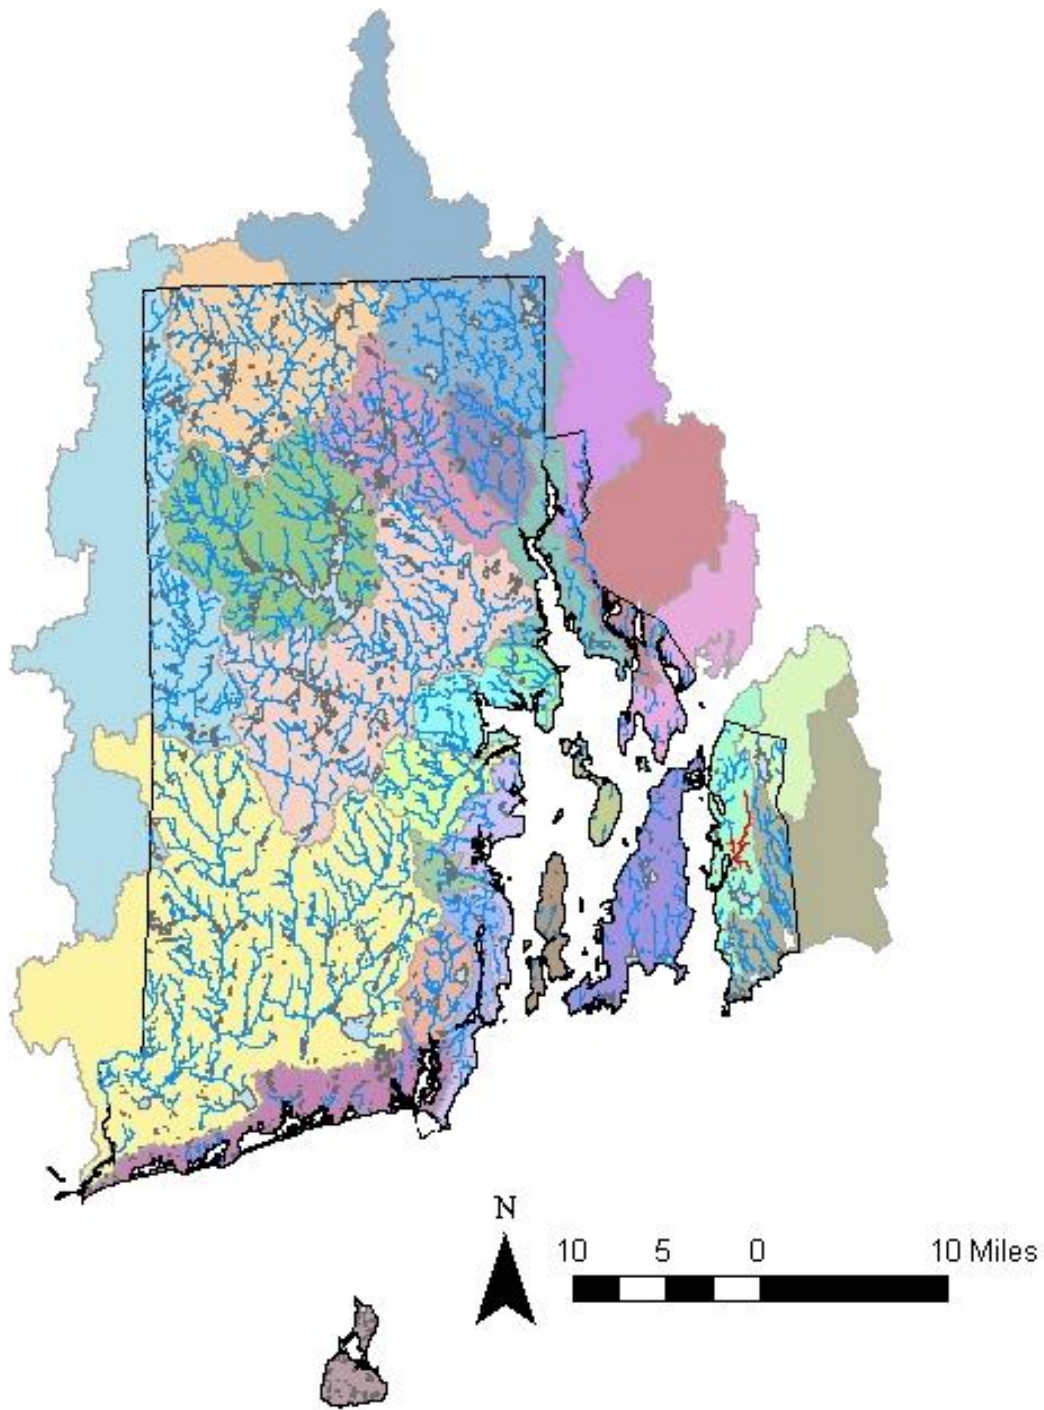
**Figure 1. Rhode Island Watershed Planning Areas with Bacteria Impaired Waters Addressed in this TMDL in Red**

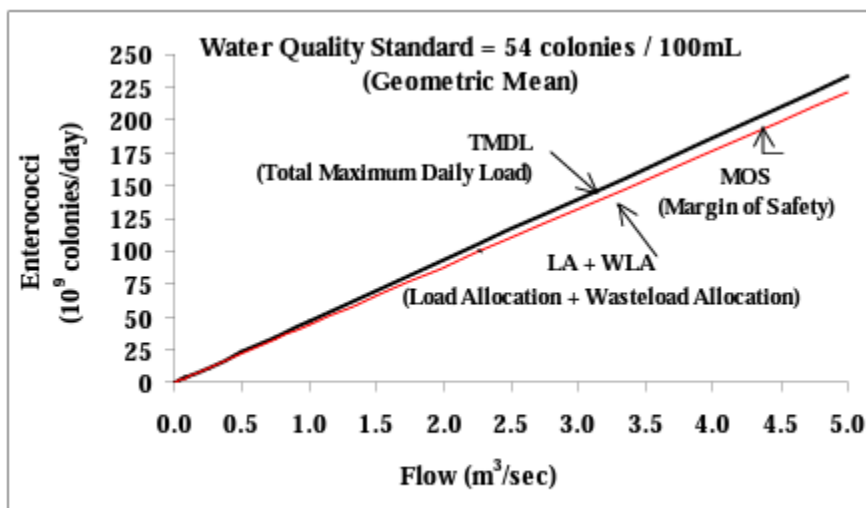
**Figure 1: Enterococci Freshwater Rivers and Streams Daily Loads**

Additionally, in the Statewide Bacteria Core Document, Appendix M provides a means to express the concentration targets as daily loads. Figure 1 and Table 1 from Appendix M (reproduced below) provide a general cross-walk for flows between 0.0 and 5.0 m<sup>3</sup>/sec. For flows >5 m<sup>3</sup>/sec Formula 1 (reproduced below on next page) can be used. Full details are documented in Appendix M<sup>3</sup>.
