INLET SUMMARY SHEET

INLET: Duck Cove (#22)

22 - DUCK COVE

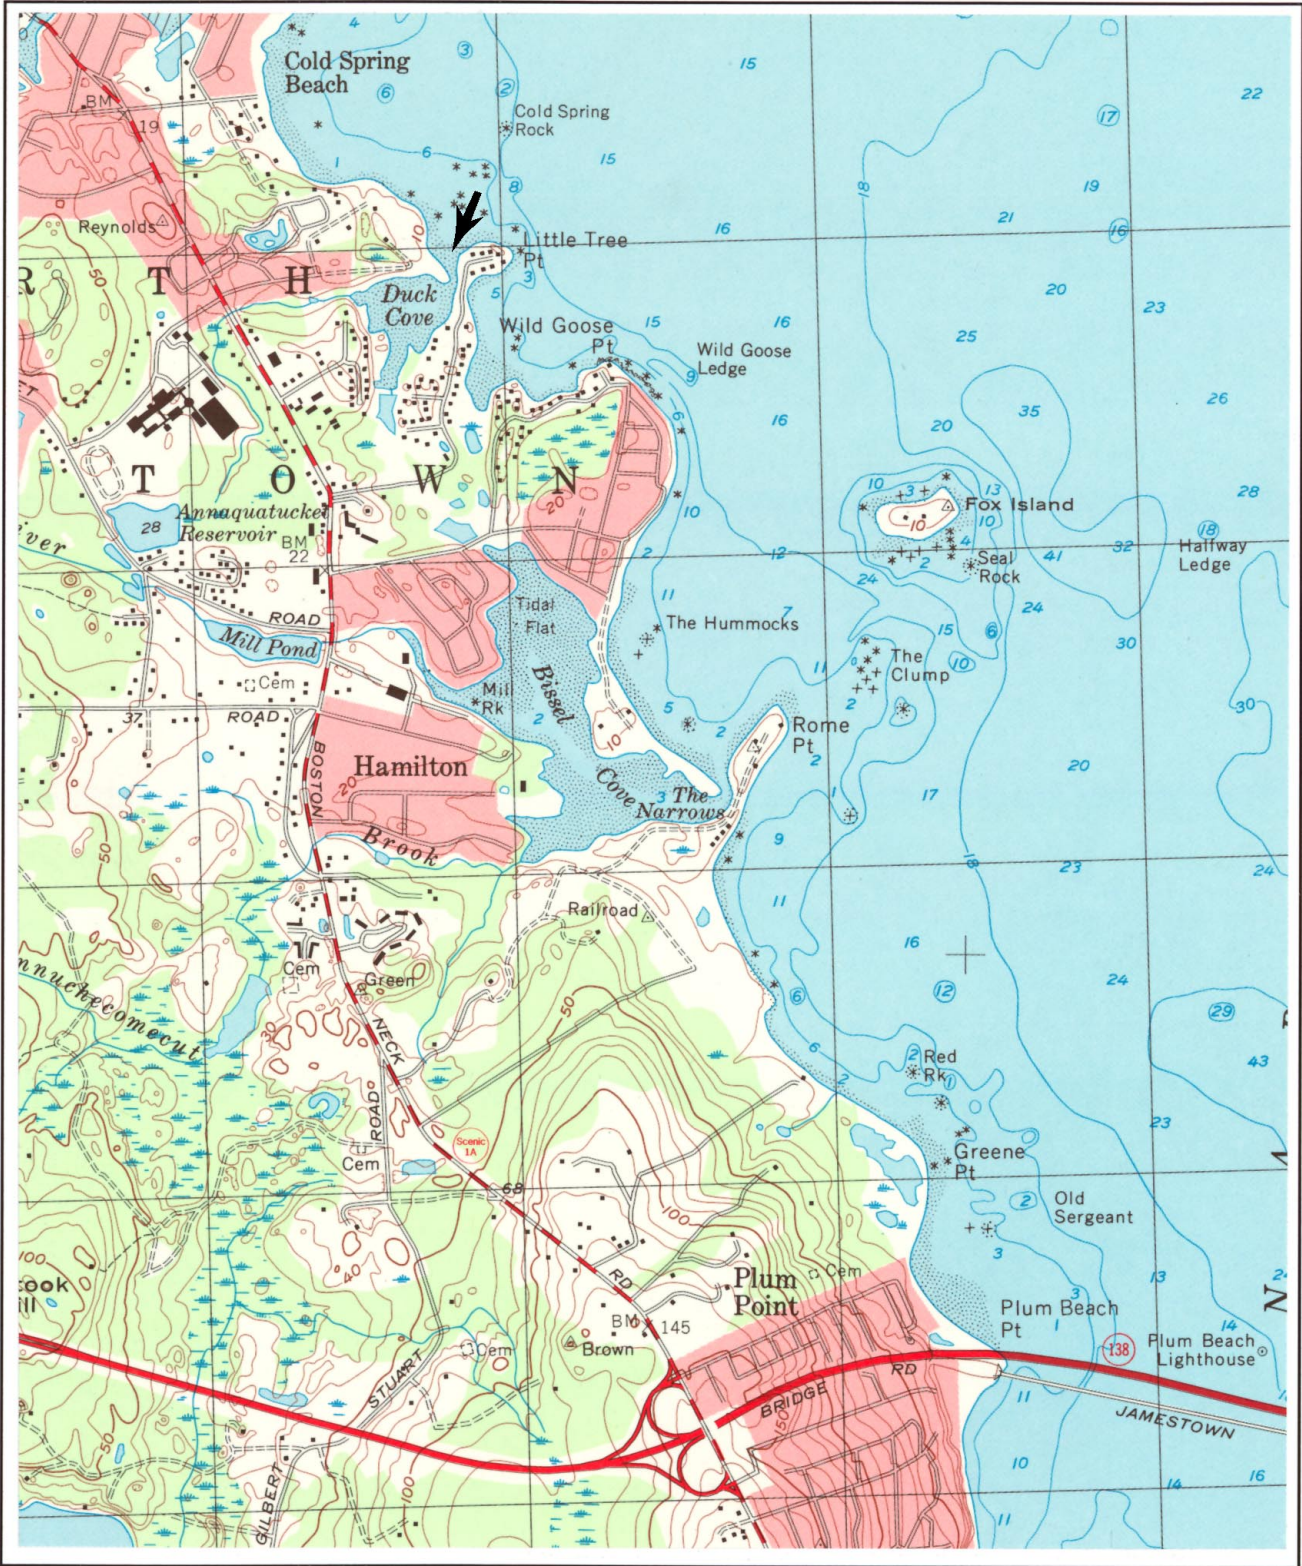
From USGS 7.5' topographic quad: Wickford, Rhode Island, published: 1995

SCALE 1 : 24,000

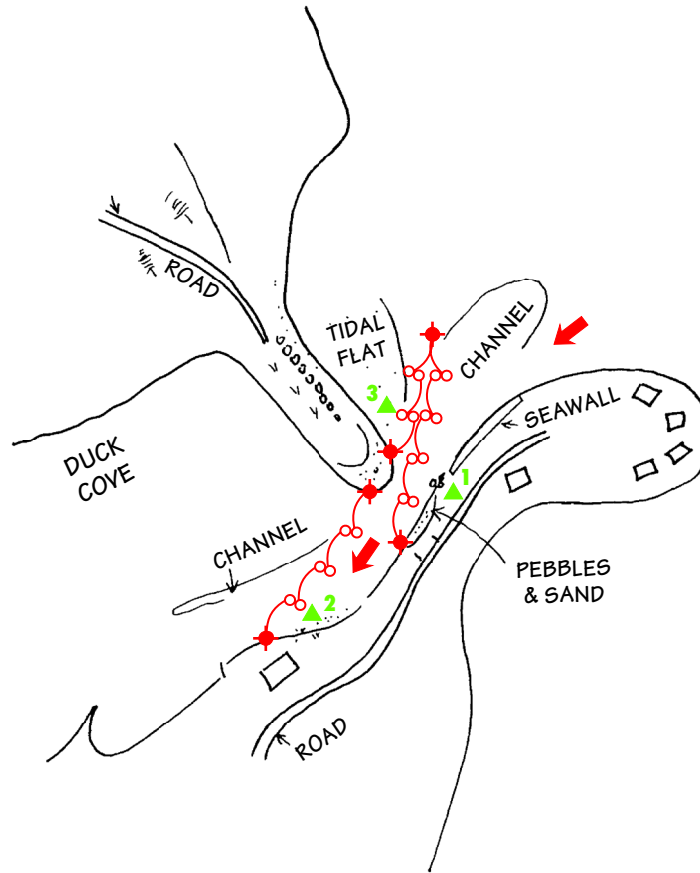
INLET SKETCH MAP

GEOMORPHOLOGY: Small "half inlet" created by sand and gravel spit building to the southeast, forcing the inlet channel against a neck of land. Tidal deltas not well developed.

POTENTIAL PROTECTION STRATEGY (FLOOD TIDE)

PRELIMINARY PROTECTION STRATEGY: Objective is to trap the majority of the incoming oil before it enters the principal body of Duck Cove. CP-1 to CP-3 are shore-based Collection Points. CP-1 and CP-2 are located on the southern side of the inlet and CP-3 on the northern side.

From an anchor point north of the mouth of the inlet, deploy deflection boom in a Christmas tree configuration, with one line of boom in a SSW orientation to a point on the spit (CP-3), and another to an anchor point (CP-1) on the southern side of the inlet entrance. From an anchor point at the SW side of the spit, deploy deflection boom in a SW direction to an anchor point (CP-2) on the southern side of the inlet at a bank composed of sand and gravel.

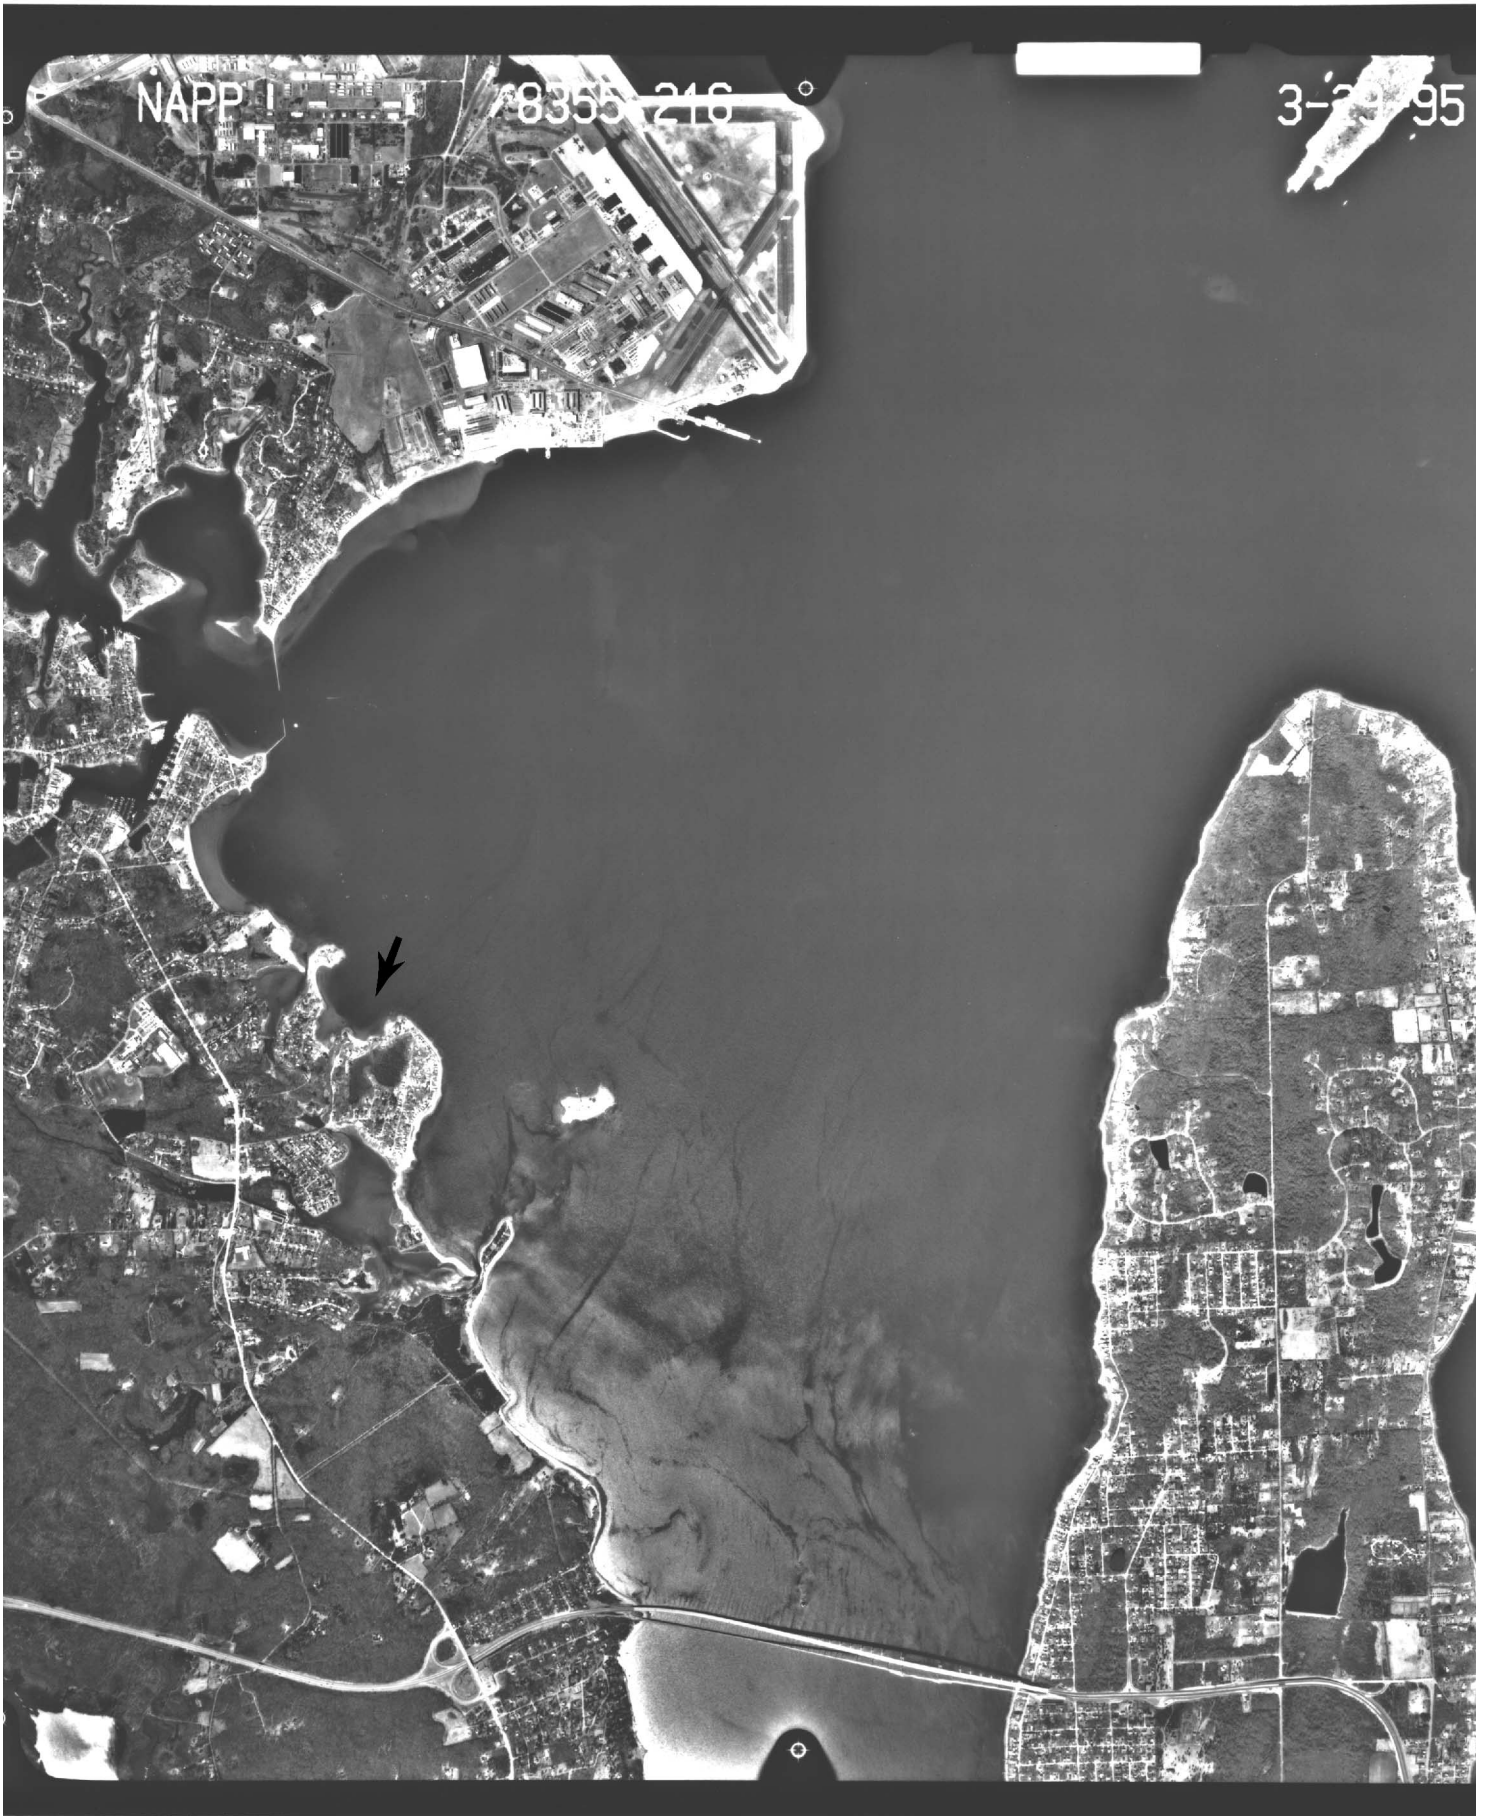
22 - DUCK COVE

From USGS NAPP: roll #8355, frame #216; March 1995; scale -1:40,000
166

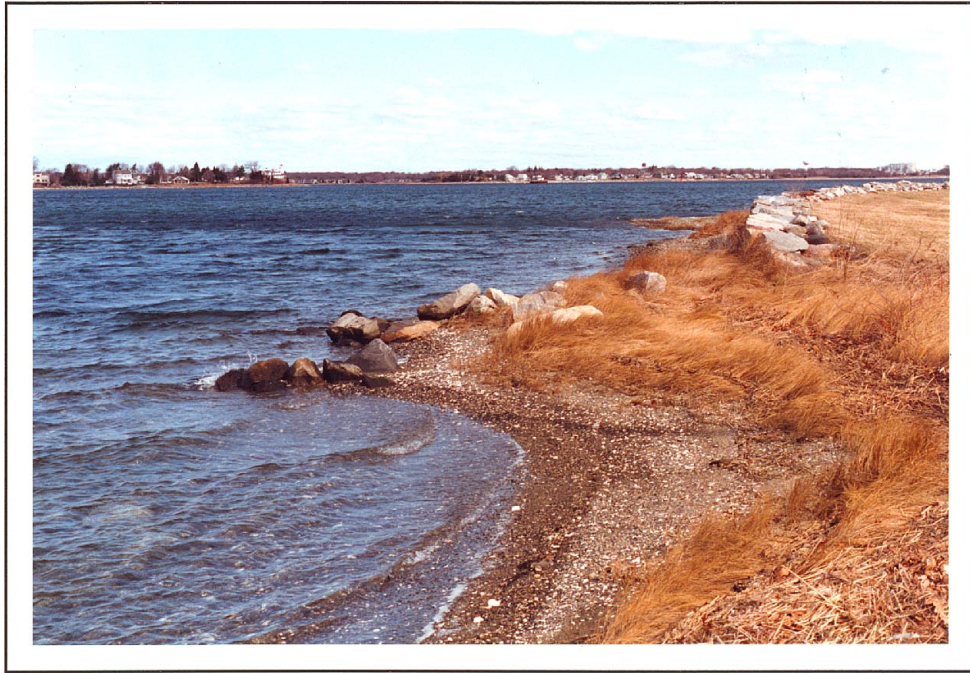
Looking north at CP-1 at high tide on 19 March 1999, Duck Cove (#22).

Collection Point	Description	Access	Proposed Equipment
CP-1	Mixed sand and gravel beach (mostly sand)	From Hwy. 1A (Boston Neck Rd.) south of Wickford, turn east on Earle Rd. to access point.	Approx. 250 ft. deflection boom, 3 sets of anchors.
CP-2	Bank with mixed sand and gravel	Same as CP-1.	Approx. 200 ft. deflection boom, 2 sets of anchors.
CP-3	Mixed sand and gravel beach (mostly sand)	From Hwy. 1A (Boston Neck Rd.) south of Wickford, turn east to access north part of Duck Cove.	Approx. 150 ft. deflection boom, 2 sets of anchors.

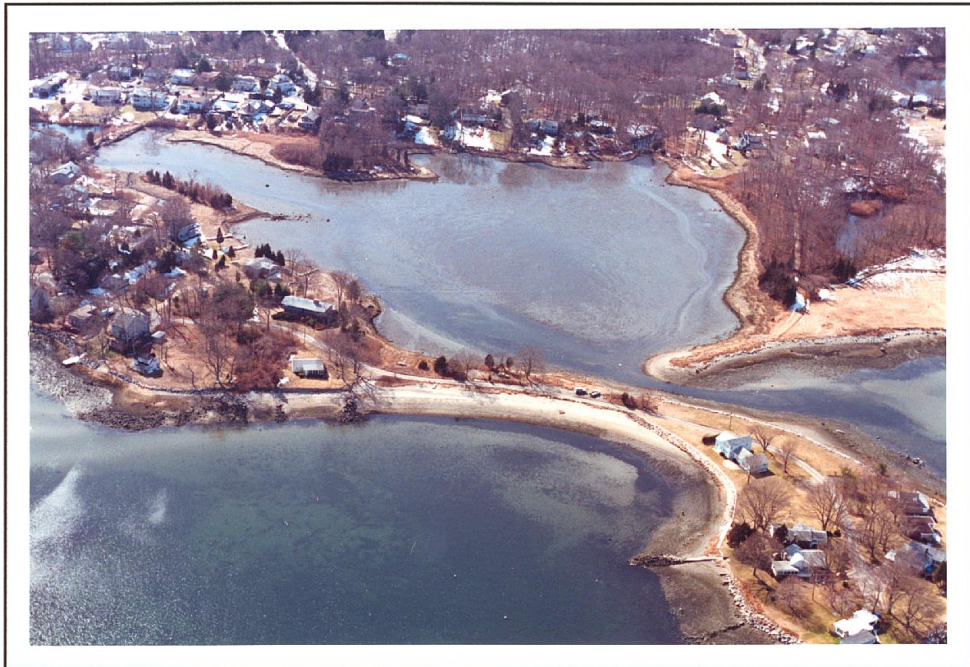
Looking west at low tide on 17 March 1999, Duck Cove (#22).
