*Former Manufactured Gas Plant
642 Allens Avenue- Area 1*

Providence,
Rhode Island

Prepared for: New England Gas Company

December 2002

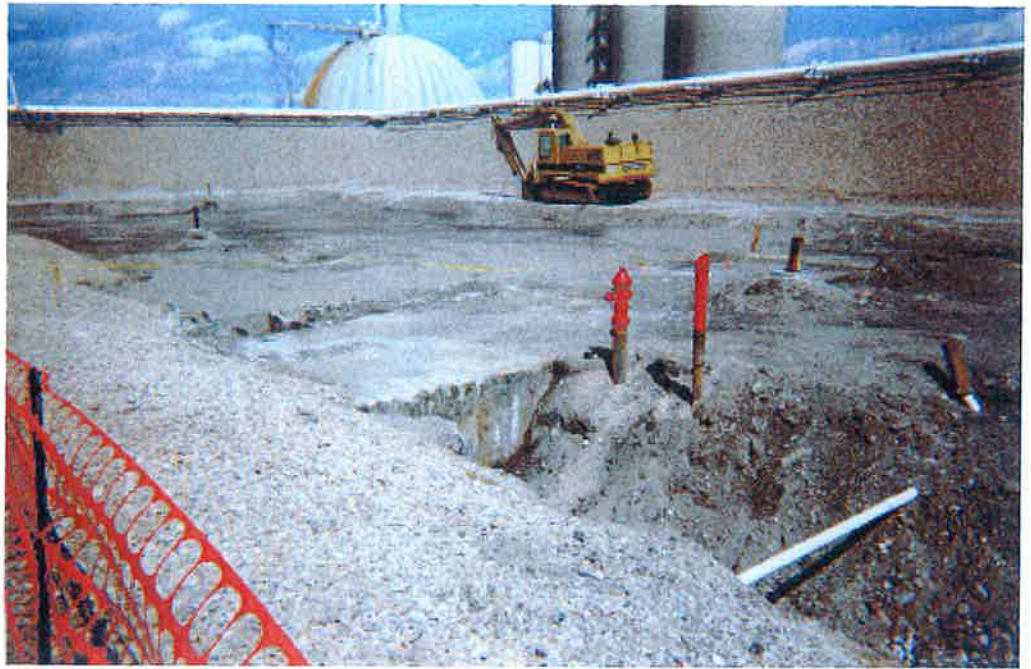
View of concrete pad looking southeast.

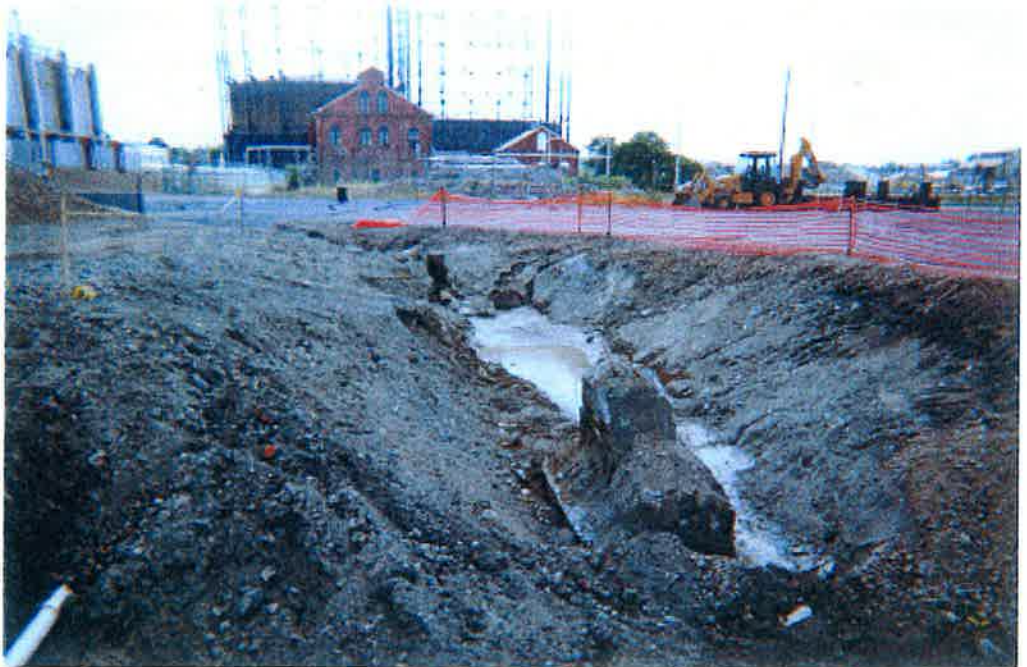
View of pipe trench excavation looking westerly.

A trench was excavated in an east/west orientation to approximately 8 feet BSG to uncover and remove the entire pipe lengths. This excavation connected the northern limits of the western and eastern trenches. It is presumed that the pipe removal was completed per the procedures outlined in the piping removal protocol (see Appendix B). Although there were no descriptions of the conditions of the removed piping, the laboratory analytical results of confirmatory samples collected beneath the pipe runs indicated that there was no release of MGI materials from the pipes.

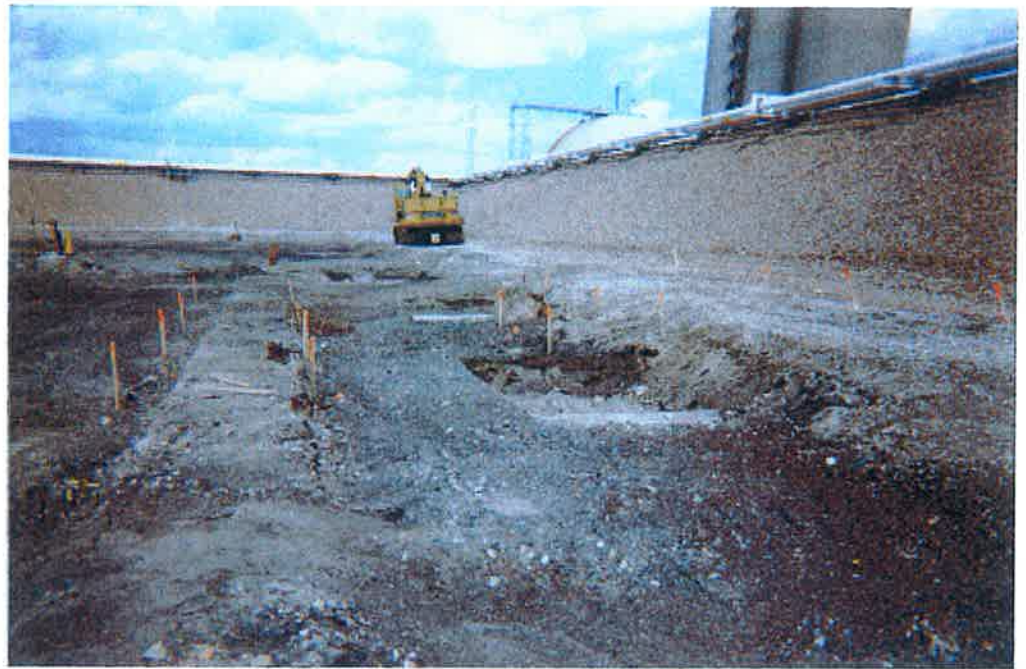
View of southeast corner of SALNG excavation.

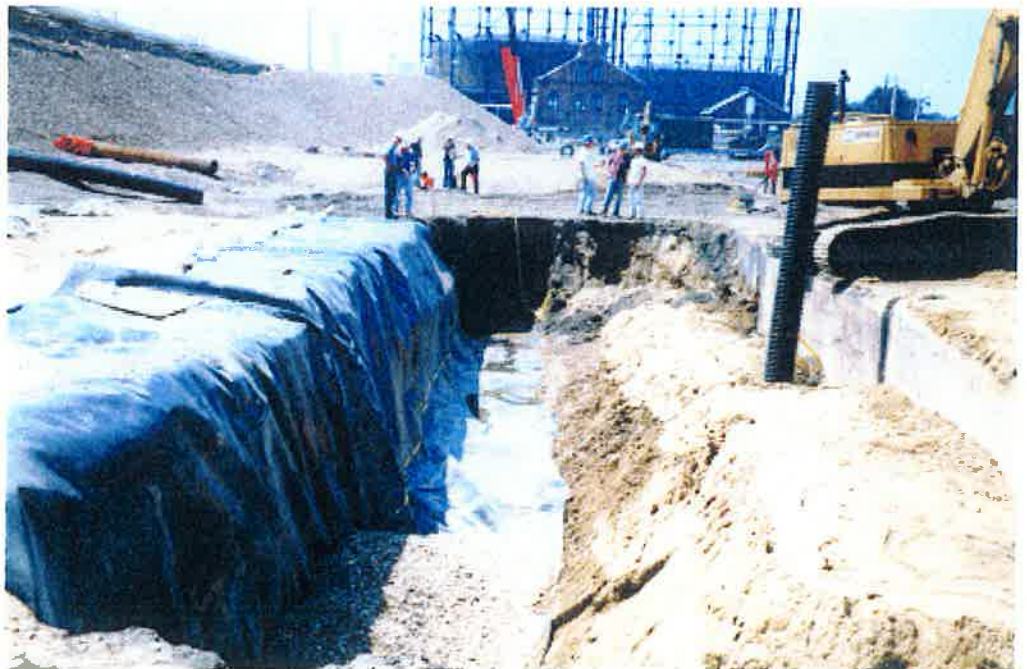
Backfill operations in SALNG Area looking westerly.

Upon completion of soil removal activities, subsurface excavations were backfilled with clean sand and a crushed stone finish. Current site-wide soil caps are depicted in Figure 3.

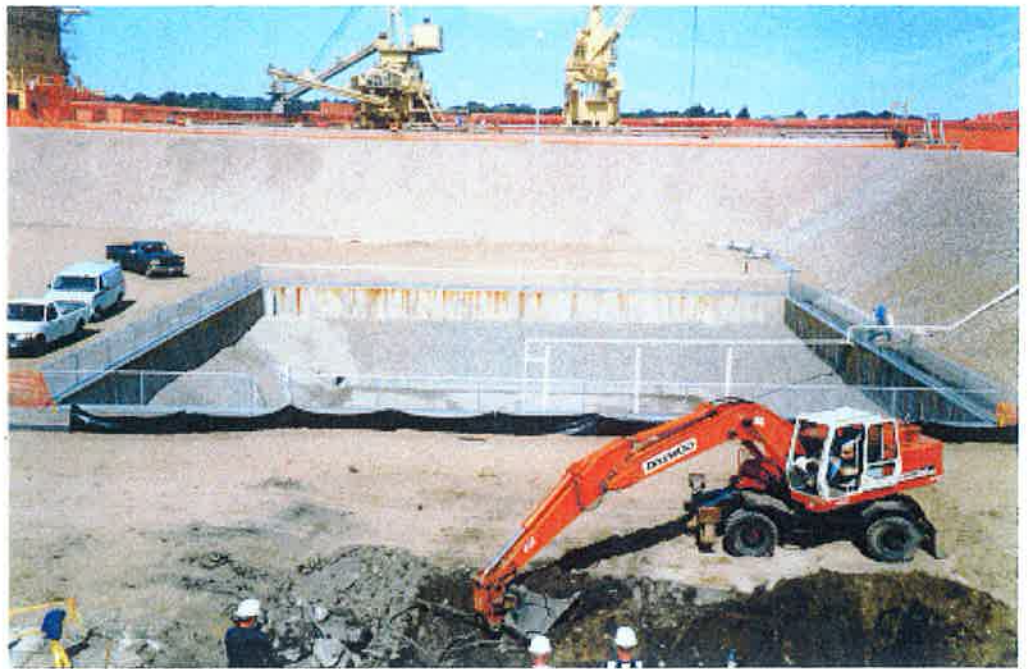
View of excavations in SALNG Area within the dike.

The excavation was conducted within the containment dike, in the southwestern corner. The excavation was bordered to the south and west by the containment dike and to the east by the Surface Water Impoundment (SWI). Based on the Site sketch developed by ESS, the excavation sidewalls were sloped and the excavation was advanced between 2 and 3 feet below the groundwater table. Dewatering and LNAPL recovery was accomplished through the use of a vacuum truck operated by Cyn Environmental. The manifests for transportation of this water are included in Appendix E. Surficial excavations were continued in a northerly direction based on exceedances of surficial soil samples. Based on a review of site sketches, continued excavations were completed until analytical results of samples conformed to the surficial soil ROs.

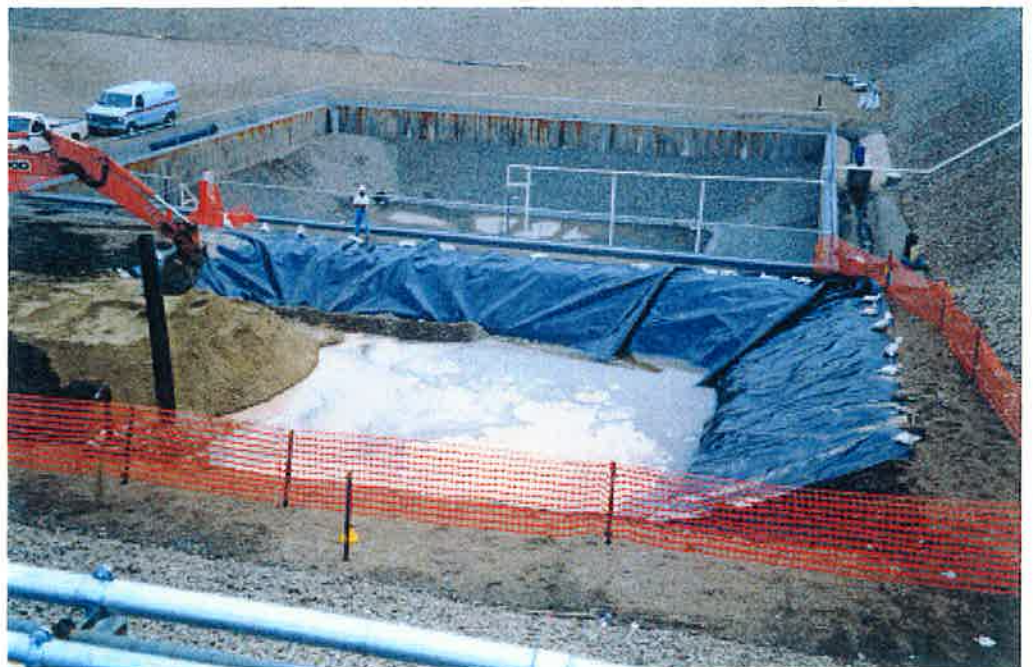
Backfill operations in SALNG Area within the dike.

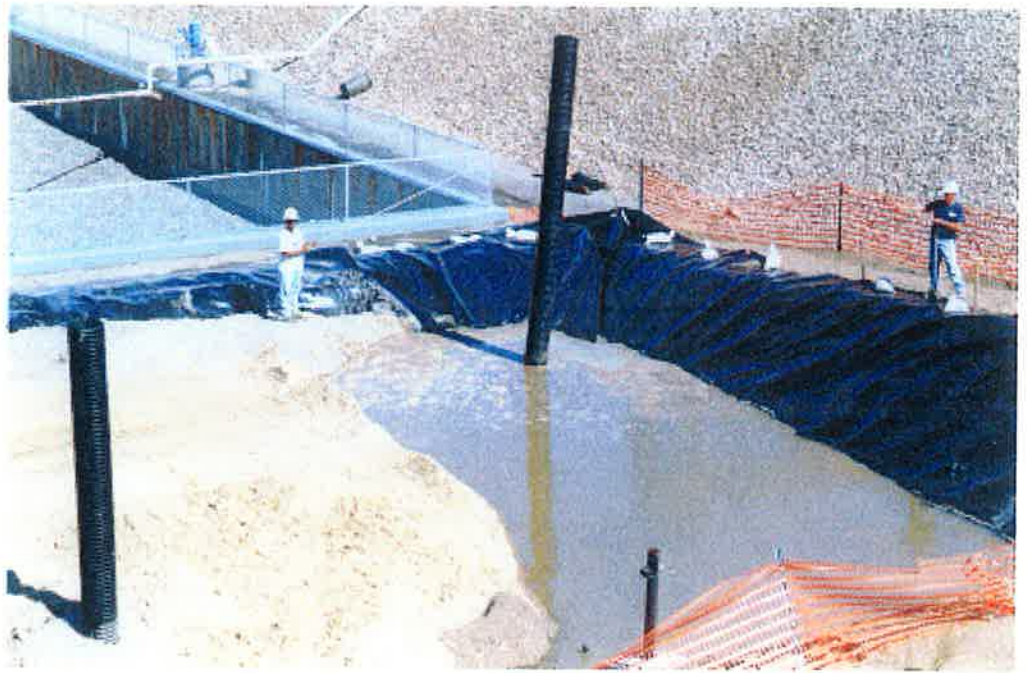
Backfill operations and installation of recovery wells in SALNG Area within dike.

Recovery wells were also installed in the SALNG Area within the containment dike. A well was installed in the southeastern corner of the excavation and another recovery well was installed along the edge of Structure 10. LNAPL barrier sheets were installed along the south and east walls of the excavation. The approximate

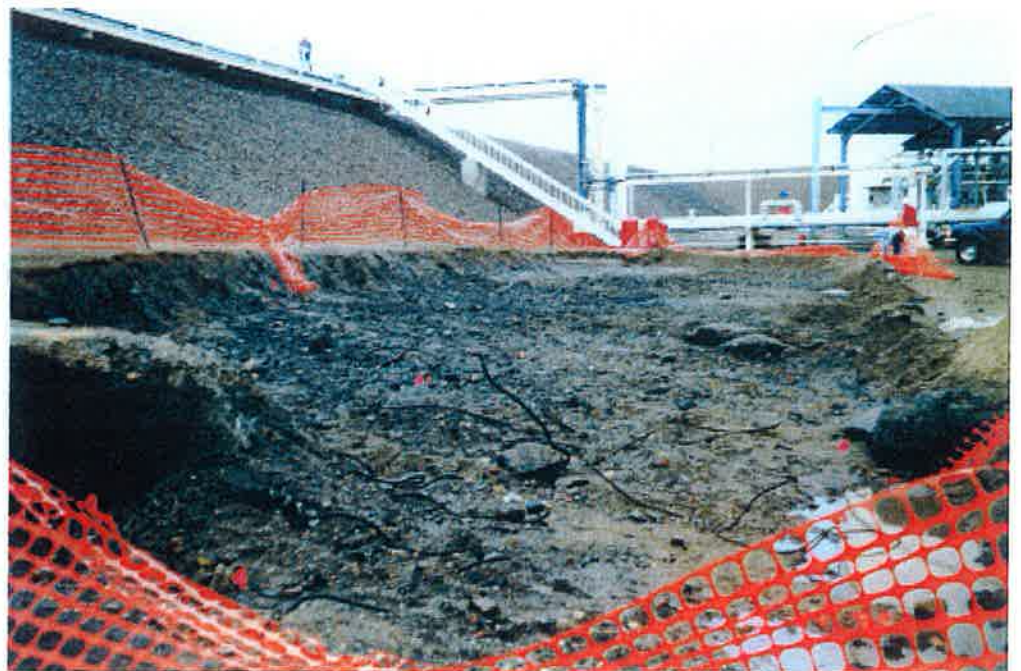
Surficial excavation in SALNG Area within the dike.

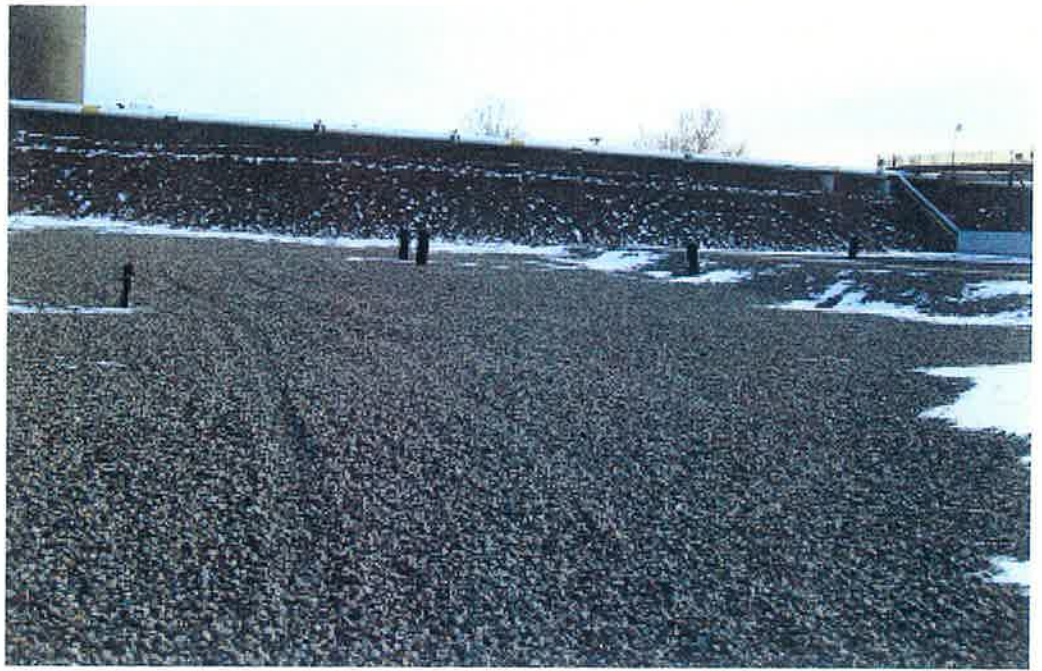
View of recent conditions of SALNG area looking to the south.

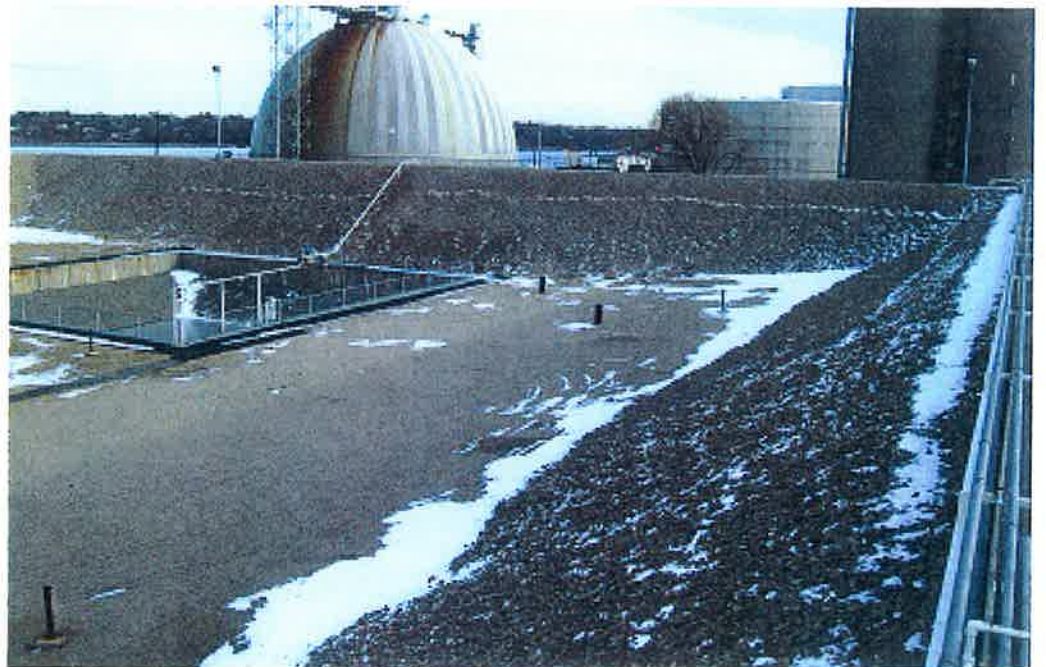
View of recent conditions of SALNG within the containment dike.
