**SUPPLEMENTAL SITE INVESTIGATION
REPORT ADDENDUM
JUNE 2007**

**FORMER GORHAM MANUFACTURING SITE
333 ADELAIDE AVENUE
PROVIDENCE, RHODE ISLAND**

**RE: Submittal of Addendum Letter
Supplemental Site Investigation Report
Former Gorham Manufacturing Site
333 Adelaide Avenue
Providence, Rhode Island**

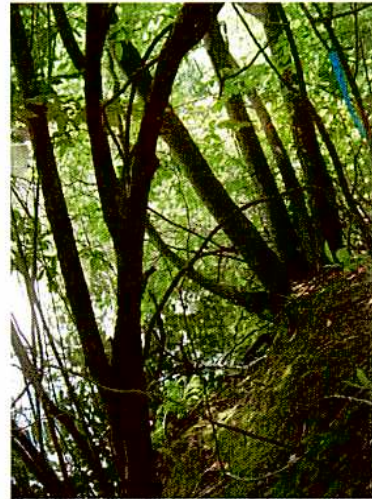
Photo 2 – Typical fringe wetland

Wetlands at the Site occur as fringe features forming a narrow band along the cove shore (Photo 2 within Appendix C). Tree species within the wetland areas include, red maple (*Acer rubrum*), silver maple (*A. saccharinum*), and black willow (*Salix nigra*). The shrub layer consists of sweet pepperbush (*Clethra alnifolia*), red osier dogwood (*Cornus stolonifera*), and buttonbush (*Cephalanthus occidentalis*). Sensitive fern (*Onoclea sensibilis*), blue flag iris (*Iris versicolor*), and poison ivy (*Toxicodendron radicans*) occur in the herbaceous understory.
