PORTSMOUTH TOWN DUMP/ AP Enterprise Inspection Report

Time	1:30:00 PM
Date	6/5/2020
Inspectors	Kasie McKenzie Mark Dennen
Reason for Inspection	Regular Inspection
Inspector Recommendation	Deficiency to be Corrected in Follow-Up

Re: RIDEM Inspection June 5, 2020
Former Portsmouth Landfill

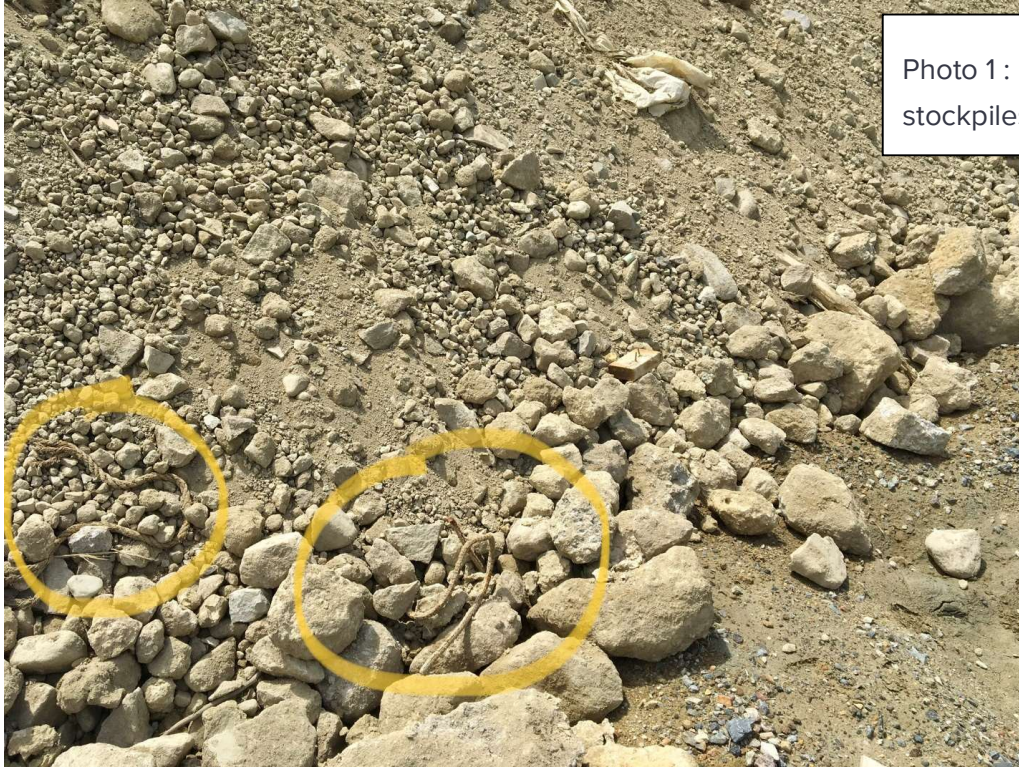
Mark Dennen and Kasie McKenzie arrived on site at 1:30 PM to meet with the site owner, Art, and environmental consultant Tim O'Connor. We observed multiple trucks bringing in soil and placing it in a stockpile towards the north/central area of the site. Multiple stock piles were present on site, waiting to be spread as grading material. It is noted that some rebar and debris were present in the soil piles (Photo 1). The grading and capping material should be free of debris and other rebar materials, this should be corrected upon a follow up inspection.

Photo 1 : Rebar located in the soil stockpiles

Response 1 – APE site contractor, Steve Oliveira, will have workers remove the rebar and debris as the soil stock piles are used during upcoming earthwork to establish final site grades. The rebar and debris will either be recycled or properly disposed.

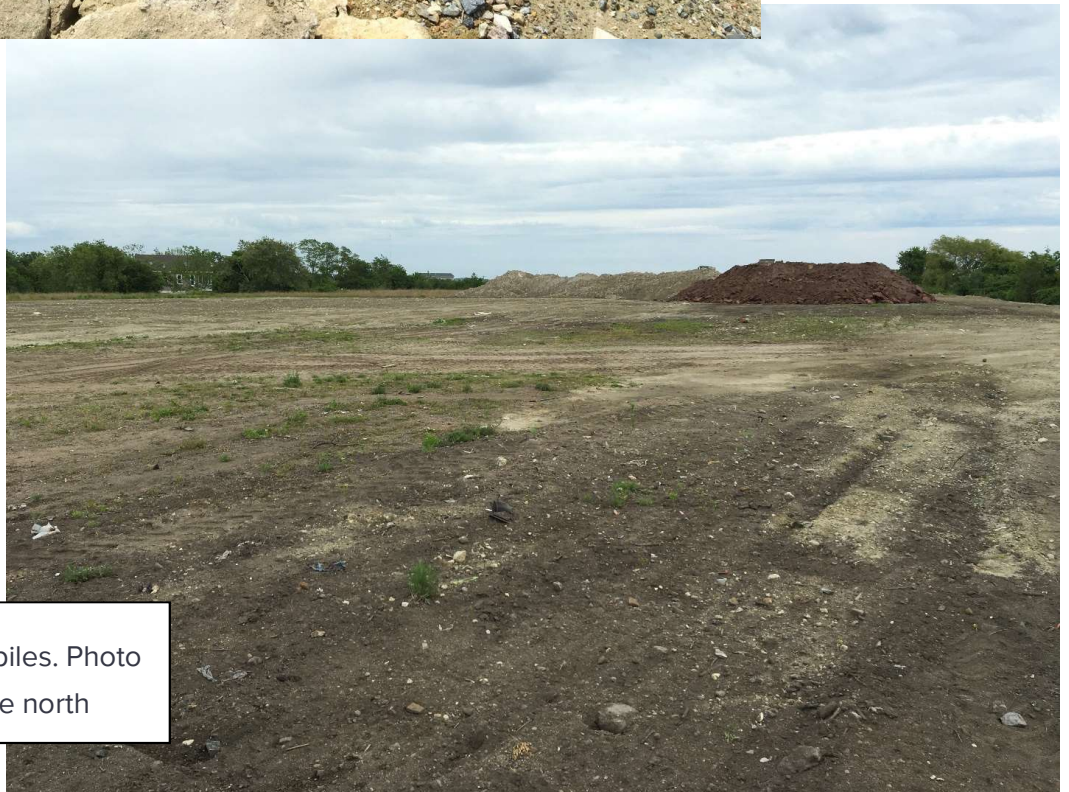
Photo 2 : soil stockpiles. Photo directed towards the north

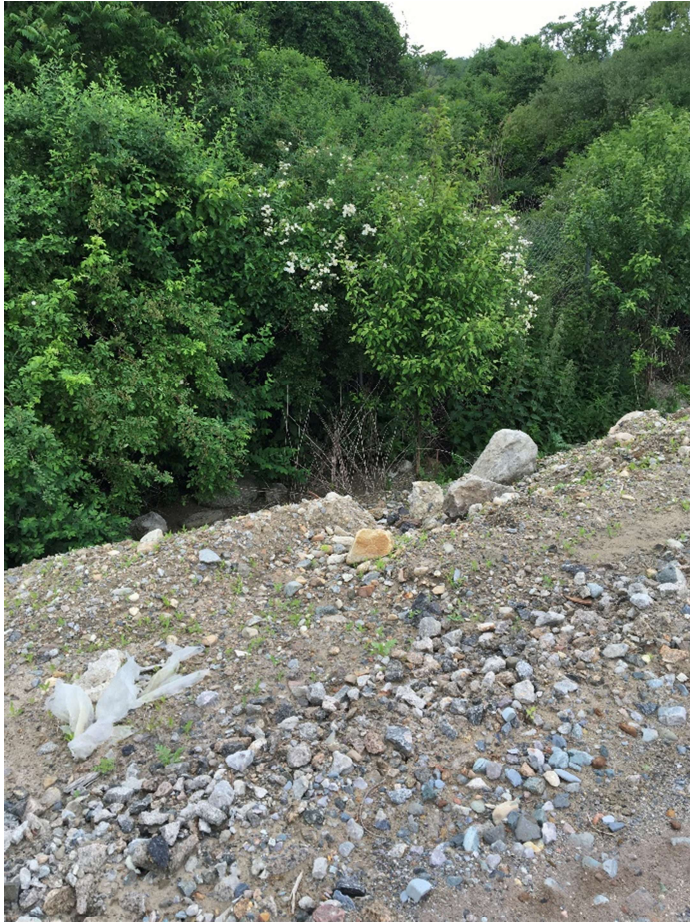
It was also noted there was significant erosion on the western slopes (Photos 3 and 4). This should also be corrected upon a follow up inspection with the replacement of the displaced soil and the use of a department approved erosion control measure on the slopes.

Photo 3 : Erosion on the western slope

Response 2 – This area will be one of the last areas of the Property to be capped and fine graded. Although the surface and side slopes looked relatively uniform, capping is not completed in this area and additional soil is required on the side slopes. In some areas this will move the toe of slope further west by several feet. Once this earthwork is completed, the western side slopes along with other vulnerable areas will be seeded and covered with a straw-based erosion control blanket.

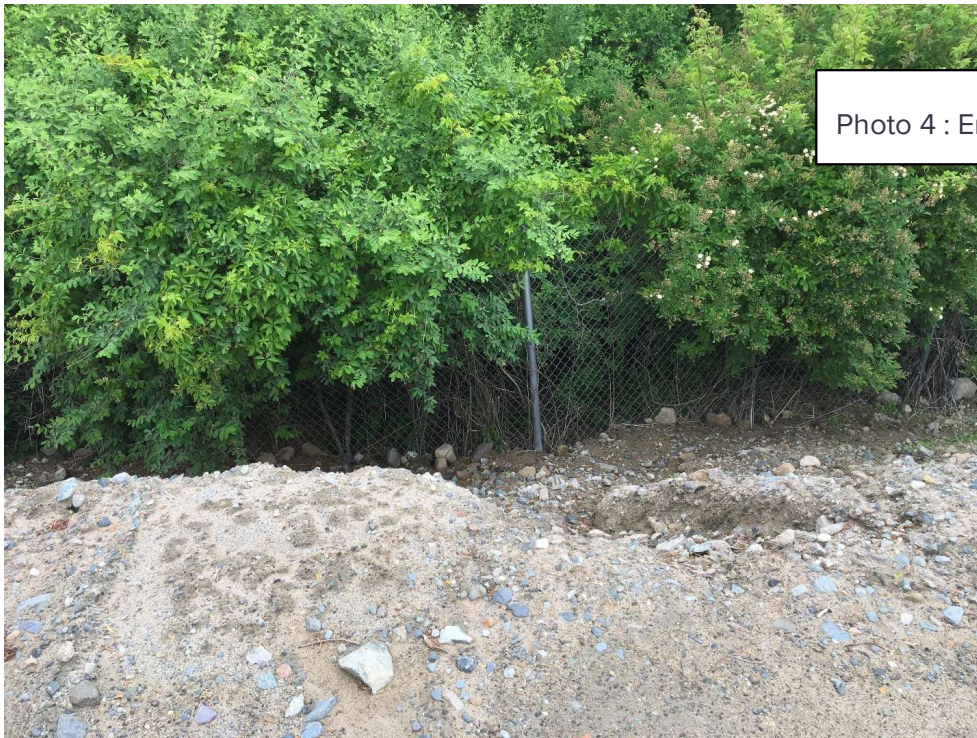
Photo 4 : Erosion on the western slope
