January 21, 2007  
File No. 05.0043654.00-C

Re: *Short-Term Response Action Plan*  
Former Tidewater Facility  
Pawtucket, Rhode Island

## PROJECT OBJECTIVE

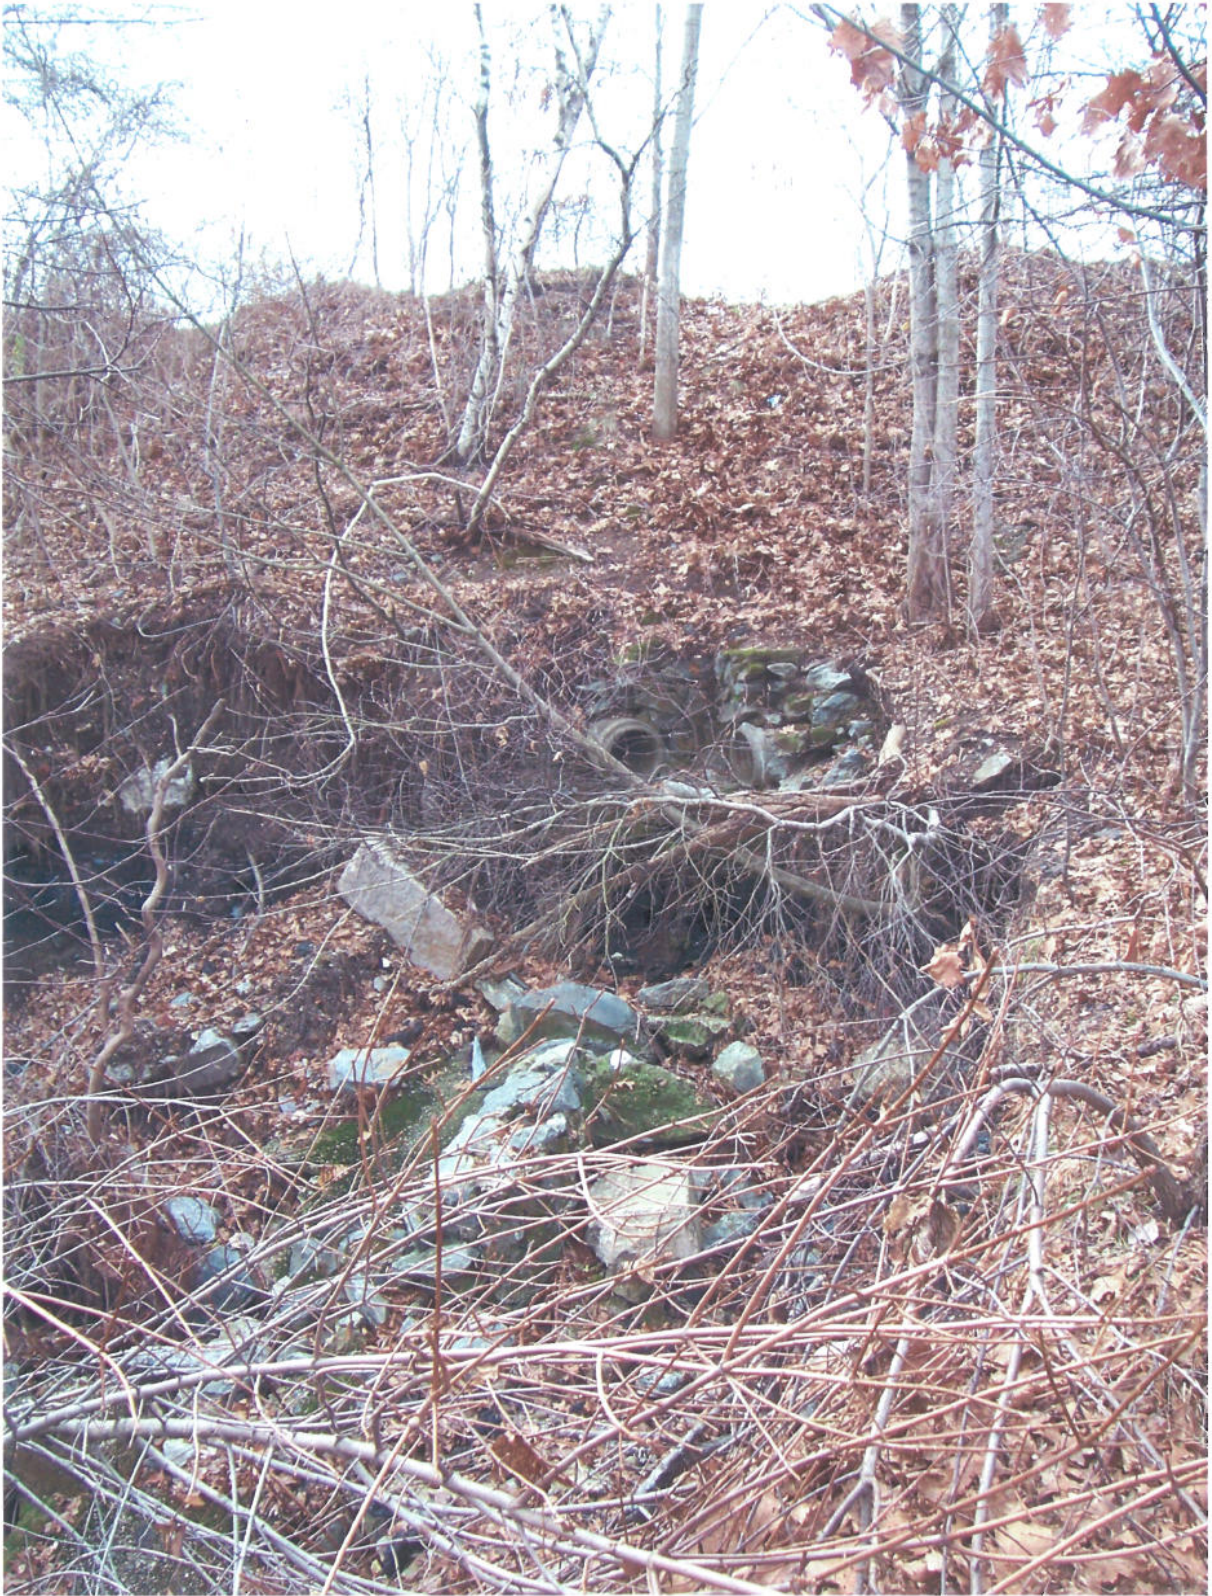
- South Washout Area. Within the South Fill Area of the Site, two surface water discharge pipes are located within a relatively large washout area which extends approximately 60 feet inward from the bank of the Seekonk River. This area, identified as the “South Washout Area” on Figure 2, appears to have resulted from the erosion of materials (surficial fills and potentially impacted MGP residuals). This erosion is apparently the result of surface water flow from the two currently visible storm drain lines located on the southwest side of the sinkhole. The remnants of a storm drain structure appear to be located in the sinkhole below the discharge of these drain lines, suggesting that the two pipes were once connected to a manhole structure.

Figure 2 presents the configuration of the washout area based on a field survey performed by GZA on December 11, 2006. Based on the field information gathered by GZA, the South Washout Area covers an area, oriented in an approximate southwest-northeast direction, which extends approximately 60 feet to the bank of the Seekonk River. The area ranges in width between approximately 10 to 38 feet and is approximately 13 feet deep at its deepest point. Photos of the South Washout Area are included in Appendix A.

**Photo 1 View of South Washout Area. Two drain lines visible in distance.**

- Once the source of the drain pipes is identified and the owners have been contacted, work will be performed to repair the drain outfall and stabilize the river bank area within the washout. Currently, it is anticipated that a new concrete manhole will be installed into which the two existing drain pipes will be routed. A new drain line will then be installed, extending from the manhole to the river's edge. To install the new manhole and associated discharge line, the washout void will be filled with trap rock and/or clean fill to bring the area up to the necessary elevation for installation of a new drain line. The washout area will be lined with a geotextile demarcation layer prior to placement of any fill material over the existing soil grades. The outfall of this drain line will be specifically designed to limit future erosion and sediment migration to the Seekonk River.

- After completing the repair of the drainage structure and drain line, the sinkhole void will be backfilled with clean, imported fill material. The washout will be backfilled to match surrounding Site grades. The underlying drain line will be specifically designed to withstand the load from these fill materials. Based on our recently completed survey work, it is estimated that approximately 400 to 500 cubic yards of fill material will be required to backfill this sinkhole. Hydroseed and degradable hay mats will be used to stabilize the backfilled area and limit the potential for erosion.

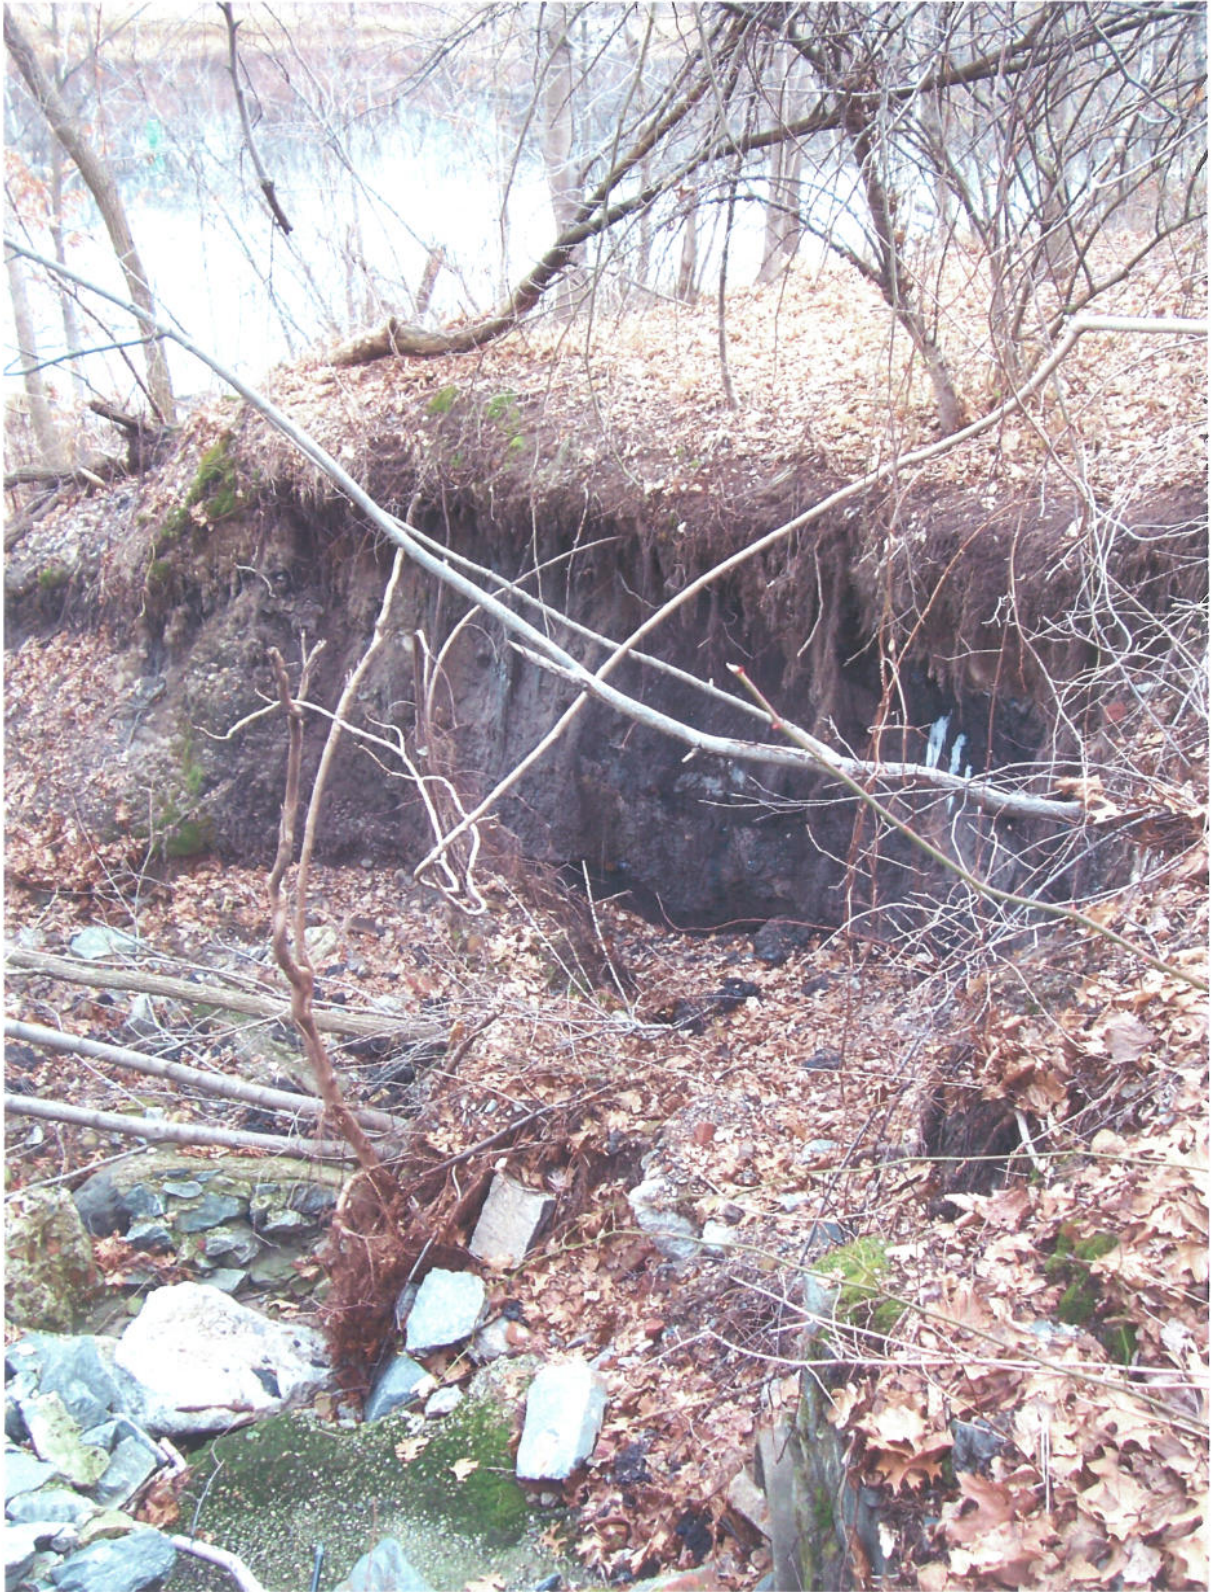
**Photo 2 View of southern sidewall of South Washout Area.**

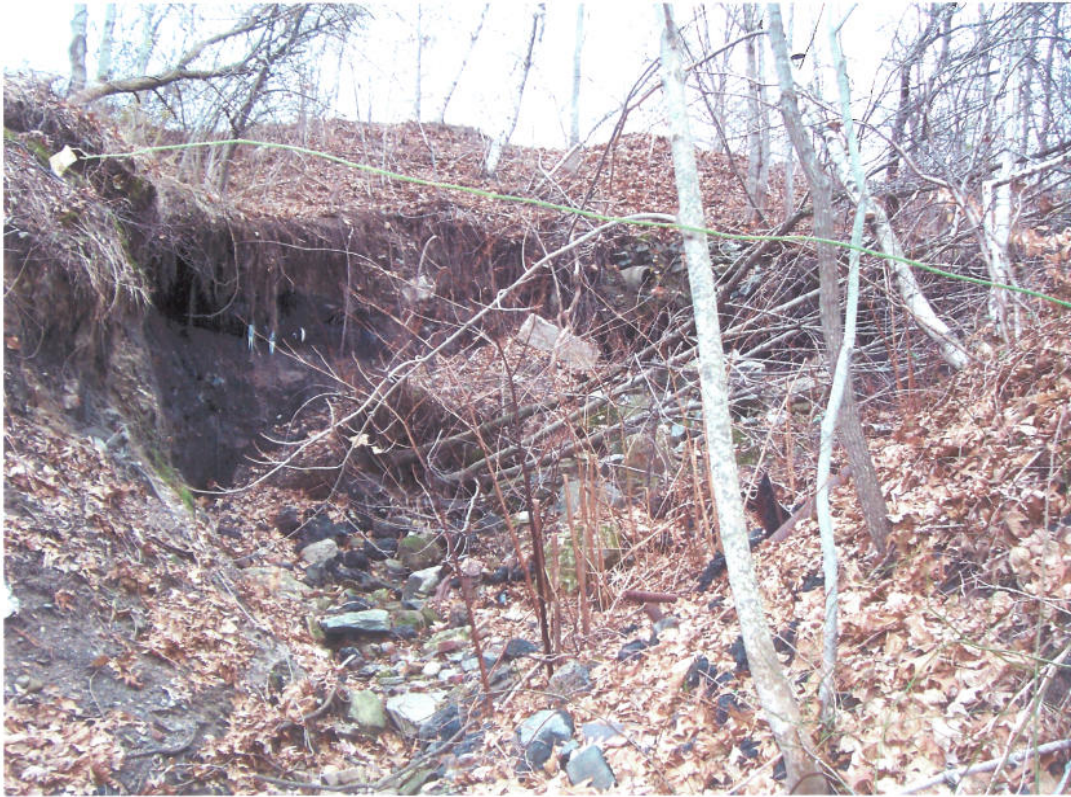
**Photo 3 View looking southwest of washout area from bottom of riverbank.**

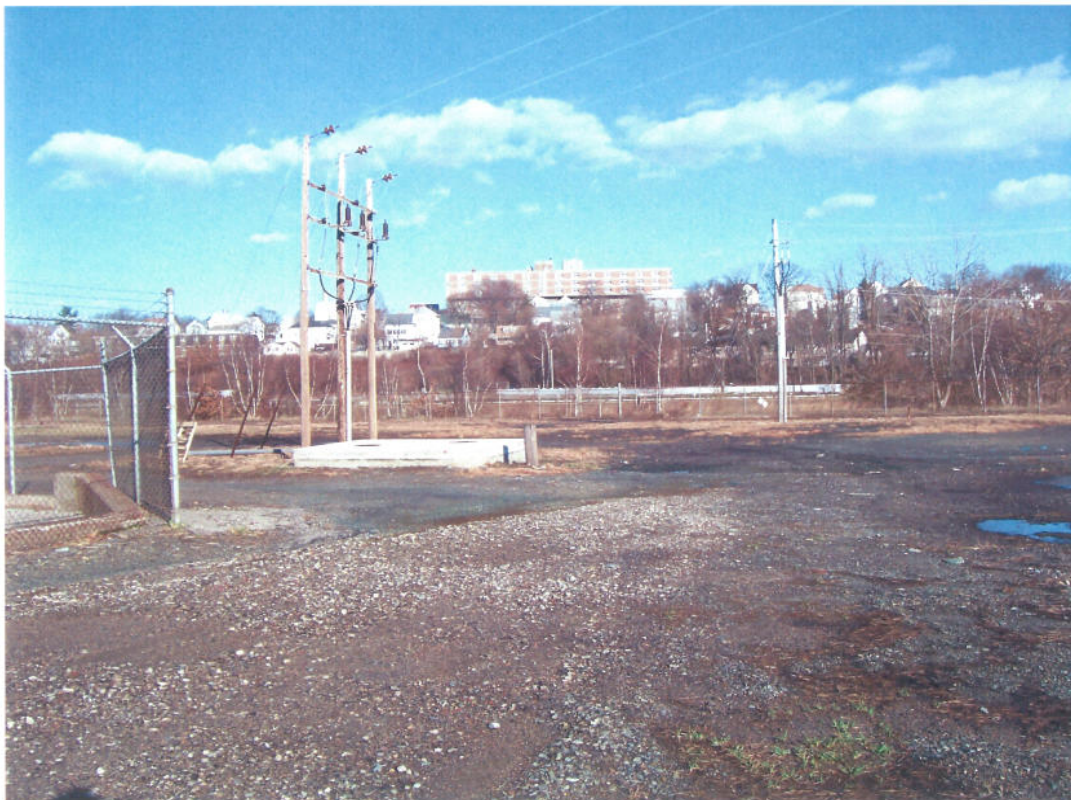
- MGP Residuals Located in Roadways/Access Ways. On the Former Power Plant Area of the Site, certain portions of the unpaved access road and parking areas located to the south and southeast of the substation were noted to consist of blue surface staining. This observed staining is typically characteristic of potentially cyanide-impacted material. This access road and parking areas are utilized by National Grid service trucks, and as such, the surface soils are prone to disturbance and possible vehicular transport. The approximate area exhibiting this surface staining is depicted on the attached Figure 2.

**Photo 4 View of roadway located southeast of Substation. Blue and yellow surface soils noted.**

- Blue stained surface soils along certain portions of the unpaved access road and parking area located south and southeast of the substation will be excavated to a depth of approximately 1 foot below existing grade. Based on existing data, it is estimated that approximately 600 tons (400 cubic yards) of material will be excavated over approximately 350 linear feet of roadway, with an average width of approximately 30 feet. The approximate area to be addressed is depicted on Figure 2. As the intent of the removal effort is to address the immediate concerns posed by the stained soil, with the assumption that engineered controls will be implemented at the Site in the future, no confirmatory samples will be collected from the sidewalls and floor of the excavation area. The excavated areas will be temporarily capped with a 20 mil polyethylene liner overlain by 1 foot of clean trap rock. The access road and paving area will be brought back to the approximate pre-excavation grade.

- Prior to excavating, roadway soils will be sampled in place for characterization purposes. Shallow samples will be collected from the upper 1 foot of soil along the portion of the roadway exhibiting blue staining at intervals of approximately 75-100 feet (i.e., total of approximately 4 samples). All of the samples will be analyzed for total and free cyanide<sup>1</sup>, total petroleum hydrocarbons (TPH) via EPA Method 8100M and polynuclear aromatic hydrocarbons (PAHs) via EPA Method 8270C. In addition, two of the samples will be submitted for typical receiving facility disposal acceptance, including volatile organic compounds (VOCs) via EPA Method 8260, semi-volatile organic compounds (SVOCs) (rest of list) via EPA Method 8270C, polychlorinated biphenyls (PCBs) via EPA Method 8082, RCRA-8 metals, TCLP lead, flashpoint/ignitability, reactivity and corrosivity. If detected contaminant concentrations are less than the RIDEM Method 1 Industrial/Commercial Direct Exposure Criteria (I/C DEC), they will be placed in the low-lying area located south of the roadway (refer to Figure 2). These materials will be graded to match existing Site grades and limit the potential for erosion. As described previously, the final remedial alternative for the Site is currently anticipated to include engineered soil controls (e.g., soil capping, fencing) and deed restrictions. The area these materials are placed is expected to be capped as part of the final Site remediation plan. If soil contaminant concentrations exceed the Method I/C DEC, they will be disposed of off-site at a permitted facility approved by National Grid.
