Branch River (Segment 1A)

Watershed Description

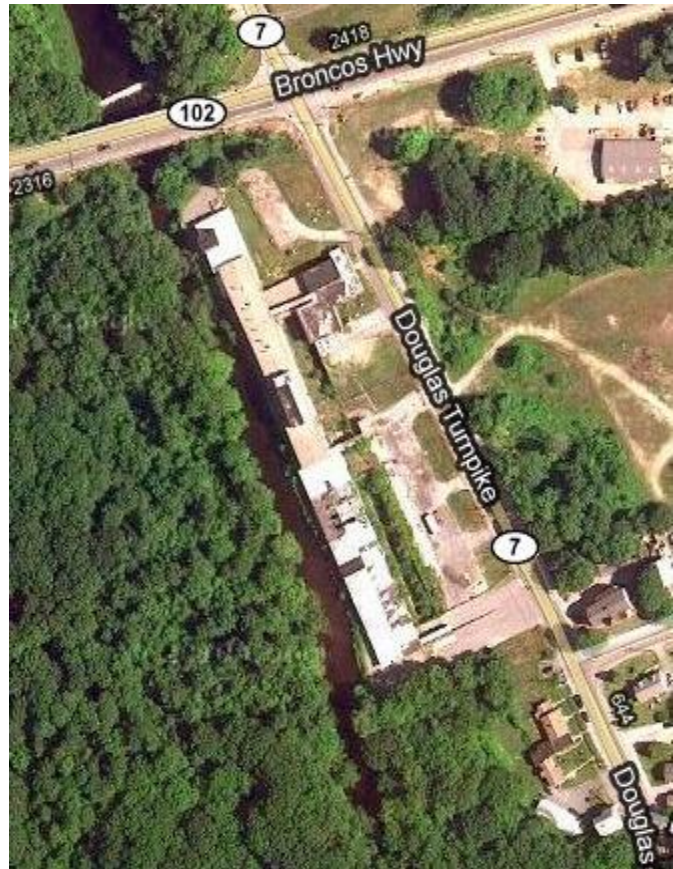
Figure 4: *Partial aerial view of the Branch River watershed, as it passes through the Village of Nasonville (Source: Google Maps).*

This impaired segment of the Branch River then continues northeast through a wooded area and flows through the Village of Nasonville. The river flows back under Broncos Highway parallel to RI Route 7 (Douglas Turnpike) where development is located directly adjacent to the river (Figure 4). The river passes under the Douglas Turnpike and empties into the Upper Slatersville Reservoir in the Village of Nasonville.
