Former Gorham Manufacturing Site

Phase II, Phase III and Parcel C Activities

February 5, 2015

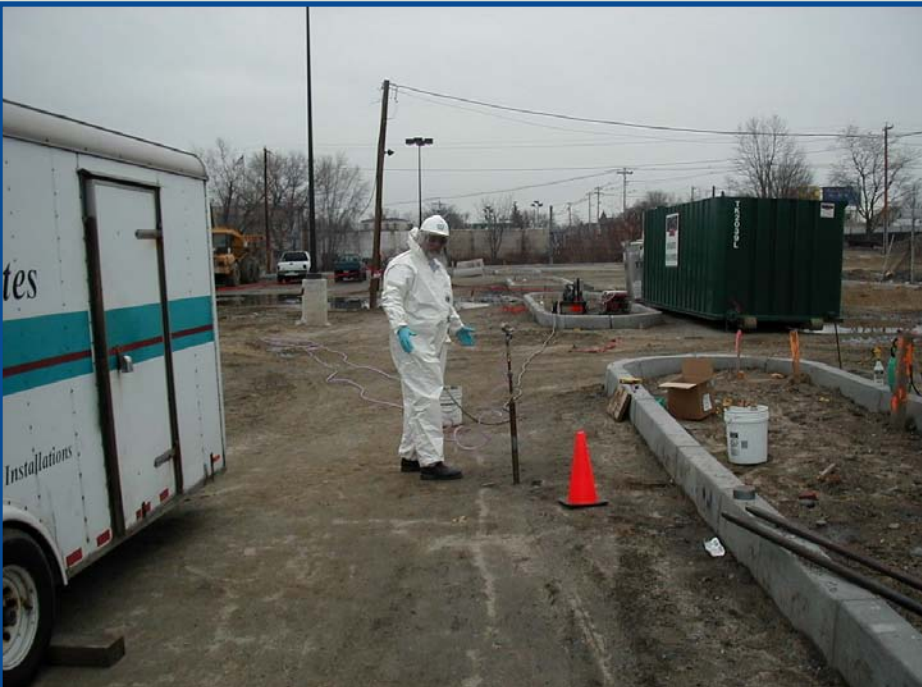
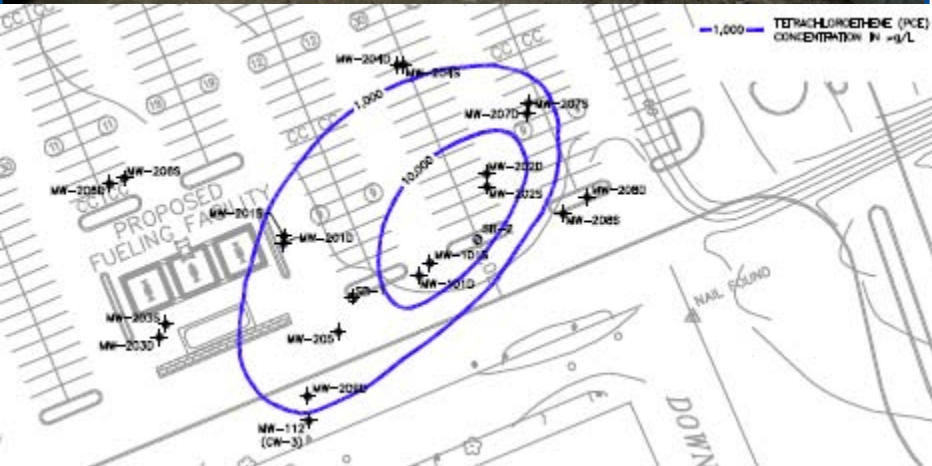
Completed Remediation Activities – Groundwater Injection Events

- Parcel A
- Two Injection Events – 2002, 2004
- Source Area was targeted and treated with an oxidant
- Chlorinated solvents – Tetrachloroethylene (PCE) and Trichloroethylene (TCE)
- Reduced impacts by over 50%

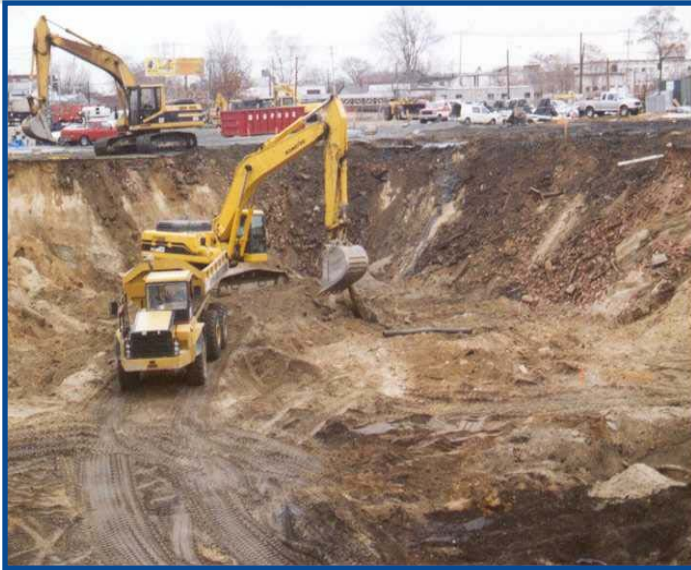
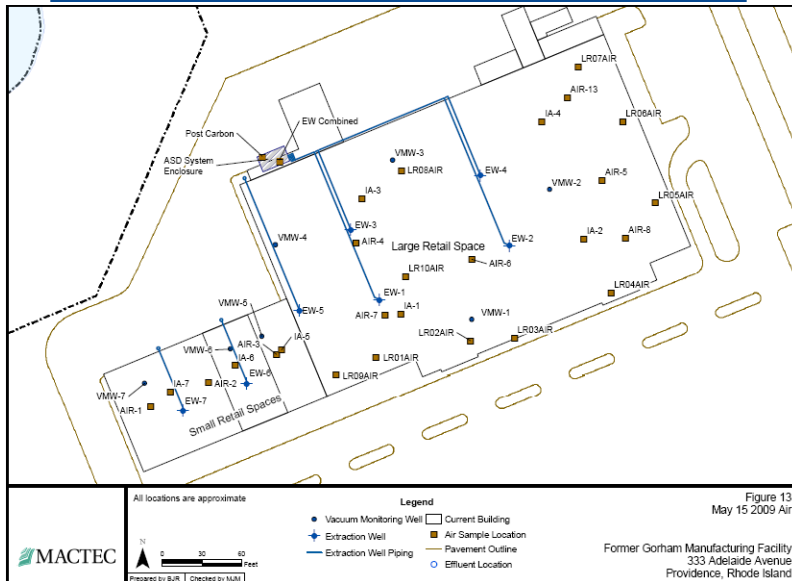
Completed Remediation Activities – Parcel A Soil Remediation

- Work completed in 2001 to allow for retail development
- 18,600 tons of petroleum impacted soil treated
- Treated material reused on site
- Capping accomplished with asphalt, soil and buildings
- Industrial/Commercial criteria
- Ongoing monitoring of cap integrity
- Sub-slab mitigation systems

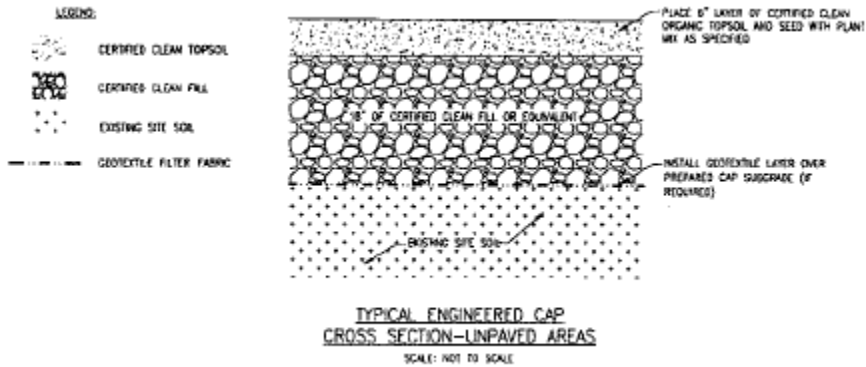
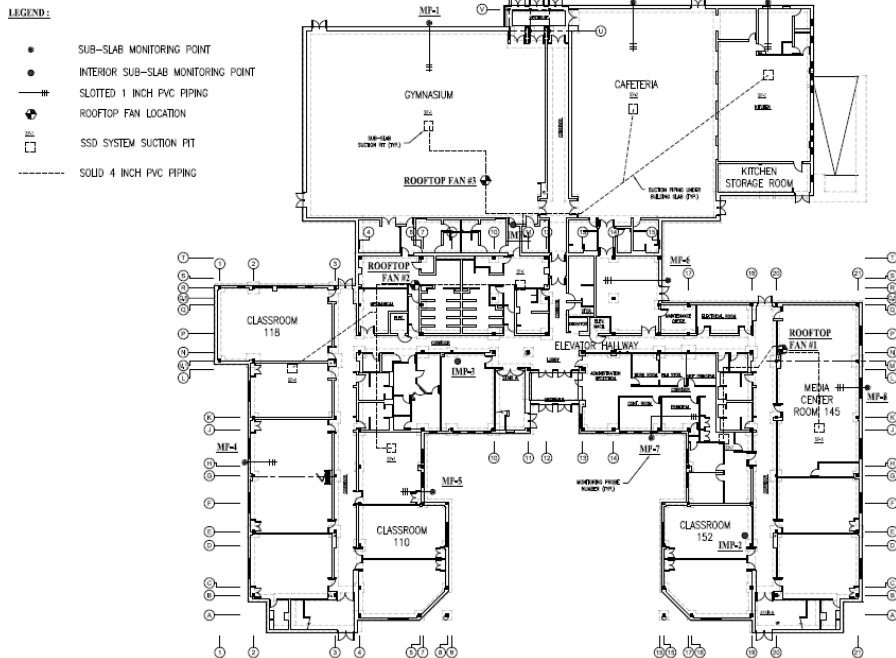
Completed Remediation Activities – Parcel B Soil Remediation (City of Providence)

- Parcel B

- Work completed by City of Providence in 2007

- Soil, asphalt and building caps

- Residential/unrestricted criteria

- Sub-slab vapor extraction system

- Ongoing monitoring

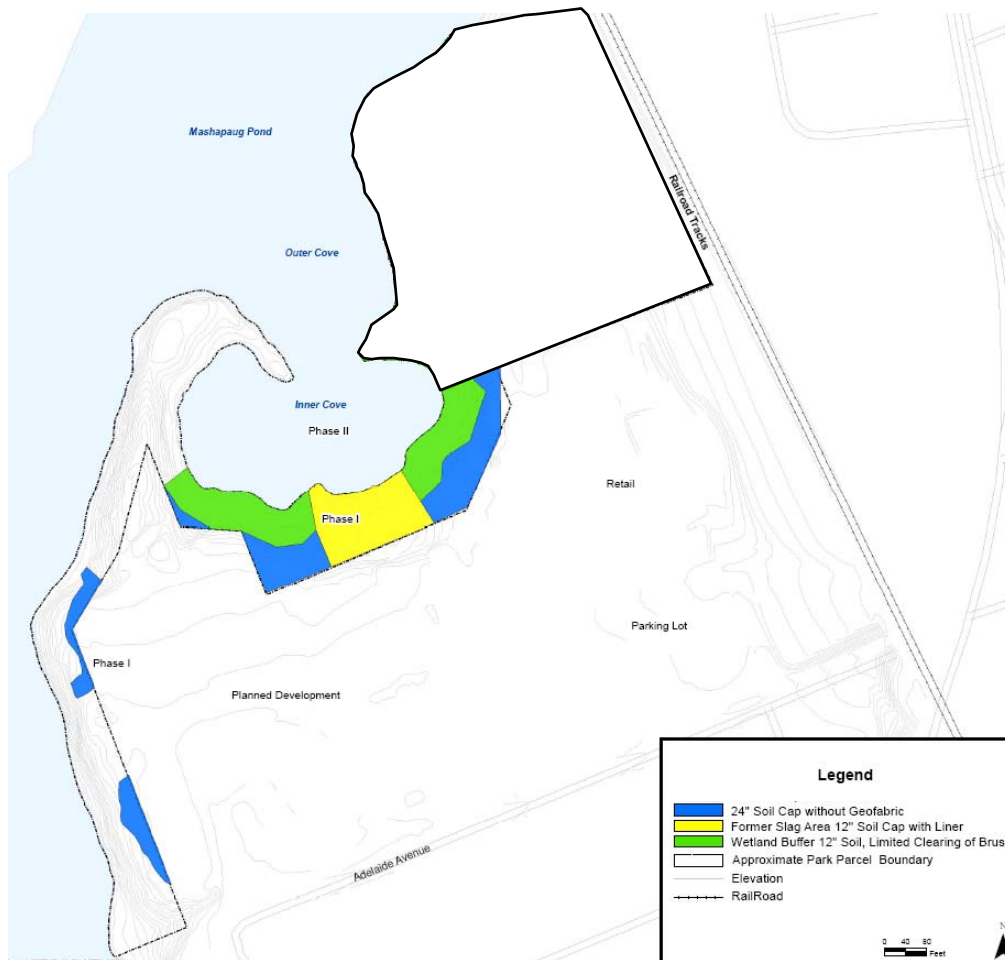
Completed Remediation Activities – Parcel C-1 - Phase I - Soil Remediation

- Parcel C-1 (Park Parcel)
- Former slag pile addressed in 2006
- Work completed in 2012
- Soil cap – location specific
- Fill areas addressed
- Residential criteria
- Ongoing monitoring

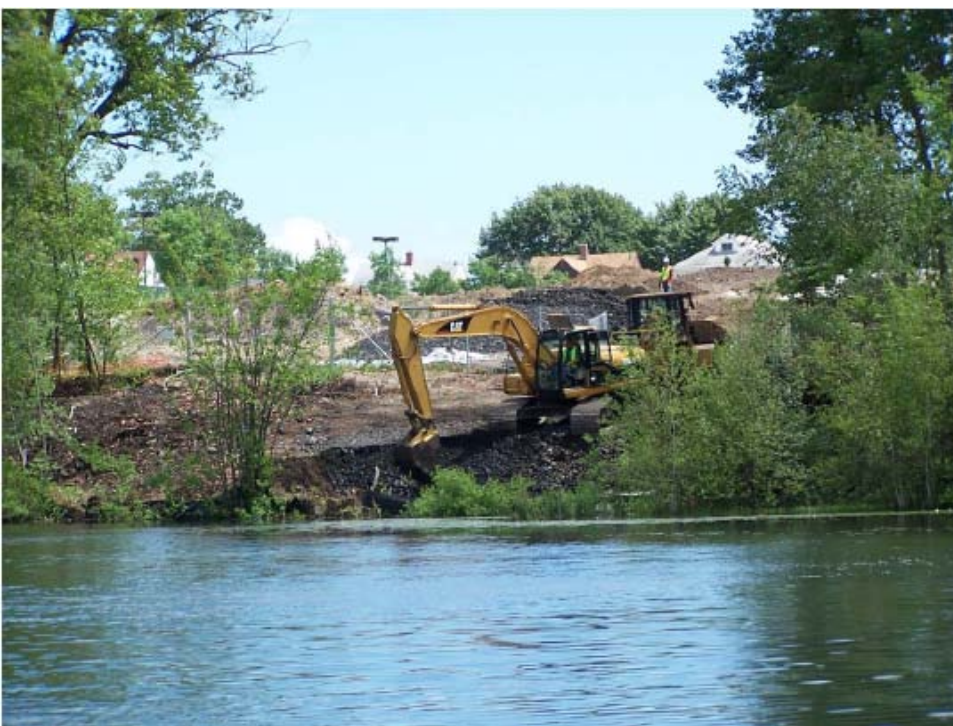
Slag Excavation

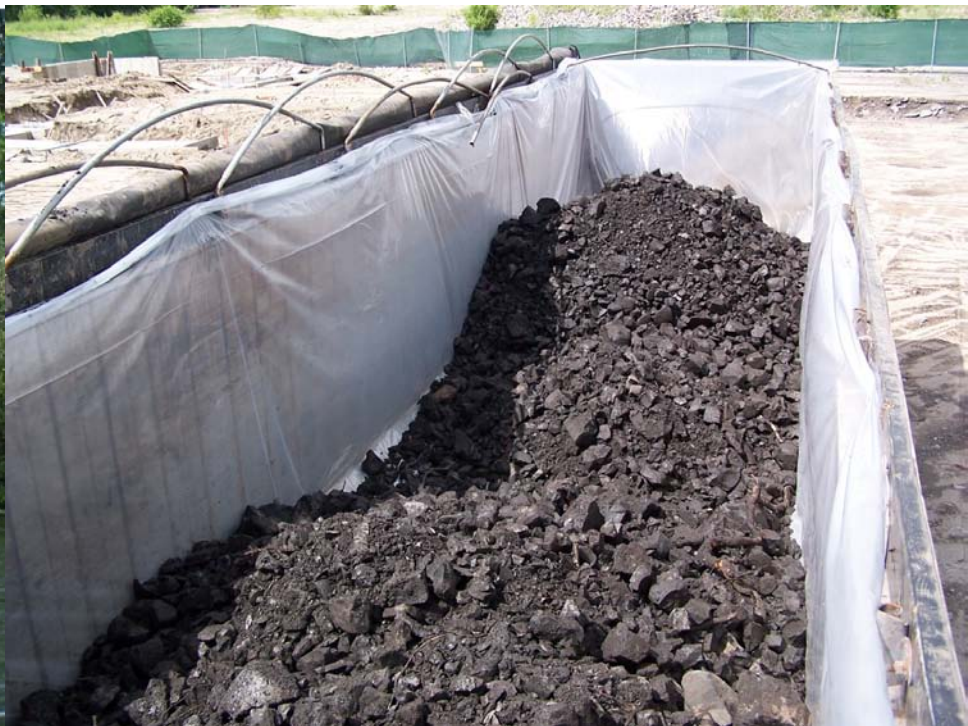
Slag material ready for disposal

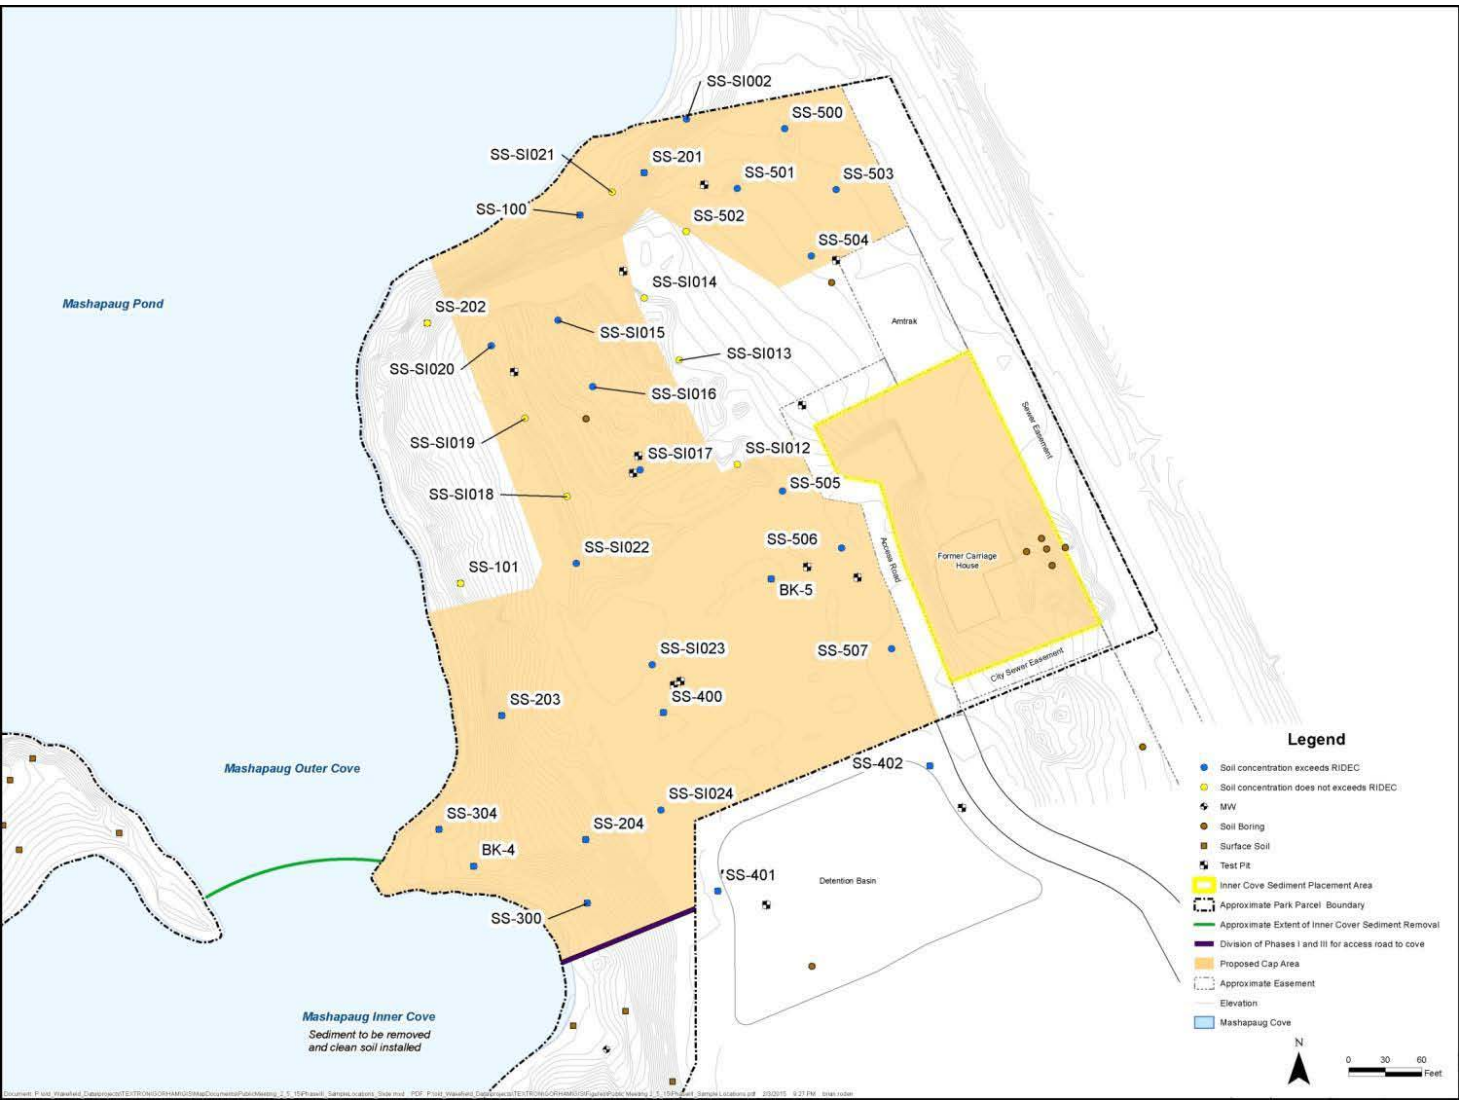
Summary of Parcel C and Phase III Soil Investigations

- Phase III Area
- Multiple soil sampling events
- Exceedances of Residential Direct Contact Standards

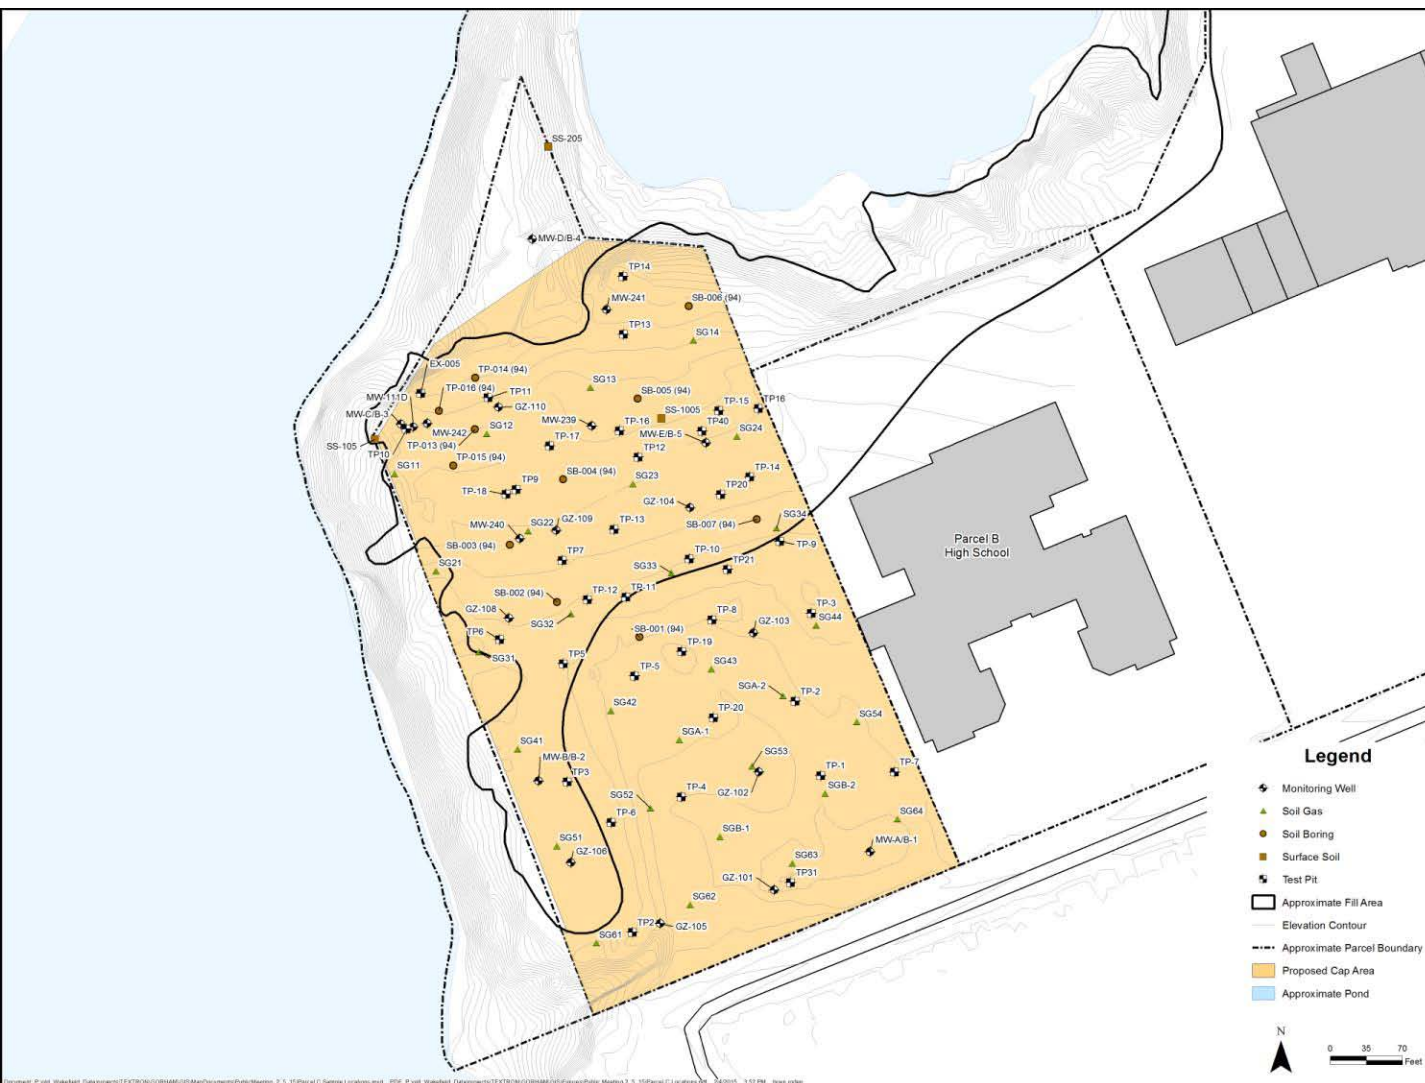
Summary of Parcel C and Phase III Soil Investigations

- Parcel C Area
- Multiple soil sampling events
- Exceedances of Residential Direct Contact Standards
- Fill Material
- Soil/Debris Pile

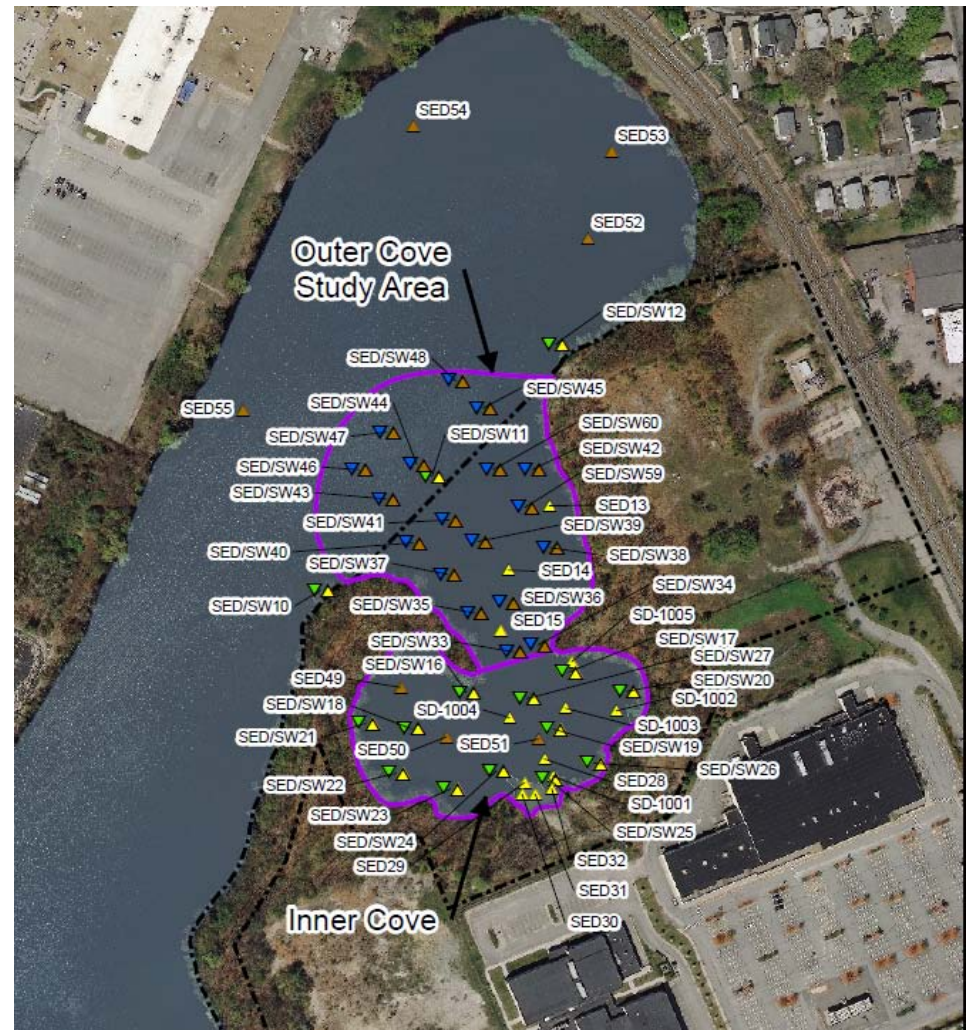
- Multiple Sediment Sampling Events
- Bathymetric Survey
- Magnetometer Survey
- Analysis performed for site-related compounds
- Physical property analysis on sediments
- Difference between Inner and Outer Cove
- Background impacts in Pond – Urban runoff
- Risk Assessment
- Surface water Sampling

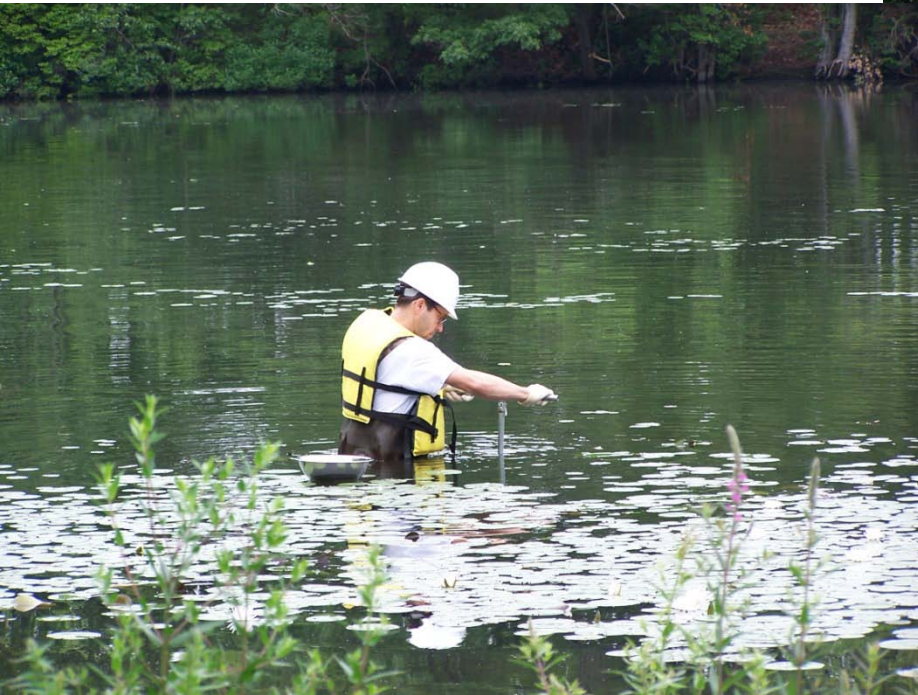
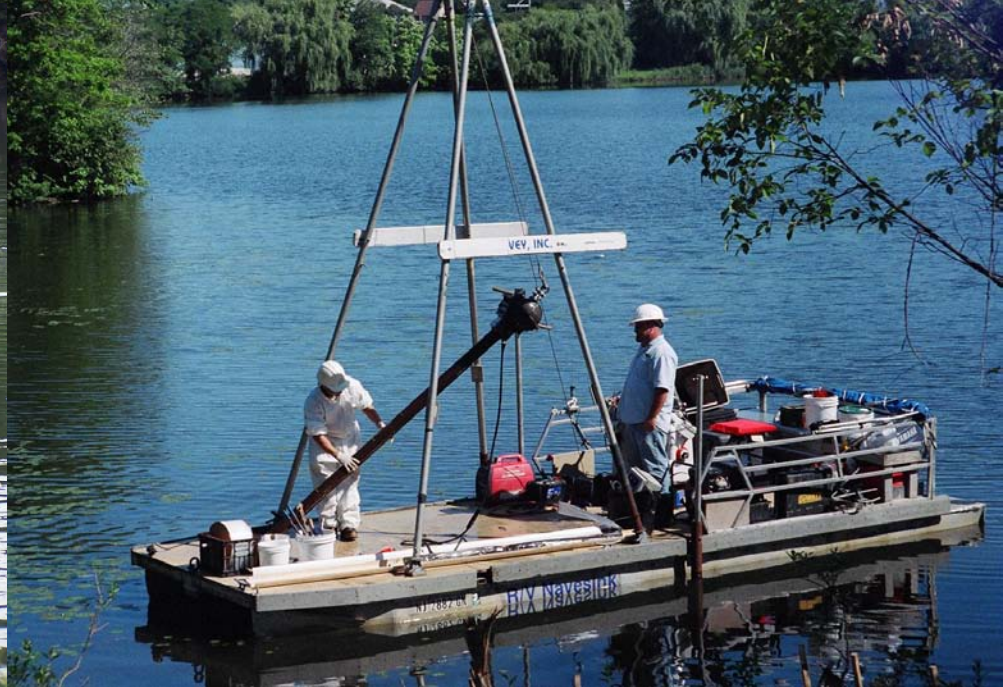
Photos of Mashapuag Cove Sediment Sampling Activities
