**Department of Environmental Management
Office of Waste Management**

FIELD INVESTIGATION REPORT

Facility Name: Portsmouth Town Dump
Date of Investigation: 3/8/2017
Facility Address: East Main Road, Portsmouth

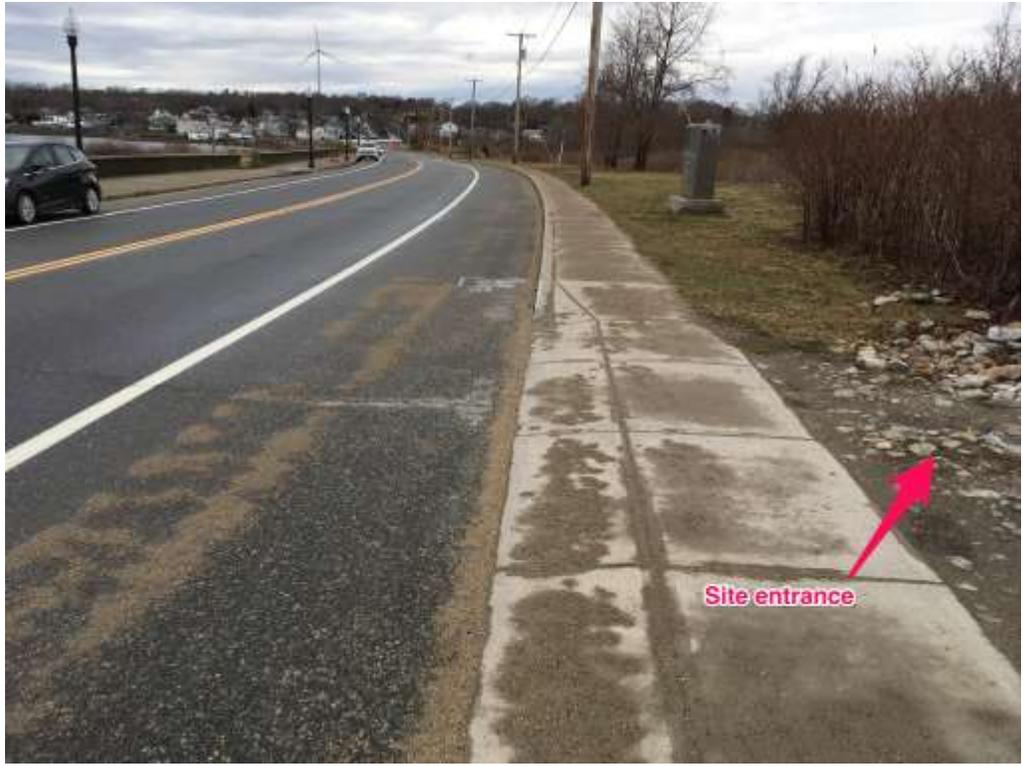
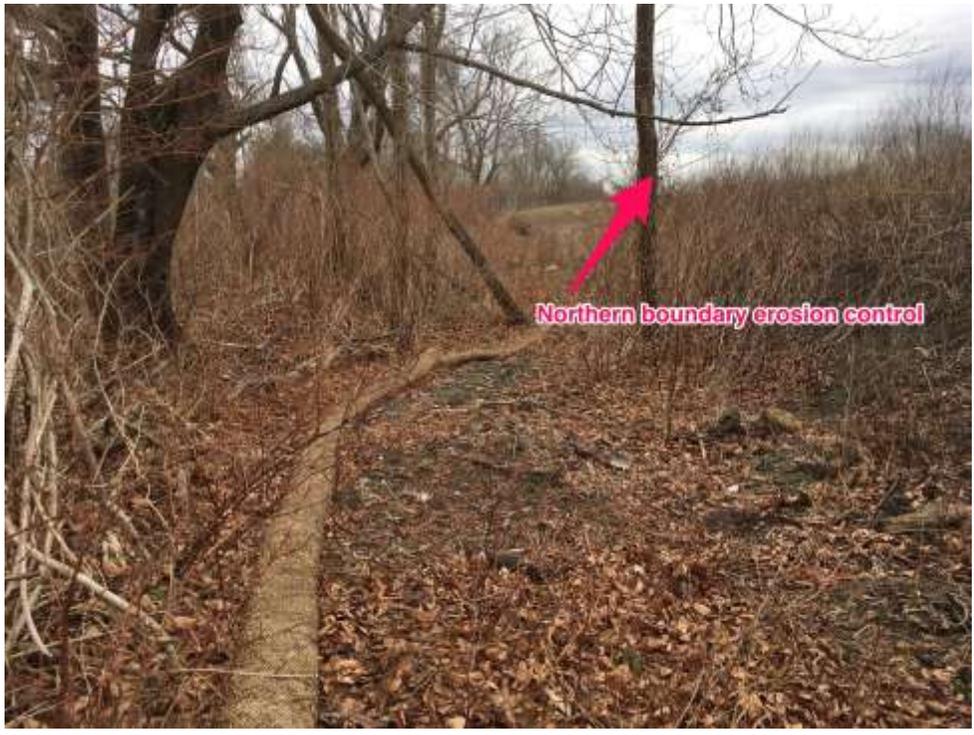
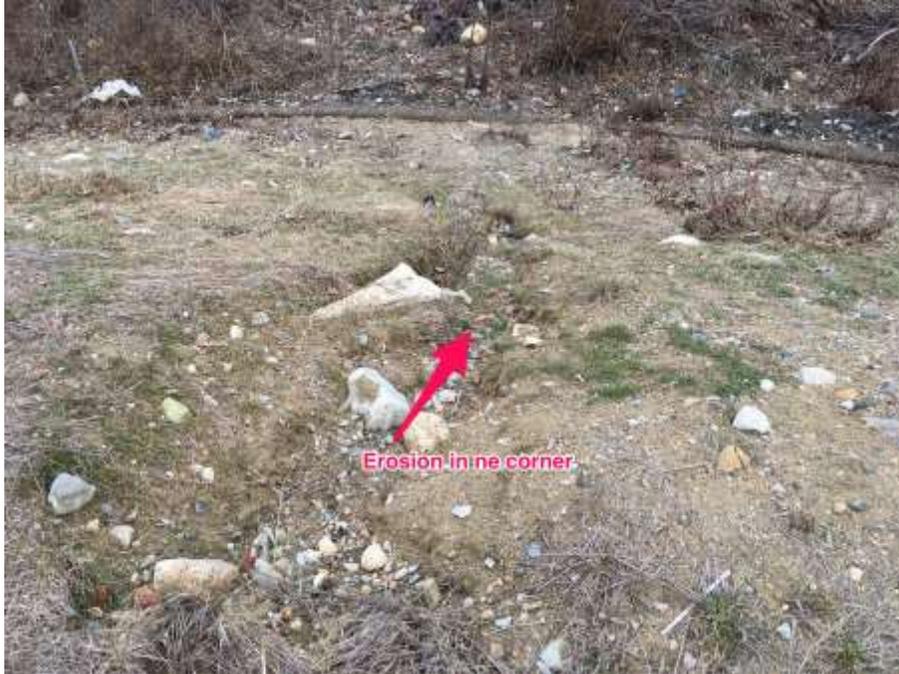
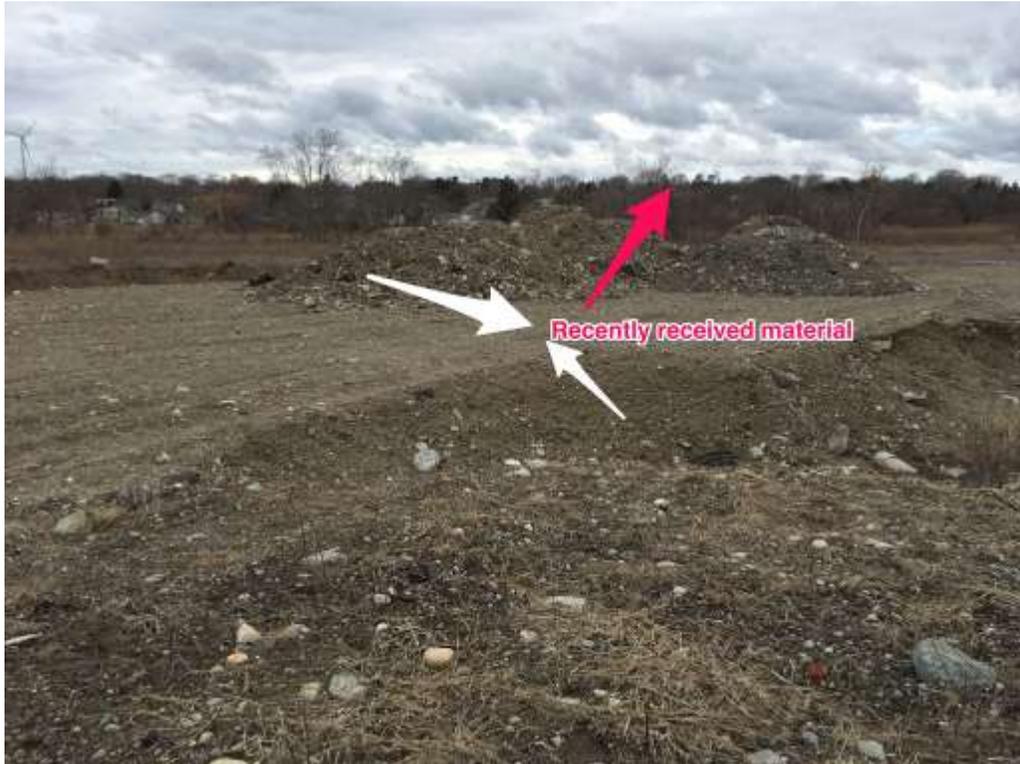
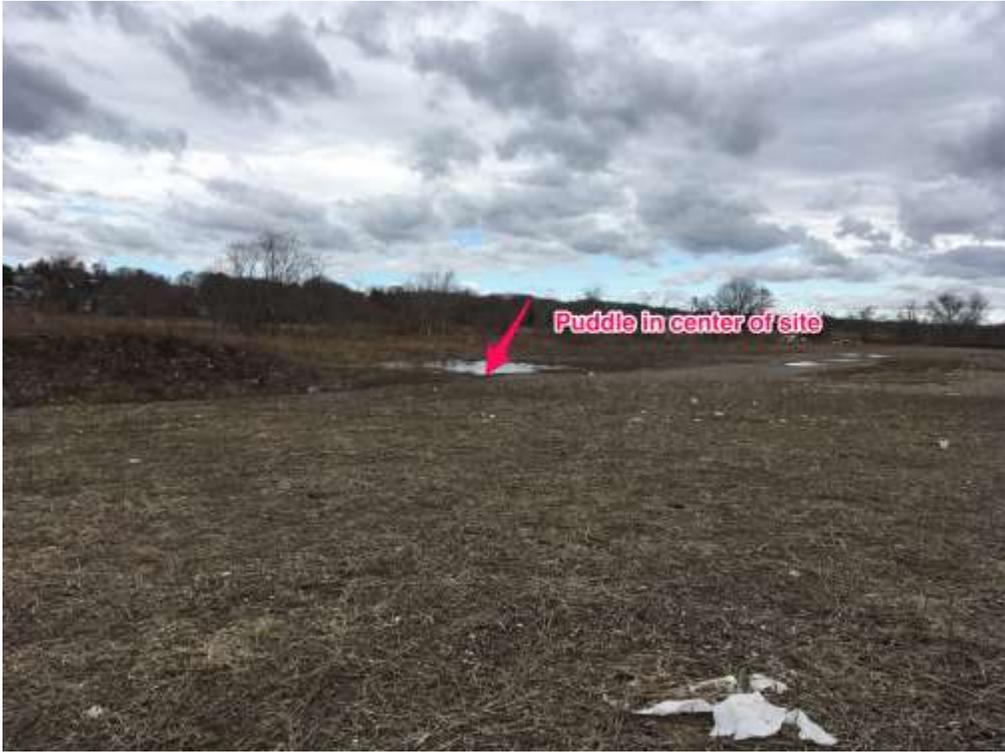
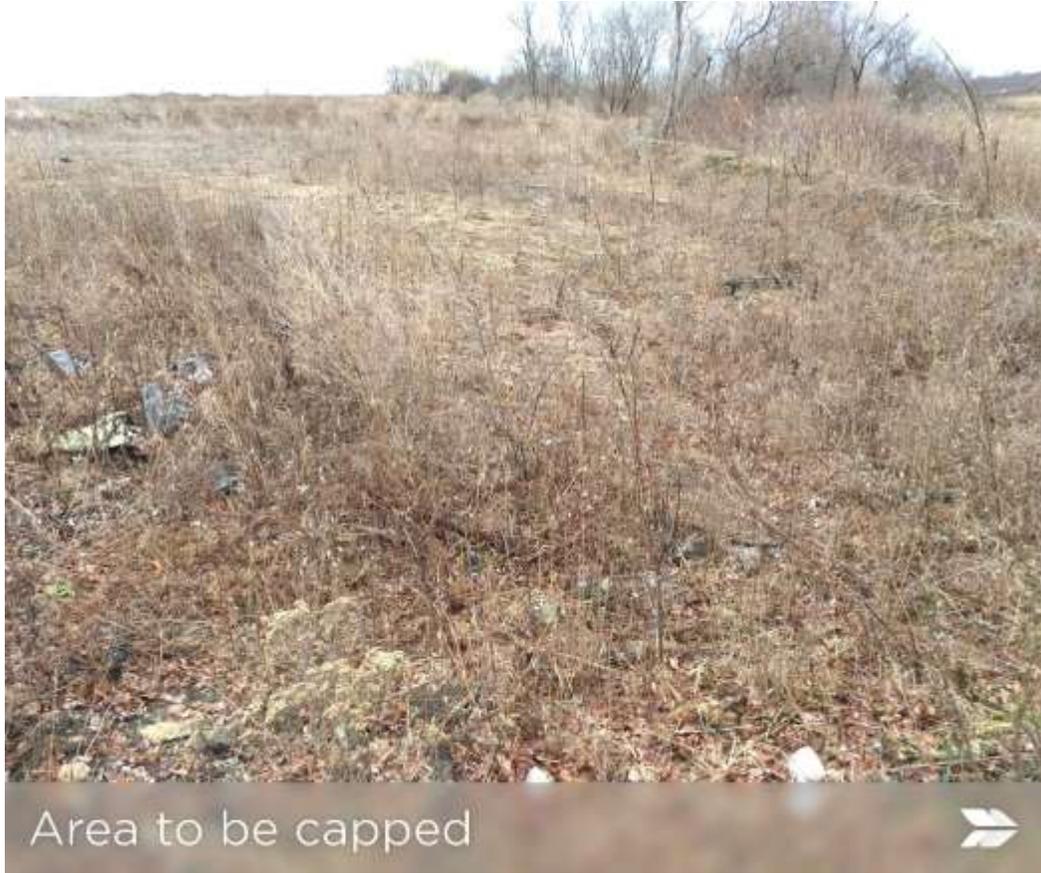
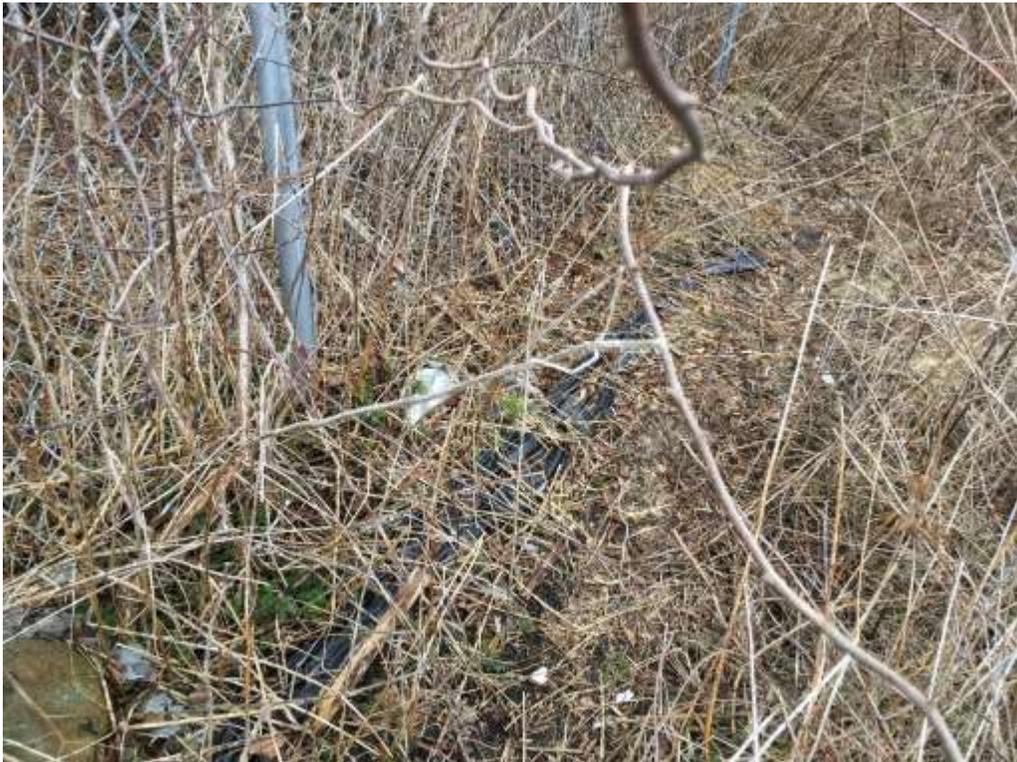
We notified the owner yesterday that we were doing an inspection and arranged for someone to be there at 11:15 AM to let us in. Art Palmer met us at 11:20 AM and accompanied us on our inspection. We walked the perimeter of the site. The area that is still active has a berm and sedimentation control. In some areas, the silt fence had flattened, but there was no sedimentation crossing it. We did suggest that in 1 place, the berm could be made slightly higher, however, we saw no evidence of sedimentation into the marsh area west of the site. The northern boundary of the site was reasonably well vegetated and had intact waddles to prevent sedimentation. A small erosion rill was noted in the northeastern corner of the site, that although it had not breached the sedimentation control, would probably do so in the future if not repaired.

The eastern boundary of the site, including the boundary with the Cardoza property, had slopes that were well vegetated with no evidence of erosion issues. As shown in the attached photograph, a small amount of soil had recently been accepted and mostly spread out. This sandy soil did not appear to contain debris or other solid waste.

In the center of the site, west of the road, was a large area where a shallow puddle had formed. This appears to be the ponded area in the photograph accompanying the complaint. However, the ponding seemed to be a result of accumulation of rain water from the site and not water from the marsh overflowing the berm.

We observed three areas that still need to be capped, which roughly measured 25 yards by 33 yards, 25 yards by 30 yards, and 75 yards by 40 yards, which equals approximately 4575 square yards remaining to be capped.
