**Department of Environmental Management  
Office of Waste Management**

**FIELD INVESTIGATION REPORT**

**Facility Name:** Portsmouth Town Dump  
**Date of Investigation:** September 12, 2014  
**Facility Address:** East Main Road, Portsmouth

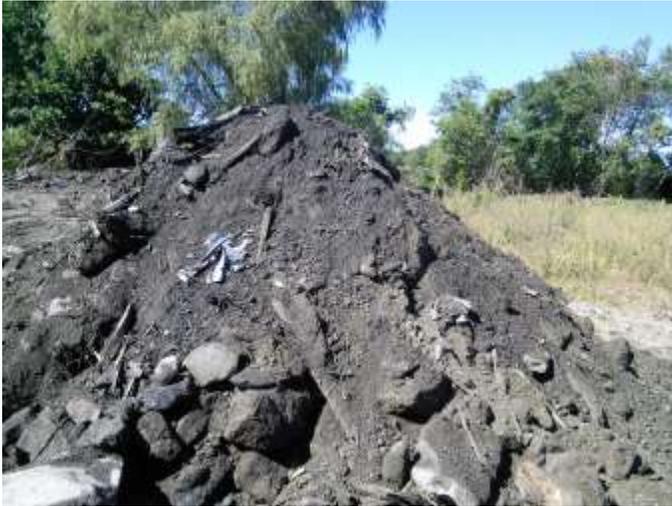
Photo 1: Freshly dumped sediments from East Providence with boulders and wood fragments looking west. Sample was taken from halfway up right side of this pile.

I arrived at the site at approximately 2:30 PM. I followed a truck into the site. When I arrived, Brian Almeida from Oliveira Construction was onsite. The truck that was in front of me was labeled M Field, Graton, MA and has a license MA 89292. Driver referred me to the truck behind him for the paperwork. That paperwork (attached photo) indicated with was from the Omega Pond Dam (copies of paperwork attached). The material they both dumped was a black sand with cobbles and boulders as well as pieces (many of them large) or highly weathered wood. The rocks in the load seems to be a blue mica schist. I did not detect any odor from these soils. I used a shovel to dig into the pile and collect a sample as per SOP's (see attached chain of custody). Mr. Almeida indicated this material met residential standards. They were spreading the material out as it was coming in, I asked why they were not using the material as cover, Mr. Almeida said that it was too difficult to screen out the pieces of wood and boulders to be able to work with the material.

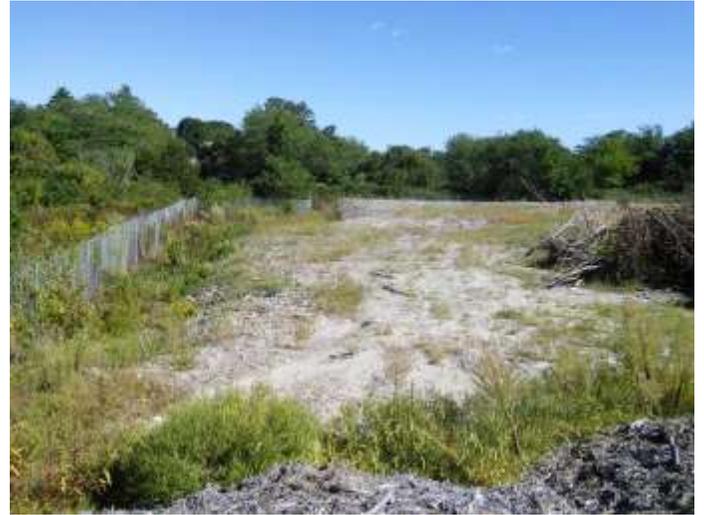
Photo 3: Area of bare soils on eastern boundary of property where grading and seeding will need to be done this fall. Looking south.

We also walked the site and he showed me the new area on the northeast corner of the site that had been cleared and fenced. The fill was very visible as shown in the picture. When they finish the area they are working it, this will be the next area filled. We also looked at the eastern boundary of the site and I mentioned the renewal requires they start loaming and seeding by 9/20 and finish by the end of November.

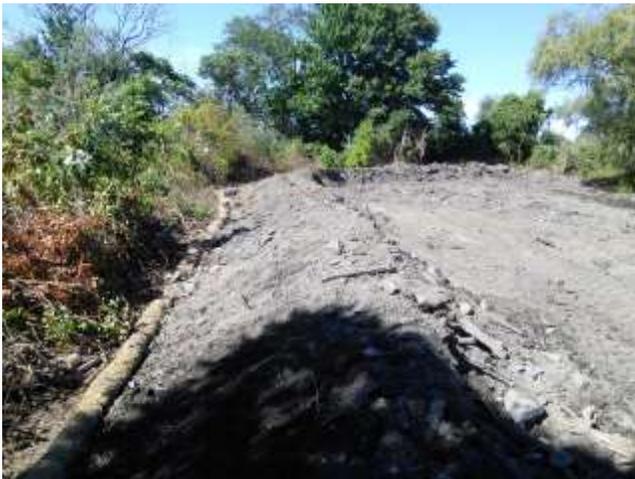
Photo 2: Looking north near property boundary showing bermed area and sedimentation controls (to left)

They were actively filling the boundary near VHB-13 and had constructed soils berms to contain the area. There was another relatively fresh surface, I asked where that material had come from. Mr. Almeida said it was from a mansion in Newport. It was a very dark, sandy material without large cobbles and wood, I took a sample of this material as well by digging a few inches from the top. Copies of paperwork are also attached.

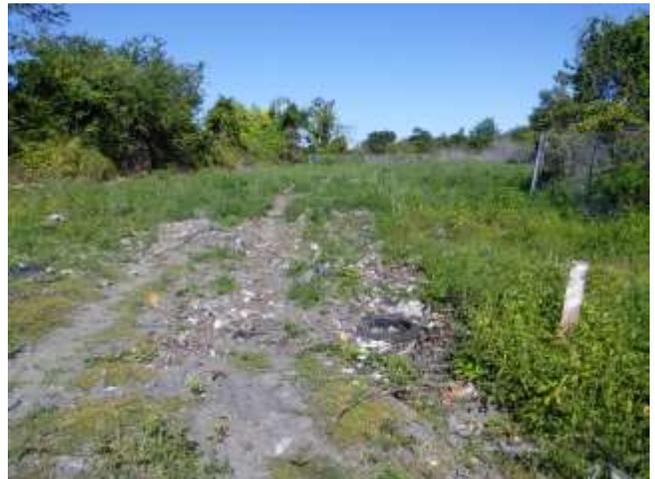
Photo 4: Newly fenced area in Northeast corner of property showing fill material that requires cover. Looking northeast.

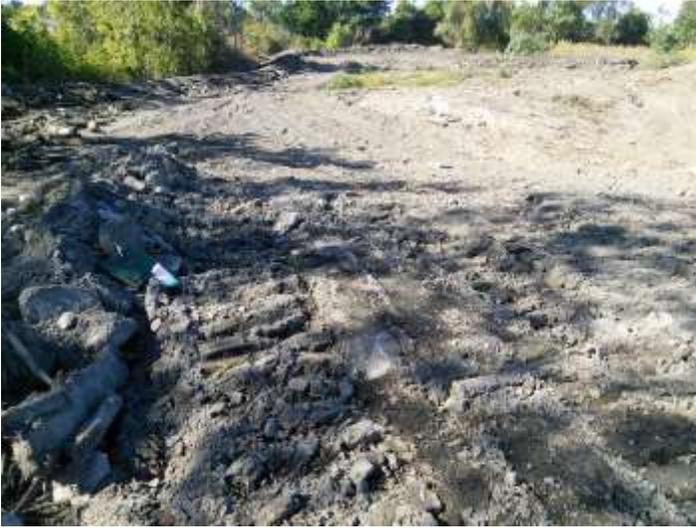
Photo 5: Soils reportedly from Newport that had been spread out in the area around TP-27 that

were sampled.

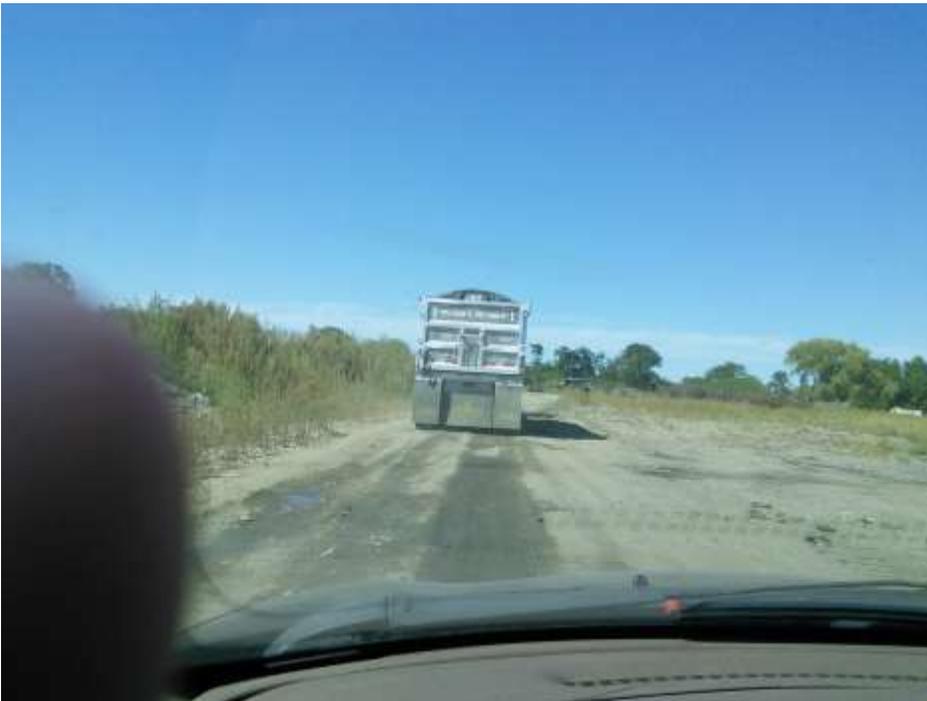
Photo 6: Photo taken on the way in showing fairly good dust control on road.

Although it has been very dry lately, dust control on the access road in the site was good. Material being dumped was relatively moist and did not seem to create a dust problem when dumped. However, there was an area just southeast of the active face. This area had a layer of dust a few inches thick, it had the consistency of talcum powder and was very dry. It seemed possible this was dust that had settled out from work being done in the area. It was so fine and dry that just walking over it kicked up dust. I asked Mr. Almeida to wet this area and stayed to observe it being done. After observing him wet it, I opined that wetting it may not be adequate and that perhaps he should cover this. He said he was thinking he would finish wetting it and then scrape and bury this material. I thought that would work also.
