**TOTAL MAXIMUM DAILY LOAD ANALYSIS FOR THE PAWCATUCK RIVER
AND LITTLE NARRAGANSETT BAY WATERS
BACTERIA IMPAIRMENTS**

**Final Report
September 28, 2010**

**RHODE ISLAND DEPARTMENT OF ENVIRONMENTAL MANAGEMENT
OFFICE OF WATER RESOURCES
235 PROMENADE STREET
PROVIDENCE, RI 02908**

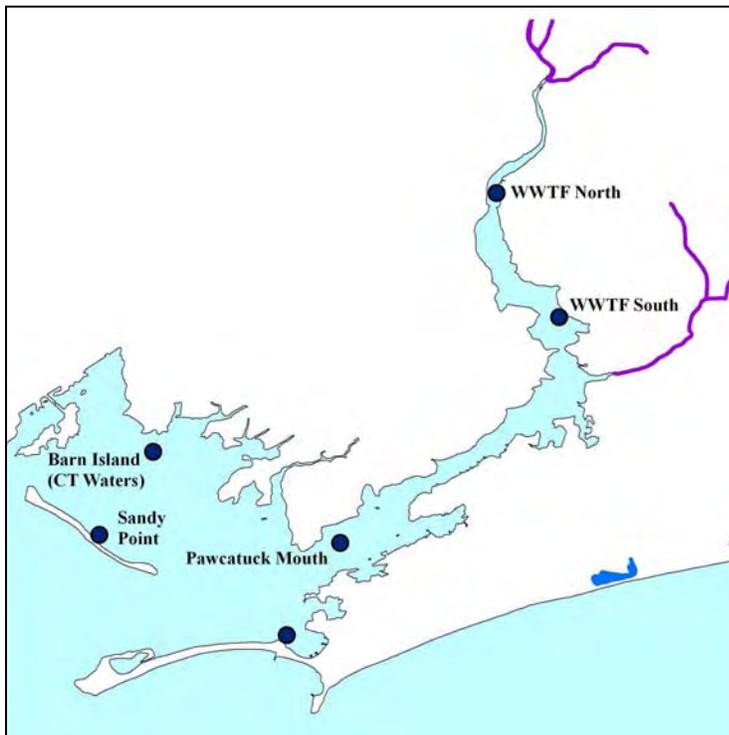
Save the Bay Enterococci Data

Station ID	Description	Latitude	Longitude
WWTF North	Upstream Westerly WWTF Outfall	41.364397	71.83723
WWTF South	At Nun Buoy #20	41.349881	71.82991
Pawcatuck Mouth	At Can Buoy #1	41.323425	71.8555
Watch Hill Harbor	At the Flashing Buoy at the entrance channel to Watch Hill Cove.	41.312644	71.86176
Sandy Point	Little Narragansett Bay – North of eastern end of Sandy Point.	41.3244	71.8837
Barn Island	Little Narragansett Bay – Barn Island Ramp (CT Waters)	41.334111	71.8774
