Bailey's Brook

Watershed Description

This **TMDL** applies to the Bailey's Brook assessment unit (RI0007035R-01), a 4.8-mile long stream located in Middletown, RI (Figure 1). The Town of Middletown is located on Aquidneck Island and Bailey's Brook is situated in the southern portion of the Island. The Bailey's Brook watershed is presented in Figure 2 with land use types indicated.

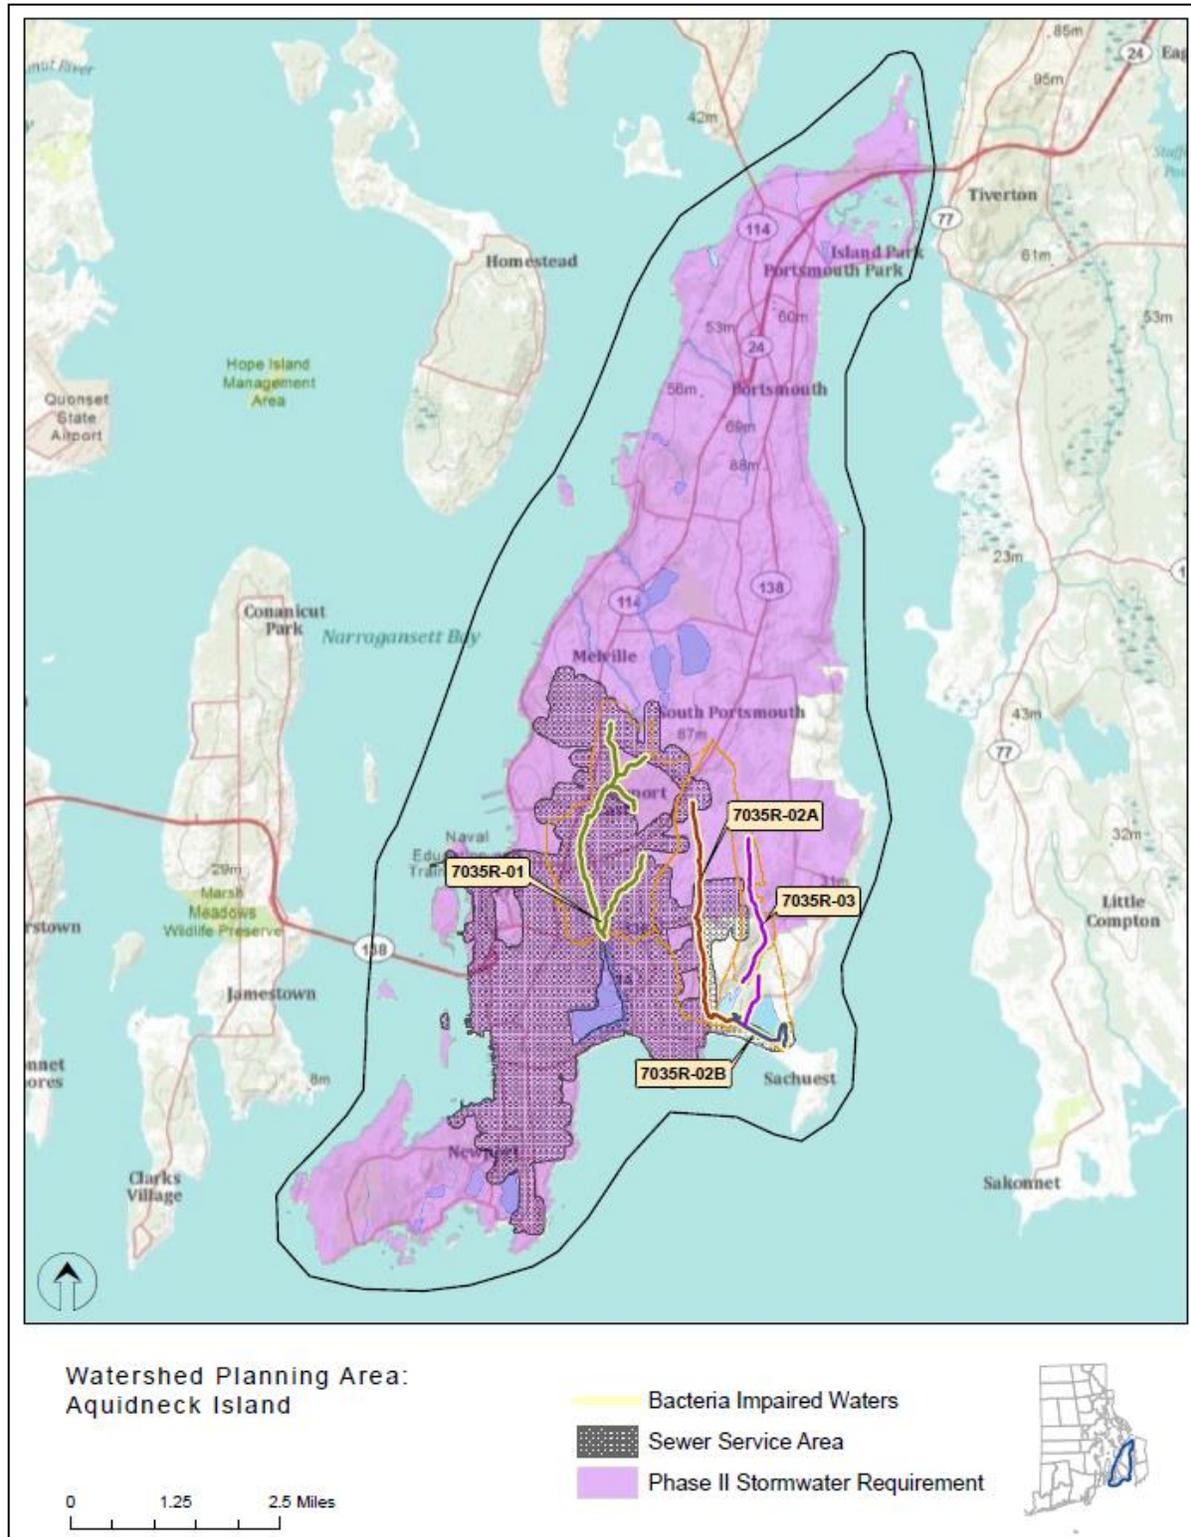
Figure 1: Map of the Aquidneck Island Watershed Planning Area with impaired segments addressed by the Statewide Bacteria TMDL, sewer service areas, and stormwater regulated zone.

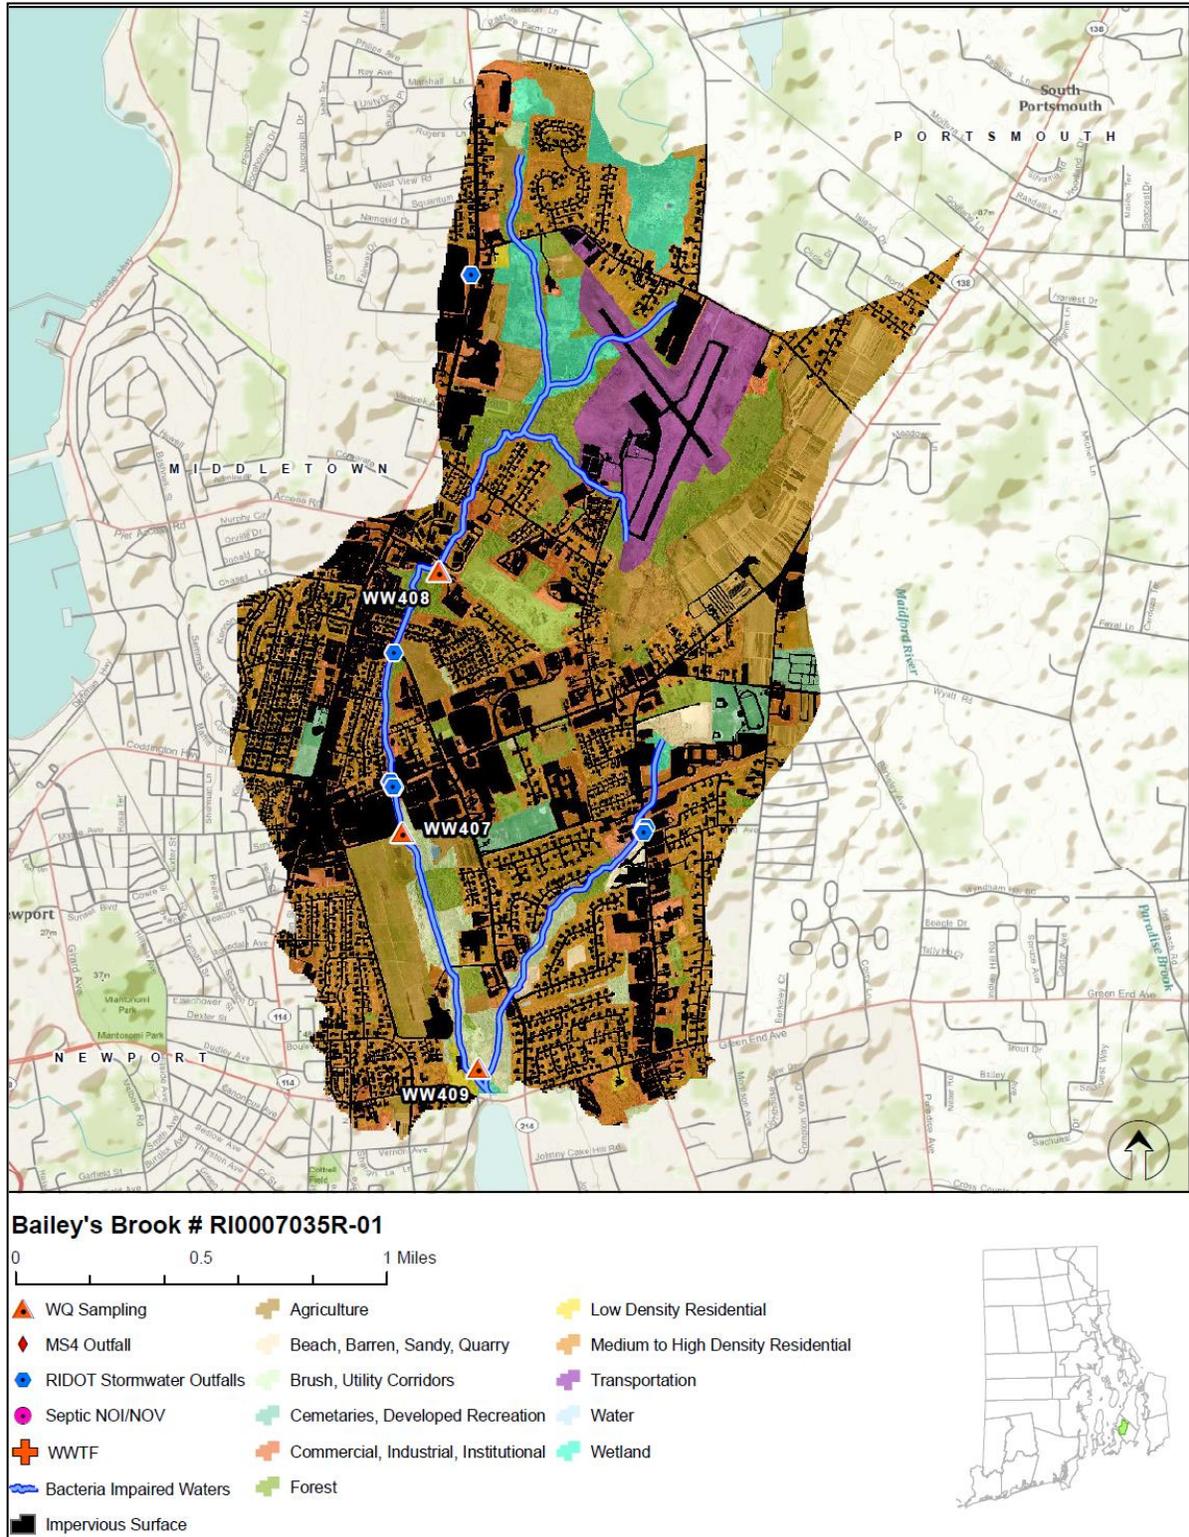
Figure 2: Map of Bailey's Brook watershed with impaired segment, sampling locations, and land cover indicated.

The Bailey's Brook watershed covers 3.1 square miles and is highly developed, as shown in Figures 2 and 3. Approximately two-thirds (68%) of the Bailey's Brook watershed is developed land, including the Newport State Airport and other commercial, residential, and transportation land uses. Agricultural uses occupy 15% of the land area. Forests and other non-developed areas occupy 12%, wetland and surface waters occupy 4%, and other land uses combine to occupy 1%.

As shown in Figure 2, five Rhode Island Department of Transportation (RIDOT) stormwater outfalls¹ have been identified in the Bailey's Brook watershed, with multiple outfalls directly on the brook. A watershed management plan was developed for Bailey's Brook and identified numerous locations where stormwater runoff was directly connected to the brook (Geosyntec, 2005). In the 2007 Eutrophic Ponds Phosphorus TMDL, these stormwater outfalls were also considered to contribute large amounts of phosphorus to Bailey's Brook, resulting in high concentrations in North Easton Pond (RIDEM, 2007). As stormwater is known to carry a suite of pollutants other than phosphorus, these locations are likely sources of bacteria to Bailey's Brook.

Bailey's Brook is mostly sewered, but also relies partially on onsite wastewater treatment systems (OWTS) (i.e., septic systems). Failing OWTS can be significant sources of bacteria by allowing raw waste to reach surface waters (RI HEALTH, 2003). As shown in Figure 2, no OWTS Notices of Violation/Notices of Intent to Violate (NOV/NOIs) have been issued by the RIDEM Office of Compliance and Inspection in the Bailey's Brook watershed.

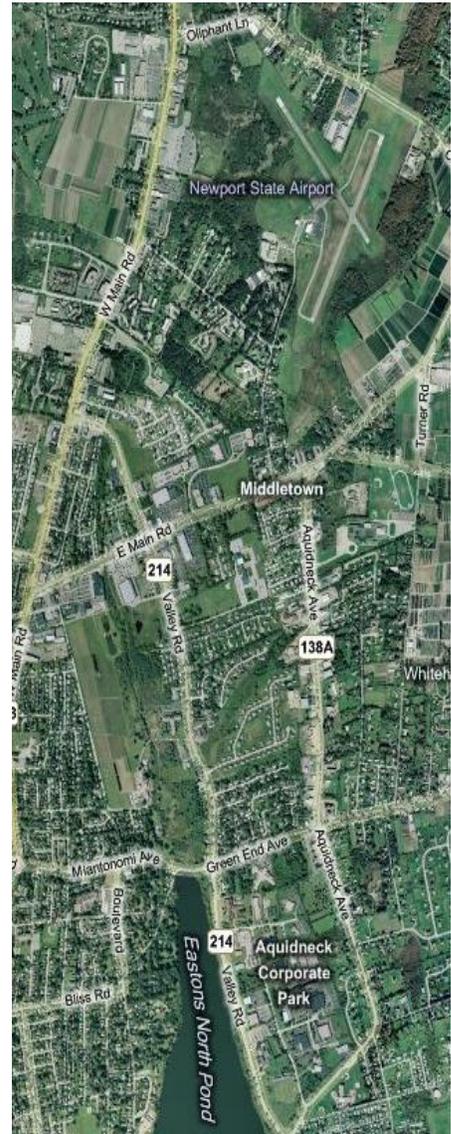
Figure 3: Partial aerial view of Bailey's Brook watershed. (Source: Bing Maps)
