# Dutemple Brook

## Watershed Description

## **Assessment Unit Facts** **(RI0008039R-30)**

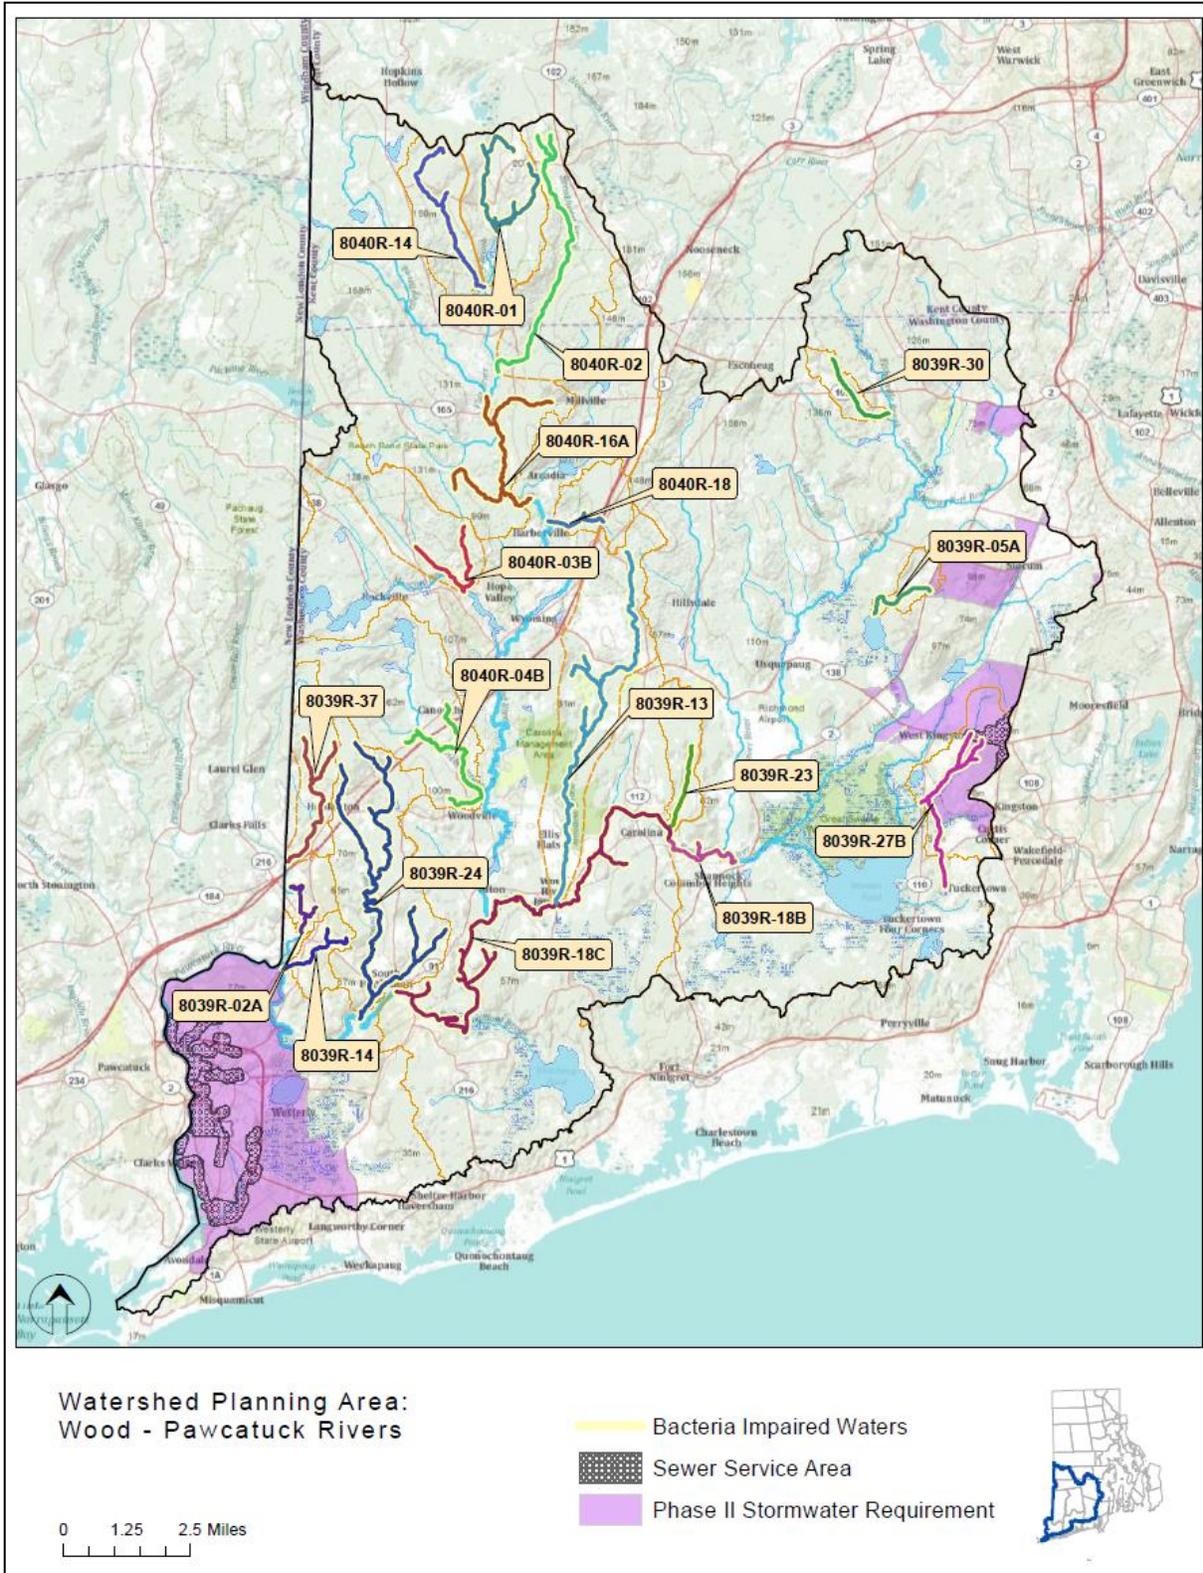
**Figure 1: Map of the Wood-Pawcatuck Watershed Planning Area with impaired segments addressed by the Statewide Bacteria TMDL, sewered areas, and stormwater regulated zones.**

This **TMDL** applies to the Dutemple Brook assessment unit (RI0008039R-30), a 1.8-mile long stream located in Exeter, RI (Figure 1). The Town of Exeter is located in the southern portion of the state and Dutemple Brook is located in the northern section of town. The Dutemple Brook watershed is presented in Figure 2 with land use types indicated.

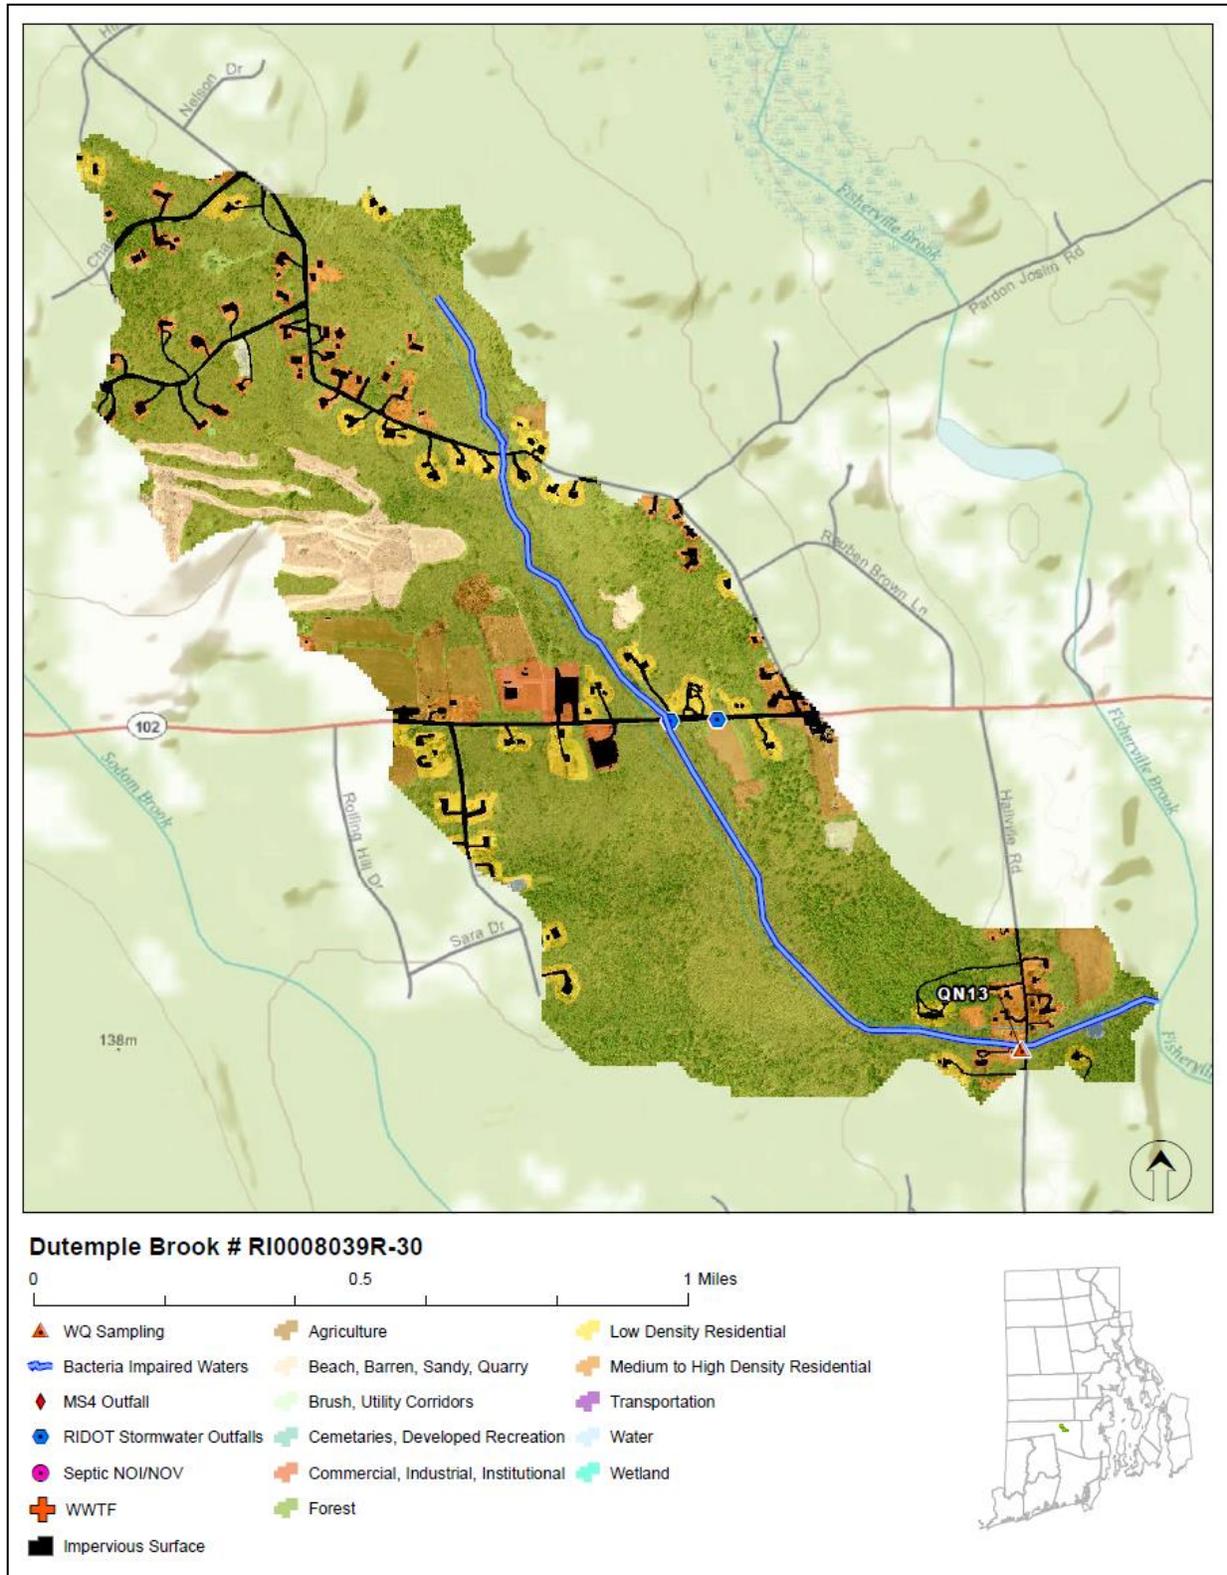
**Figure 2: Map of the Dutemple Brook watershed with impaired segment, sampling location, and land cover indicated.**

As part of Phase II requirements, the Rhode Island Department of Transportation (RIDOT) has identified and mapped its stormwater outfalls throughout the state. As shown in Figure 2, two outfalls are found in the Dutemple Brook watershed, and are concentrated along Route 102.

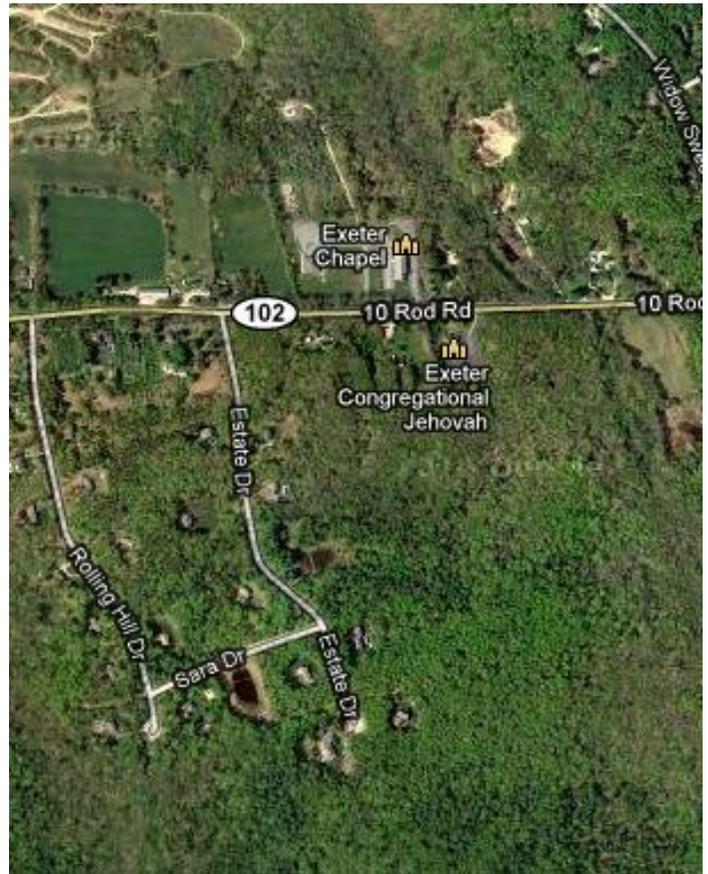
**Figure 3: Partial aerial view of the Dutemple Brook watershed. (Source: Google Maps)**
