# Shellfish Program Classification Report

# **Upper Narragansett Bay**

## **Growing Area 1 Triennial Re-Evaluation**

**May 2015**

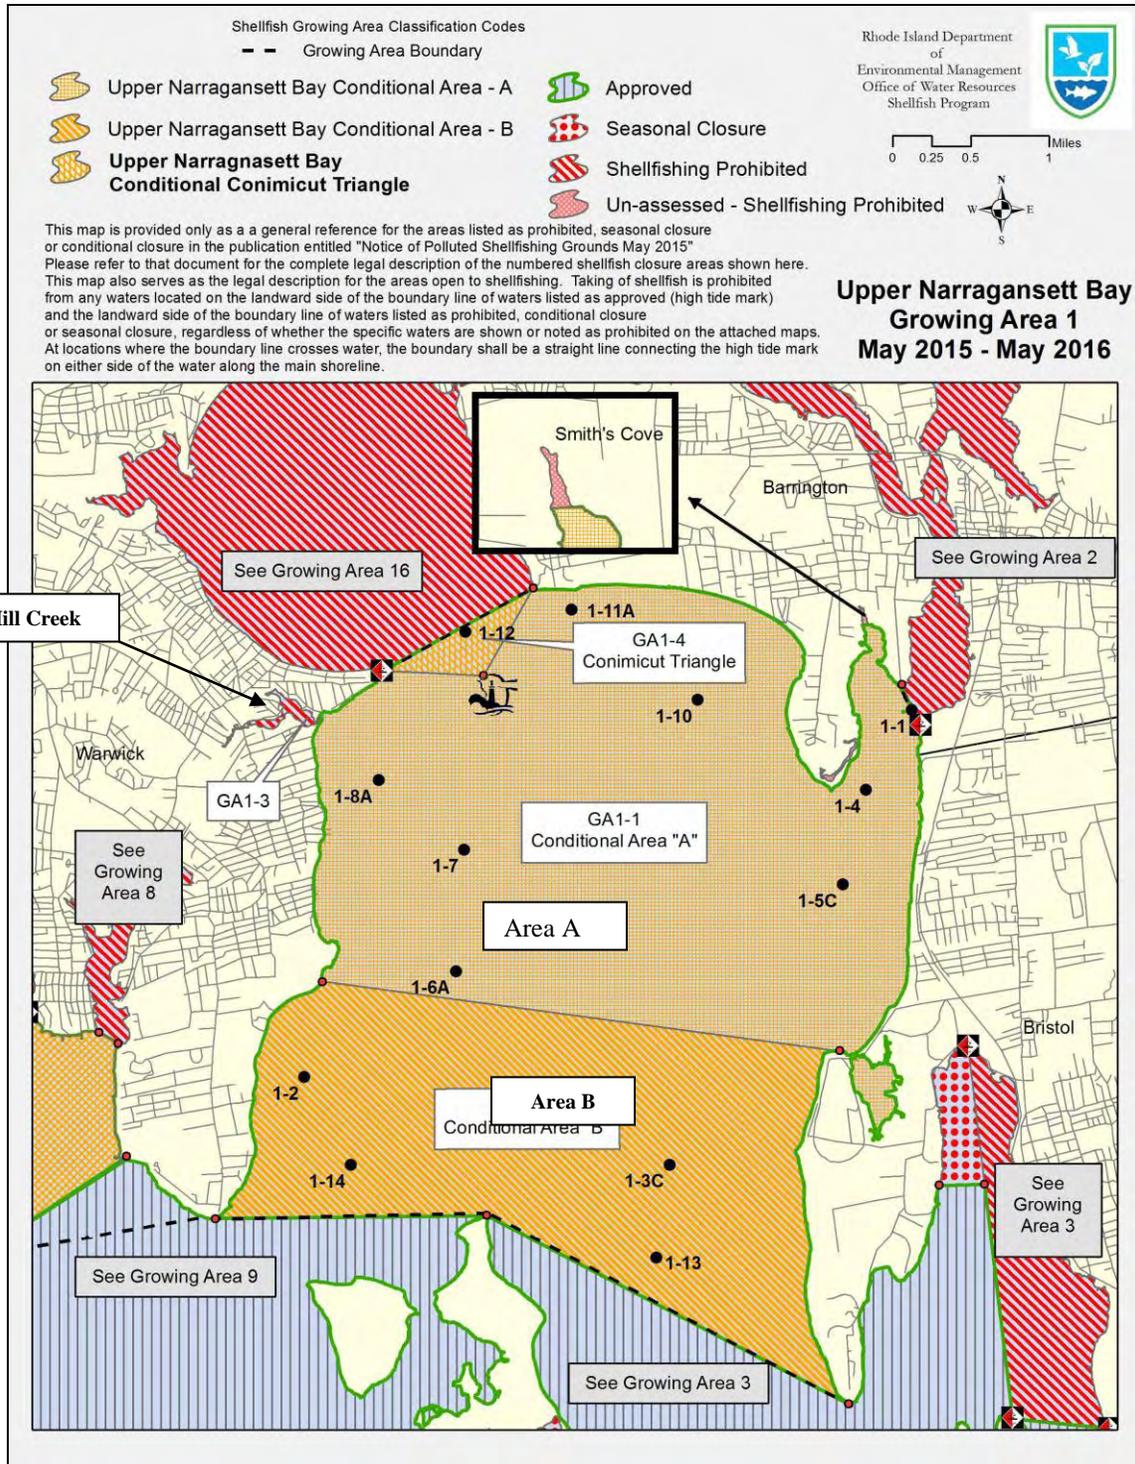
**Figure 1 Upper Narragansett Bay – Growing Area 1**

The Upper Narragansett Bay – Growing Area 1 is presently divided into three sections, conditionally approved areas A and B and the Conimicut Triangle (Figure 1.1). There is currently one area; Old Mill Creek closure number GA1-3 that is classified as prohibited to shellfishing. Two other areas east of Rumstick Neck are unassessed, Smith Cove and a smaller inlet to the south and are therefore also prohibited. With the addition of two stations in conditional area “B” in 2010, the total number of monitoring stations within this growing area is thirteen.

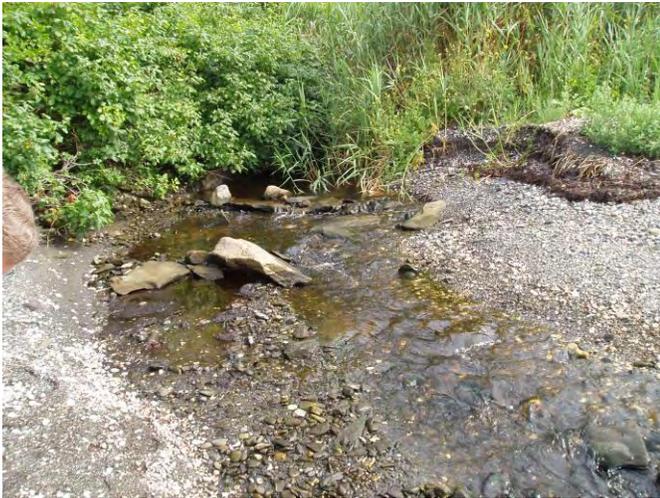
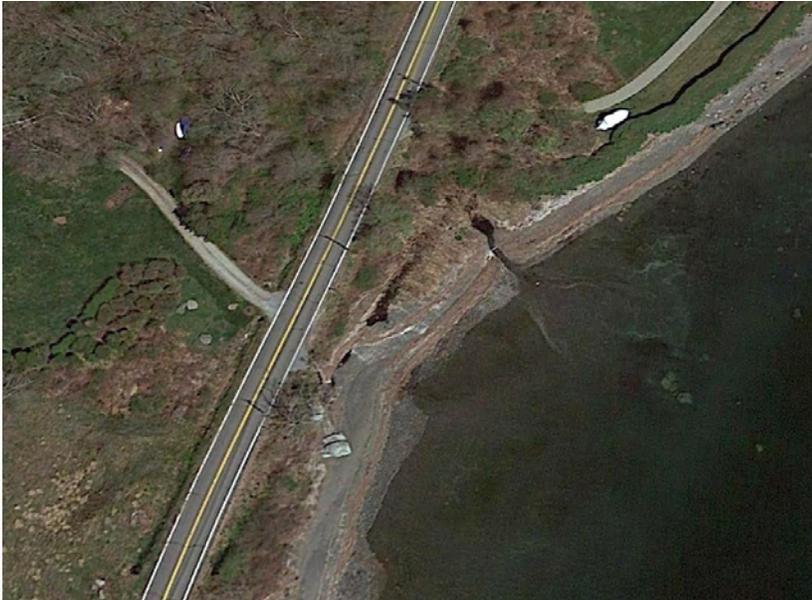
Source 2015-6-001 is a small stream that emanates from an upstream wetlands thru a culvert under E. Shore Rd. Initially during the survey in July this source had bacteria counts of 800 CFU/100ml and a volume of flow of 1.06 cfs. This stream due to the larger flow volume was re-inspected in October. On the 23<sup>rd</sup> a sample with results of 677 CFU/100 ml and a flow rate of 0.03 cfs were measured. In addition a sample of the receiving waters in front of this stream was also taken. Results were 320 CFU/100ml. General observations at the time were there were numerous marine birds in the general area of this stream and a kayaker was unloading gear from his kayak at this popular launch site.

Impacts from this stream are calculated in the following analysis and are used to support a closure area for this point source.

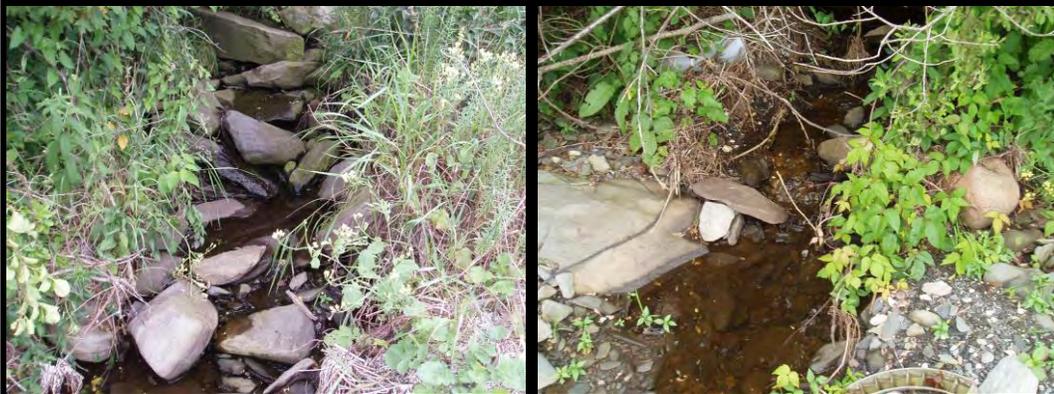
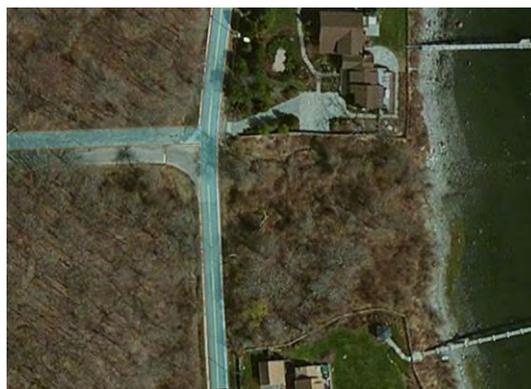
Source 2015-6-102 is a small stream with bacteria counts of 1100 CFU/100ml and an estimated volume of flow of .035 cfs. This stream flows through an empty lot and originates from a large wooded area to the west. There would not appear to be any anthropogenic sources influencing this source and therefore not having a negative impact on the receiving waters.

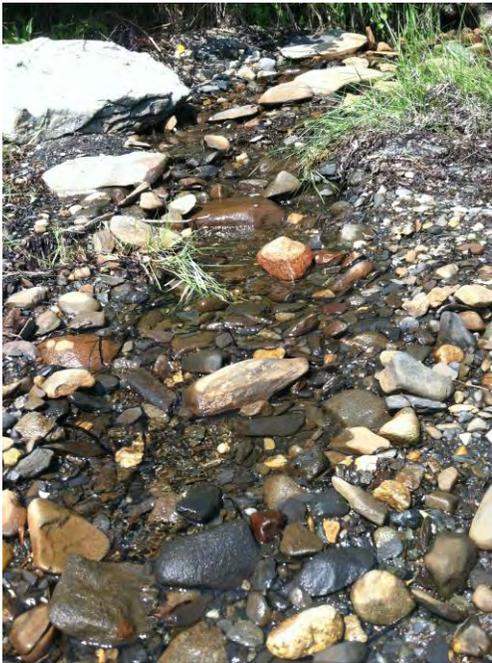
2015-6-106

Source 2015 6-106, 107 and 109 are small streams through the woods from the rear of very large acreage residential lots. Bacteria counts for 6-106 were 1430 CFU/100ml very low flows that faded out into the sand prior to reaching the high tide line. This source would not appear to be impacting the receiving waters.

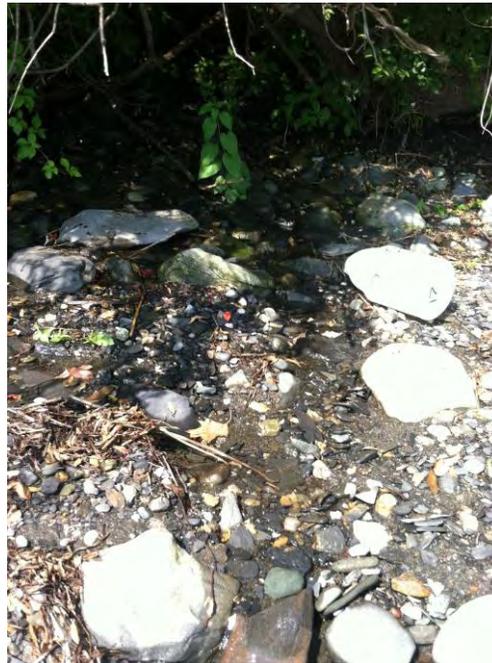
Source 2015-6-107 is a small 2” dia. pvc pipe again at the rear of a very large residential lot south of the source mentioned above. Bacteria counts were 662 CFU/100ml with again very low flows that did not reach the receiving waters and therefore not impacting water quality.

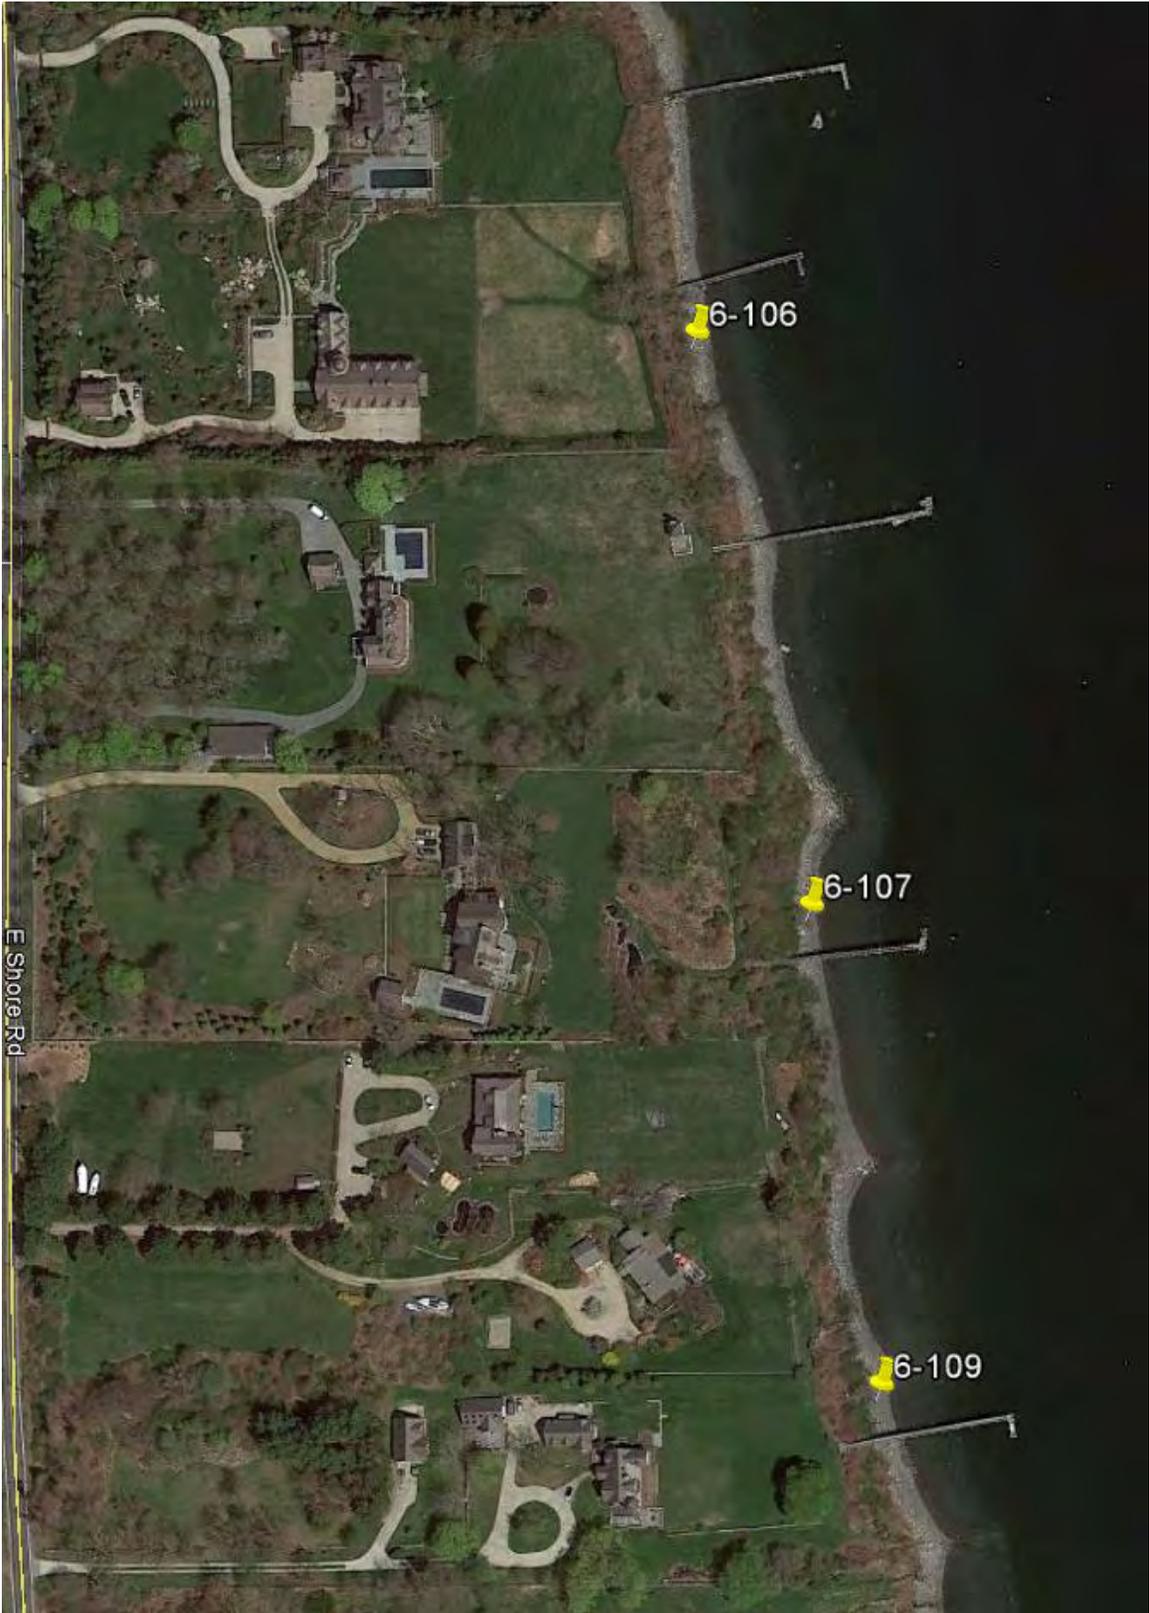
Source 2015-6-109 (No picture available) is another stream south of the above two source with similar conditions. Bacteria counts were 685 CFU/100ml and again faded into the sand above the high tide mark. The following photograph locates all three sources and the landward upstream conditions of these large residential lots.

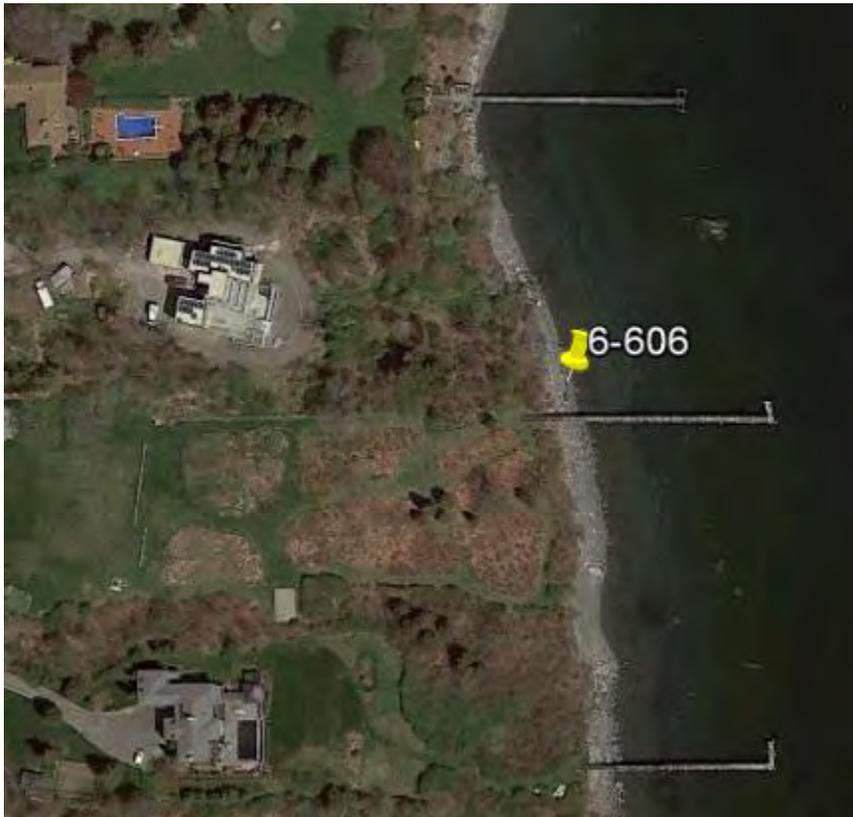
Source 2015-6-606 were multiple groundwater seeps flowing over a rock faced wall. Each of the streams were only a drip with bacteria counts of 1720 CFU/100ml. Although the bacteria count was slightly elevated the volume of these drips and the fact they were not reaching the receiving waters would indicate that they are not having a negative impact on water quality.

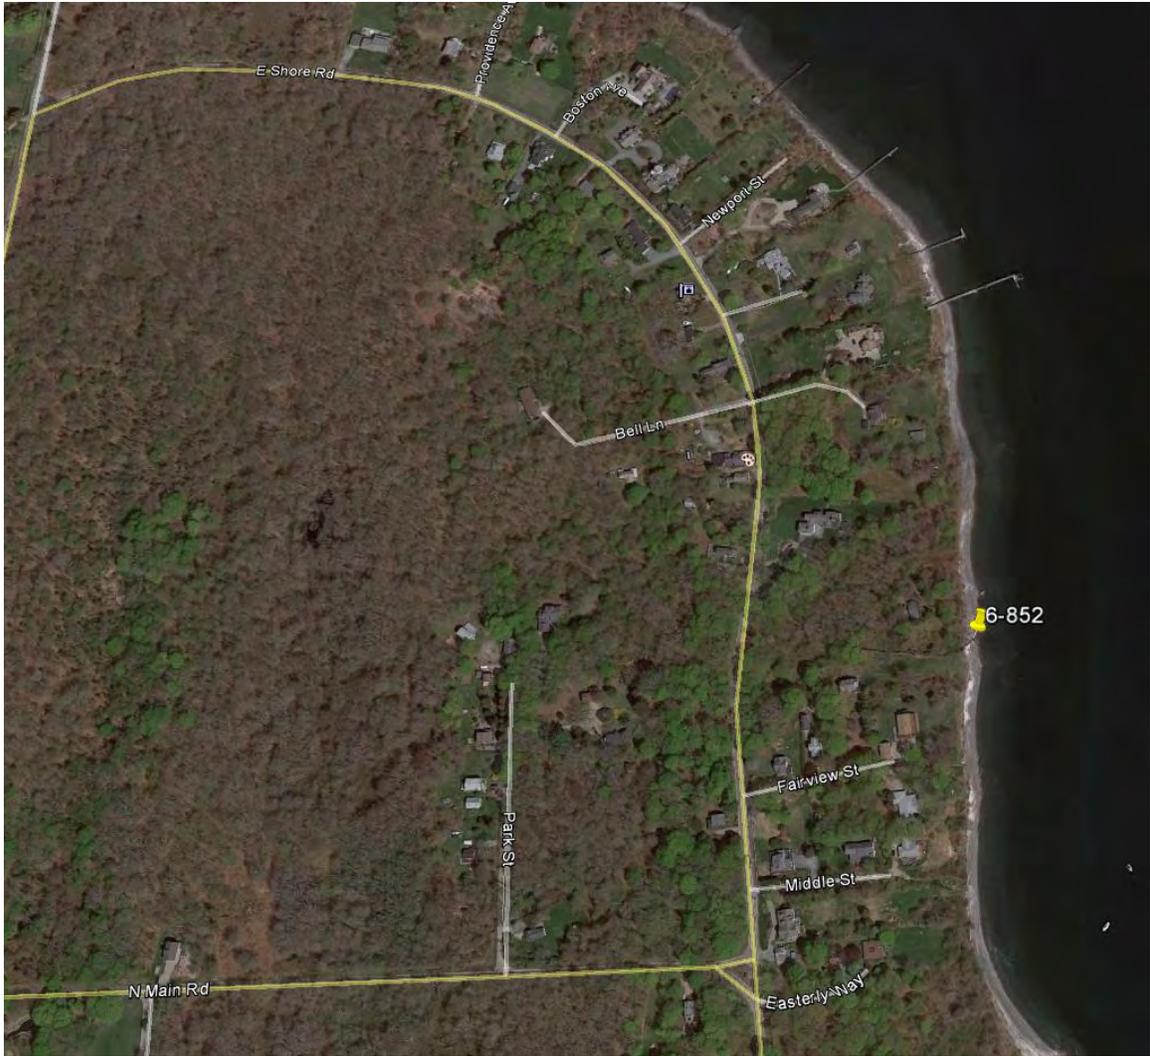
Sources 2015-6-850 and 852 are at the northern end of Jamestown. Source 6-850 is a ground water seep at a brick abutment north of Broad Street. The bacteria count was 300 CFU but volume of flow was only a drip. This would indicate there are not impacts to the receiving waters by this insignificant source. Source 6-852 was a larger stream again north of Broad Street. Bacteria counts were 560 CFU/100ml and volume of flow was 0.4 cfs. This upland landuse is sparsley populated with a very large wooded area surrounding the source of this stream. Due to the lack of anthropegenic source it would not appear that this source is having a negative impact to water quality.

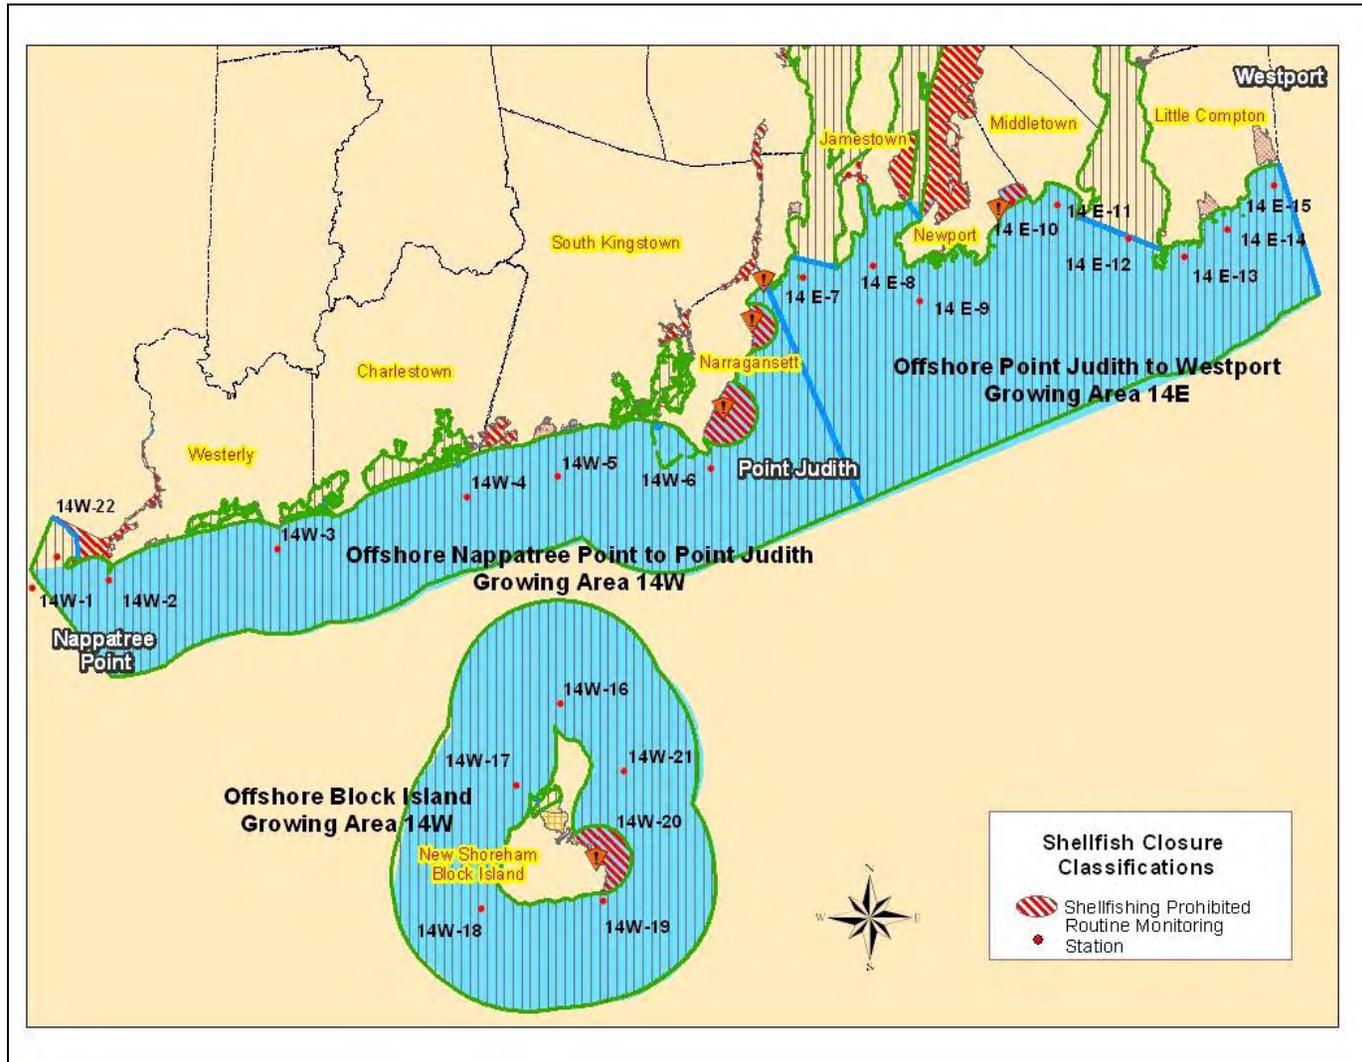
Figure 2-1 Offshore Growing Area 14E and 14W including Block Island Offshore

Growing area 14W is approximately 54,962 acres and additionally includes the offshore Block Island growing area of approximately 62,633 acres for a total of 117,595 acres. The easterly portion of the growing area designated GA-14E is approximately 83,512 acres of offshore waters. The offshore growing area is considered remote and is monitored following the guidance of the NSSP manual for remote areas. Routine sampling is conducted twice a year either by Office of Water Resources Shellfish Program personnel or the New Shoreham Harbor Masters Office.
