May 24, 2004

Subject: Notice of Intent to Enforce dated April 30, 2004, received May 5, 2004
Springfield Street School Complex, Case 99-018

TITLE: **PHOTOGRAPHS OF EROSION CONTROL REPAIRS**

LOCATION:
SPRINGFIELD STREET SCHOOL COMPLEX
SPRINGFIELD STREET
PROVIDENCE, RHODE ISLAND

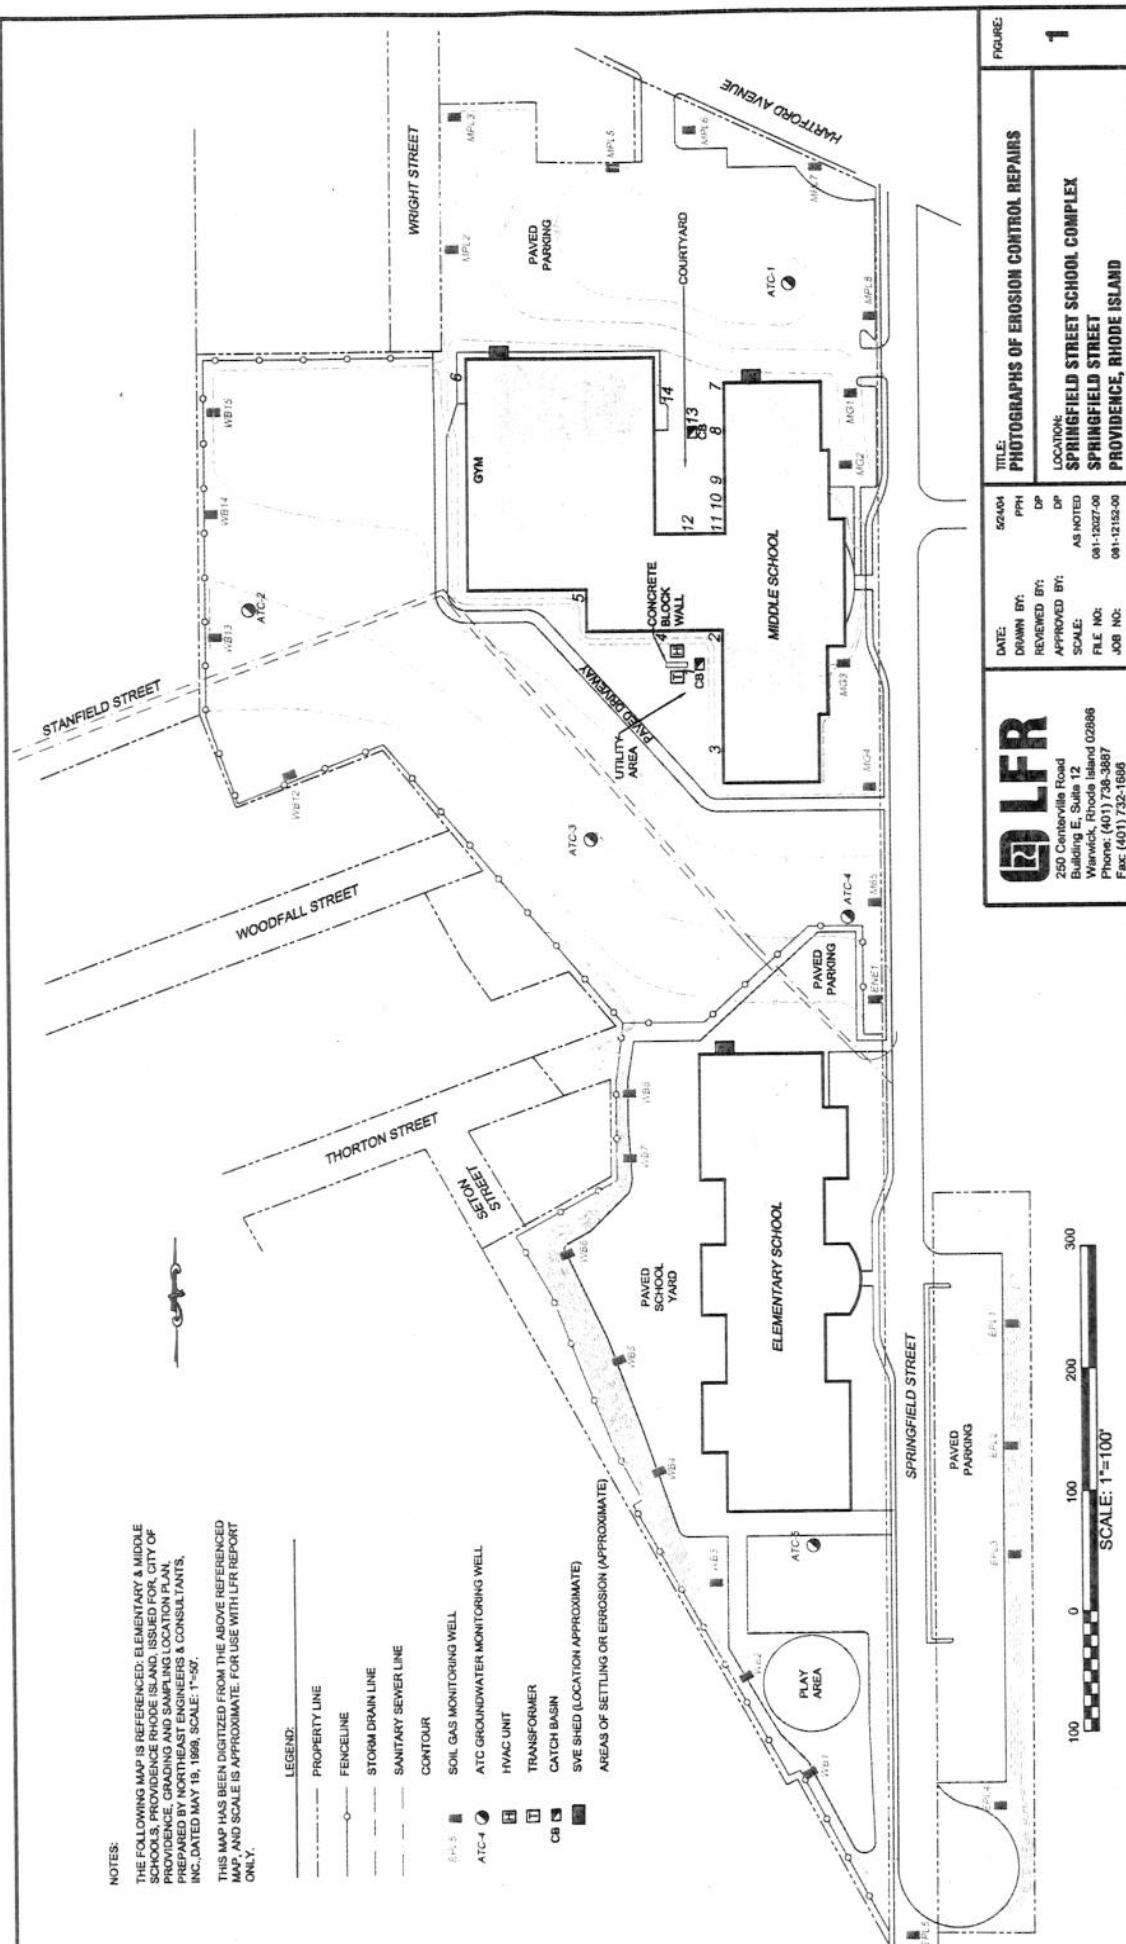
- b) Settled and eroded areas were repaired on May 13, 2004. Photographs taken on May 14, 2004 showing the repaired areas are attached along with a map showing the locations of the repairs.
