Field Inspection Report

September 27, 2006
Anthony Carnevale Elementary School
Christopher Del Sesto Middle School
Springfield Street, Providence R.I.

RE: RIDEM Office of Waste Management
2006 Inspection of exterior cap and grounds of the elementary and middle school property
(approx. 9:50 am- 10:40 am)

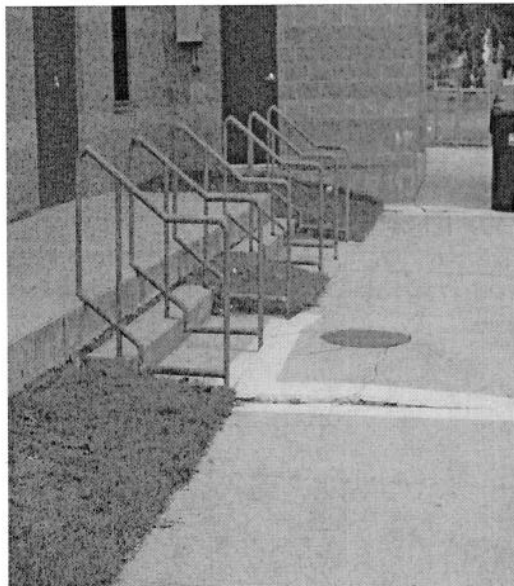
18

The grass on the north side of the main entrance appears to have exposed surface soil along with some brown spots where the grass has either worn out or failed to grow (Photos #12 and 13). On the north side of the middle school building and near the faculty parking lot, there are some areas of exposed soils near the building exits #18 and #19 (Photo #14). As previously reported, in the courtyard on the north end of the building standing water and asphalt patching is present around the storm drain that is need of a major repair (Photos #15 and 16). There are some cracks visible, but no evidence of the underlying marker barrier or waste materials. Also as previously reported the handicap ramp, walkways on the north and west side have been affected by the ground settling and door's labeled #9, #10 and #11 (Photos#17-20). The equipment in the mechanical room was running.
