-- WATERMAN LAKE DAM --

VISUAL INSPECTION / EVALUATION REPORT

Owner: *Citizens for the Preservation of Waterman Lake, Inc.*

Date of Inspection: *June 9, 11, and 12, 2020*

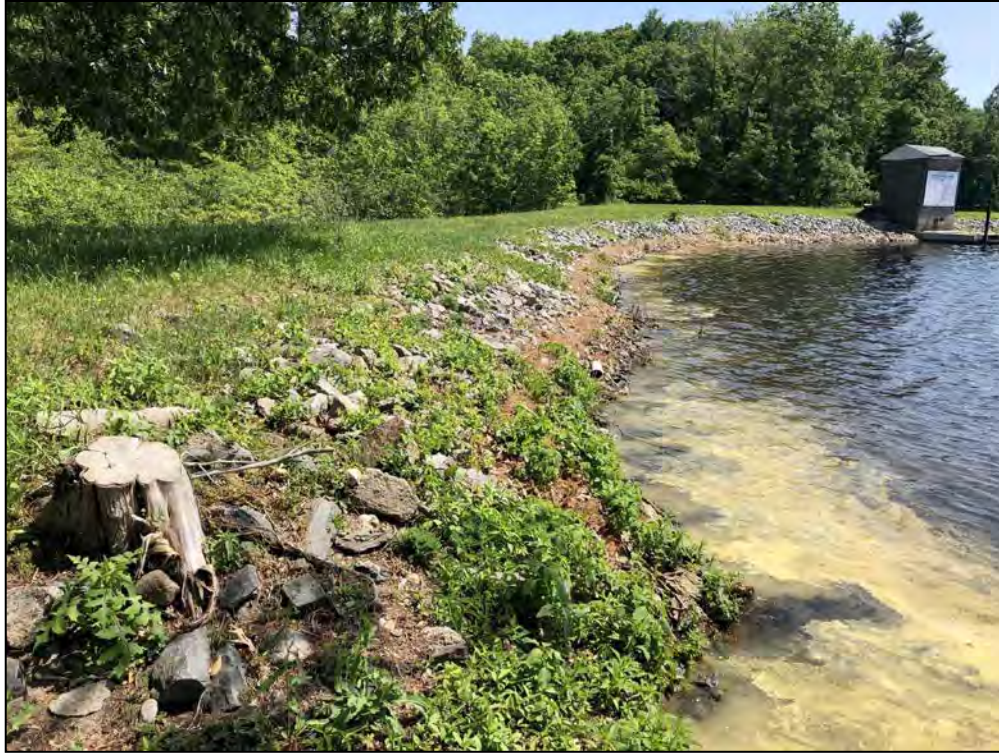
Photo No. 1: Main Dam - Upstream side of the dam from near the left abutment looking right.

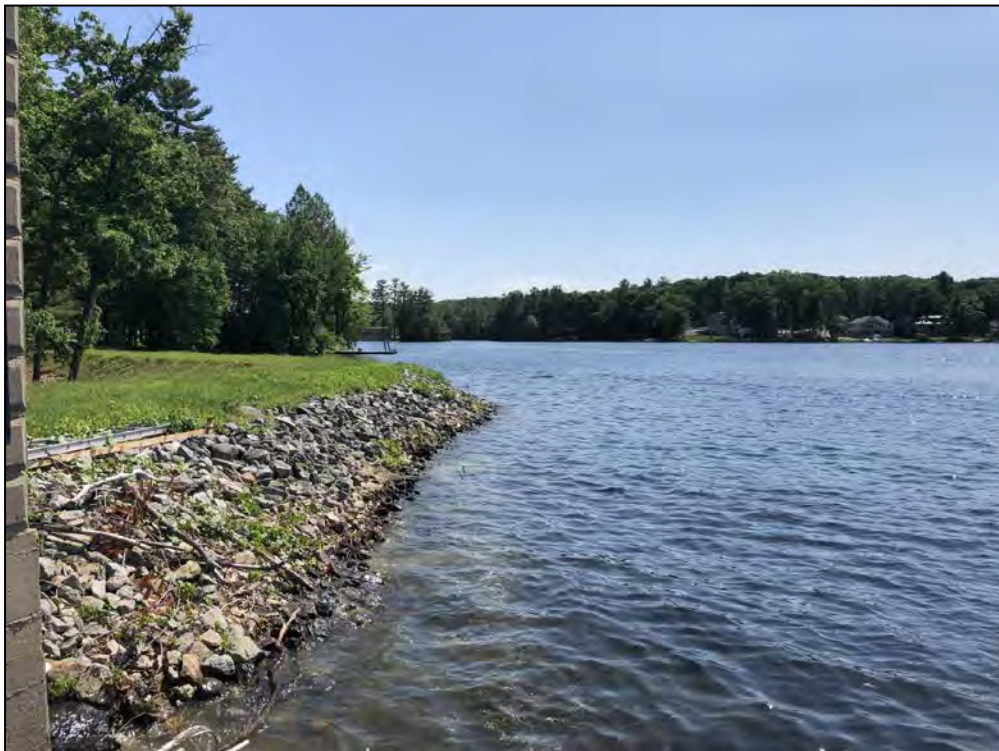
Photo No. 2: Main Dam - Upstream side of the dam from near the gatehouse looking left.

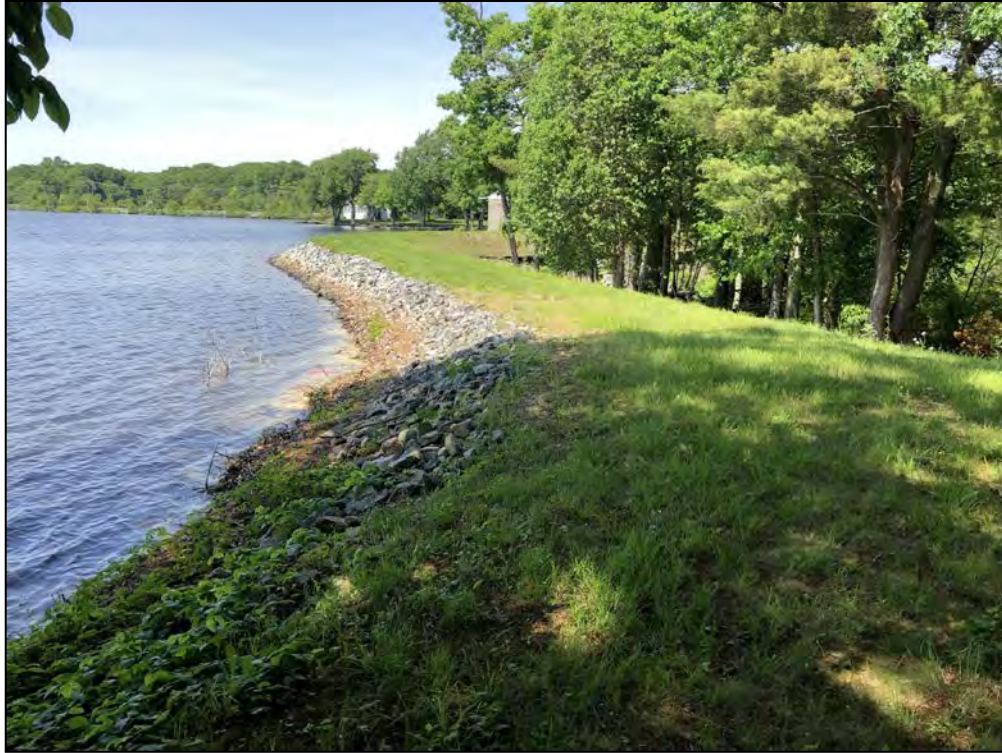
Photo No. 3: Main Dam - Upstream slope from the right abutment looking left.

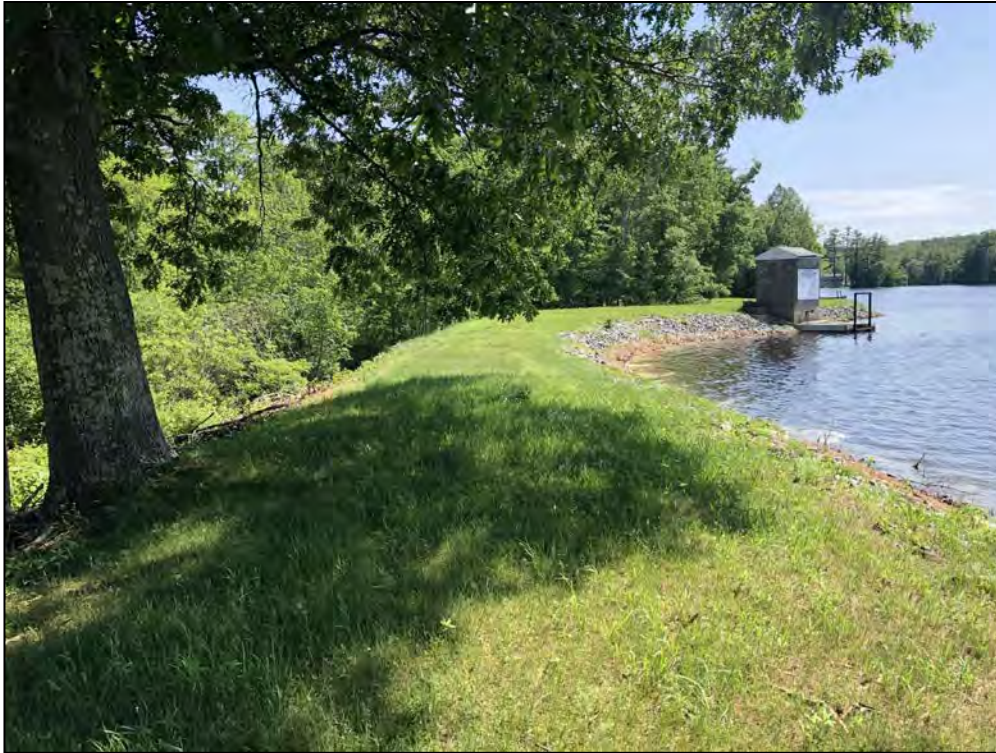
Photo No. 5: Main Dam - Crest from left abutment looking right.

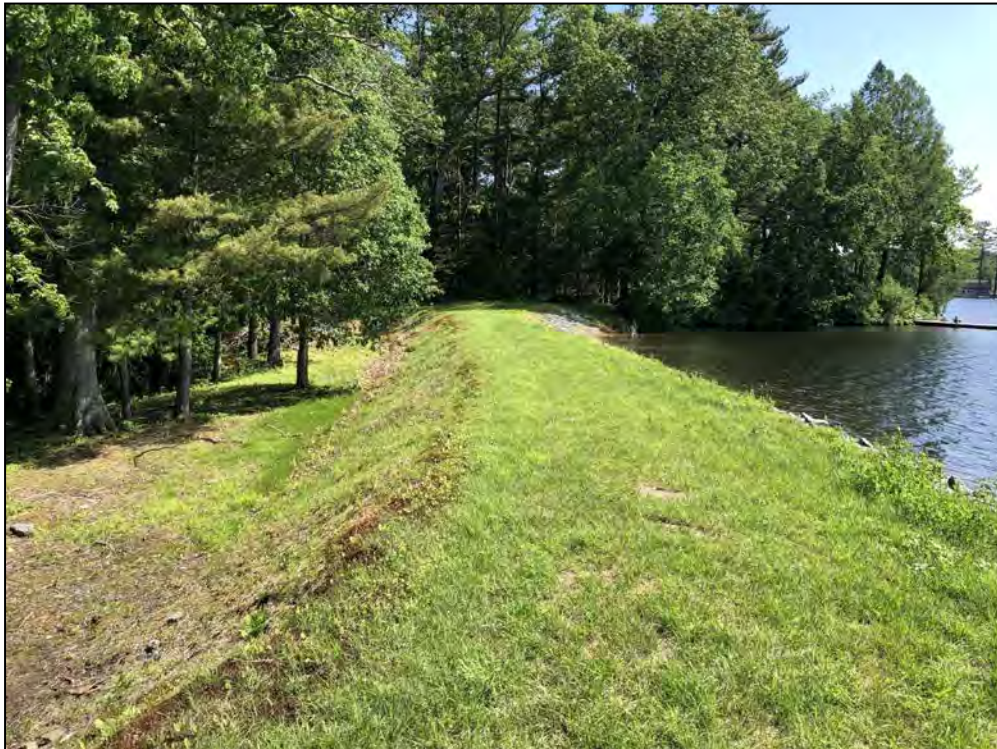
Photo No. 6: Main Dam – Crest from right of the low-level outlet looking right.

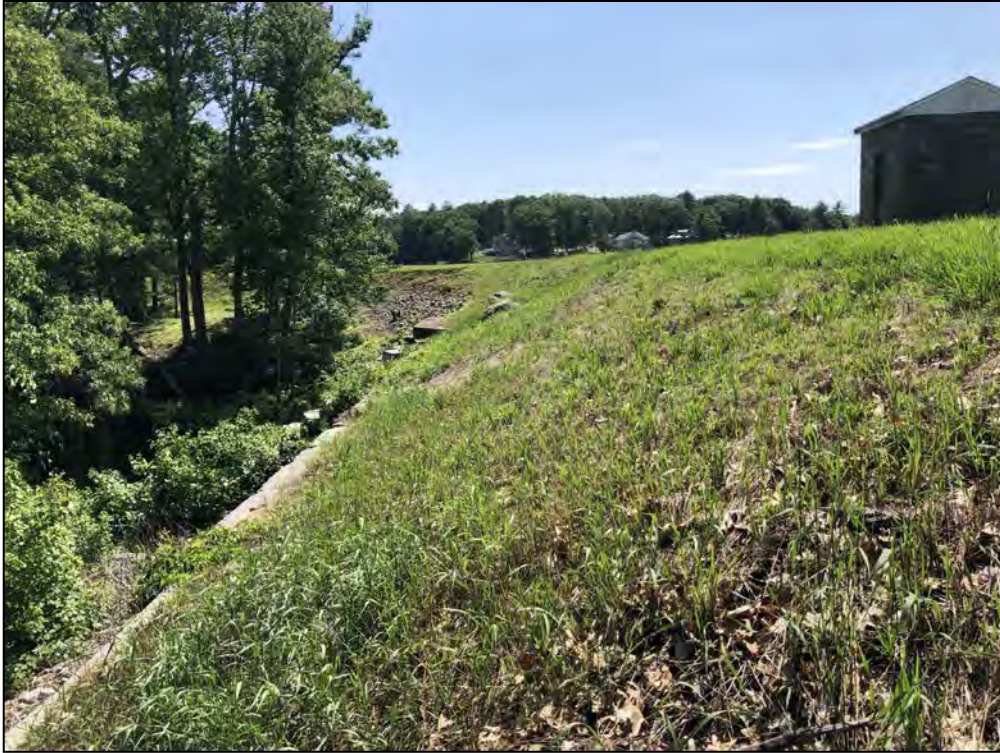
Photo No. 7: Main Dam - Downstream side of the crest from left of the low-level outlet looking right.

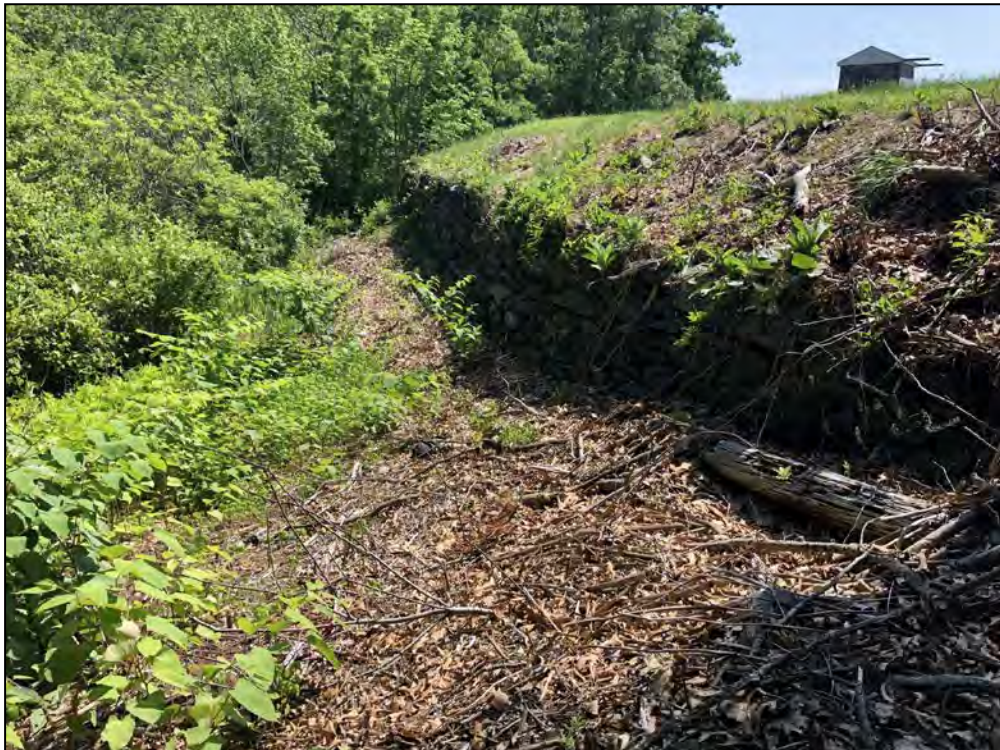
Photo No. 8: Main Dam - Area downstream of the downstream wall from near the left abutment looking right.

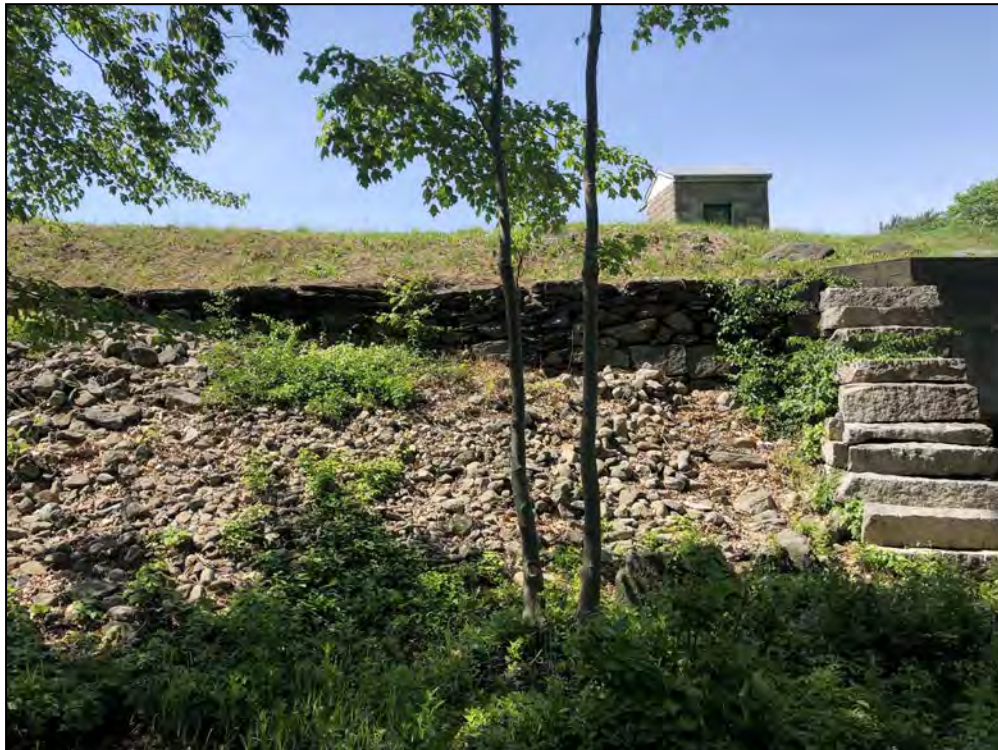
- The wall right of the outlet was buttressed with 3 to 6-inch diameter stone and was generally clear of unwanted vegetation.
 - An area of seepage was previously observed along a 3 to 5-foot long section of the toe of the buttress stone with clear flow approximated at 10-20 gpm. During this inspection, the tailwater (approximately 6 inches higher than reported during the previous inspection) inhibited confirmation of this observation. No signs of flow were observed during this inspection. Minor scarping up to 6 inches was located along this area at the waterline.

Photo No. 10: Main Dam - Downstream wall and area right of the low-level outlet wall.

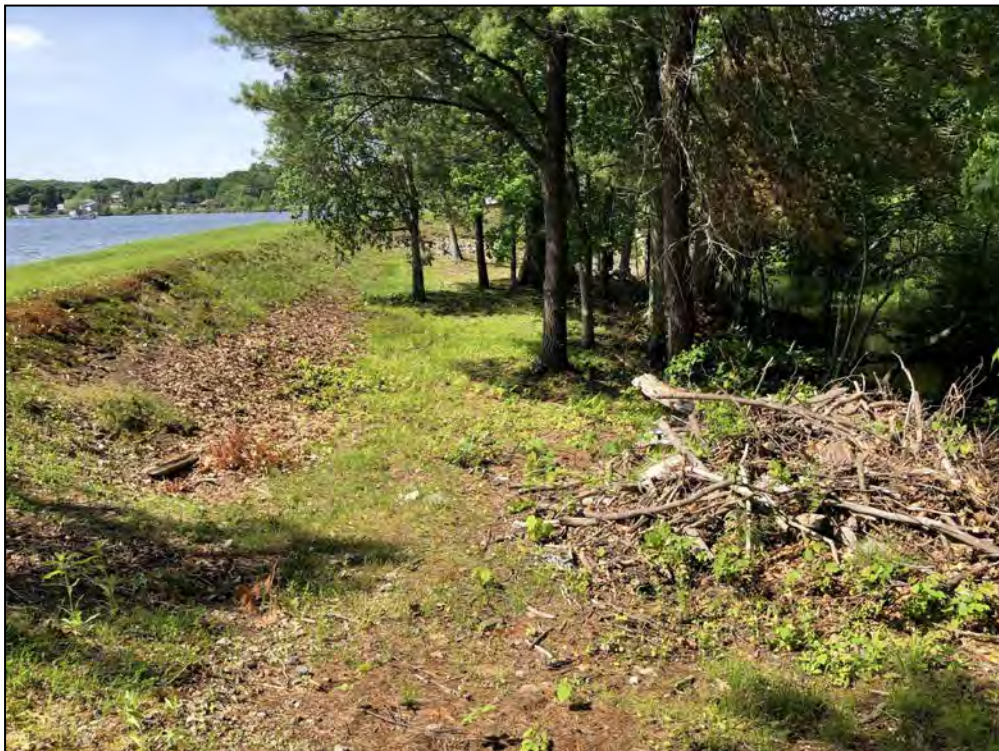
Photo No. 12: Main Dam - Downstream side of the embankment from near the right abutment looking left.

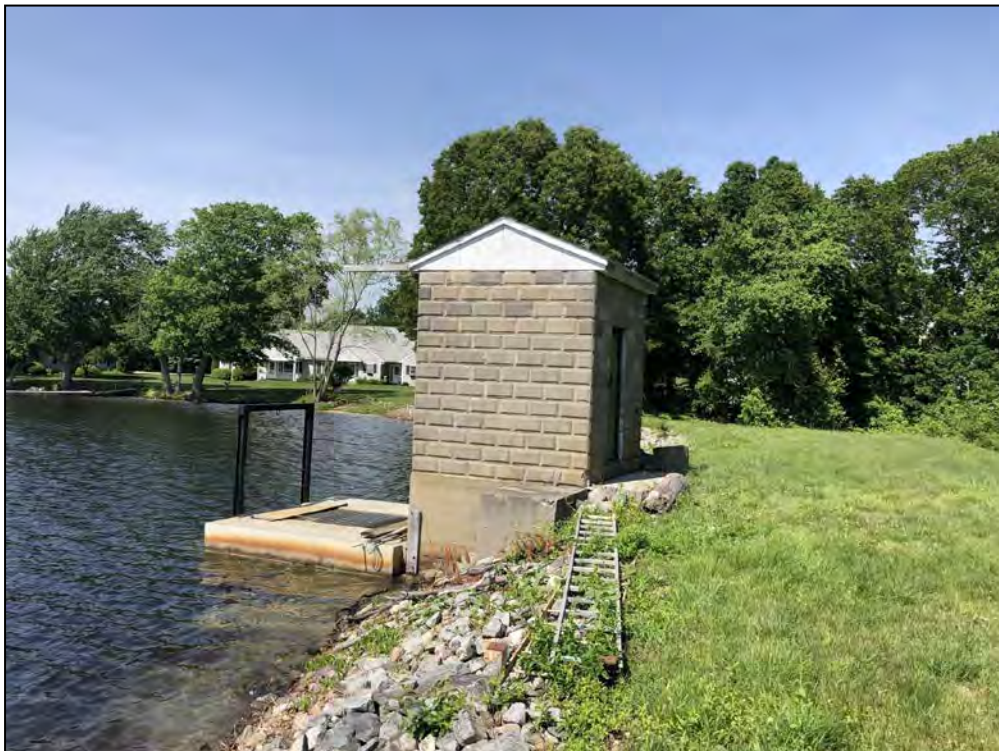
Photo No. 14: Main Dam - Upstream end of the outlet structure.

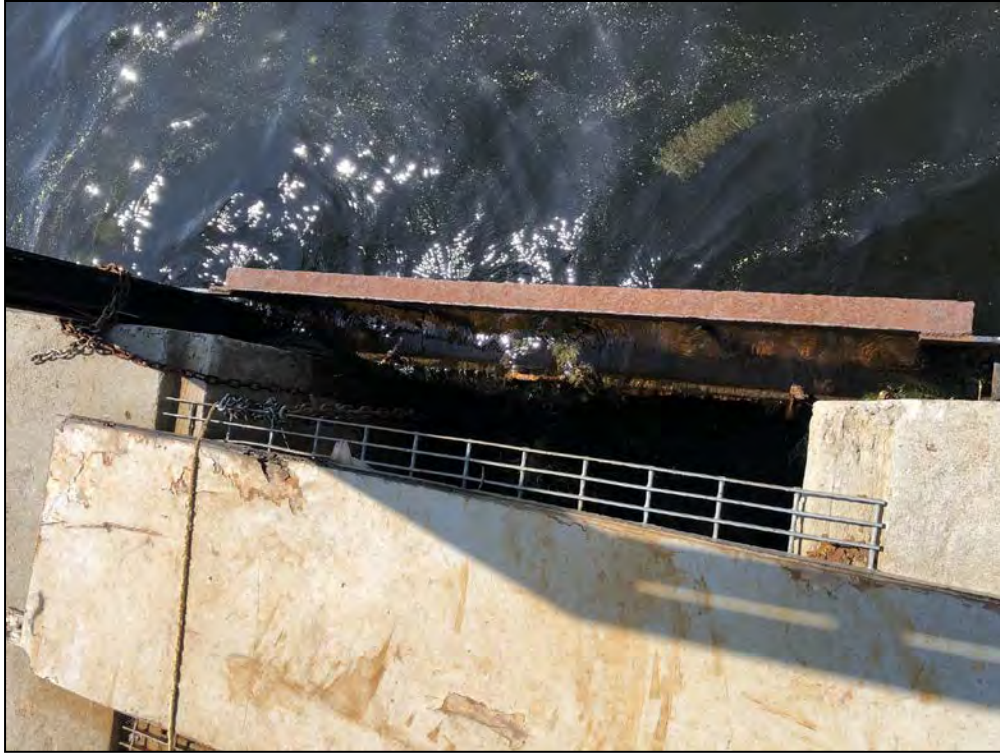
Photo No. 15: Main Dam - Upstream end of the intake to the outlet structure.

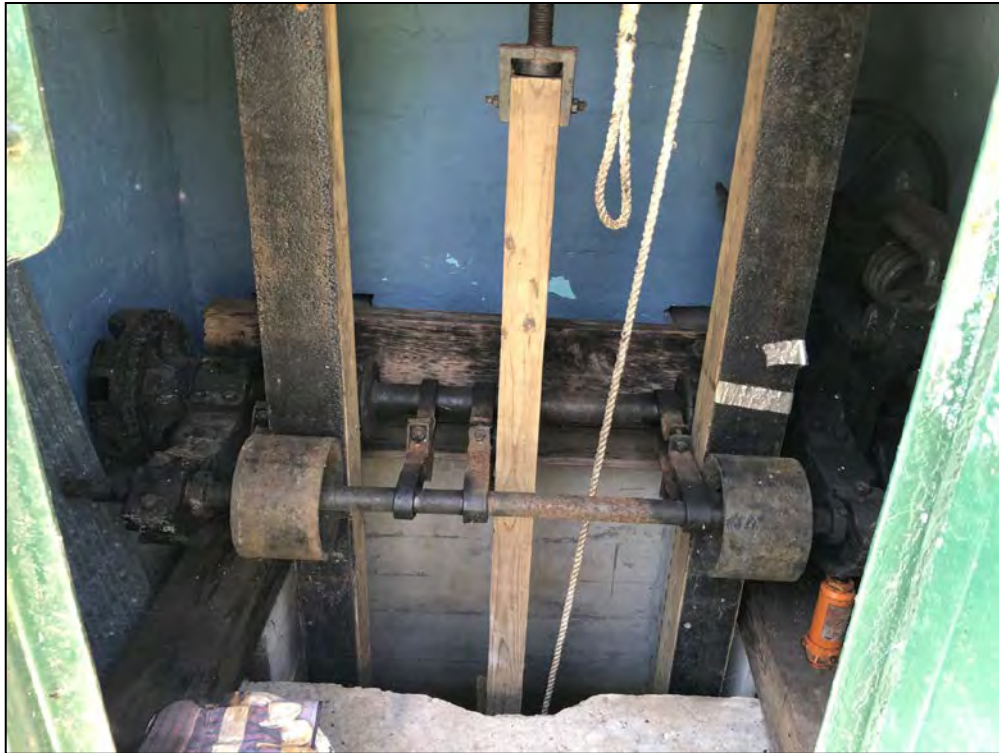
Photo No. 17: Main Dam - Gate controls within the interior of the outlet structure.

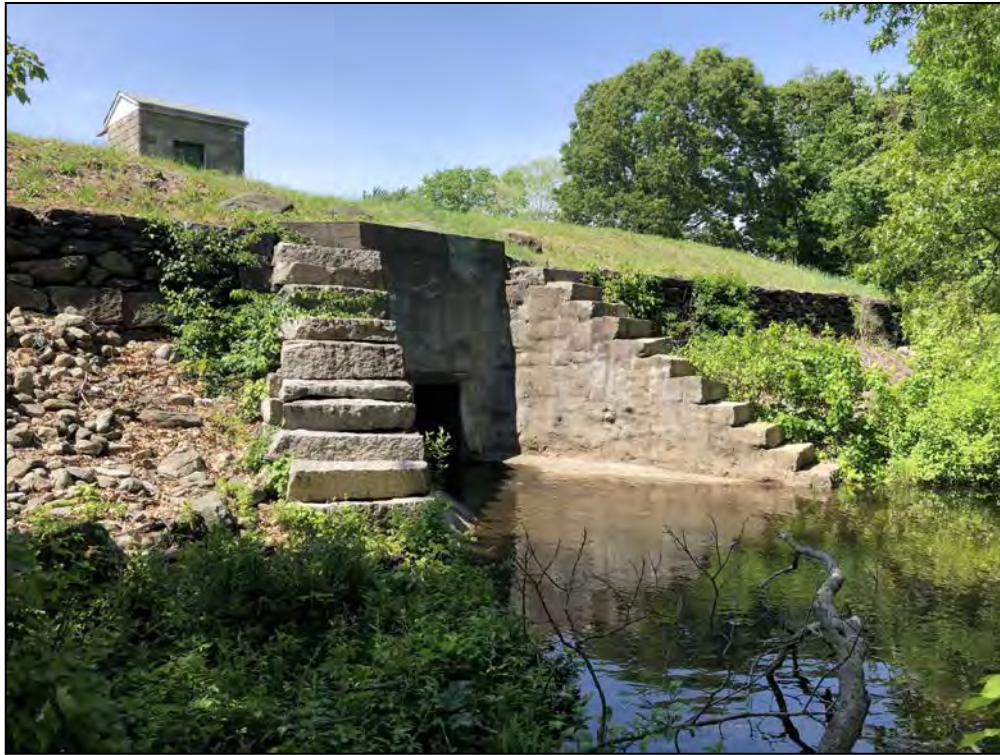
Photo No. 19: Main Dam - Overview of the discharge end of the conduit and the outlet left downstream channel wall.

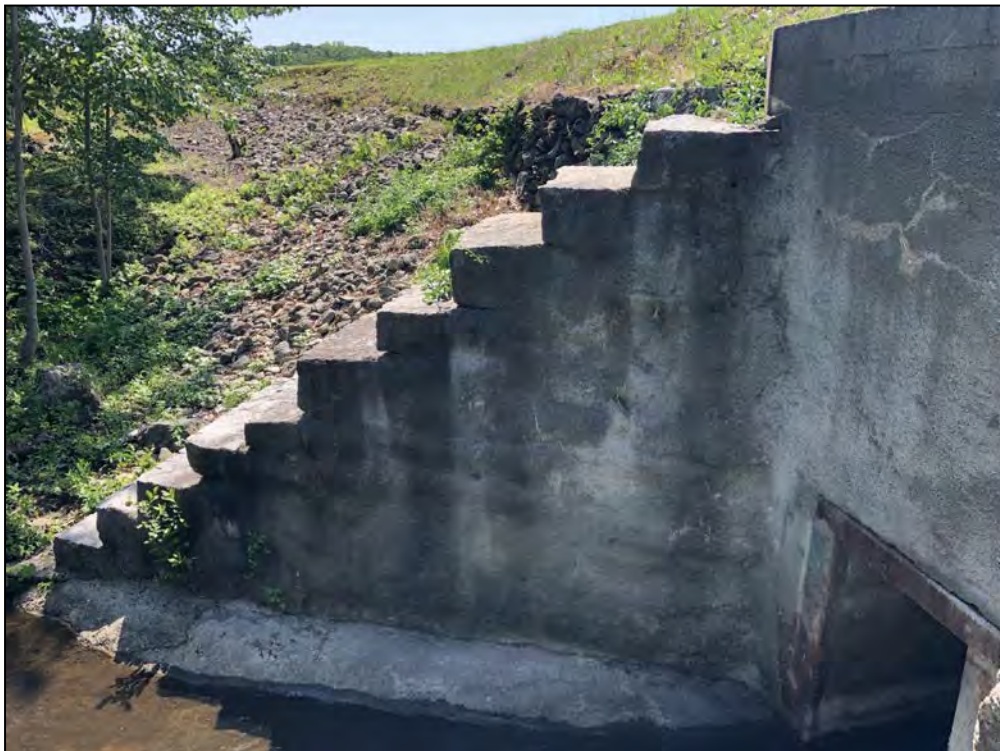
Photo No. 20: Main Dam - The outlet right downstream channel wall.

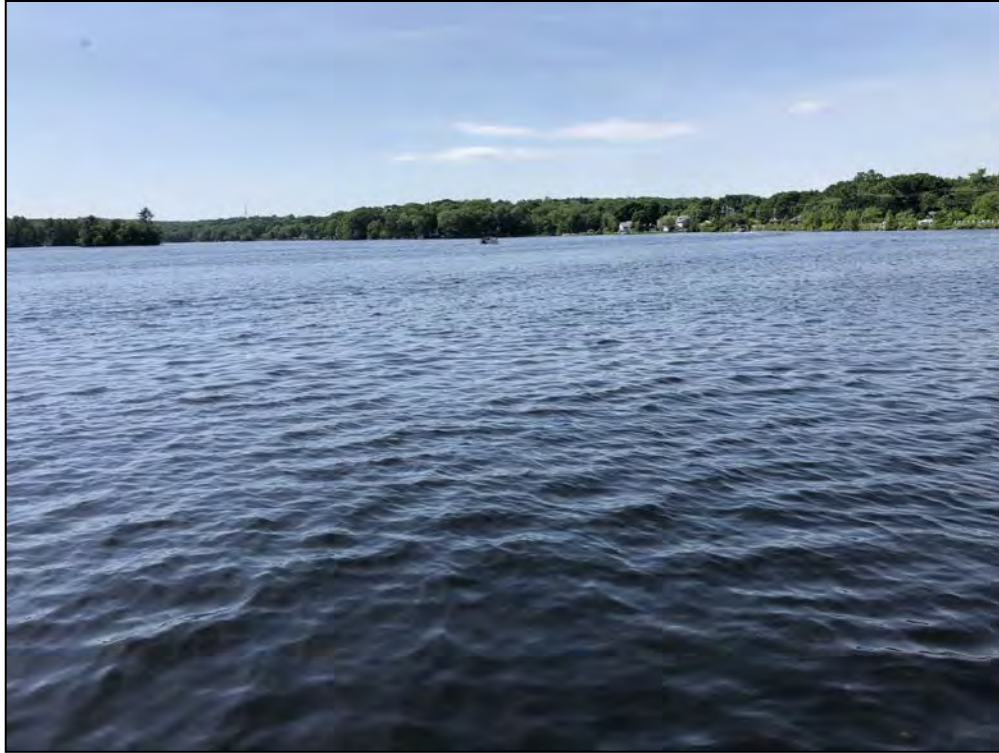
Photo No. 21: Main Dam - Overview of the impoundment.

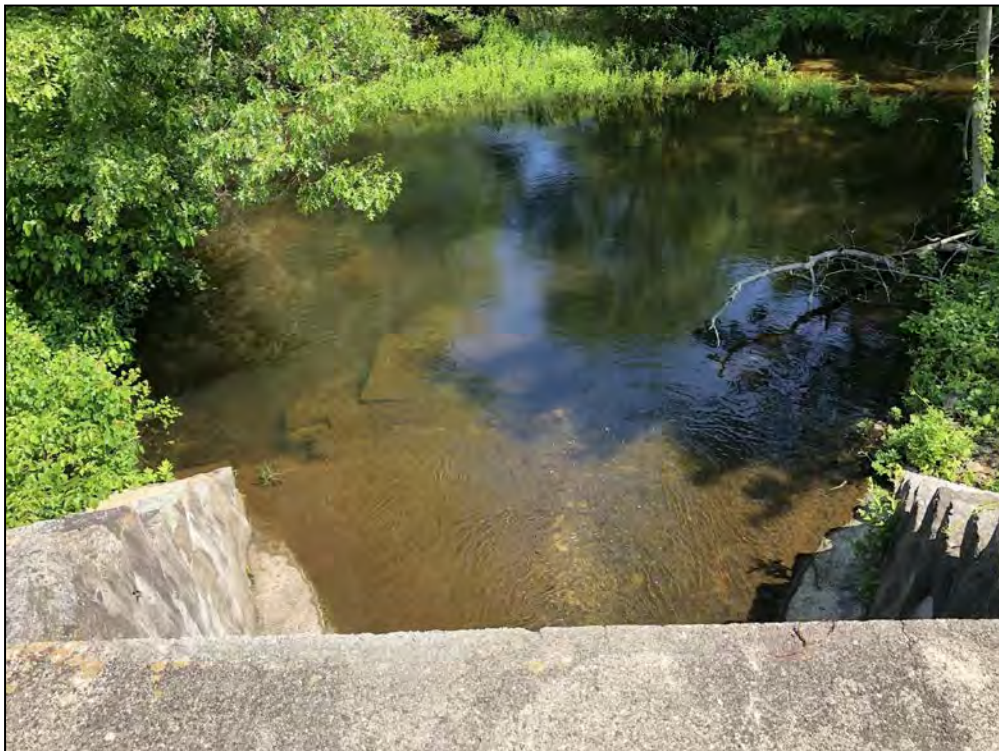
Photo No. 22: Main Dam - Overview of the downstream channel from the low-level outlet.

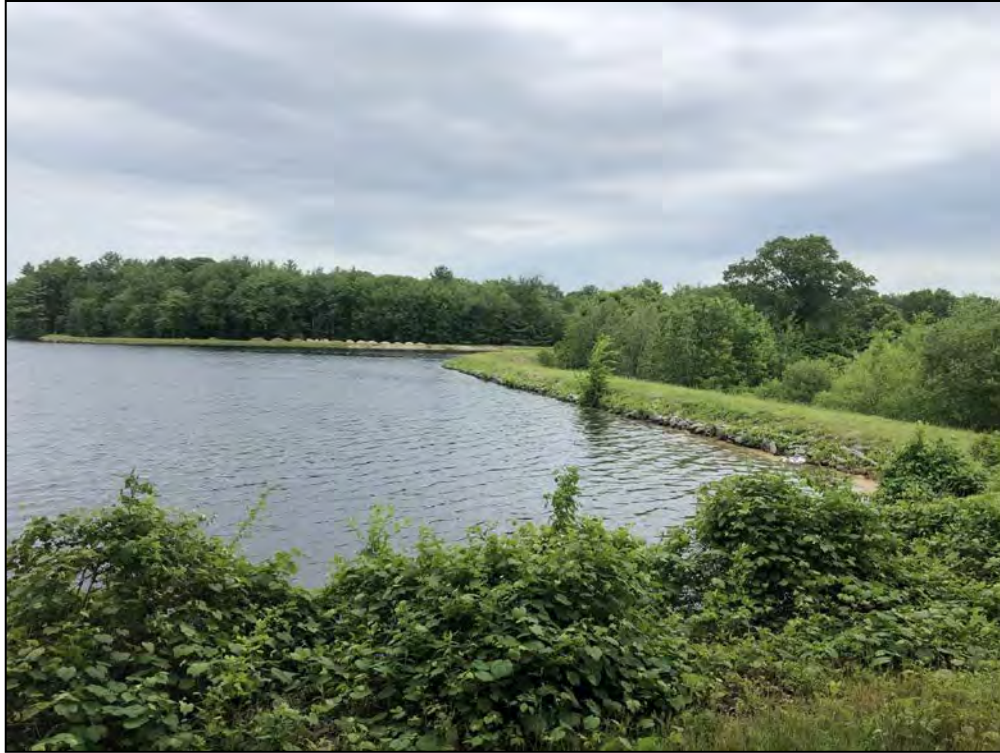
Photo No. 23: Bookers Dam - Overview of the upstream side of the dam from the right abutment looking left.

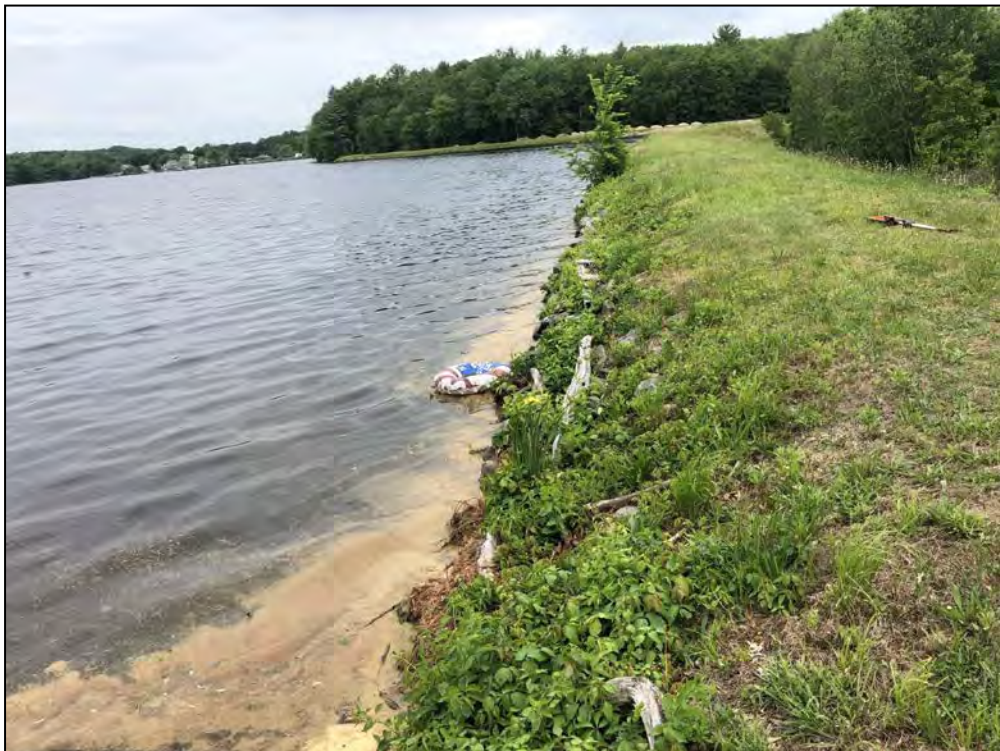
Photo No. 24: Bookers Dam - Upstream slope from near STA 3+00 looking left.

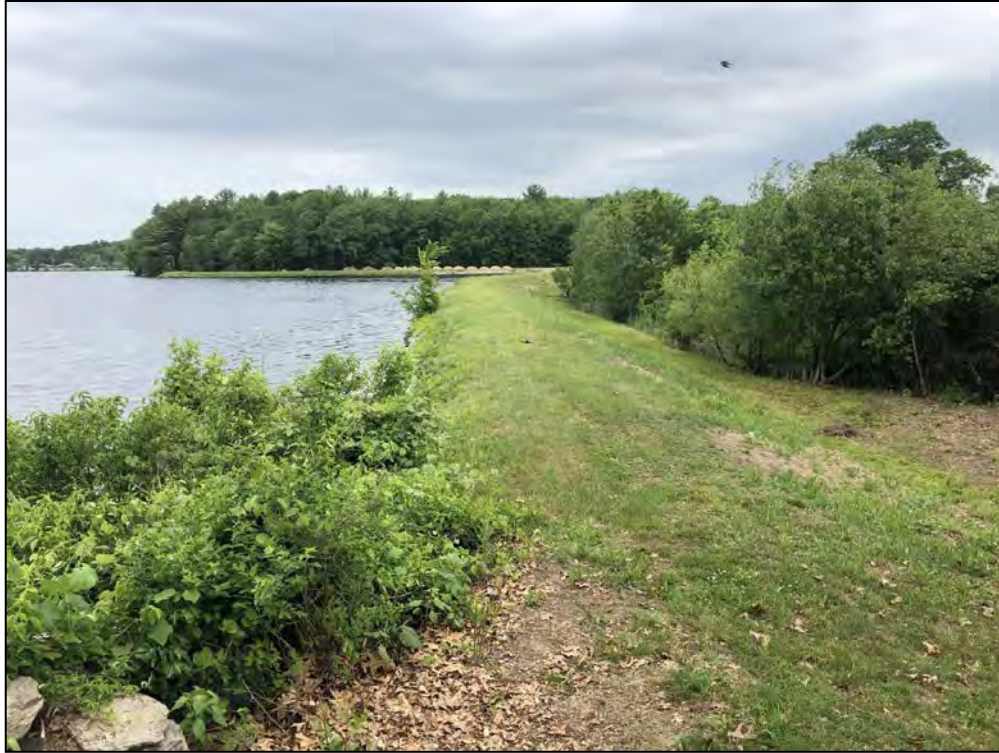
Photo No. 27: Bookers Dam - Crest from near the right abutment looking left.

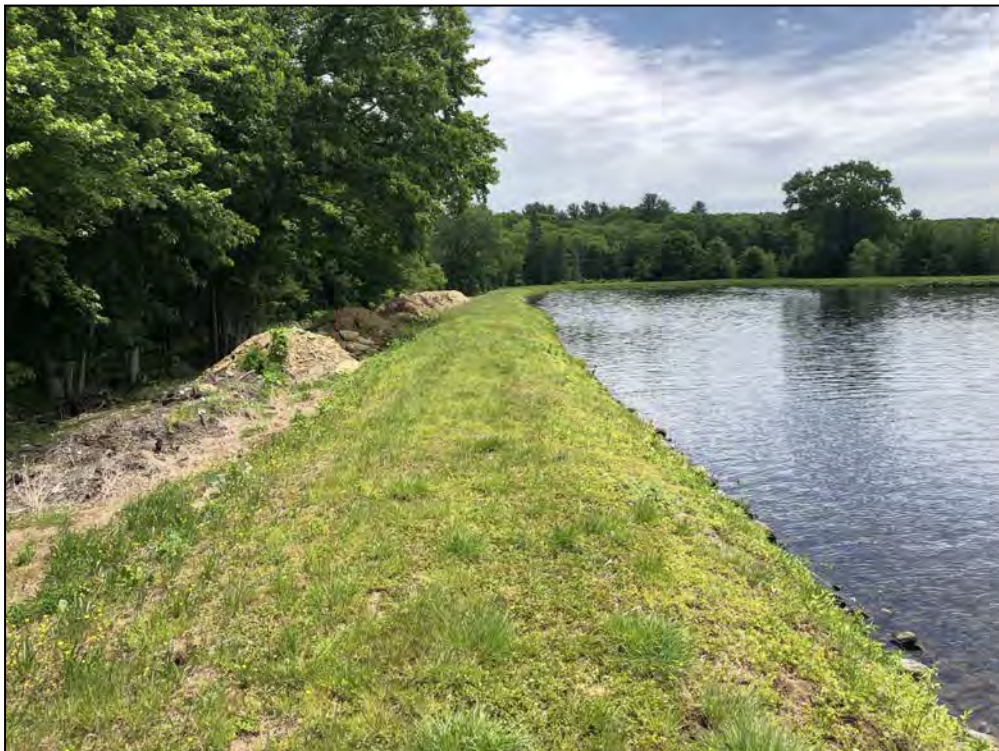
Photo No. 28: Bookers Dam - Crest from near STA 12+00 looking right.

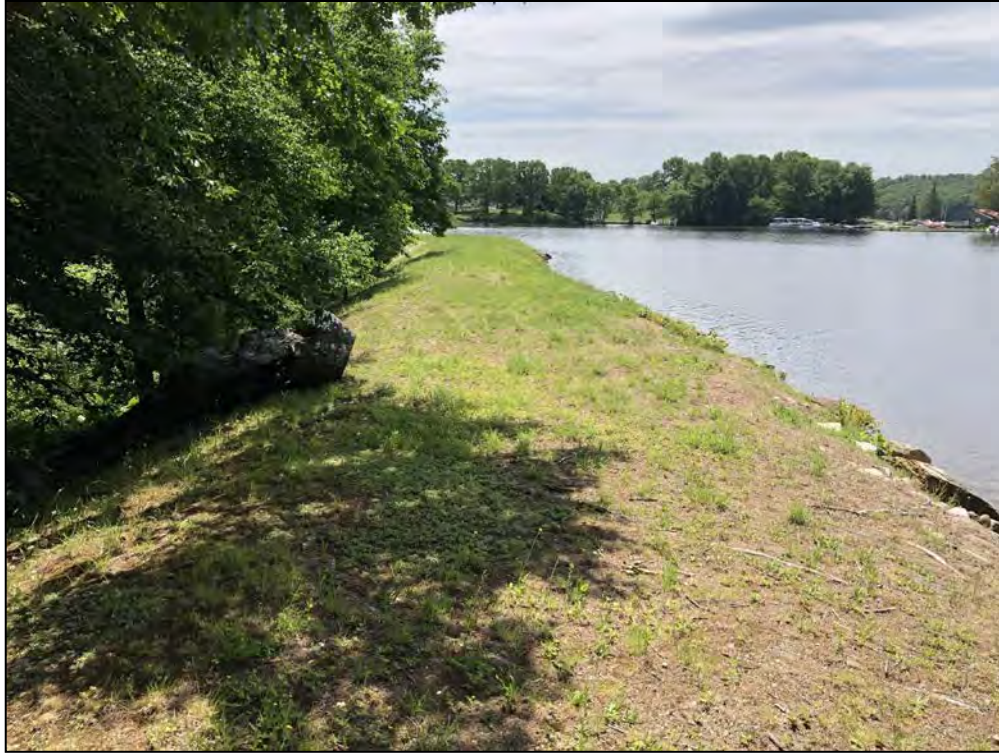
Photo No. 29: Bookers Dam - Crest from near the left abutment looking right.

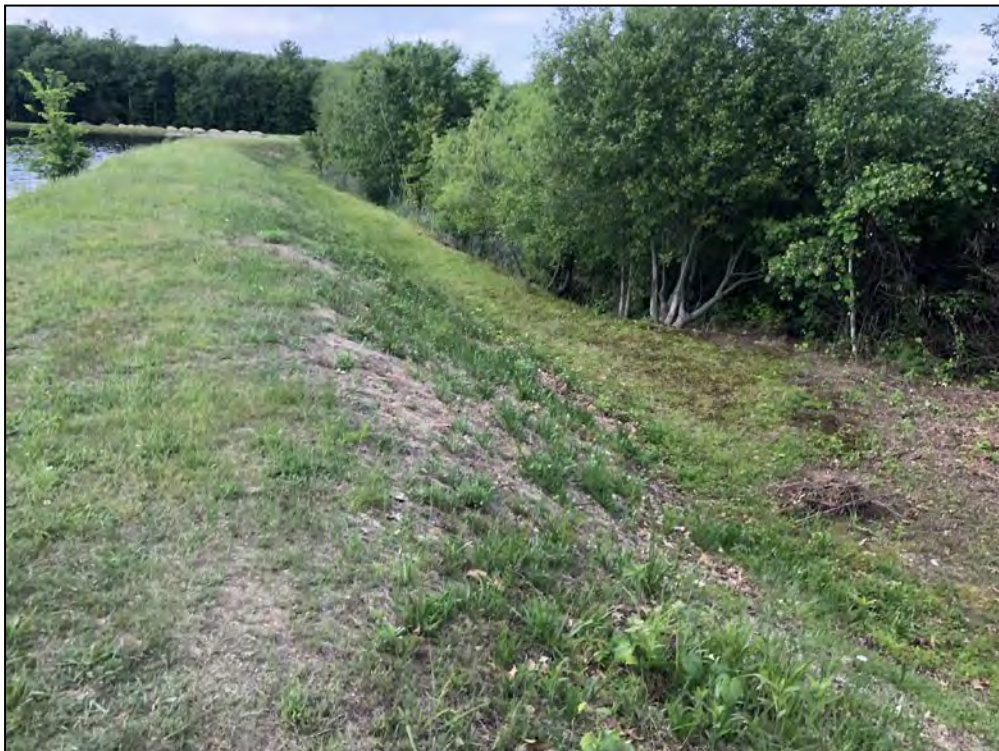
Photo No. 30: Bookers Dam - Downstream slope from near the right abutment looking left.

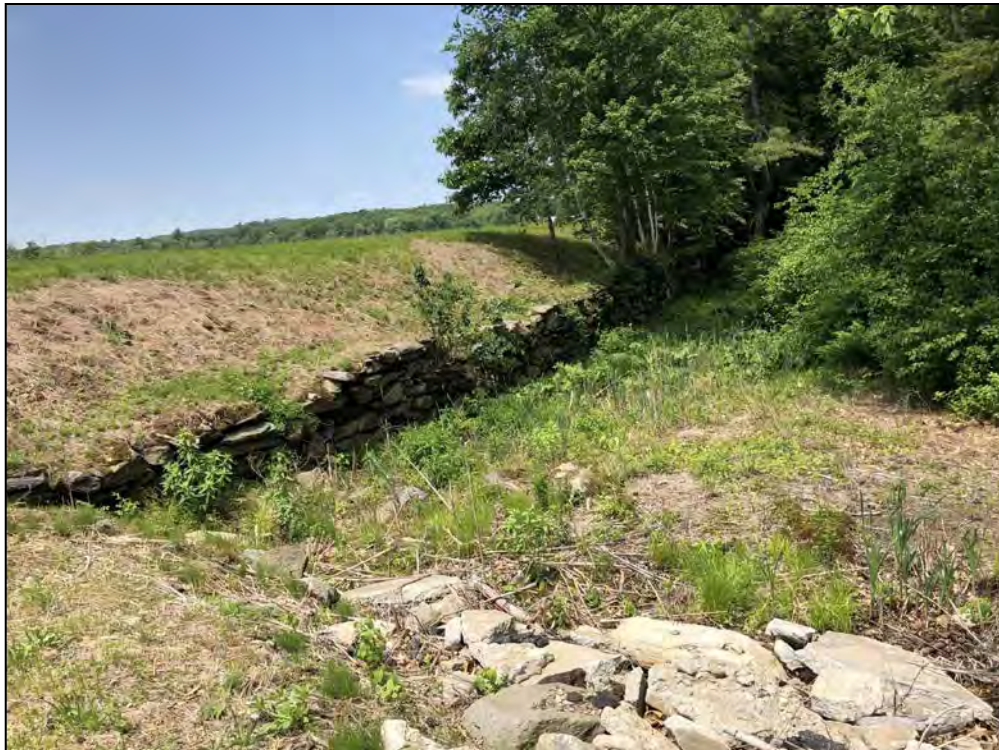
Photo No. 36: Bookers Dam - Downstream slope and stone masonry wall from STA 12+00 looking left.

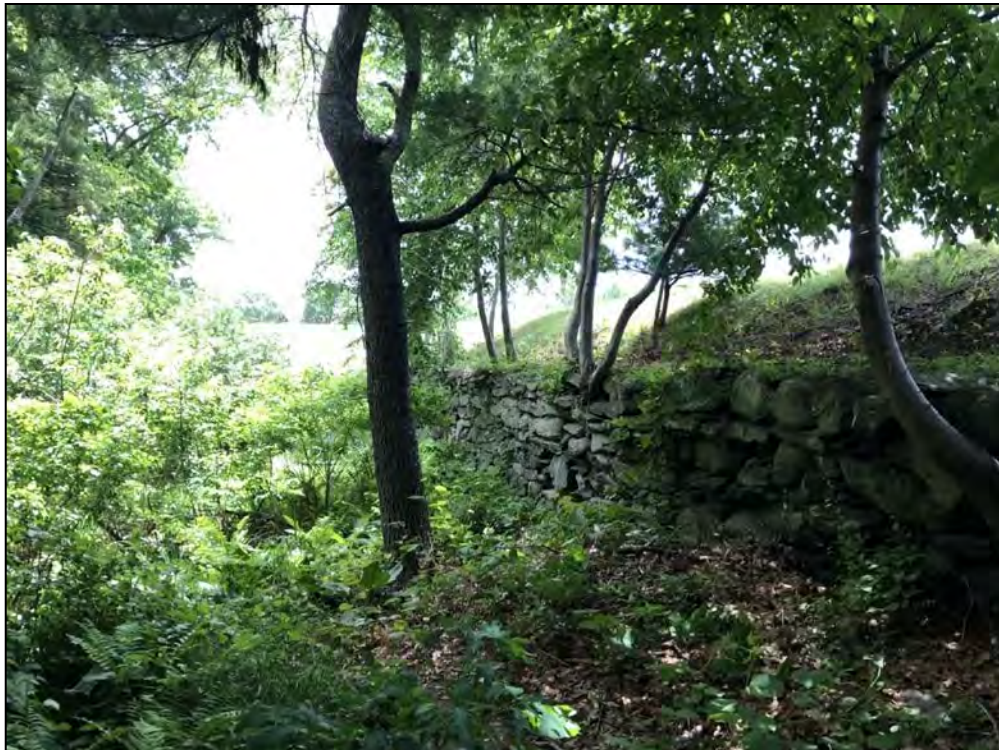
Photo No. 38: Bookers Dam - Downstream stone masonry wall viewed from near the left abutment looking right.

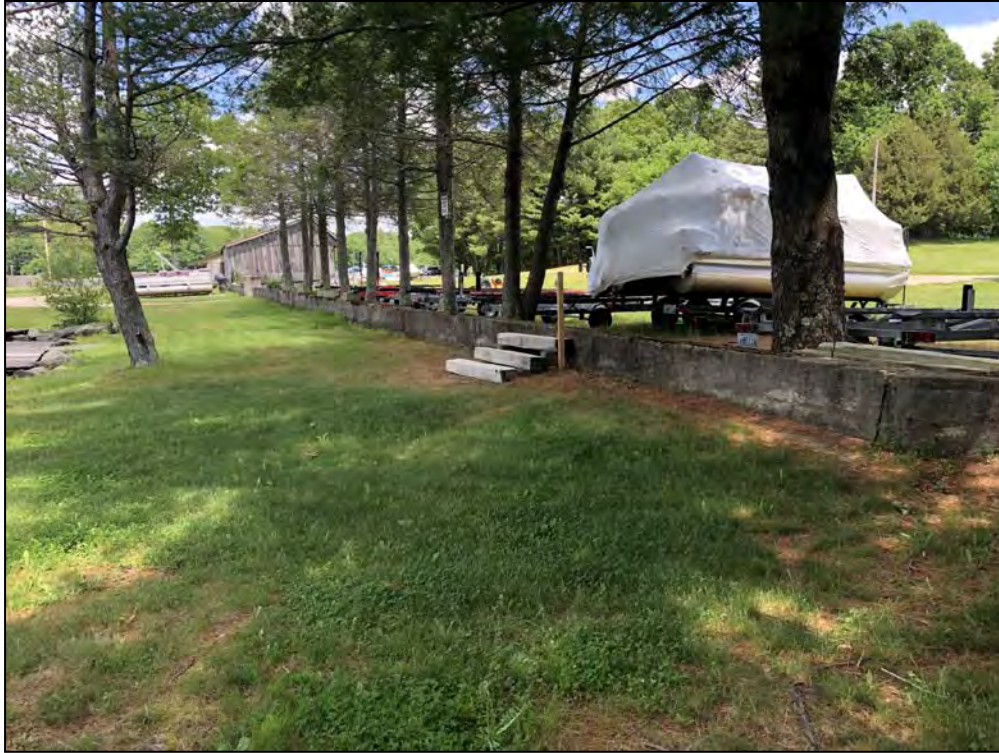
Photo No. 39: Marina Dam – View of the upstream side of the floodwalls at the Marina looking left.

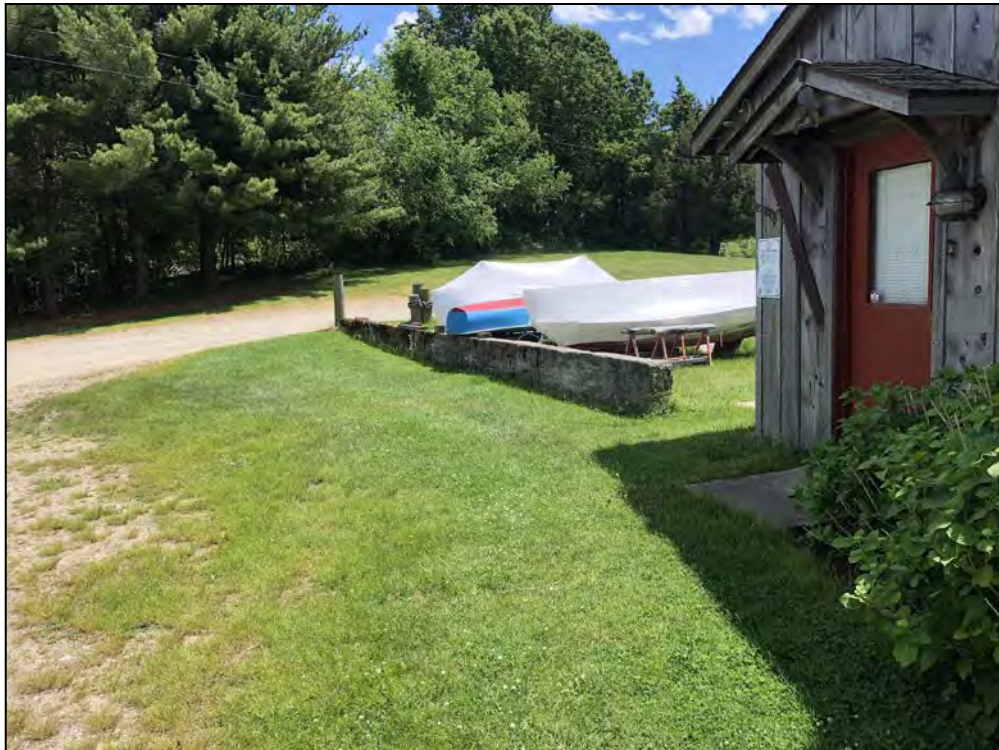
Photo No. 42: Marina Dam – Overview of the floodwalls left of the storage building.

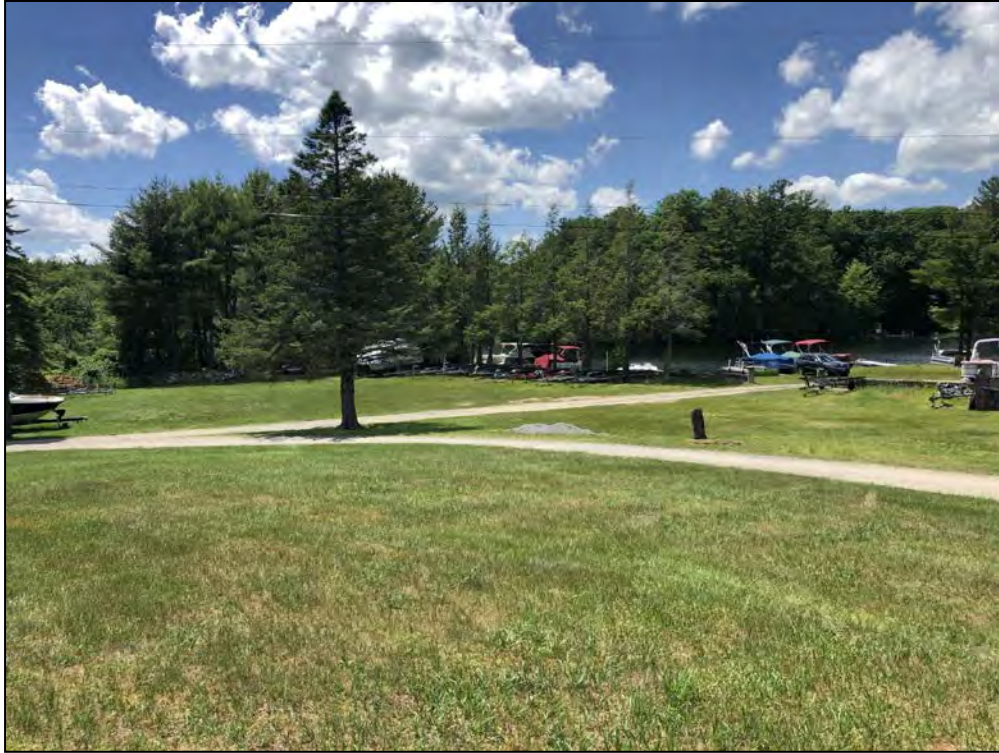
Photo No. 43: Marina Dam – Downstream area of the marina dam

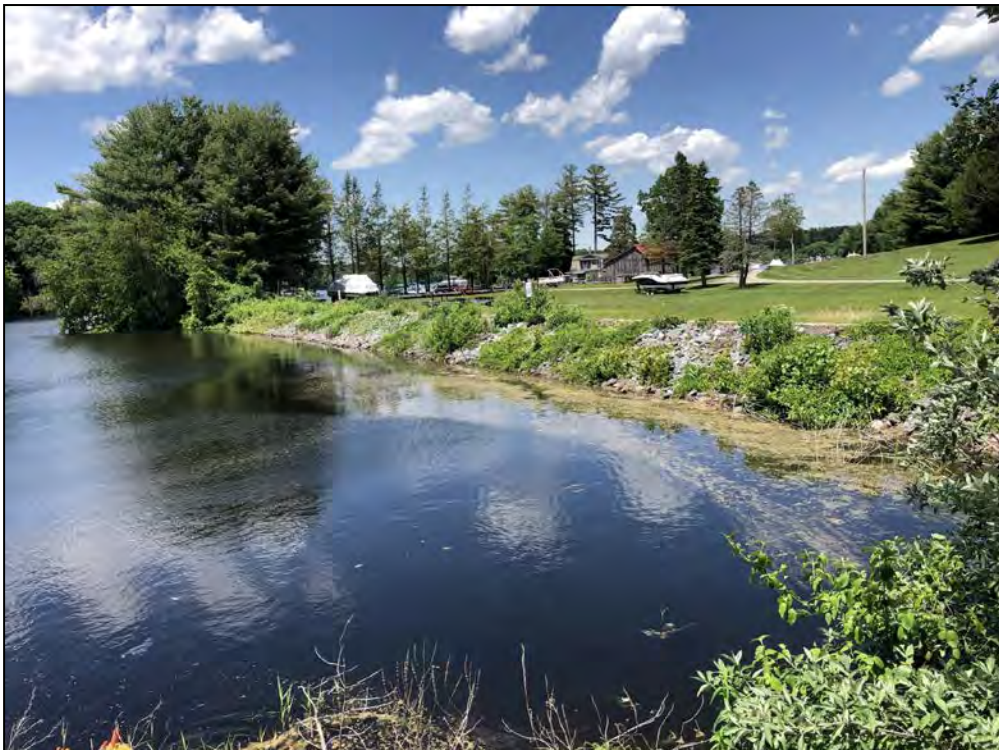
Photo No. 44: Pine Ledge Road to West Greenville Road Dam – Upstream side of the dike from Pine Ledge Road looking left.

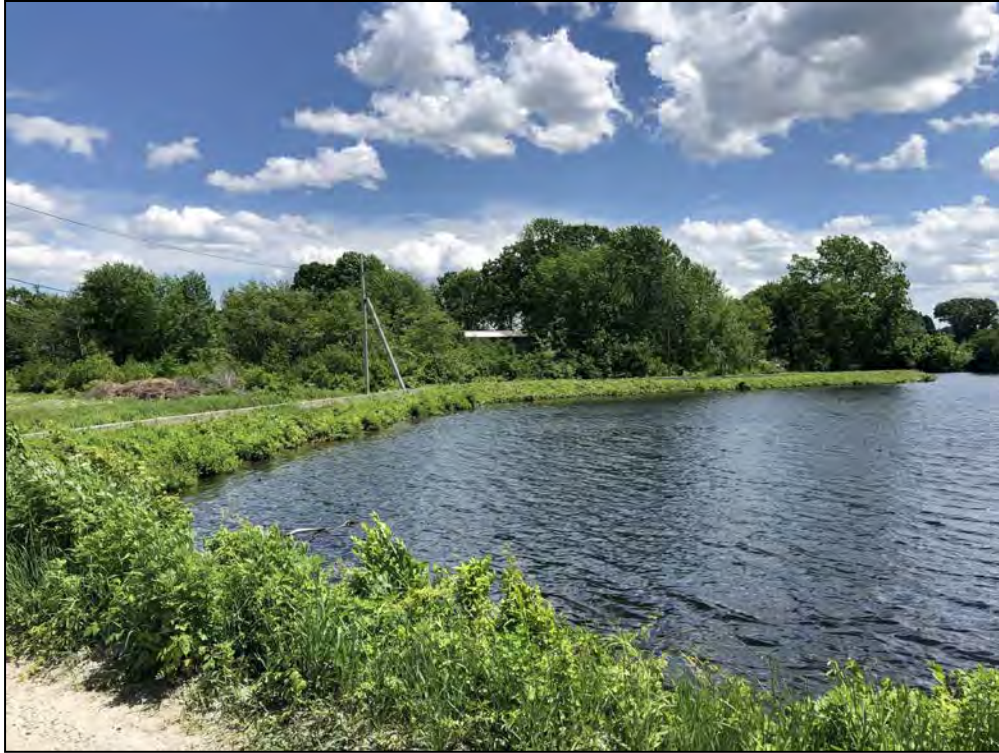
Photo No. 47: Pine Ledge Road to West Greenville Road Dam – Upstream side of the embankment from pine ledge road looking right.
