-- WATERMAN LAKE DAM --

VISUAL INSPECTION / EVALUATION REPORT

Owner: *Citizens for the Preservation of Waterman Lake, Inc.*

Date of Inspection: *June 9, 11, and 12, 2020*

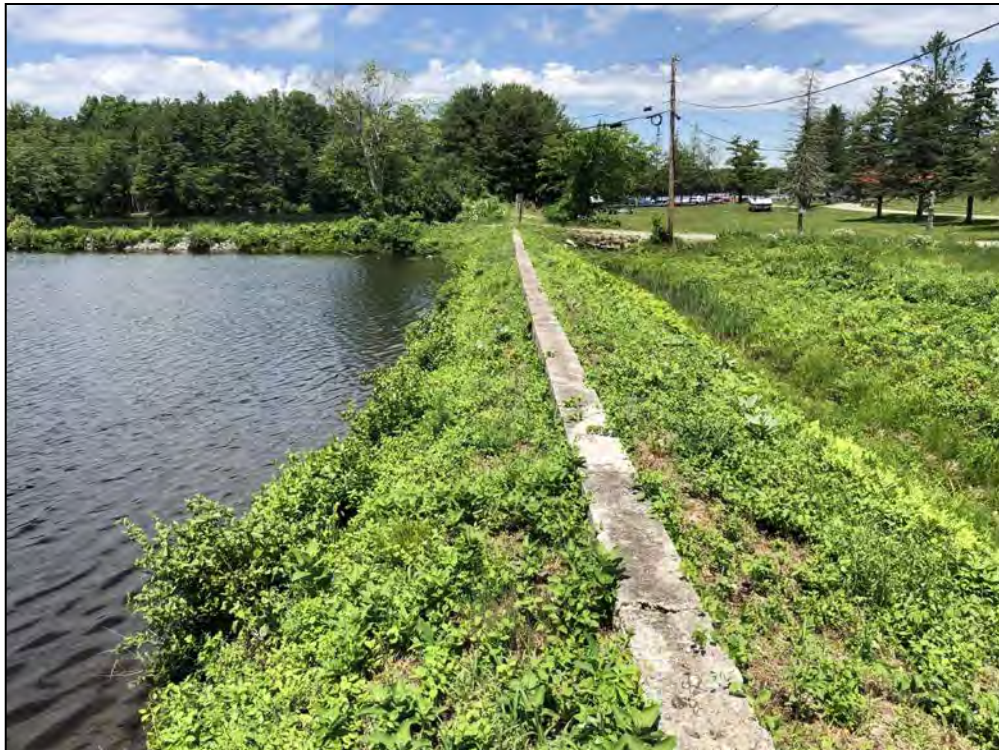
Photo No. 48: Pine Ledge Road to West Greenville Road Dam – Crest, concrete corewall, and upstream slope of the embankment right of Pine Ledge Road from near STA 1+30 looking left.

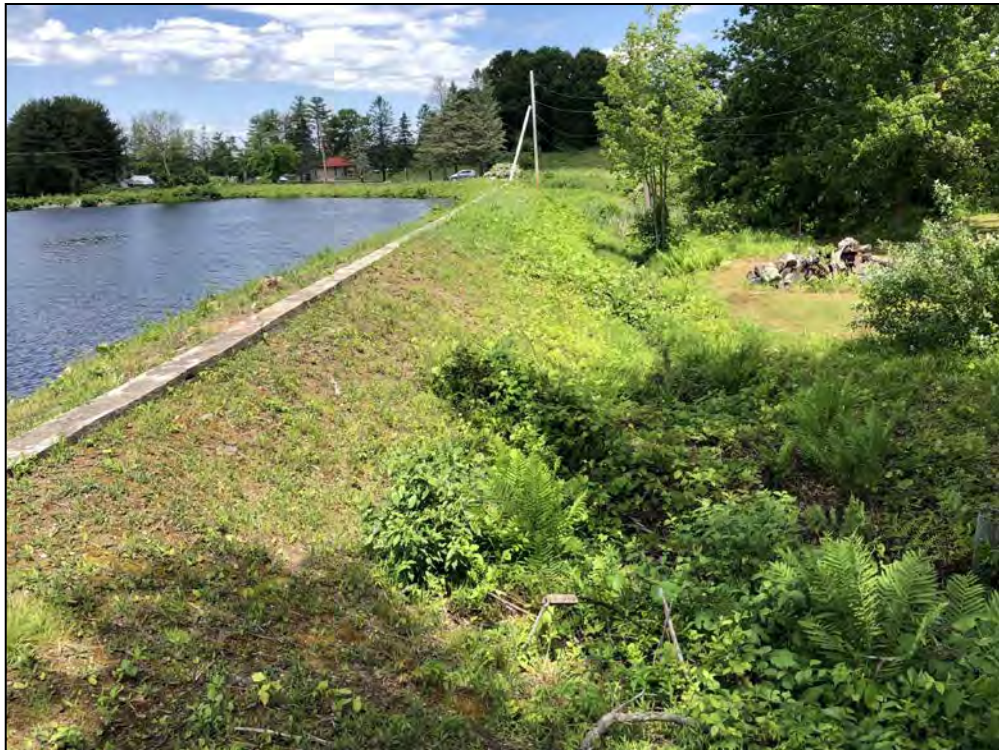
Photo No. 52: Pine Ledge Road to West Greenville Road Dam – Downstream slope from near STA 3+50 looking left.

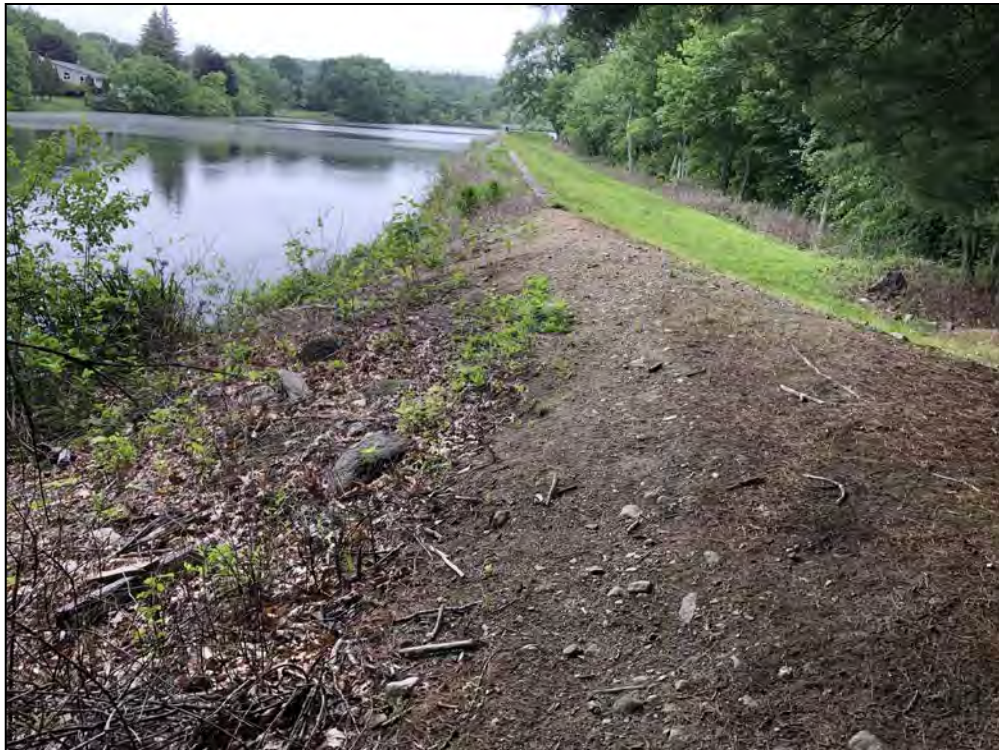
Photo No. 54: Spillway Section – Upstream slope from the right embankment looking left.

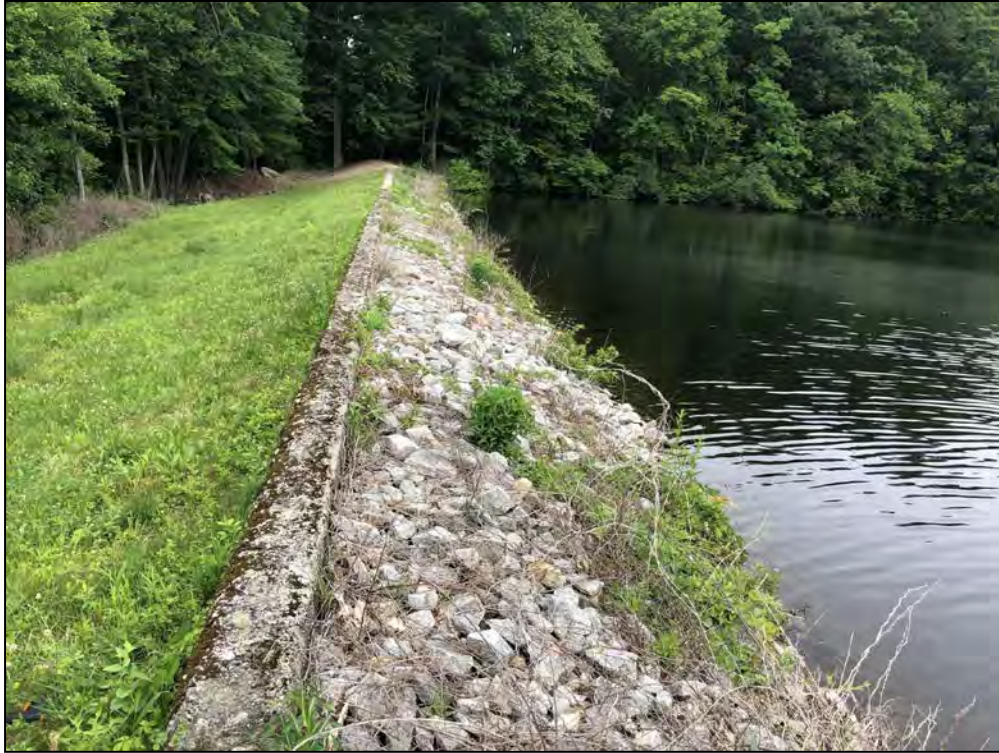
Photo No. 55: Spillway Section – Upstream slope and crest from near STA 2+50 looking right.

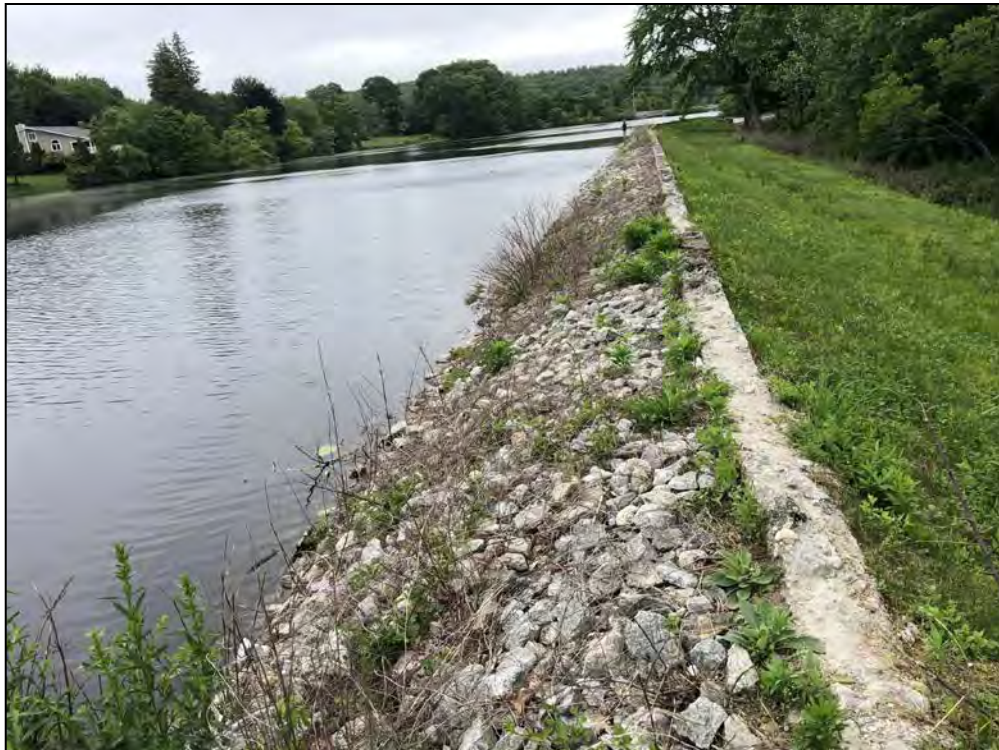
Photo No. 56: Spillway Section – Upstream slope and crest from near STA 2+50 looking left.

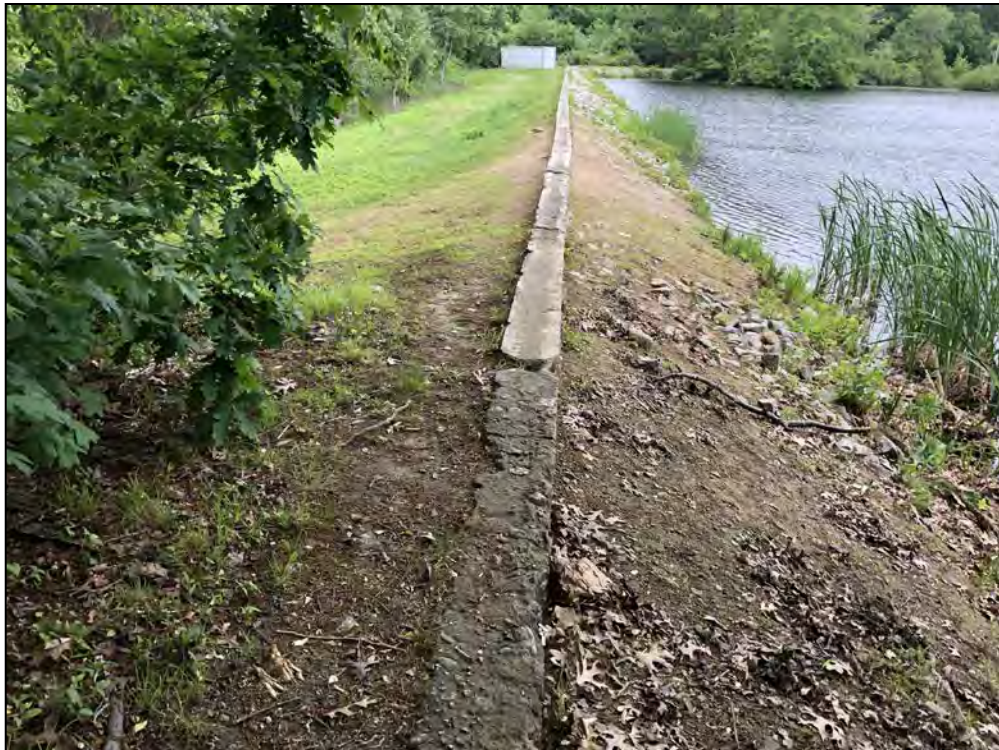
Photo No. 58: Spillway Section – Upstream slope and crest from near the left abutment looking right.

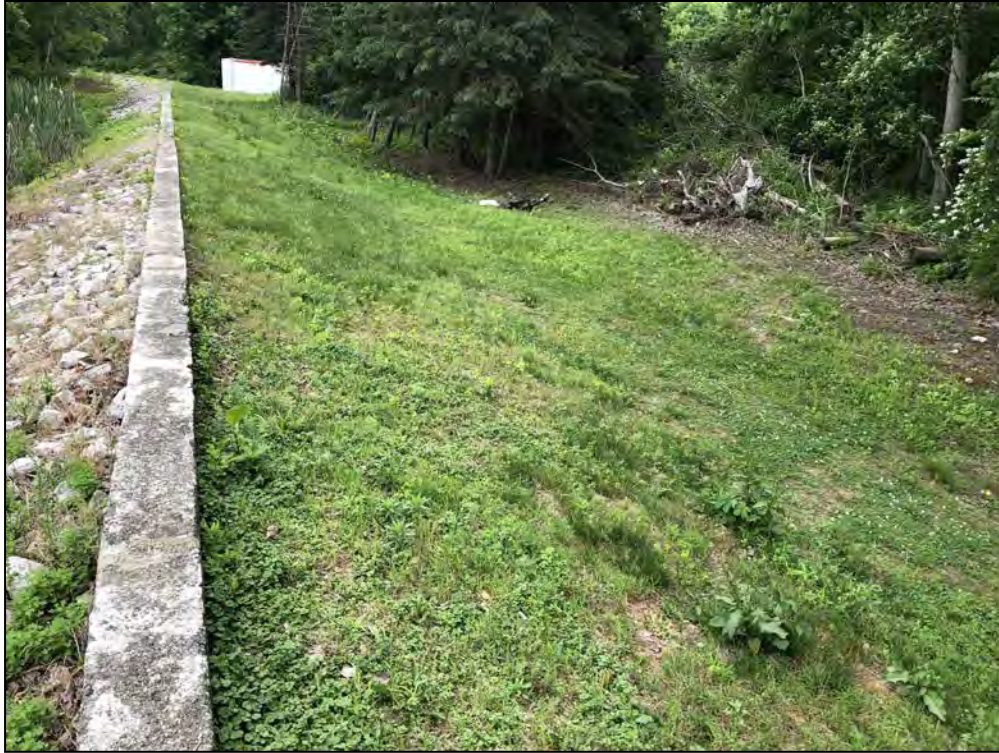
Photo No. 61 Spillway Section - Downstream slope from left of the spillway looking left.

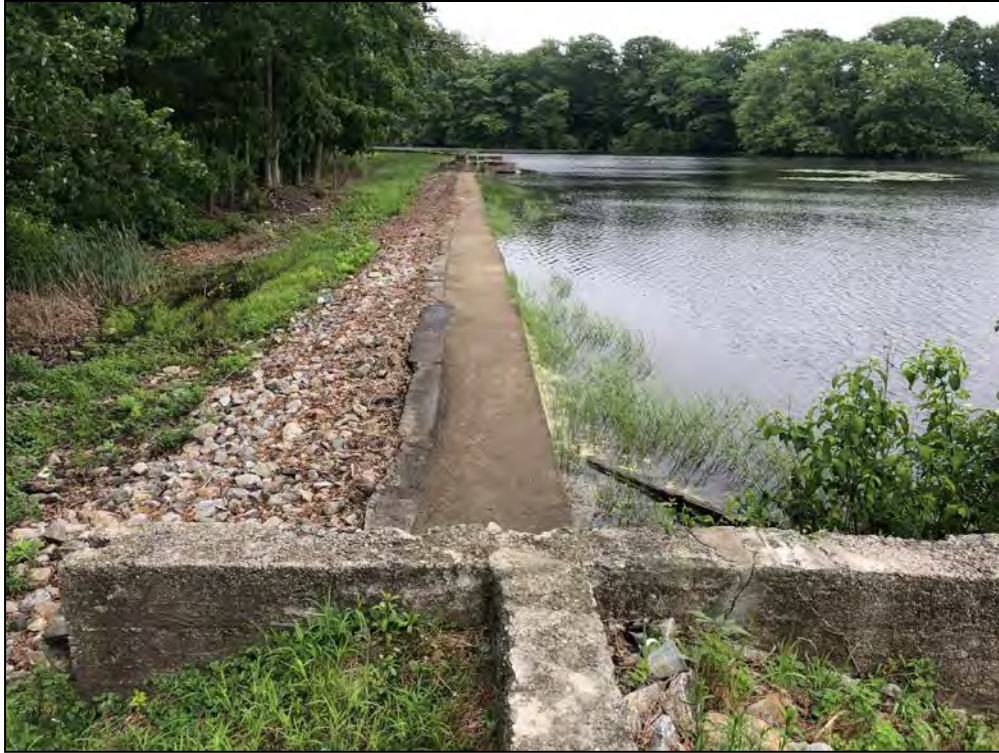
Photo No. 63 Spillway Section – Crest of the spillway section from the spillway left channel wall looking right.

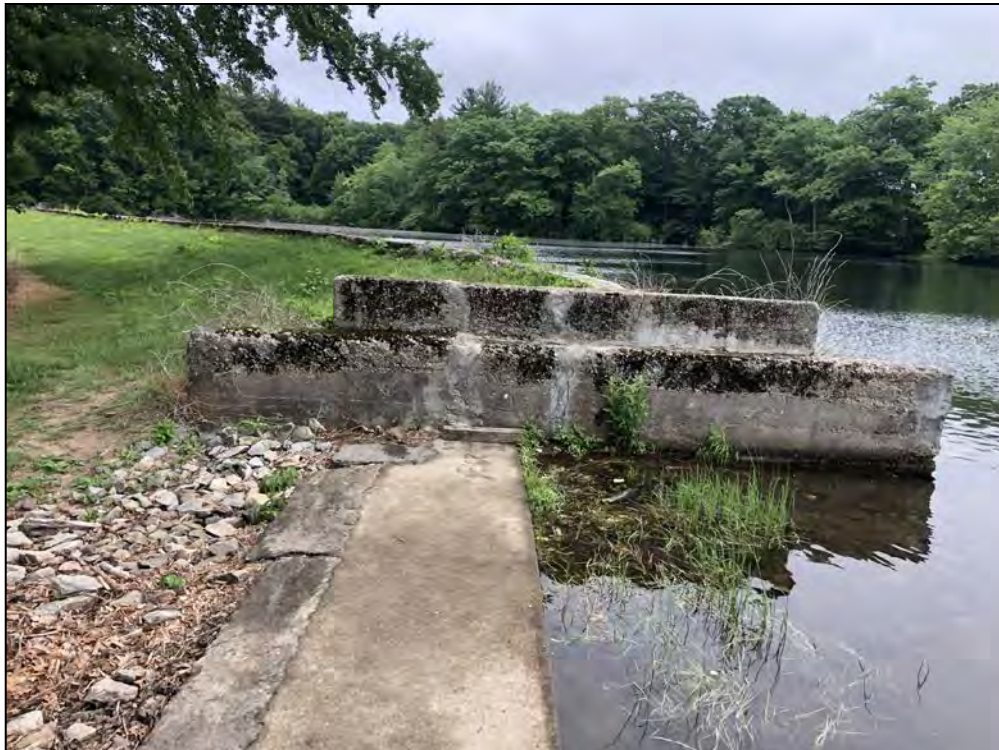
Photo No. 64: Spillway Section – View of the spillway weir and the spillway right channel wall.

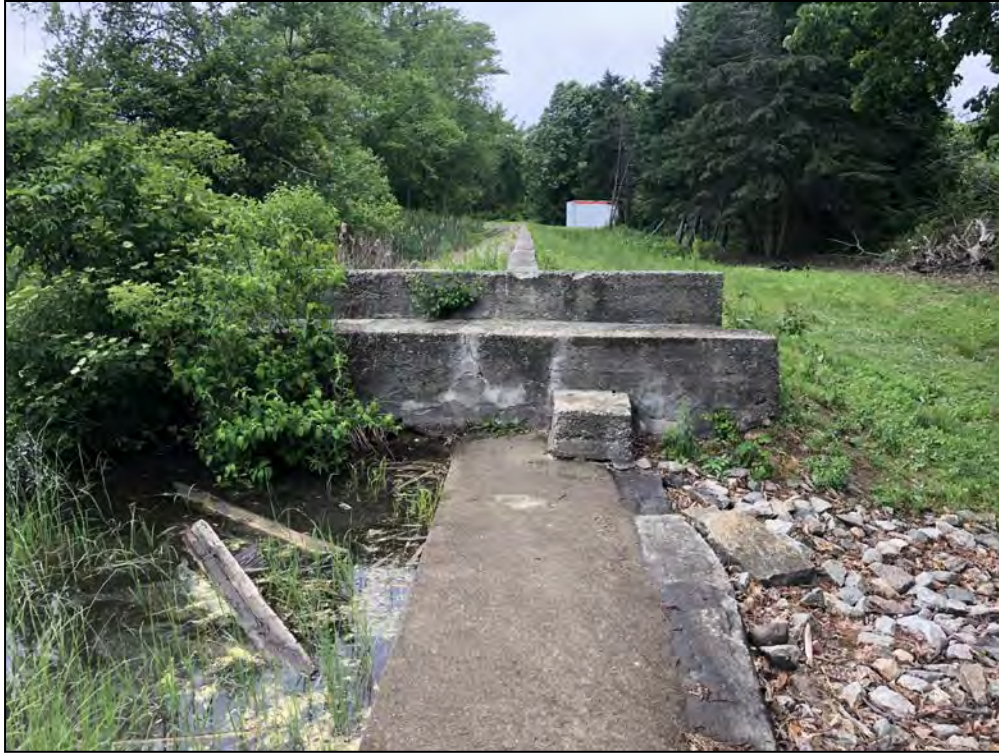
Photo No. 65 Spillway Section – View of the spillway weir and the spillway left channel wall.

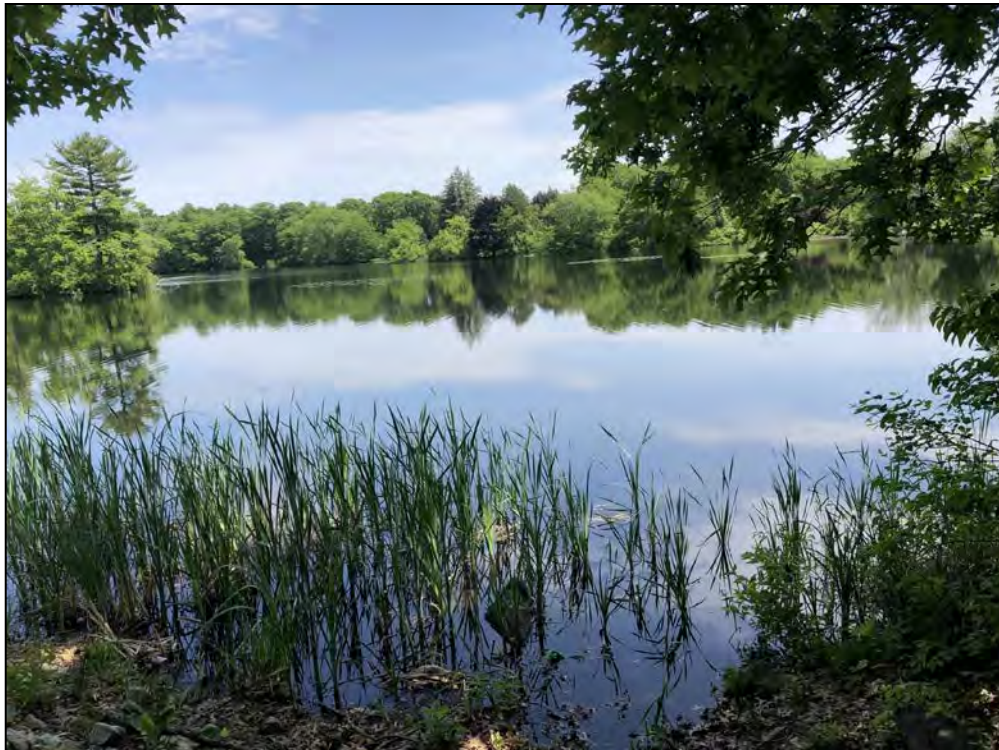
Photo No. 66: Spillway Section – Overview of the impoundment from the left abutment.

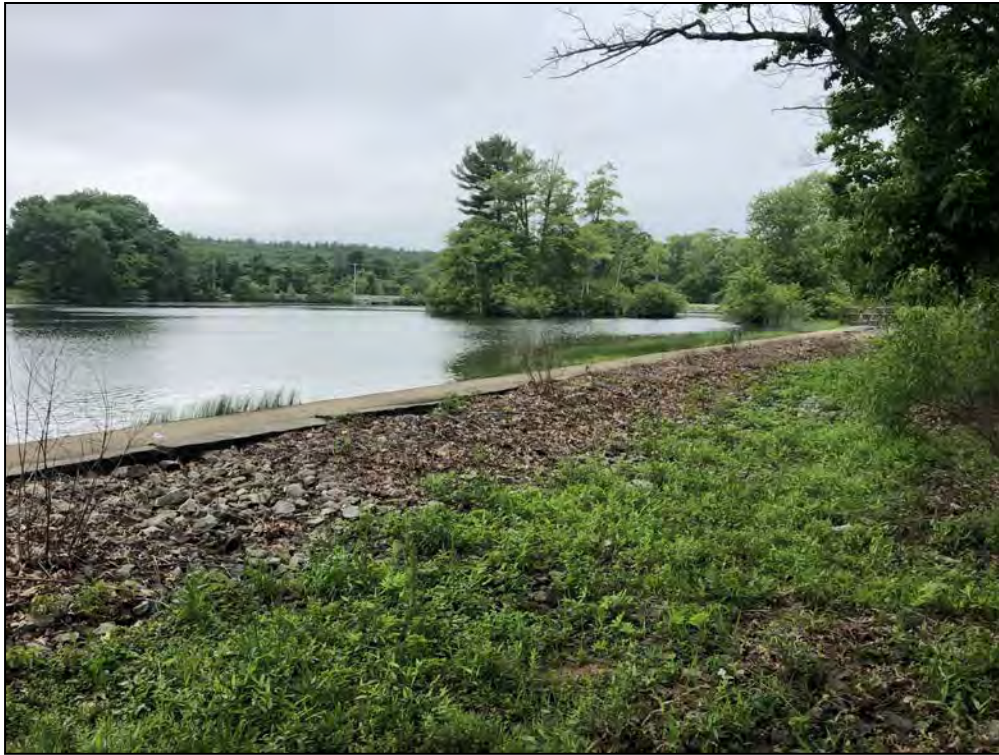
Photo No. 67 Spillway Section – Discharge area of the spillway.
