SAFER SEAS DIGEST

LESSONS LEARNED FROM MARINE ACCIDENT INVESTIGATIONS

2016

NATIONAL
TRANSPORTATION
SAFETY BOARD

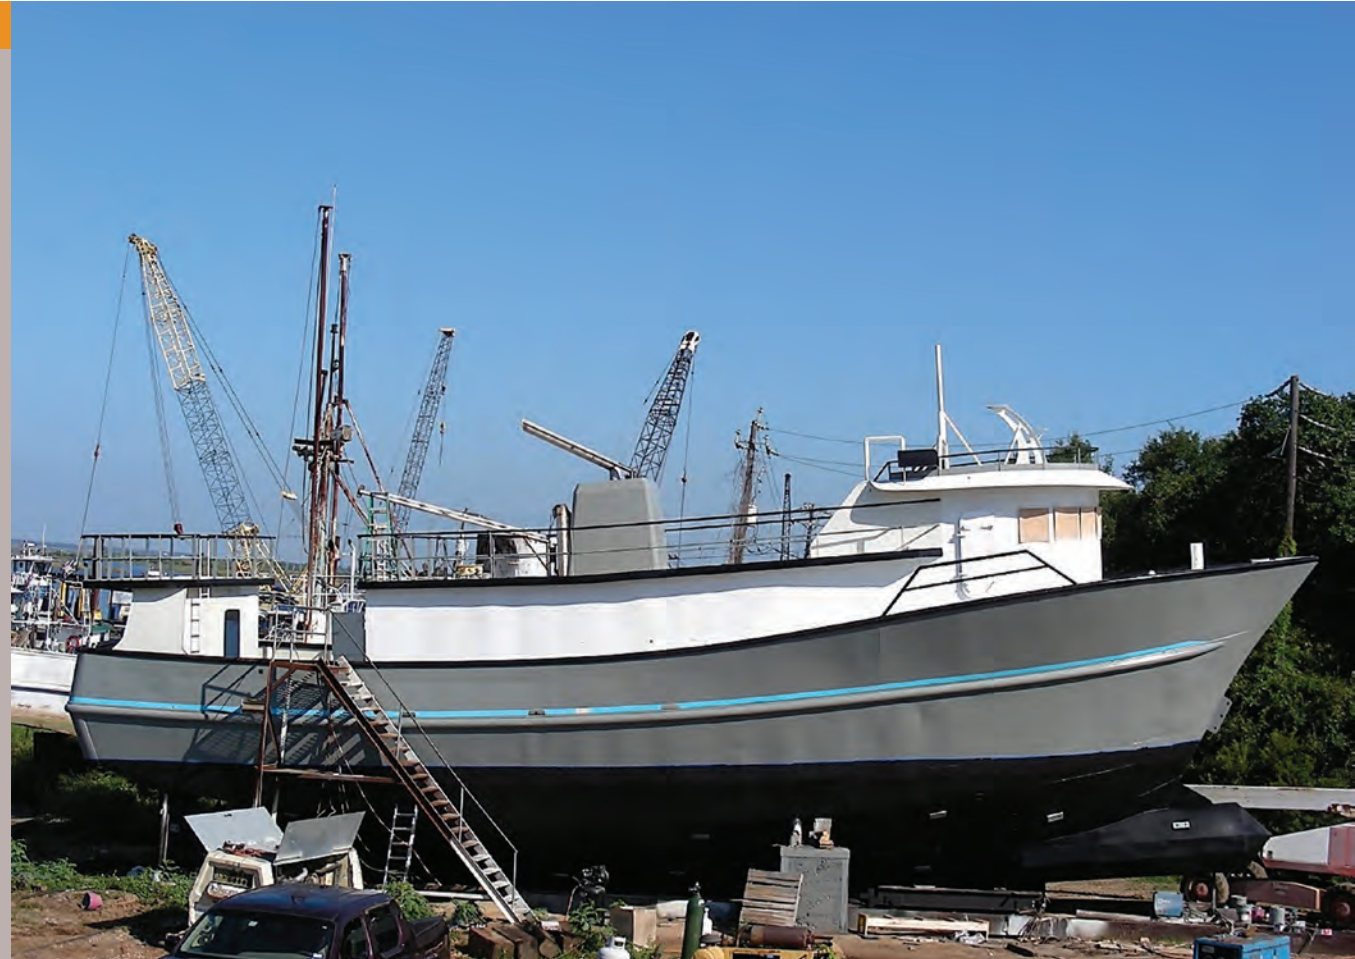
Figure 7: Side profile of fishing vessel *Hawaii Five-1* while in a conversion shipyard in Pascagoula, Mississippi, prior to the accident. PHOTO BY C. E. COLLIER & ASSOCIATES, INCORPORATED

From March to November 2015, the uninspected fishing vessel *Hawaii Five-1* was converted from a shrimp trawler to a longline fishing vessel in Pascagoula, Mississippi. The conversion work included removing trawl systems and replacing an estimated 60–70 percent of the hull plating, as well as a significant amount of deck plating, internal framing, and bulkhead plating. Additionally, a new deckhouse, stern house, and bulbous bow were constructed and installed. These modifications to the vessel were made without plans and without oversight or input from a marine engineer or naval architect.

When vessels with originally adequate stability have the height of their center of gravity substantially increased by stowing large weights on high decks, they will have less resistance when rolling to port or starboard. In this condition, when the vessel does experience a roll, it will have a larger angle of heel for a longer period of time and can capsize if the center of gravity shifts farther outboard than the center of buoyancy. This likely was the case for the *Hawaii Five-1*.

■ The National Transportation Safety Board determined that the probable cause of the capsizing and sinking of fishing vessel *Hawaii Five-1* was inadequate intact stability due to the owners' failure to determine and mitigate the impacts that the conversion to longline fisheries services had on the vessel's overall stability. Contributing to the loss of the vessel was the master's insufficient understanding of stability principles, as demonstrated by his lack of action to improve the vessel's stability during adverse sea conditions, and his failure to maintain watertight integrity.

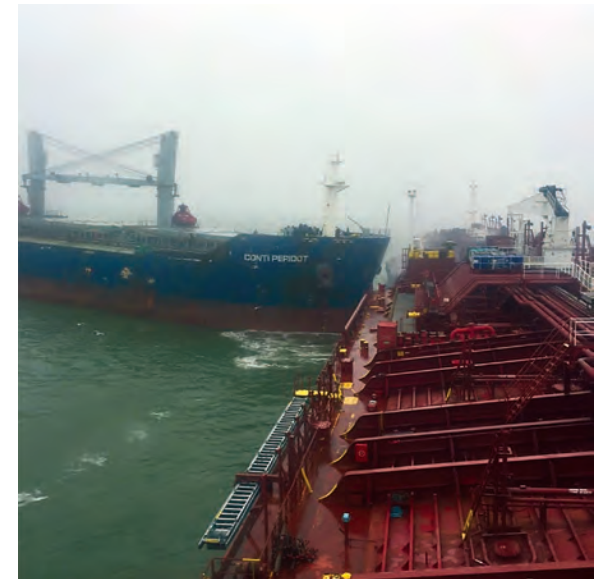
At 1230, the bow of the *Conti Peridot* struck the port side of the *Carla Maersk* just forward of midship. The collision ruptured several ballast tanks and cargo tanks on the *Carla Maersk* and damaged the bow on the *Conti Peridot*. An estimated 88,200 gallons of methyl tertbutyl ether spilled from the *Carla Maersk*, and the two vessels sustained about \$8.2 million in total damage.

Figure 15: Bulk Carrier *Conti Peridot* and tanker *Carla Maersk*, moments after the collision.

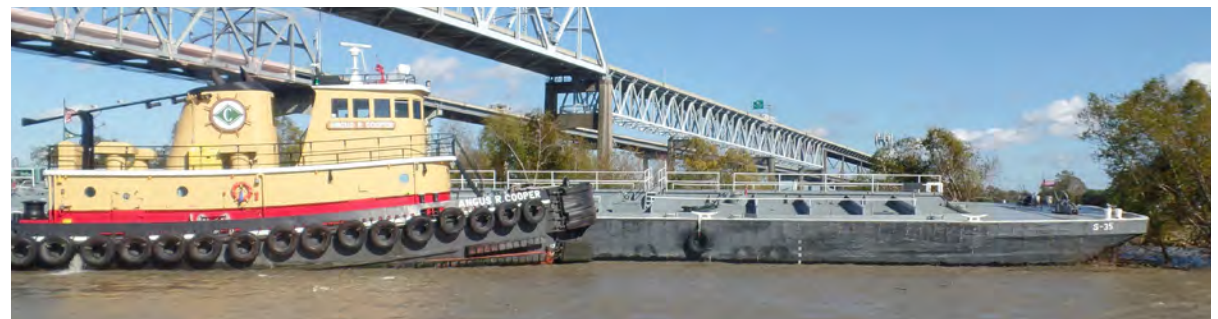
Figure 26: Towing vessel *Angus R Cooper* holding damaged tank barge S-35 against the right descending bank of the Mississippi River. PHOTO BY COAST GUARD

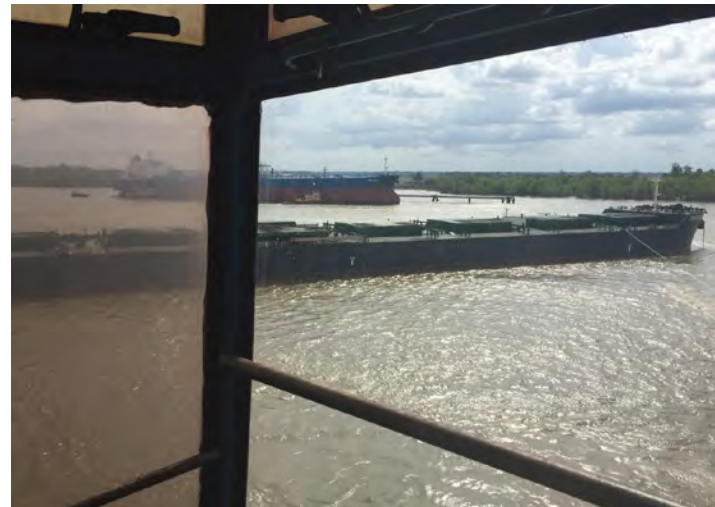
Figure 30: Bulk carrier *Privocean* drifting across the river, with tanker *Bravo* in the background.

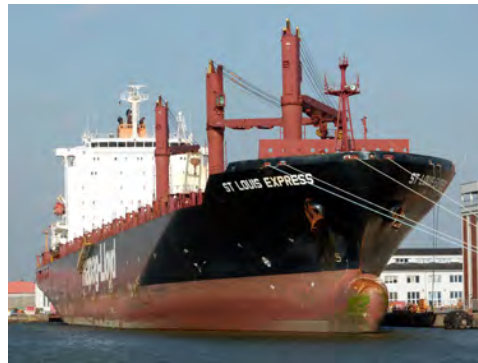
Figure 32: *St. Louis Express* moored port side to. PHOTO COURTESY OF MARTIN TOLLE

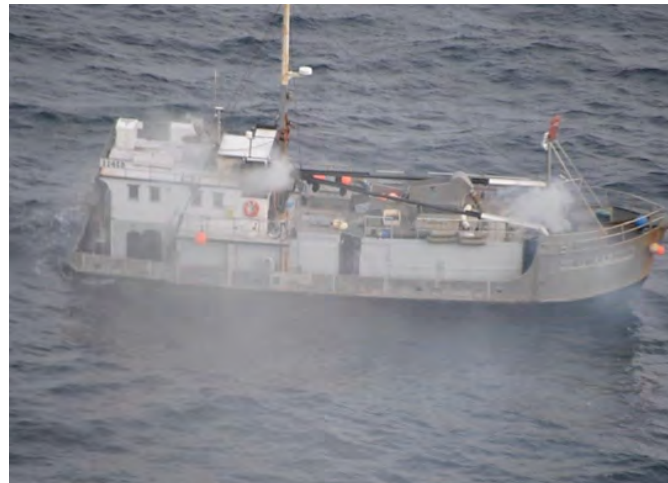
Figure 45: Fishing vessel *Northern Pride* with smoke exiting the forepeak and wheelhouse. PHOTO BY COAST GUARD

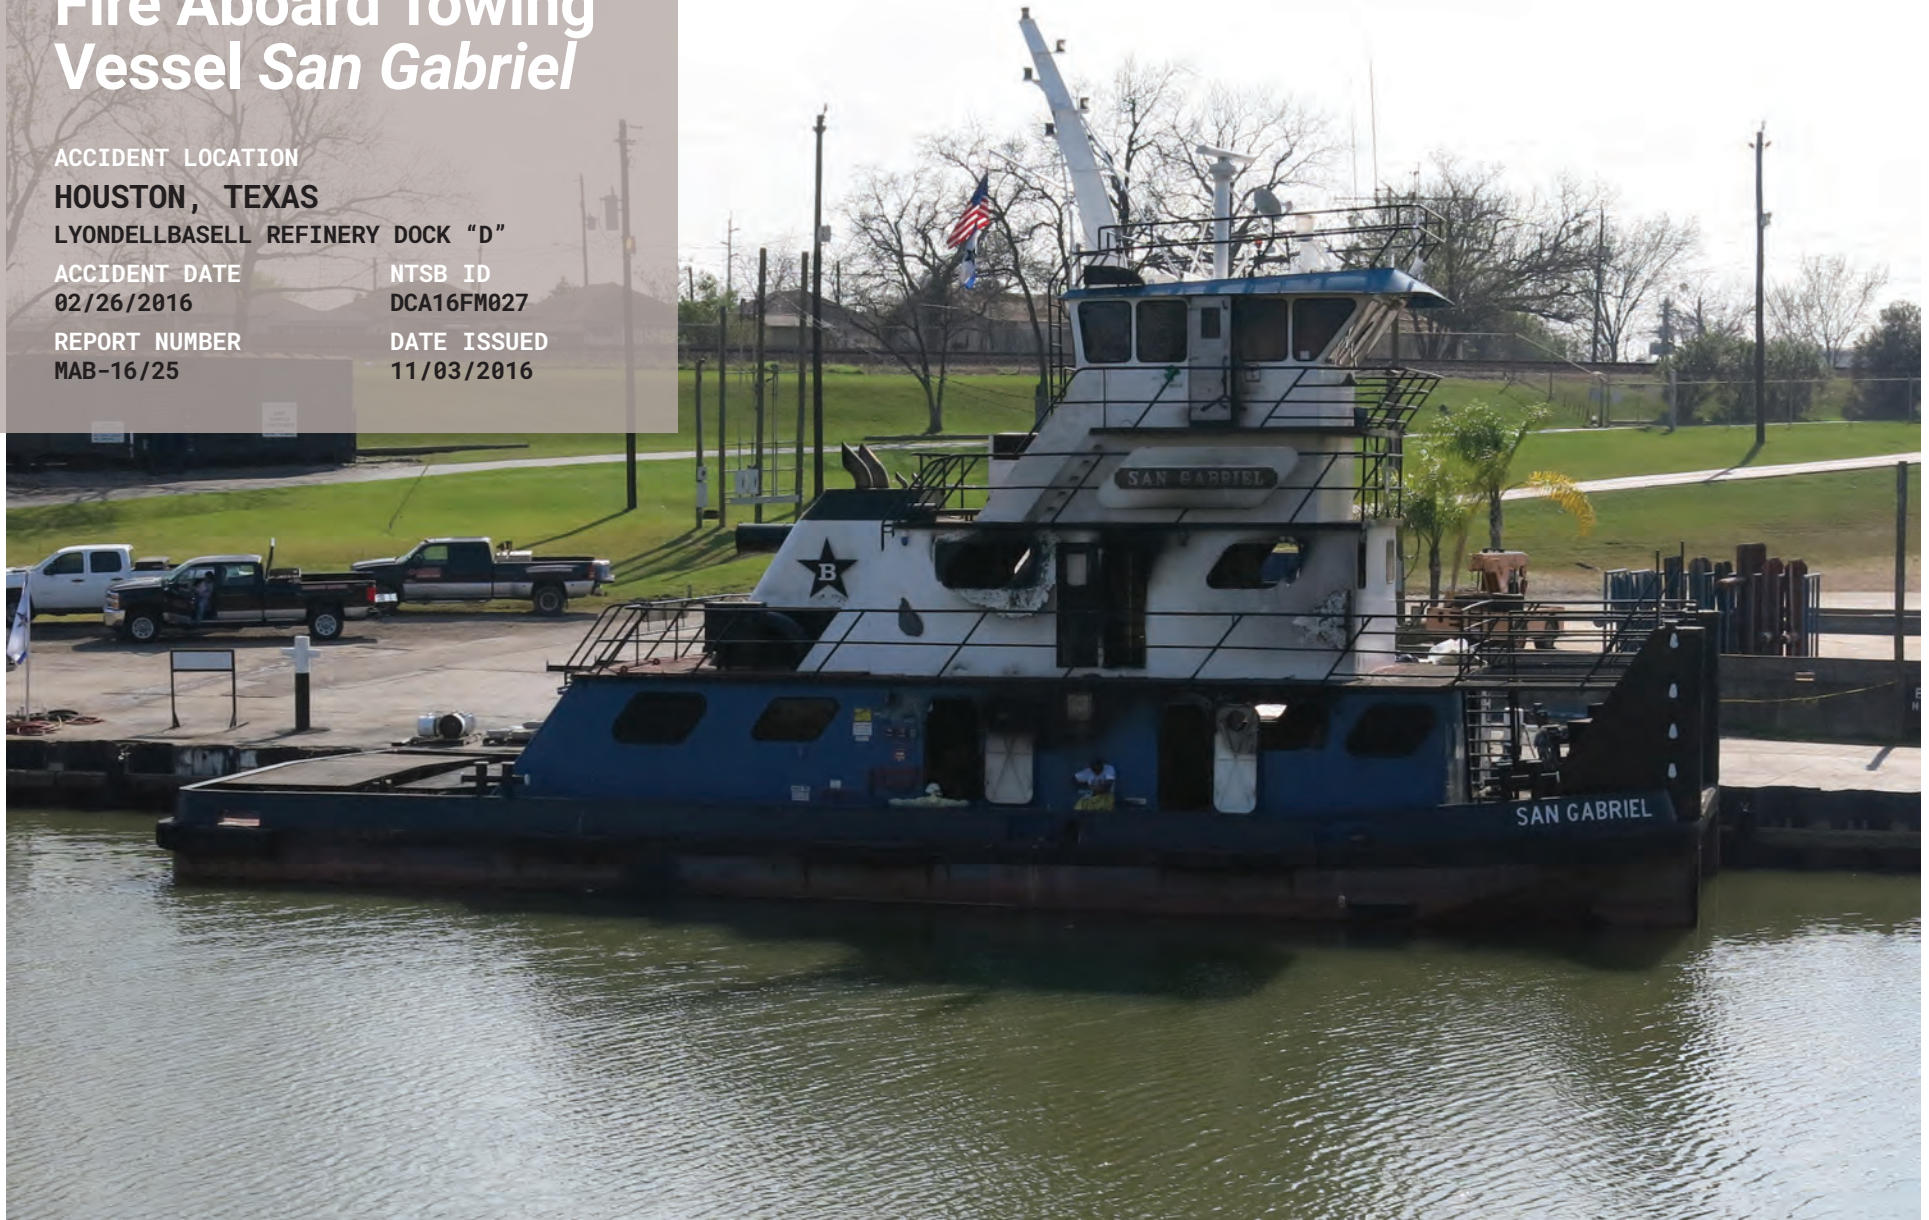
Figure 46: Fire damage to the towing vessel *San Gabriel*.

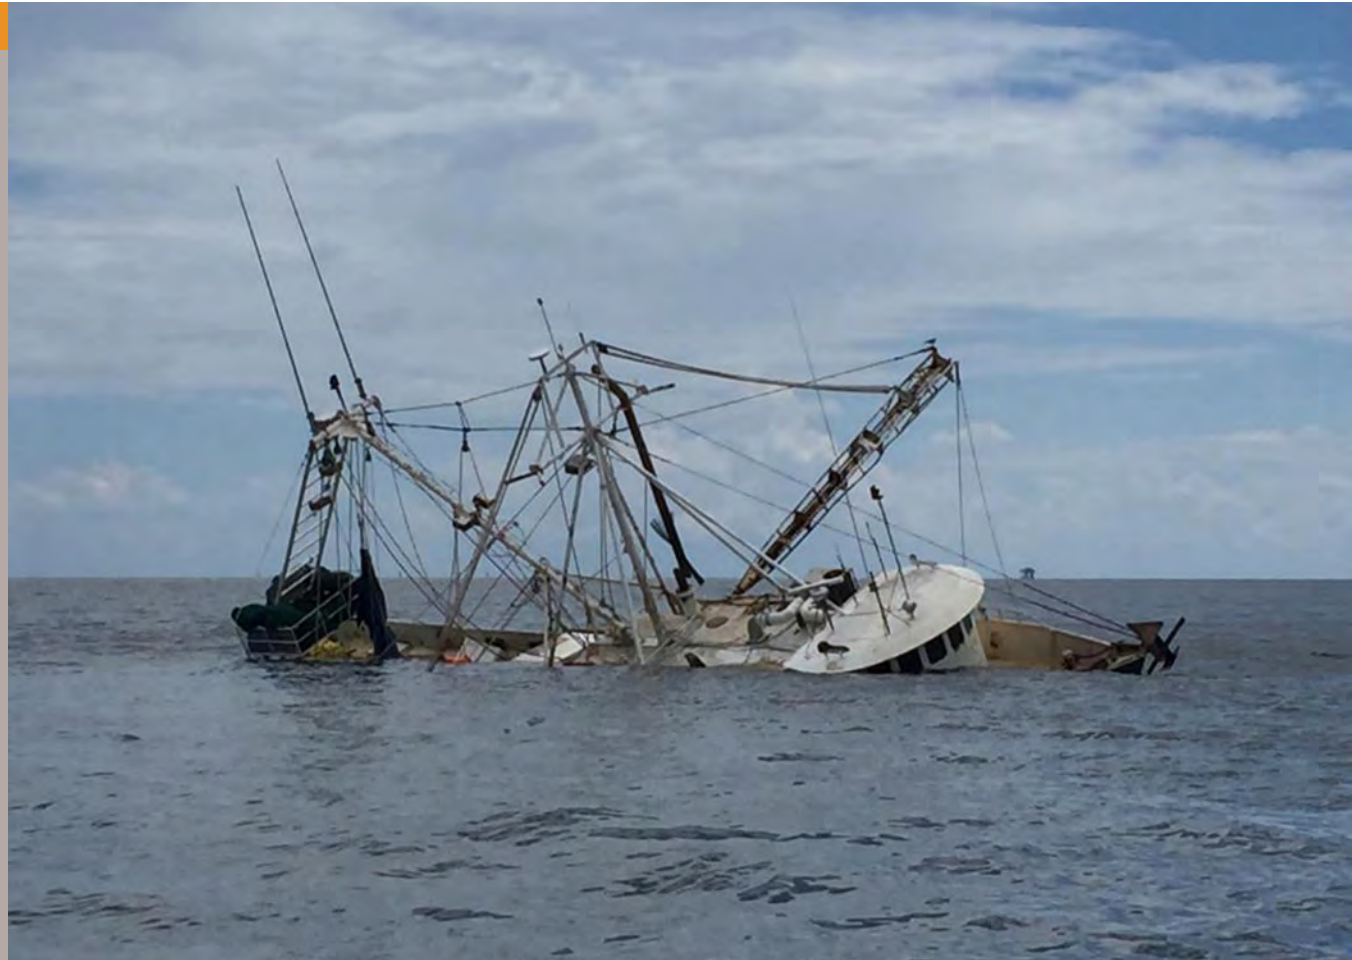
Figure 48: Fishing vessel *Capt Richie Rich* listing to starboard, lying on the bottom.

■ The National Transportation Safety Board determined that the probable cause of the sinking of fishing vessel *Capt Richie Rich* was a collapse of the port outrigger and a hull penetration resulting in uncontrolled flooding in the engine room.

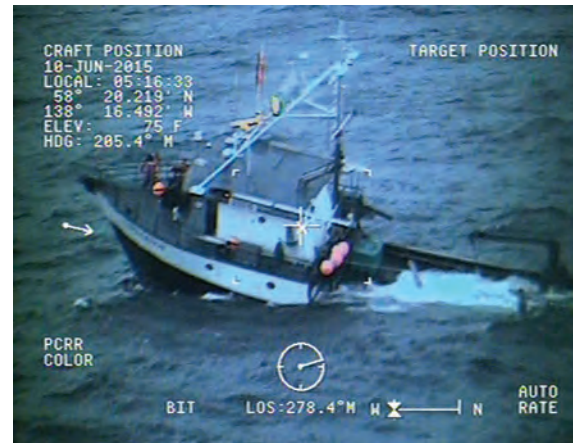
Figure 51: Coast Guard video image of the sinking fishing vessel *Kupreanof* soon after the arrival of a rescue helicopter.

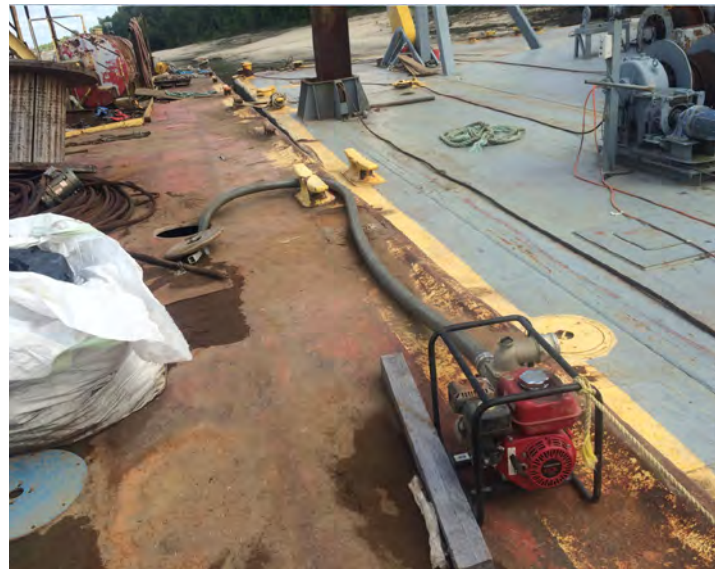
Figure 53: Portable pump and hose rigged to dewater a void on a similar deck barge.

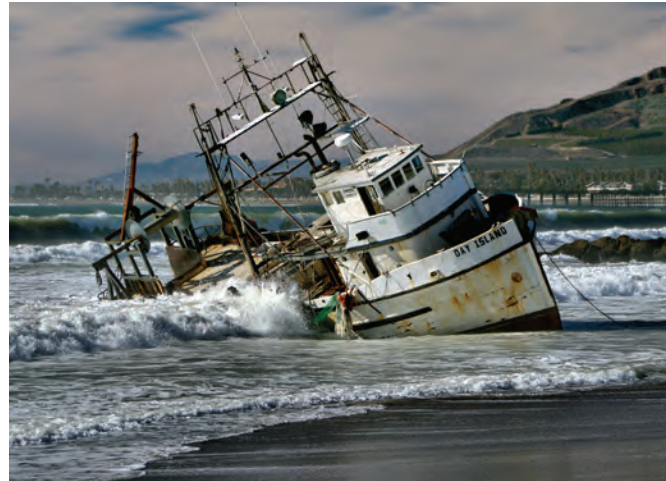
Figure 55: Fishing vessel *Day Island* on Ventura Beach, California, after the grounding. PHOTO COURTESY OF MICHAEL GORDON

■ The National Transportation Safety Board determined that the probable cause of the grounding of fishing vessel *Day Island* was the captain falling asleep while operating it due to the effects of his acute fatigue. Contributing to the grounding was the captain’s use of medication that may have been sedating.

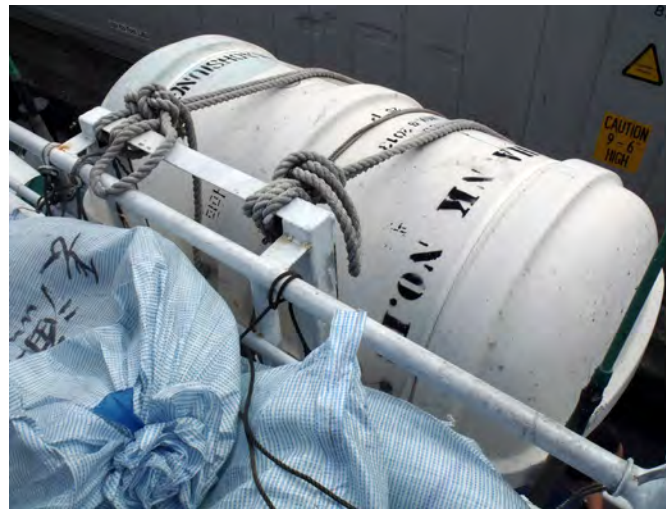
Figure 59: Liferaft aboard sister-vessel *SeaHawk No. 18* secured to its cradle with lines. PHOTO BY COAST GUARD

Investigators also found that the liferaft on the *SeaHawk No. 18* was improperly secured using several lines. The captain and the engineer of the *SeaHawk No. 68* stated that the liferaft aboard their vessel was secured in the same manner, which is why crewmembers had to use a knife to release it. Neither vessel's liferaft was equipped with a hydrostatic-release device.

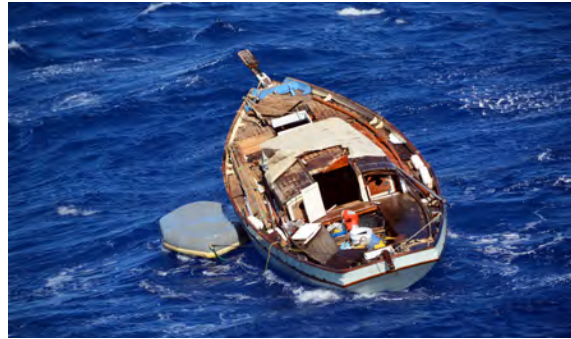
Figure 61: Sailing vessel *Kolina* on the morning after the accident. PHOTO BY COAST GUARD

Investigators learned that the vessel was in poor condition prior to the accident. Fittings and equipment throughout the vessel were broken, and there was significant water leakage. The operating company of a vessel that had previously towed the *Kolina* told investigators that "the vessel was in no condition to be in the water, let alone go outside the harbor." State officials familiar with the vessel expressed amazement that the captain would consider attempting a cross channel voyage in a vessel as degraded as the *Kolina*.
