# STATE OF RHODE ISLAND

## DEPARTMENT OF ENVIRONMENTAL MANAGEMENT

### PARKS AND RECREATION GUIDANCE DOCUMENT FOR THE DEVELOPMENT AND OPERATION OF BEAVERTAIL STATE PARK, JAMESTOWN, RHODE ISLAND

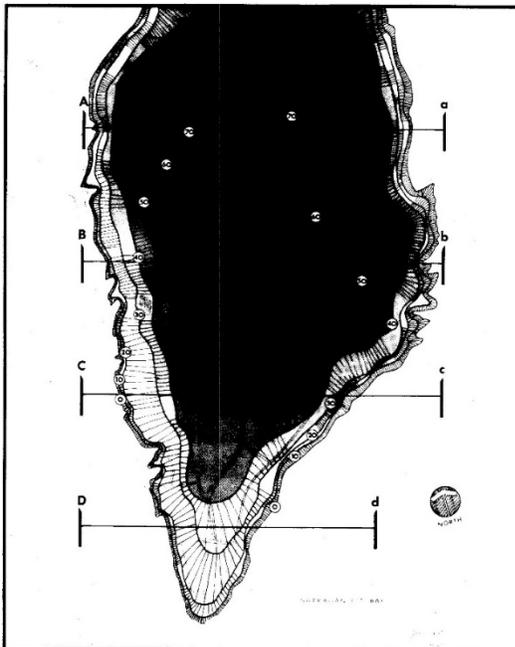
**INVENTORY SHEET NO. 1**

**TOPOGRAPHY**

**SECTIONS**

HORIZONTAL SCALE 1 inch = 400 feet  
VERTICAL SCALE 1 inch = 200 feet

A Abandoned Naval Buildings

C Naval Communication Center

- A. Analysis of the physical and biological characteristics of the Beavertail Peninsula, as described and portrayed below, compels the following findings and conclusions relative to the peninsula and its development as a park:
1. Topography: The topography of Beavertail creates quite a subtle landform except for certain places along the shoreline where the land drops dramatically 20 to 30 feet to the ocean. The rest of the land gently rolls up to a slight crown 72 feet above sea level. This crown unfortunately peaks just to the west of the main road so any view of the ocean from the main road is completely cut off. Any conception of being on a peninsula with ocean on three sides is totally diminished until you reach the very tip where the topography and vegetation finally open up to the ocean.

One solution that would allow a park visitor to know what type of landform he was approaching would be to pull the main road up and over the crown. This would enable a commanding view of the ocean as well as experiencing the landscape as it rolled down to the rocky shoreline, yet would have an acceptably small impact on existing soils and vegetation.

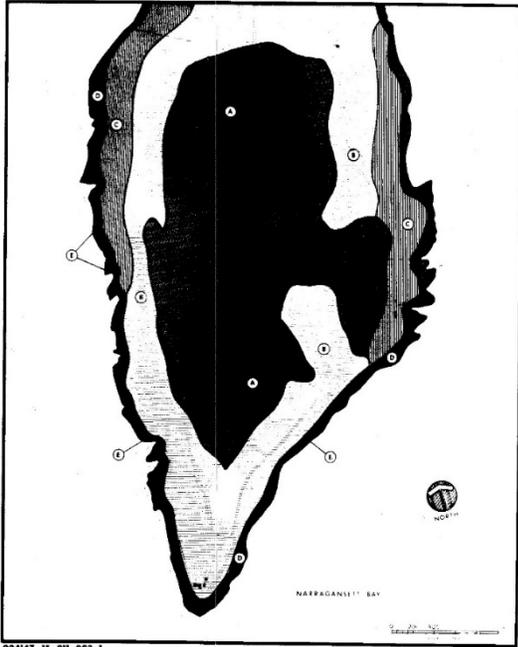
INVENTORY SHEET NO. **2**  
**BEAVERTAIL**

### SLOPE

The slope of the land is expressed in terms of percent. For example, a slope of 3 percent means a difference in elevation of three feet for each 100 feet of horizontal distance. In the map symbol, slope class is indicated by a letter as follows:

- 0-2 percent slope
- 3-8 percent slope
- 8-15 percent slope
- 15-25 percent slope
- 25 and over percent slope

2. Slope: The slope is not a major development factor of Beavertail except for along the shoreline. For most of the land this slope ranges from 0 - 8 percent but as it was pointed out in topography, the drop to the ocean along the shoreline can range from 15 percent to well over 60 percent. The western shoreline is the one that presents the most problems. The nature of the geology (see Map 6) plus the constant battering from the wind and sea has caused this abrupt change from a gently rolling landscape to the rocky shoreline cliffs.

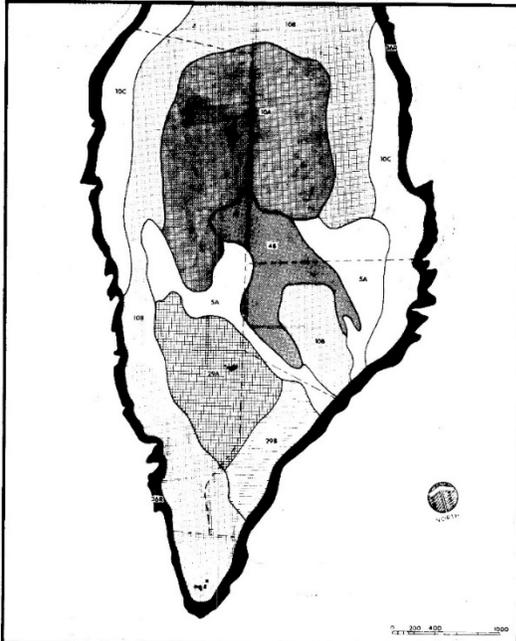
INVENTORY SHEET NO. **3**

### SOILS KEY

**10A** Neopark silt loam, 0 to 3 percent slopes  
**10B** Neopark silt loam, 3 to 8 percent slopes  
**10C** Neopark silt loam, 8 to 15 percent slopes

3. Soils: Within the soils found at Beavertail some have very slow permeability in the substratum. (See Mapping Units 29A, 29B, and 48). This will create problems locating septic tank absorption fields. Location of any sanitary facility must be within the Newport series (See Mapping Units 10A, 10B, and 10C) and then only if the proper percolation tests show suitability.

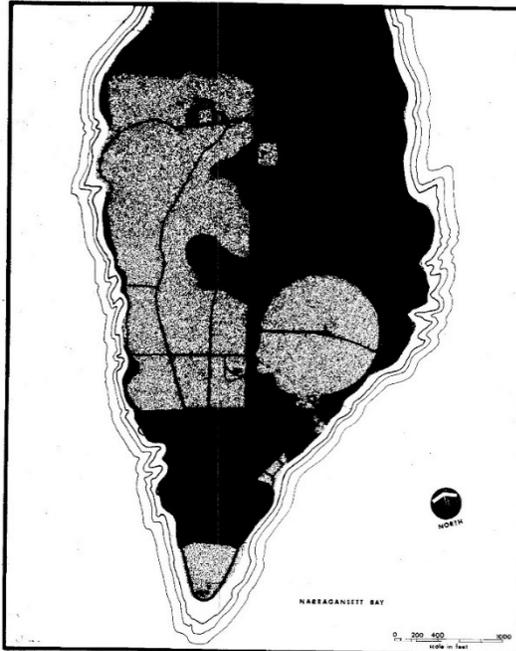
INVENTORY SHEET NO. **4**

### VEGETATION

**CLASS I**  
 High Vegetation 8 ft & above  
 mapping symbol: [stippled pattern]

**CLASS II**  
 Low Vegetation 2 ft to 8 ft  
 mapping symbol: [dotted pattern]

**CLASS III**  
 Field Vegetation  
 mapping symbol: [cross-hatched pattern]

4. Vegetation: The vegetation, as shown in Map 4 of this Part is broken into three distinct classes, high vegetation, low vegetation and field vegetation.

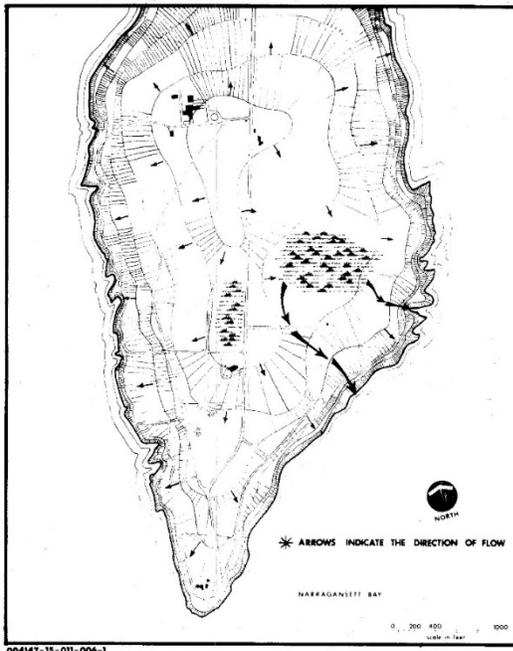
**5**

## HYDROLOGY

Except for two small wetlands, the entire Beavertail peninsula drains directly into the ocean. (See adjacent map.)

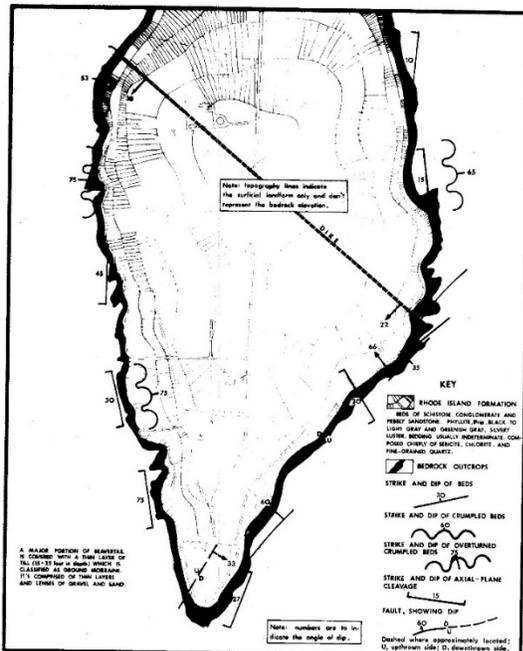
**6**

## GEOLOGY

The most unique feature of the bedrock along Beavertail's shoreline is the remarkable difference between horizontal bedding of the west shore and the very steep side of the bedrock on the east shore. Notice erosion has caused the bedrock along the west shore to be tilted into the east where both rocky and sandy beaches can be found.

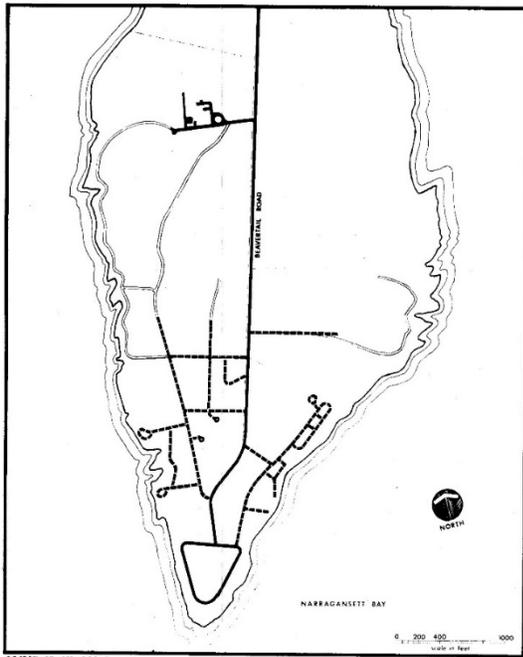
INVENTORY SHEET NO. **7**  
**BEAVERTAIL**

### EXISTING ROADS

7. Existing Roads: An important piece of the inventory stage was the mapping of existing roads (Map 7). This is because the park development must minimize any unnecessary removal of plant material and cause the least disturbance to the soils. The existing road beds which were mostly gravel and left behind by the Navy served to determine how a new park loop road could be incorporated to circulate people through different areas of the site. The field roads, most of them made by fishermen, have also been utilized to lay out a 2 mile bicycle route.

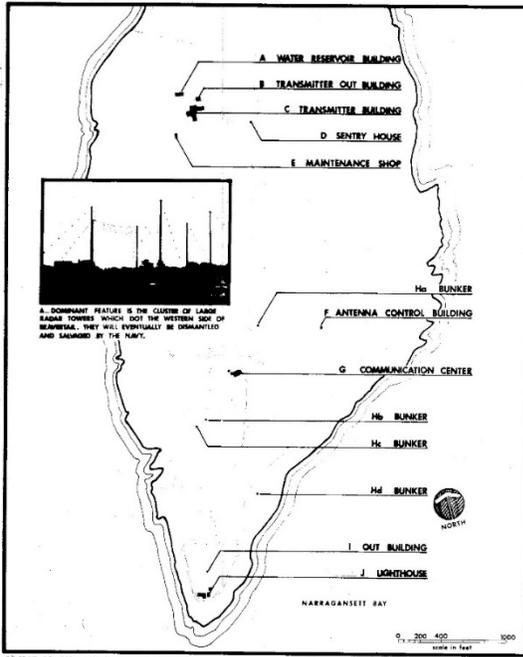
INVENTORY SHEET NO. **8**  
**BEAVERTAIL**

### EXISTING BUILDINGS

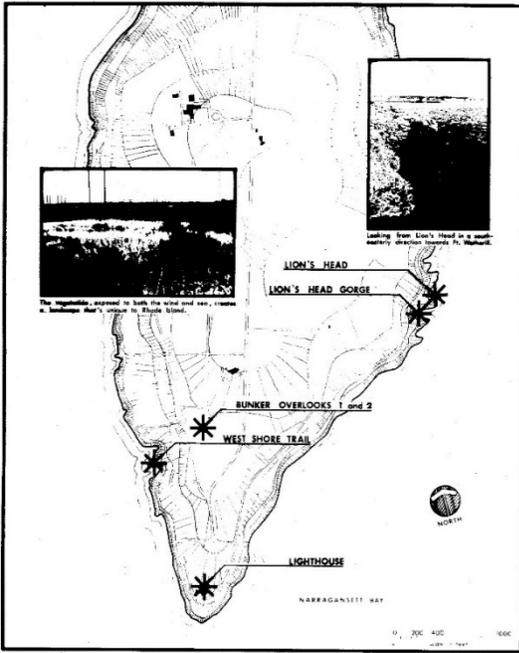
### SPECIAL FEATURES

**LION'S HEAD** The name was given the rock formation because the head of the water surging into the straits resembles that of a lion's nose.

One of the four bunkers that can be found at Beavertail.

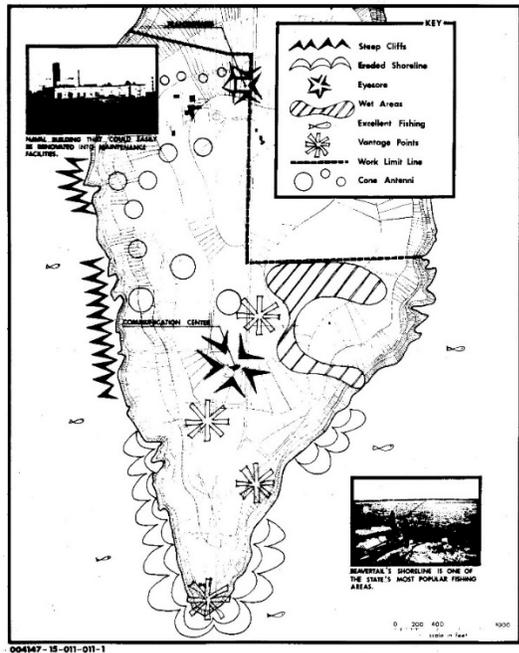
### SITE ANALYSIS

Erosion along the shoreline that was caused by heavy foot traffic.
