October 1, 2007

081-12152-04

Subject: Site Work Conducted at Springfield Street School, Providence, RI

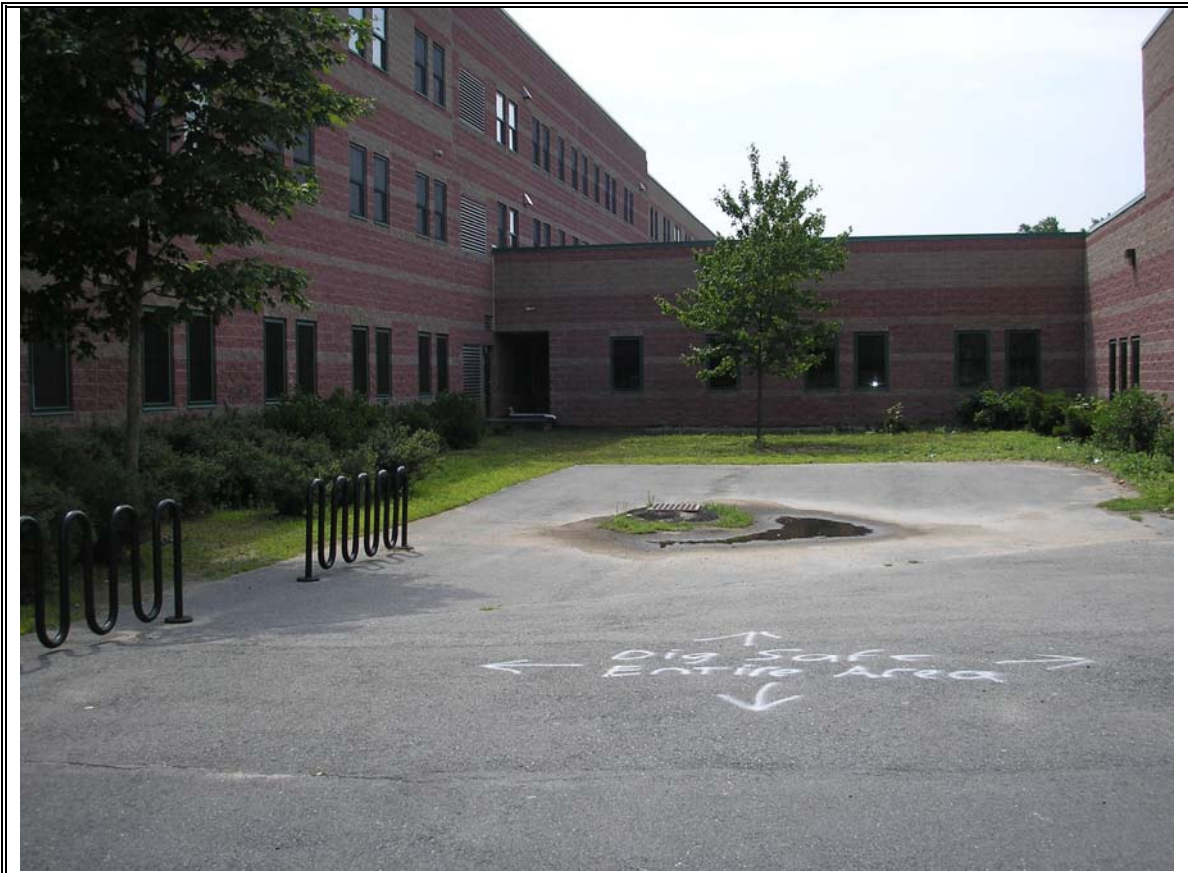
1

Middle School Courtyard prior to repair work (7/16/07).

- The catch basin in the courtyard area of the Middle School: the catch basin was lowered to allow it to function, and the area around the catch basin was regraded and repaved. Disturbed areas were reseeded.

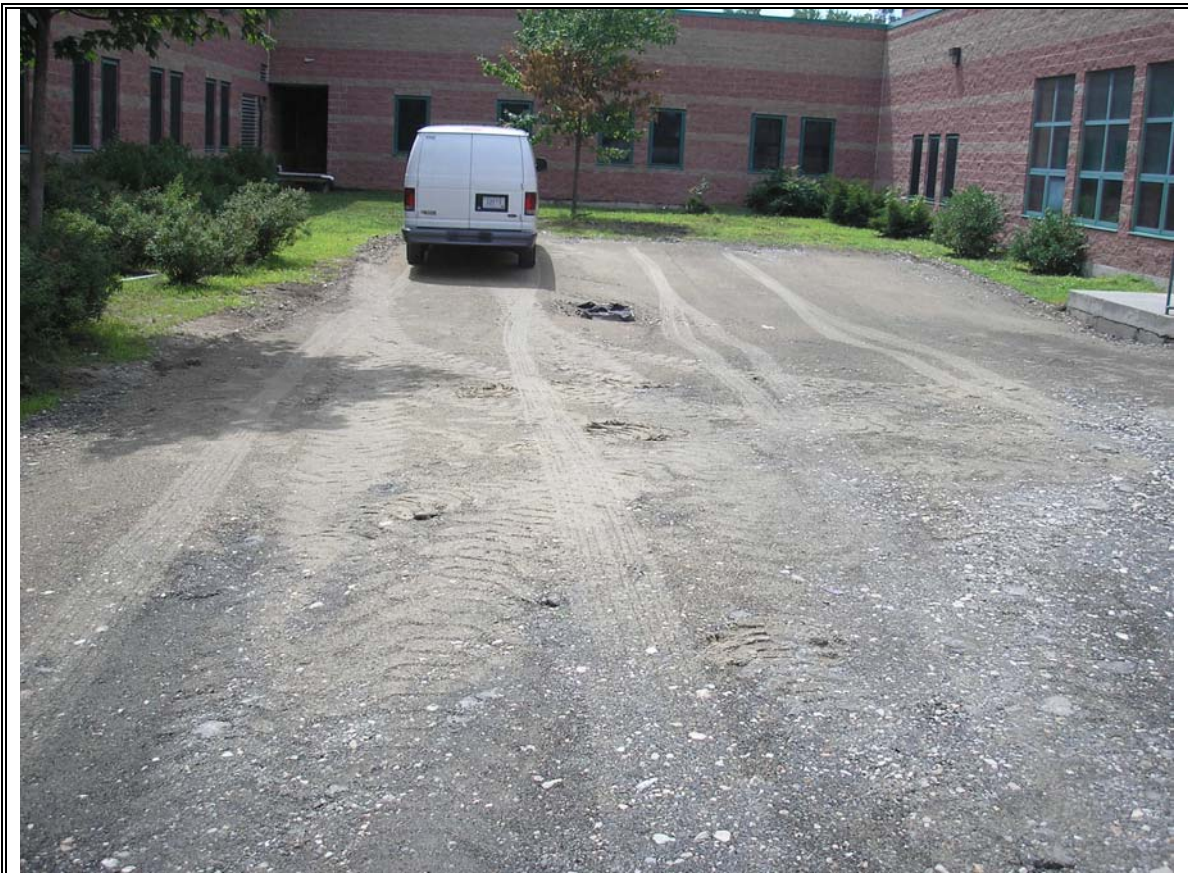
2

Middle School Courtyard during repair work (7/30/07).

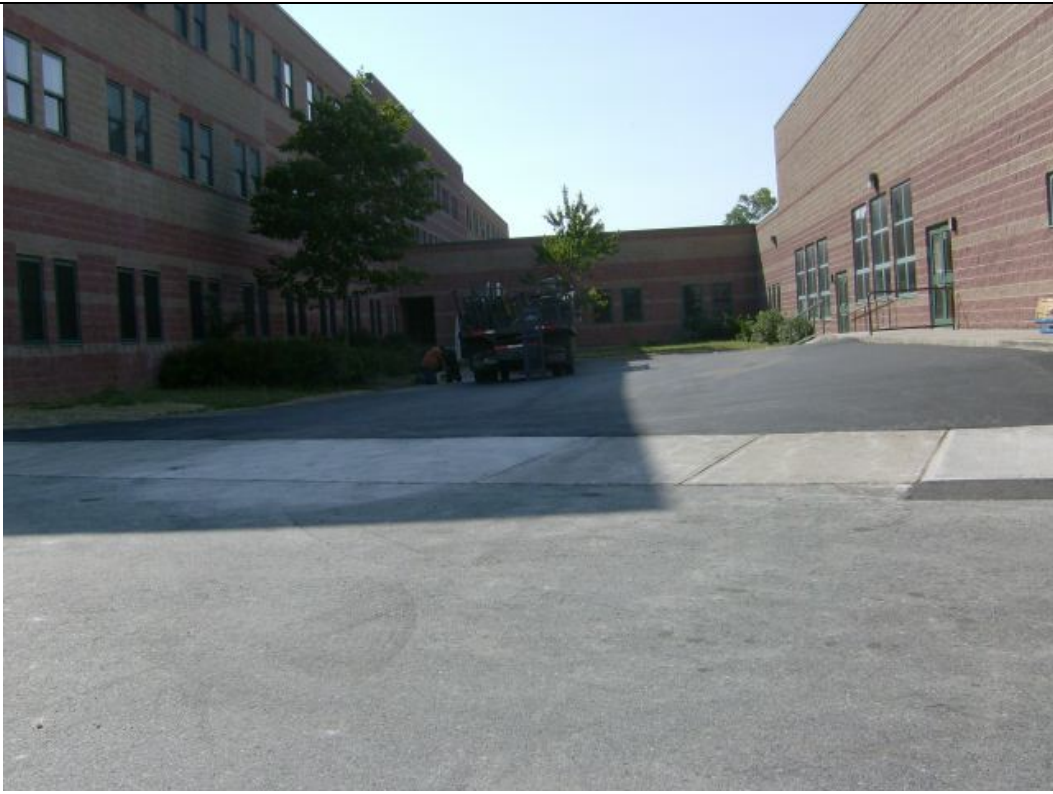
3

Middle school courtyard after repairs completed (9/4/07)

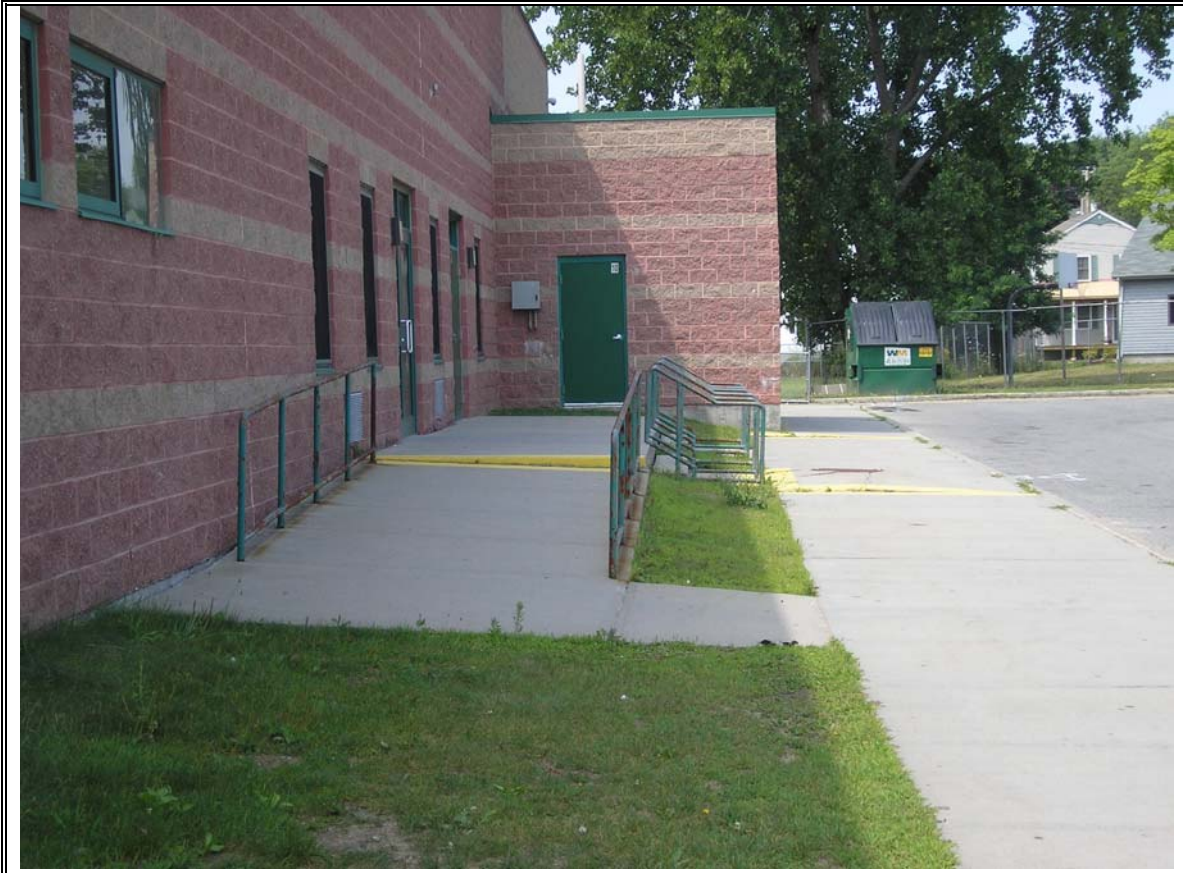
5

North end of middle school prior to repairs (7/16/07)

- The concrete sidewalk and ramp on the north side of the middle school: the concrete sidewalks, stairs and ramp were removed and reconstructed. Adjacent asphalt was patched.

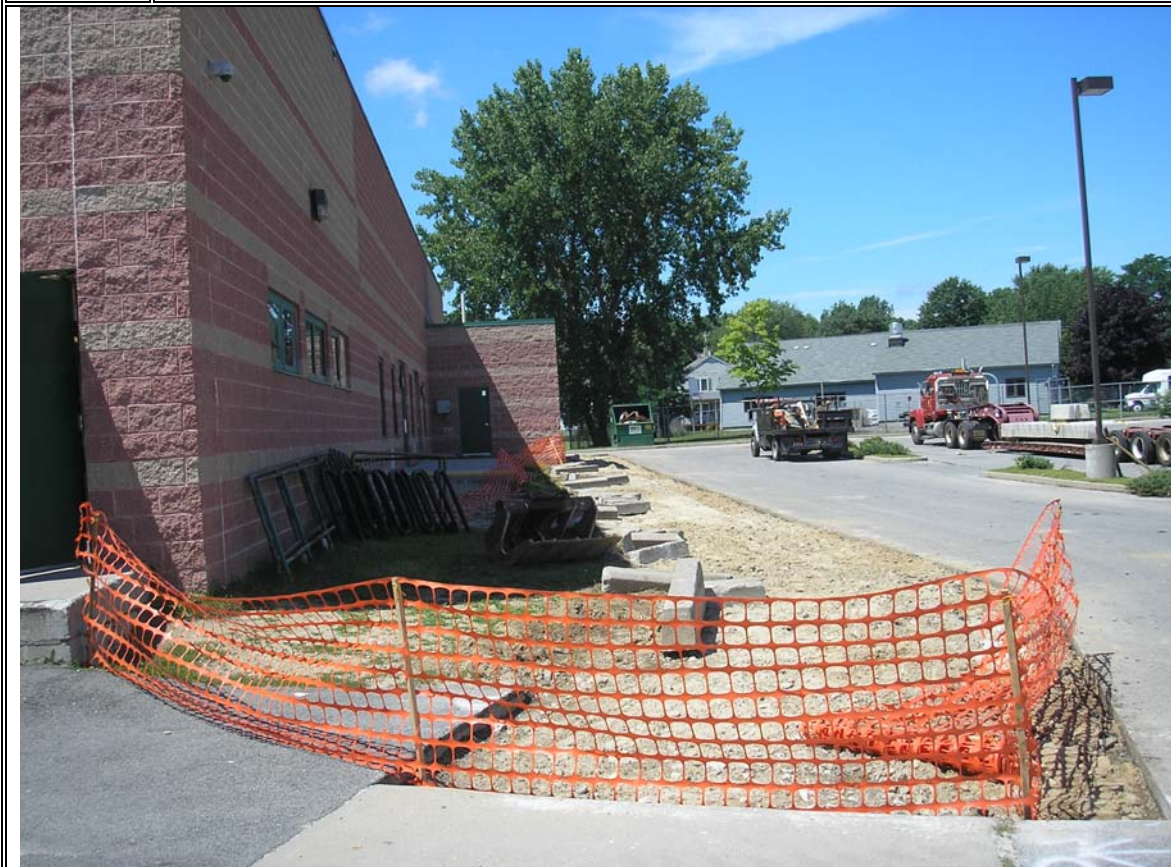
6

North end of Middle school during repairs (7/24/07).

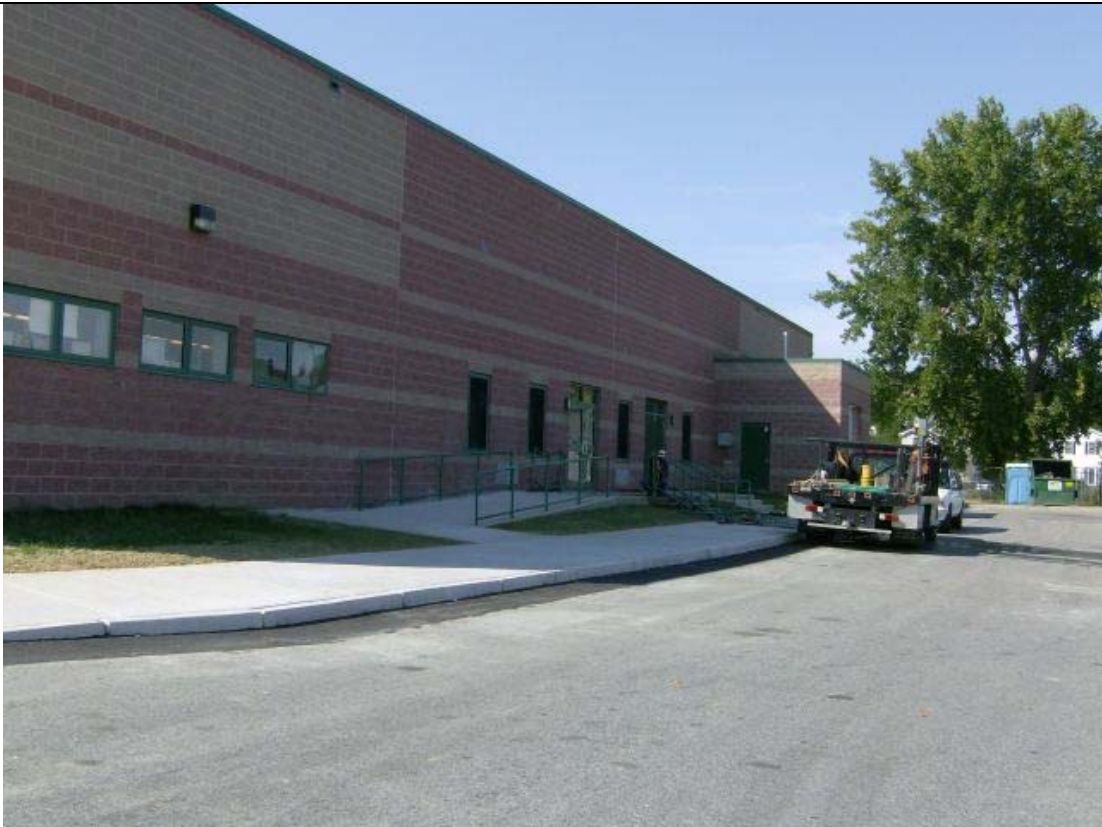
7

North end of Middle school after repairs were completed (9/4/07)

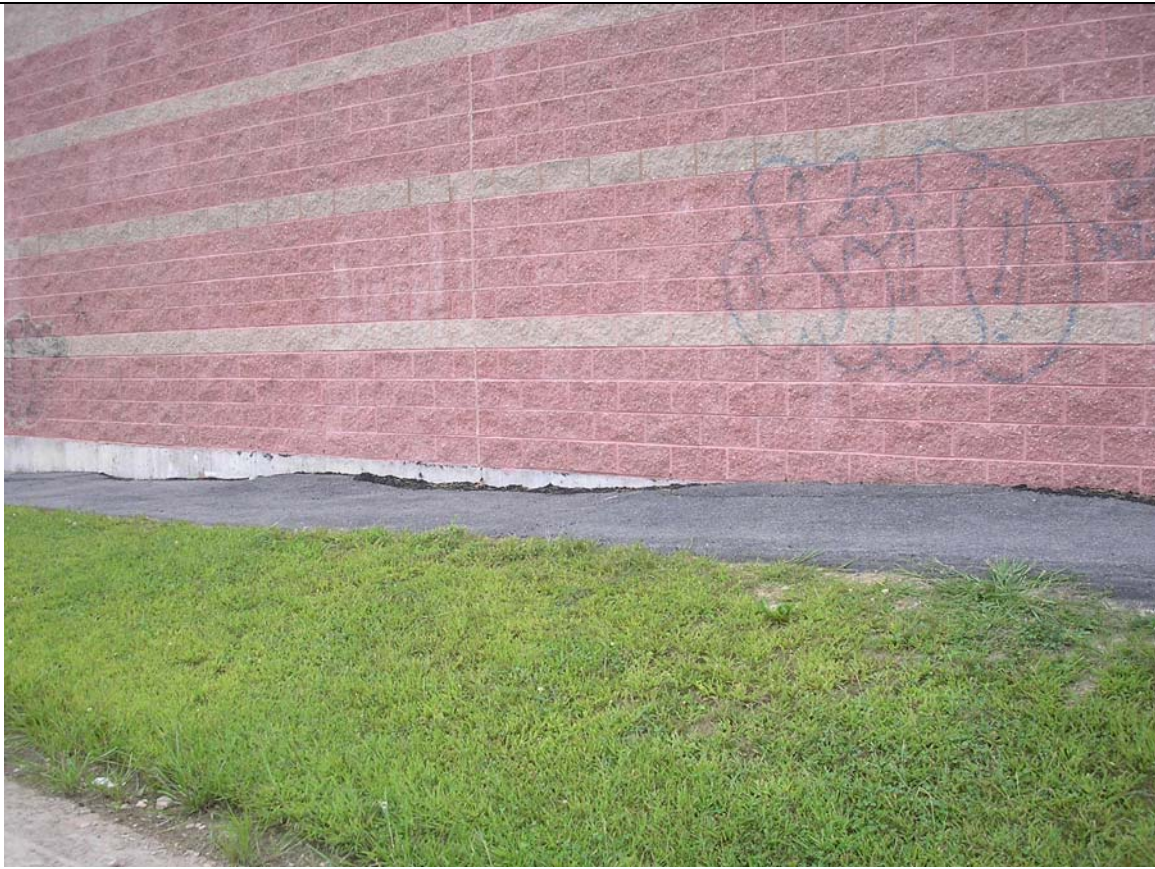
8

Back of middle school gym prior to repairs (8/25/06).

- The concrete and asphalt walkways on the west side of the Middle School gymnasium: the concrete landings and asphalt walkways were removed and replaced with new landings and walkways. Disturbed areas were graded and seeded.

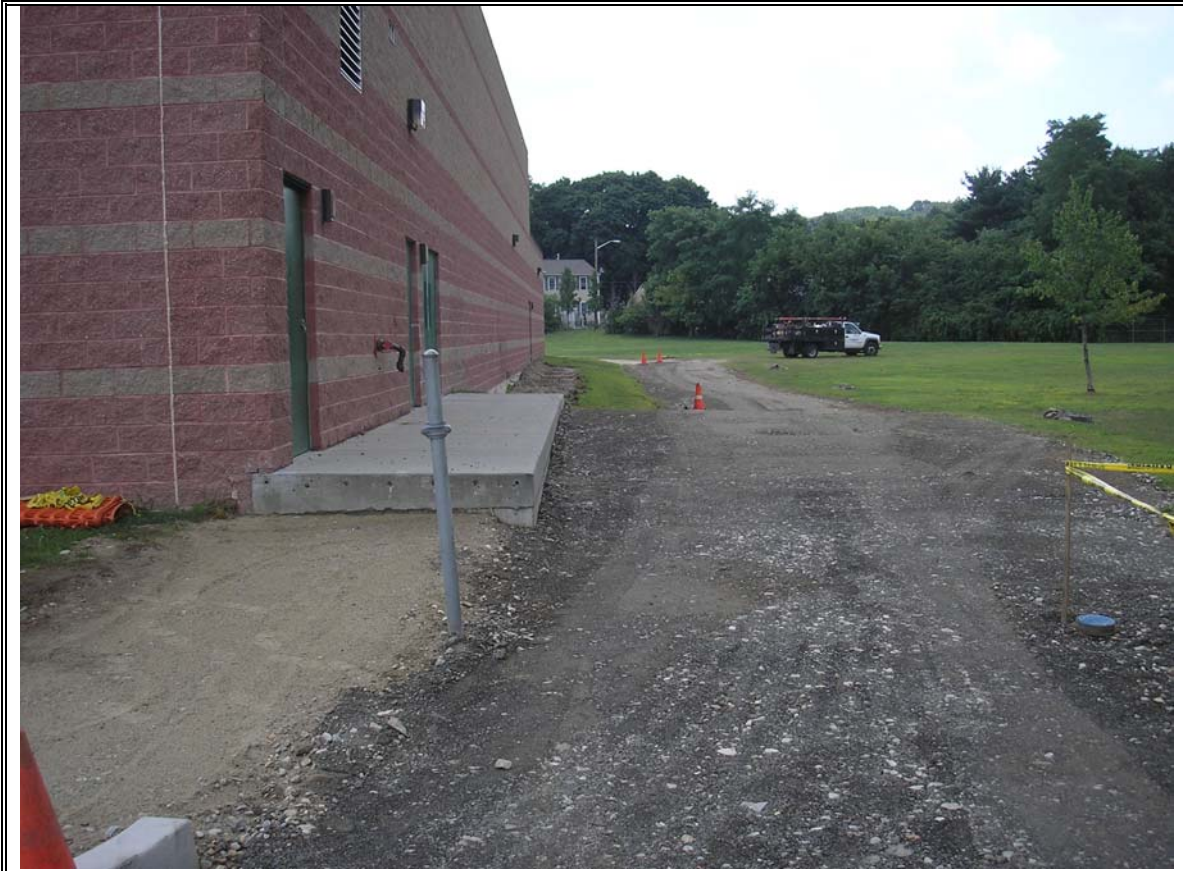
9

Back of middle school gym during repairs (7/30/07)

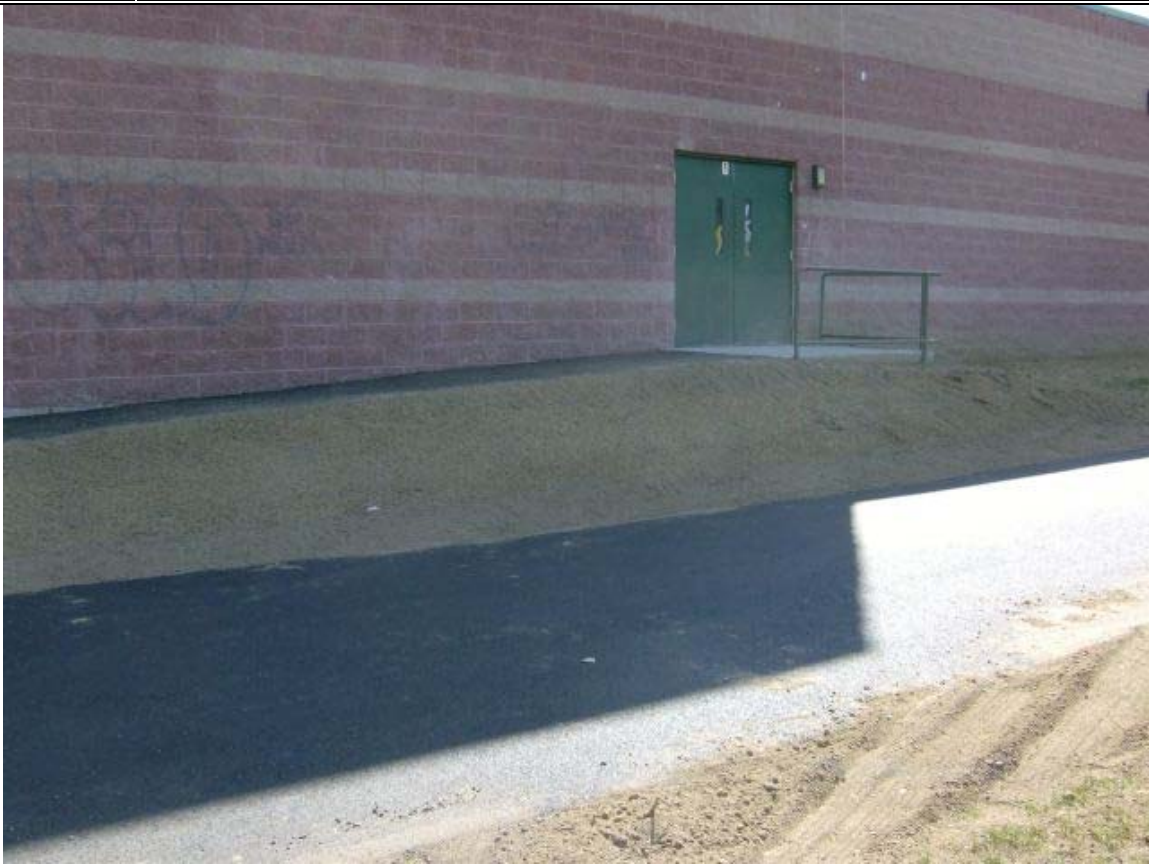
10

Back of Middle school gym after repairs were completed (9/4/07).

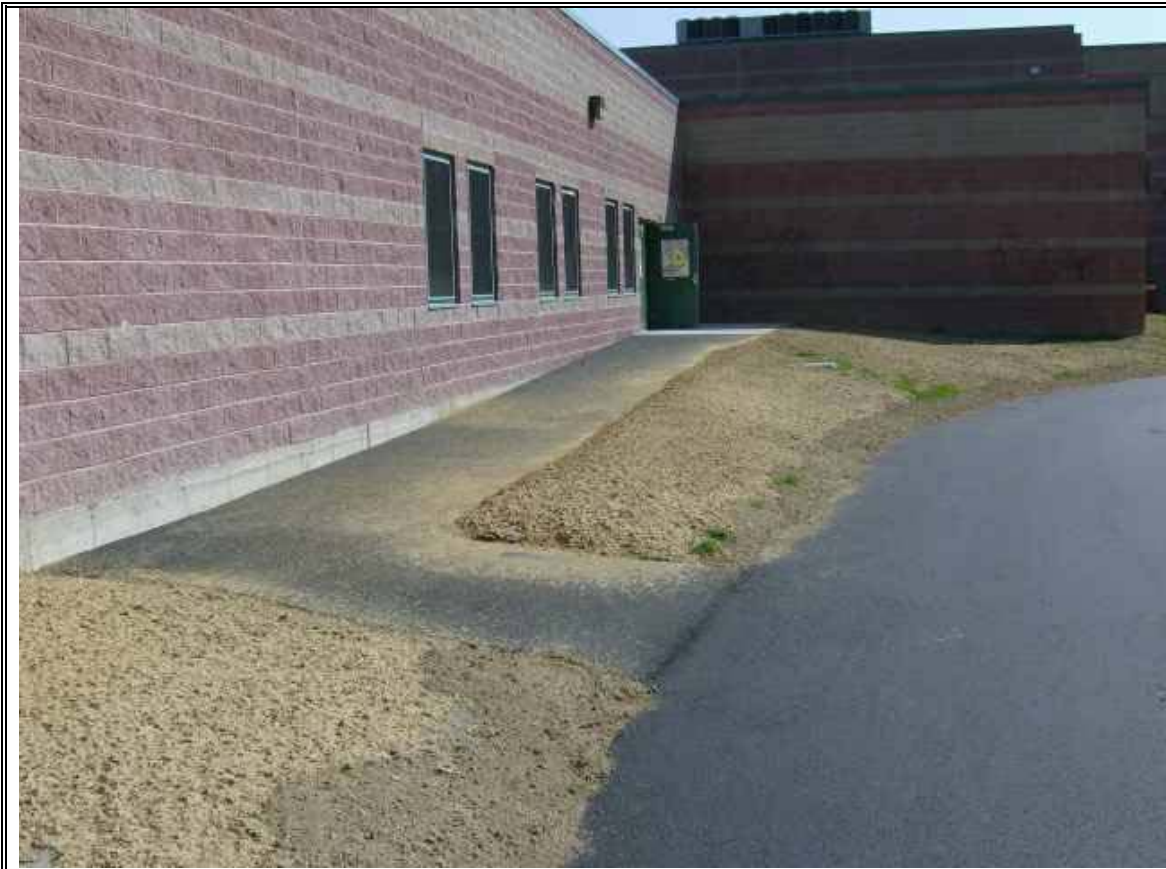
11

Middle school south of gym after repairs completed (9/4/07)

- The concrete and asphalt walkway on the south side of the Middle School near the gymnasium: the asphalt walkway was removed and replaced. Disturbed areas were restored with loam and seed.

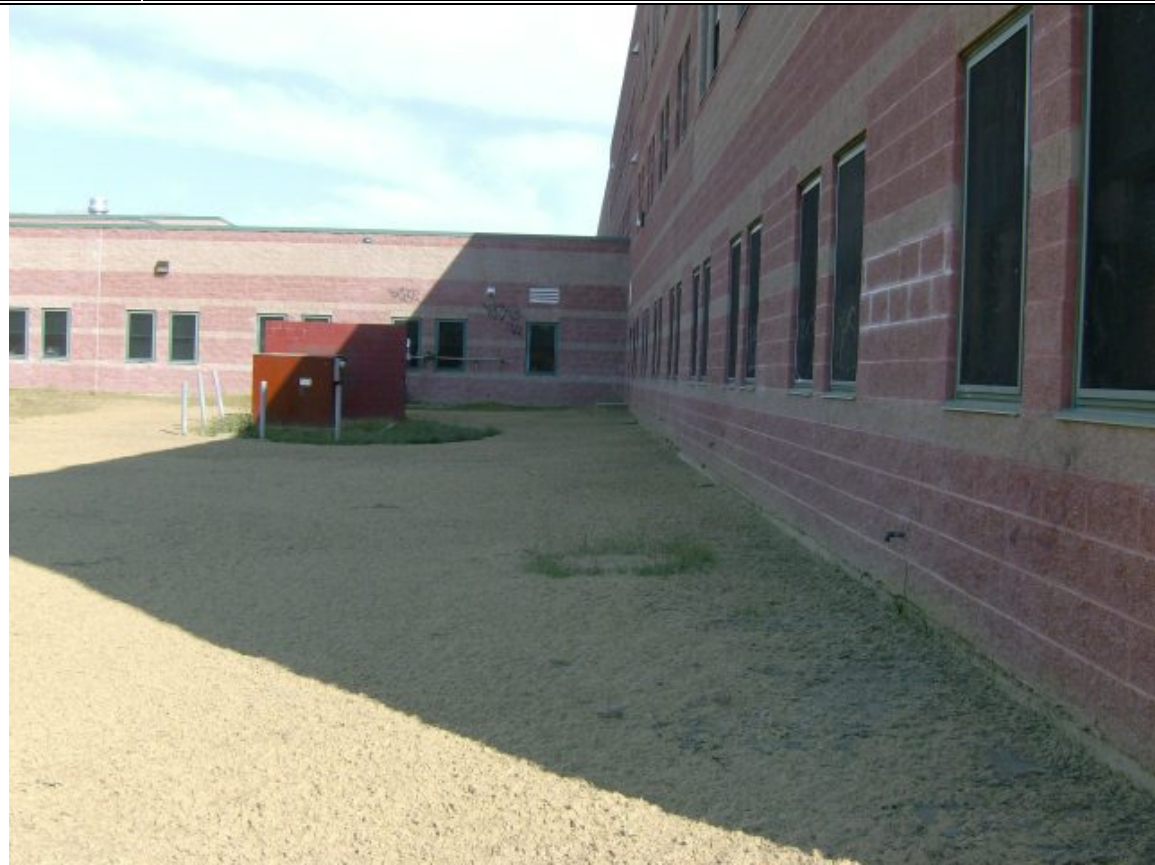
12

Middle school transformer area southwest of building after repairs completed (9/4/07).

- The southwest corner of the middle school including the area around the transformer: this area was regraded for proper drainage, the asphalt walkway was removed and replaced, and the catch basins were reset to obtain proper elevations for stormwater drainage. Disturbed areas were restored with loam and seed.

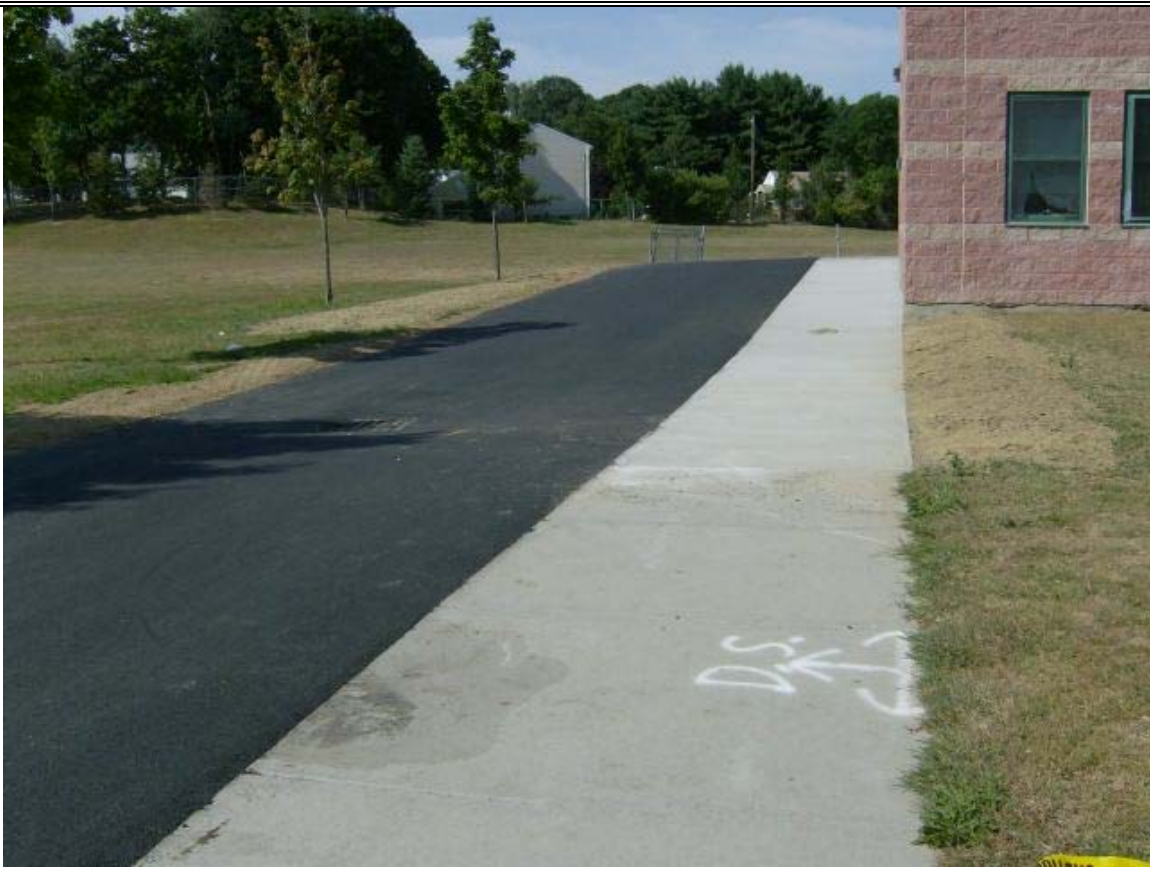
13

Driveway on southern end of Middle school after repairs completed (9/4/07)

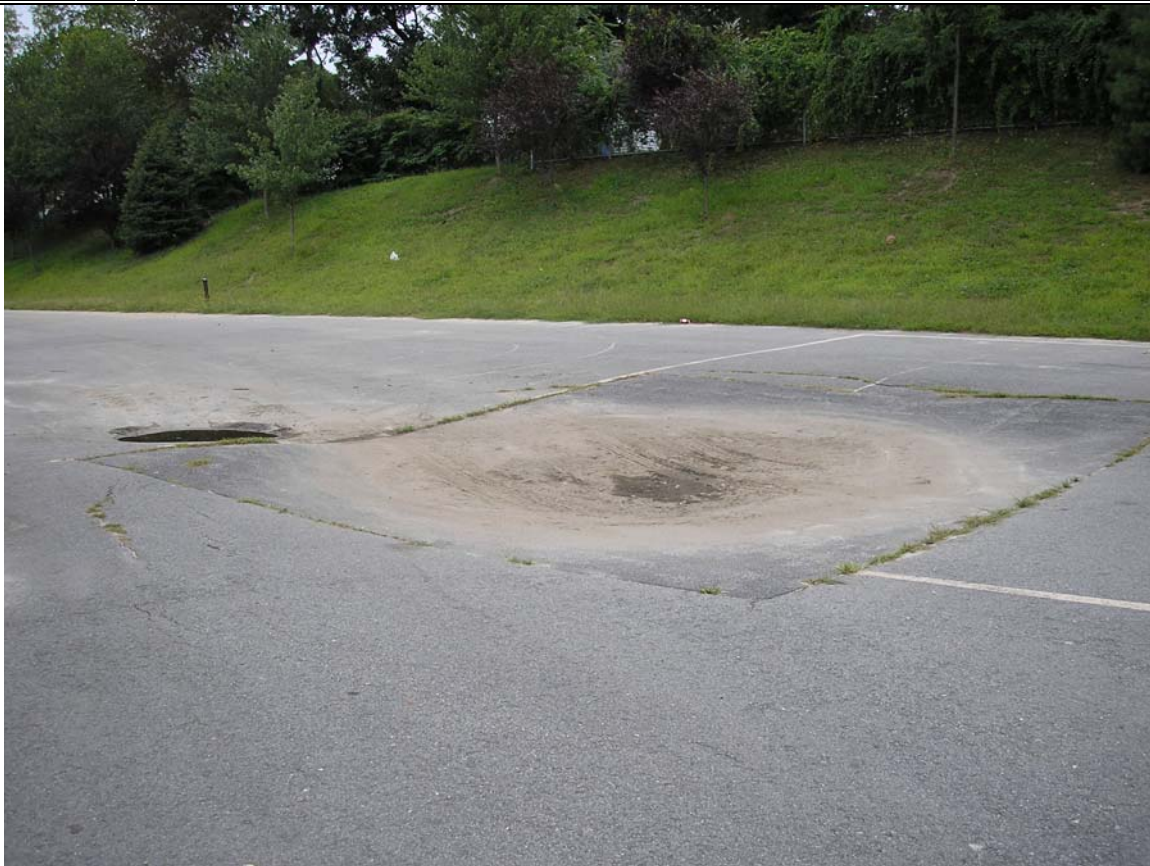
14

Sinkhole behind Elementary school before repairs (8/25/06).

Work was conducted above the orange snow fence barrier; the barrier was not observed except in the area of the catch basin near the southwest corner of the middle school, and the sinkhole behind the elementary school. At these locations, excavation ceased when the barrier was encountered, and soil was not excavated from below the barrier.

- The area of settled asphalt west of the elementary school: the pavement was removed and the area was regraded and repaved. After removing fill placed in the area during a previous attempted repair, a structural geomembrane fabric was placed over the orange indicator layer to attempt to prevent future settling. This is a deviation from the plan presented in our letter of June 9, which indicated that lightweight fill would be used. The lightweight fill blocks originally proposed were found to be too thick to achieve the desired final grades. The structural geomembrane fabric was used as an alternate method to control future settling of this area.

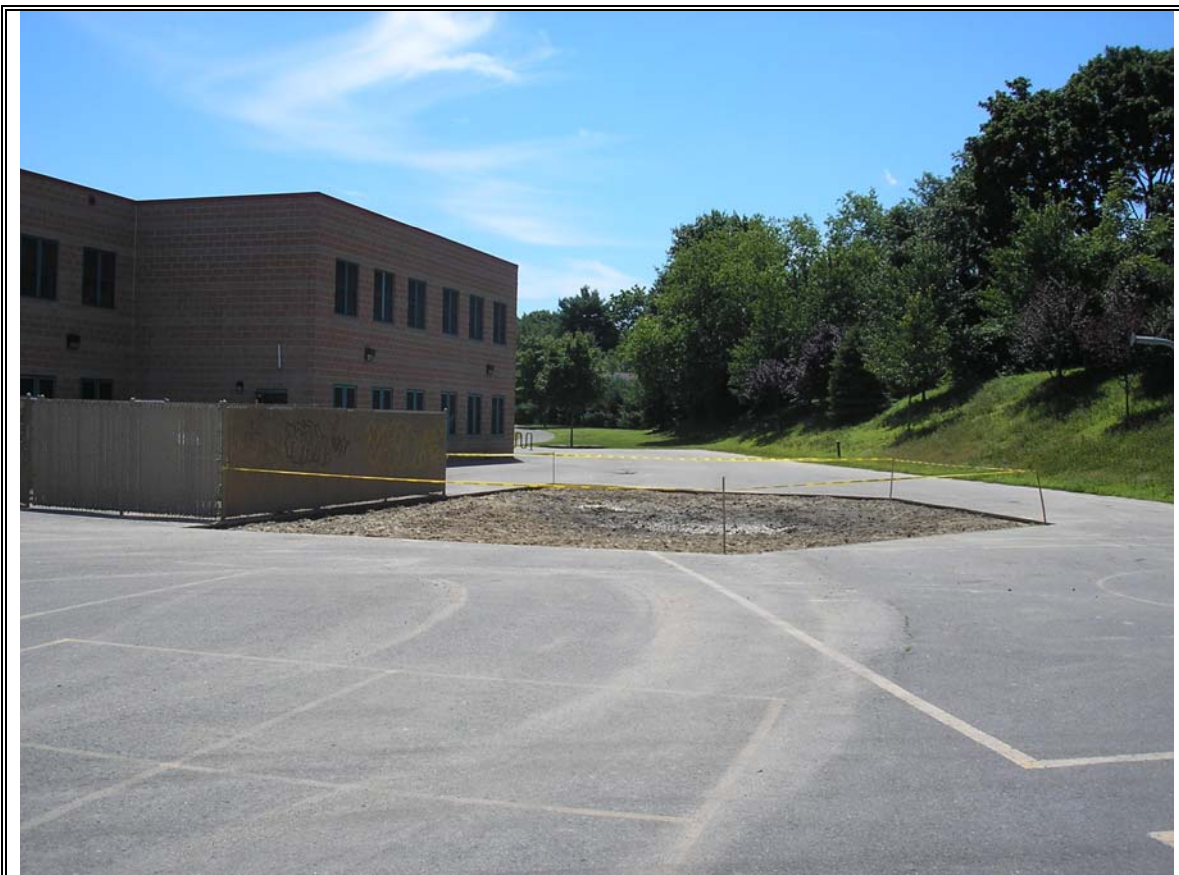
15

Sinkhole behind elementary school during repairs (7/24/07).

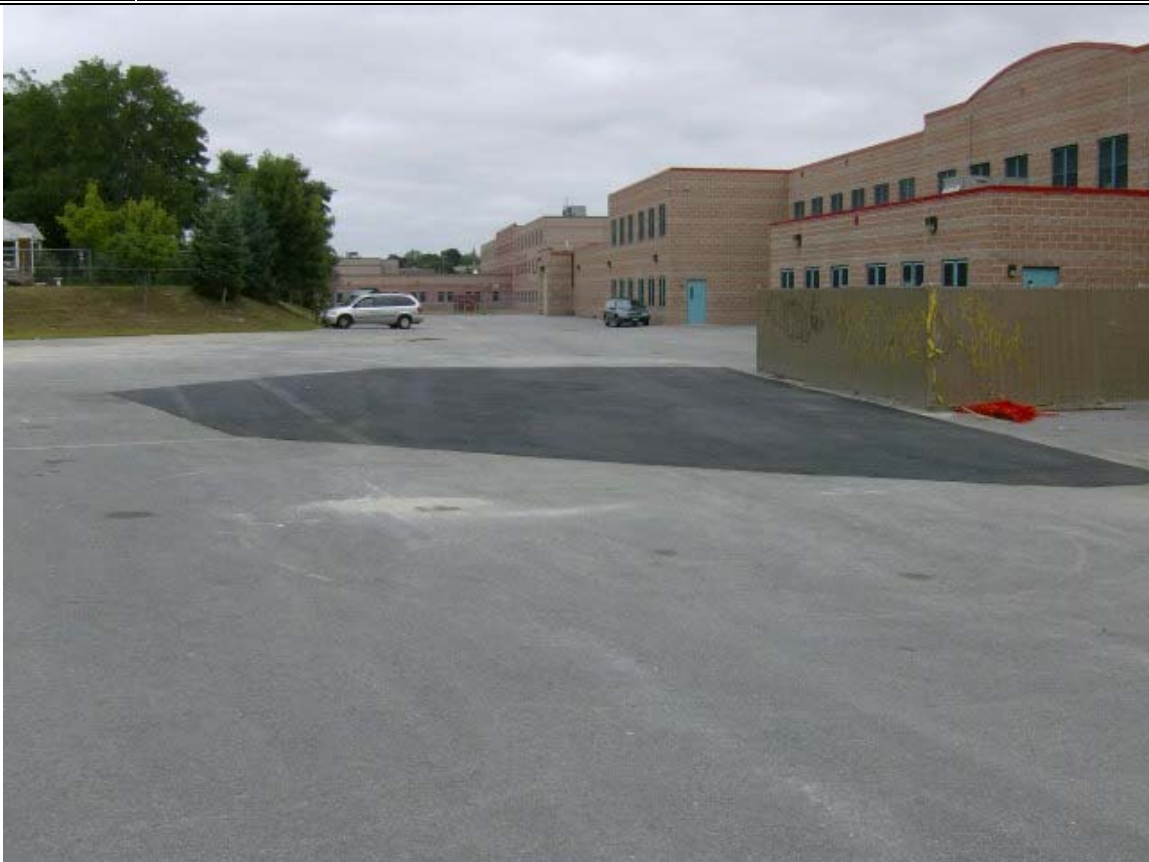
16

Elementary School after repairs completed (8/23/07).
