GZA PROJECT NO. 05.0043654.60

SUBJECT: River Sheen Impacts
Former Tidewater Facility
Pawtucket, Rhode Island

Approximate Extent of Visual Impact in River

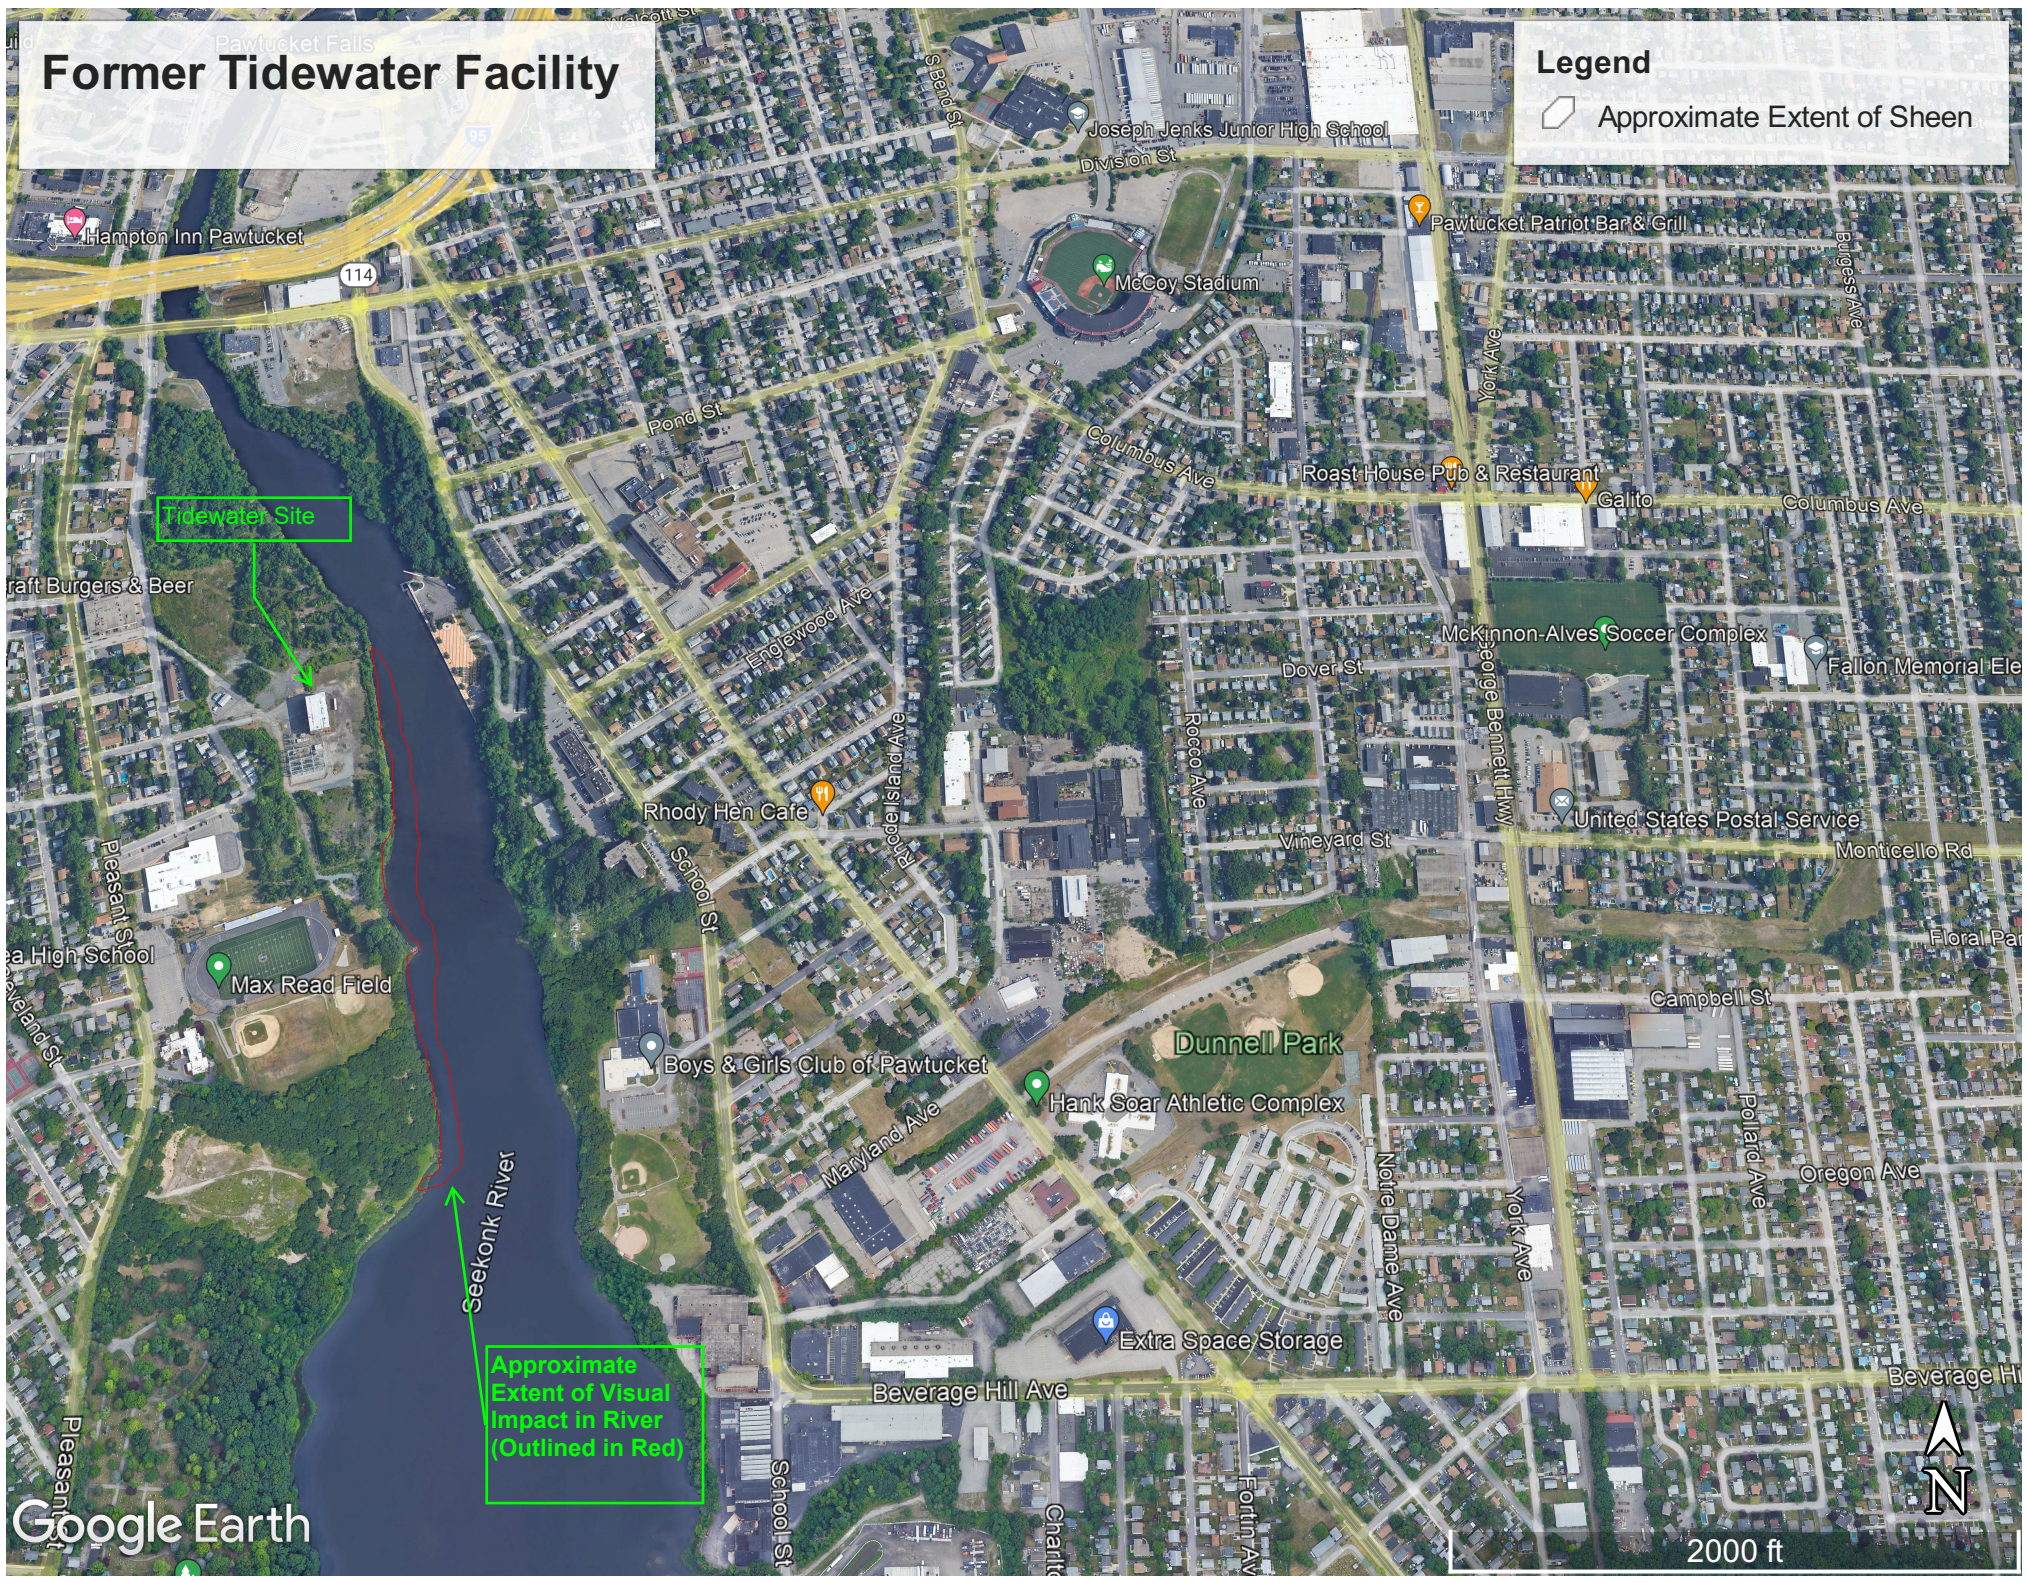
On December 1, 2021 at approximately 7:30 am, during regrading of the shoreline in the northern portion of the Site proximate to a riverbank cap that was previously installed in 2009, petroleum sheens breached the absorbent boom and turbidity curtain installed in the river. The breach resulted in the migration of a petroleum sheen extending approximately 2,200 feet downriver (south) of the active work area as shown on the attached figure. Based on observations made in the field on the day of the incident, the visual water impacts predominantly consisted of light-colored sheens. Although the amount of coal tar released from the soils/sediments being excavated is unknown, we have estimated that 2 to 20 gallons of weathered coal tar breached the absorbent boom and turbidity curtain based on the type of sheen observed and the area the sheen covered.

- Approximate Extent of Sheen

Upon identification of the breach, Charter discontinued work, notified the United States Coast Guard's National Response Center at 10:26 am, and immediately implemented corrective measures. TNEC also notified RIDEM of the breach at 09:53 am. Corrective measures implemented by Charter included:

- Deployment of additional absorbent booms directly downstream of the work area;
- Deployment of absorbent booms at the downriver end of the observed extent of impact (approximately 2,200 feet downriver of the work area);
- Recovery of the observed sheens on the surface of the water using absorbent booms dragged by work boats; and,
- Recovery of the observed sheens proximate to the shoreline using absorbent booms dragged between a work boat in the river and a laborer walking on the shoreline of the river.

- Additional absorbent boom and pads will be acquired and be available on Site for rapid deployment;
- An additional work/support boat will be mobilized to the Site and made available to support inspections, replacement of spent materials, and to respond to sheens within the containment boom as they occur; and
- The extent of disturbed/uncapped riverbank at any given time will be reduced to limit the potential migration of upland impacts to the river.
