REMEDIAL EVALUATION REPORT ADDENDUM

**Former Lincoln Lace & Braid Company and
Providence Turners of Rhode Island Properties
Providence, Rhode Island**

Revised
March 2003

FUSS & O'NEILL, INC.
PROVIDENCE, RHODE ISLAND

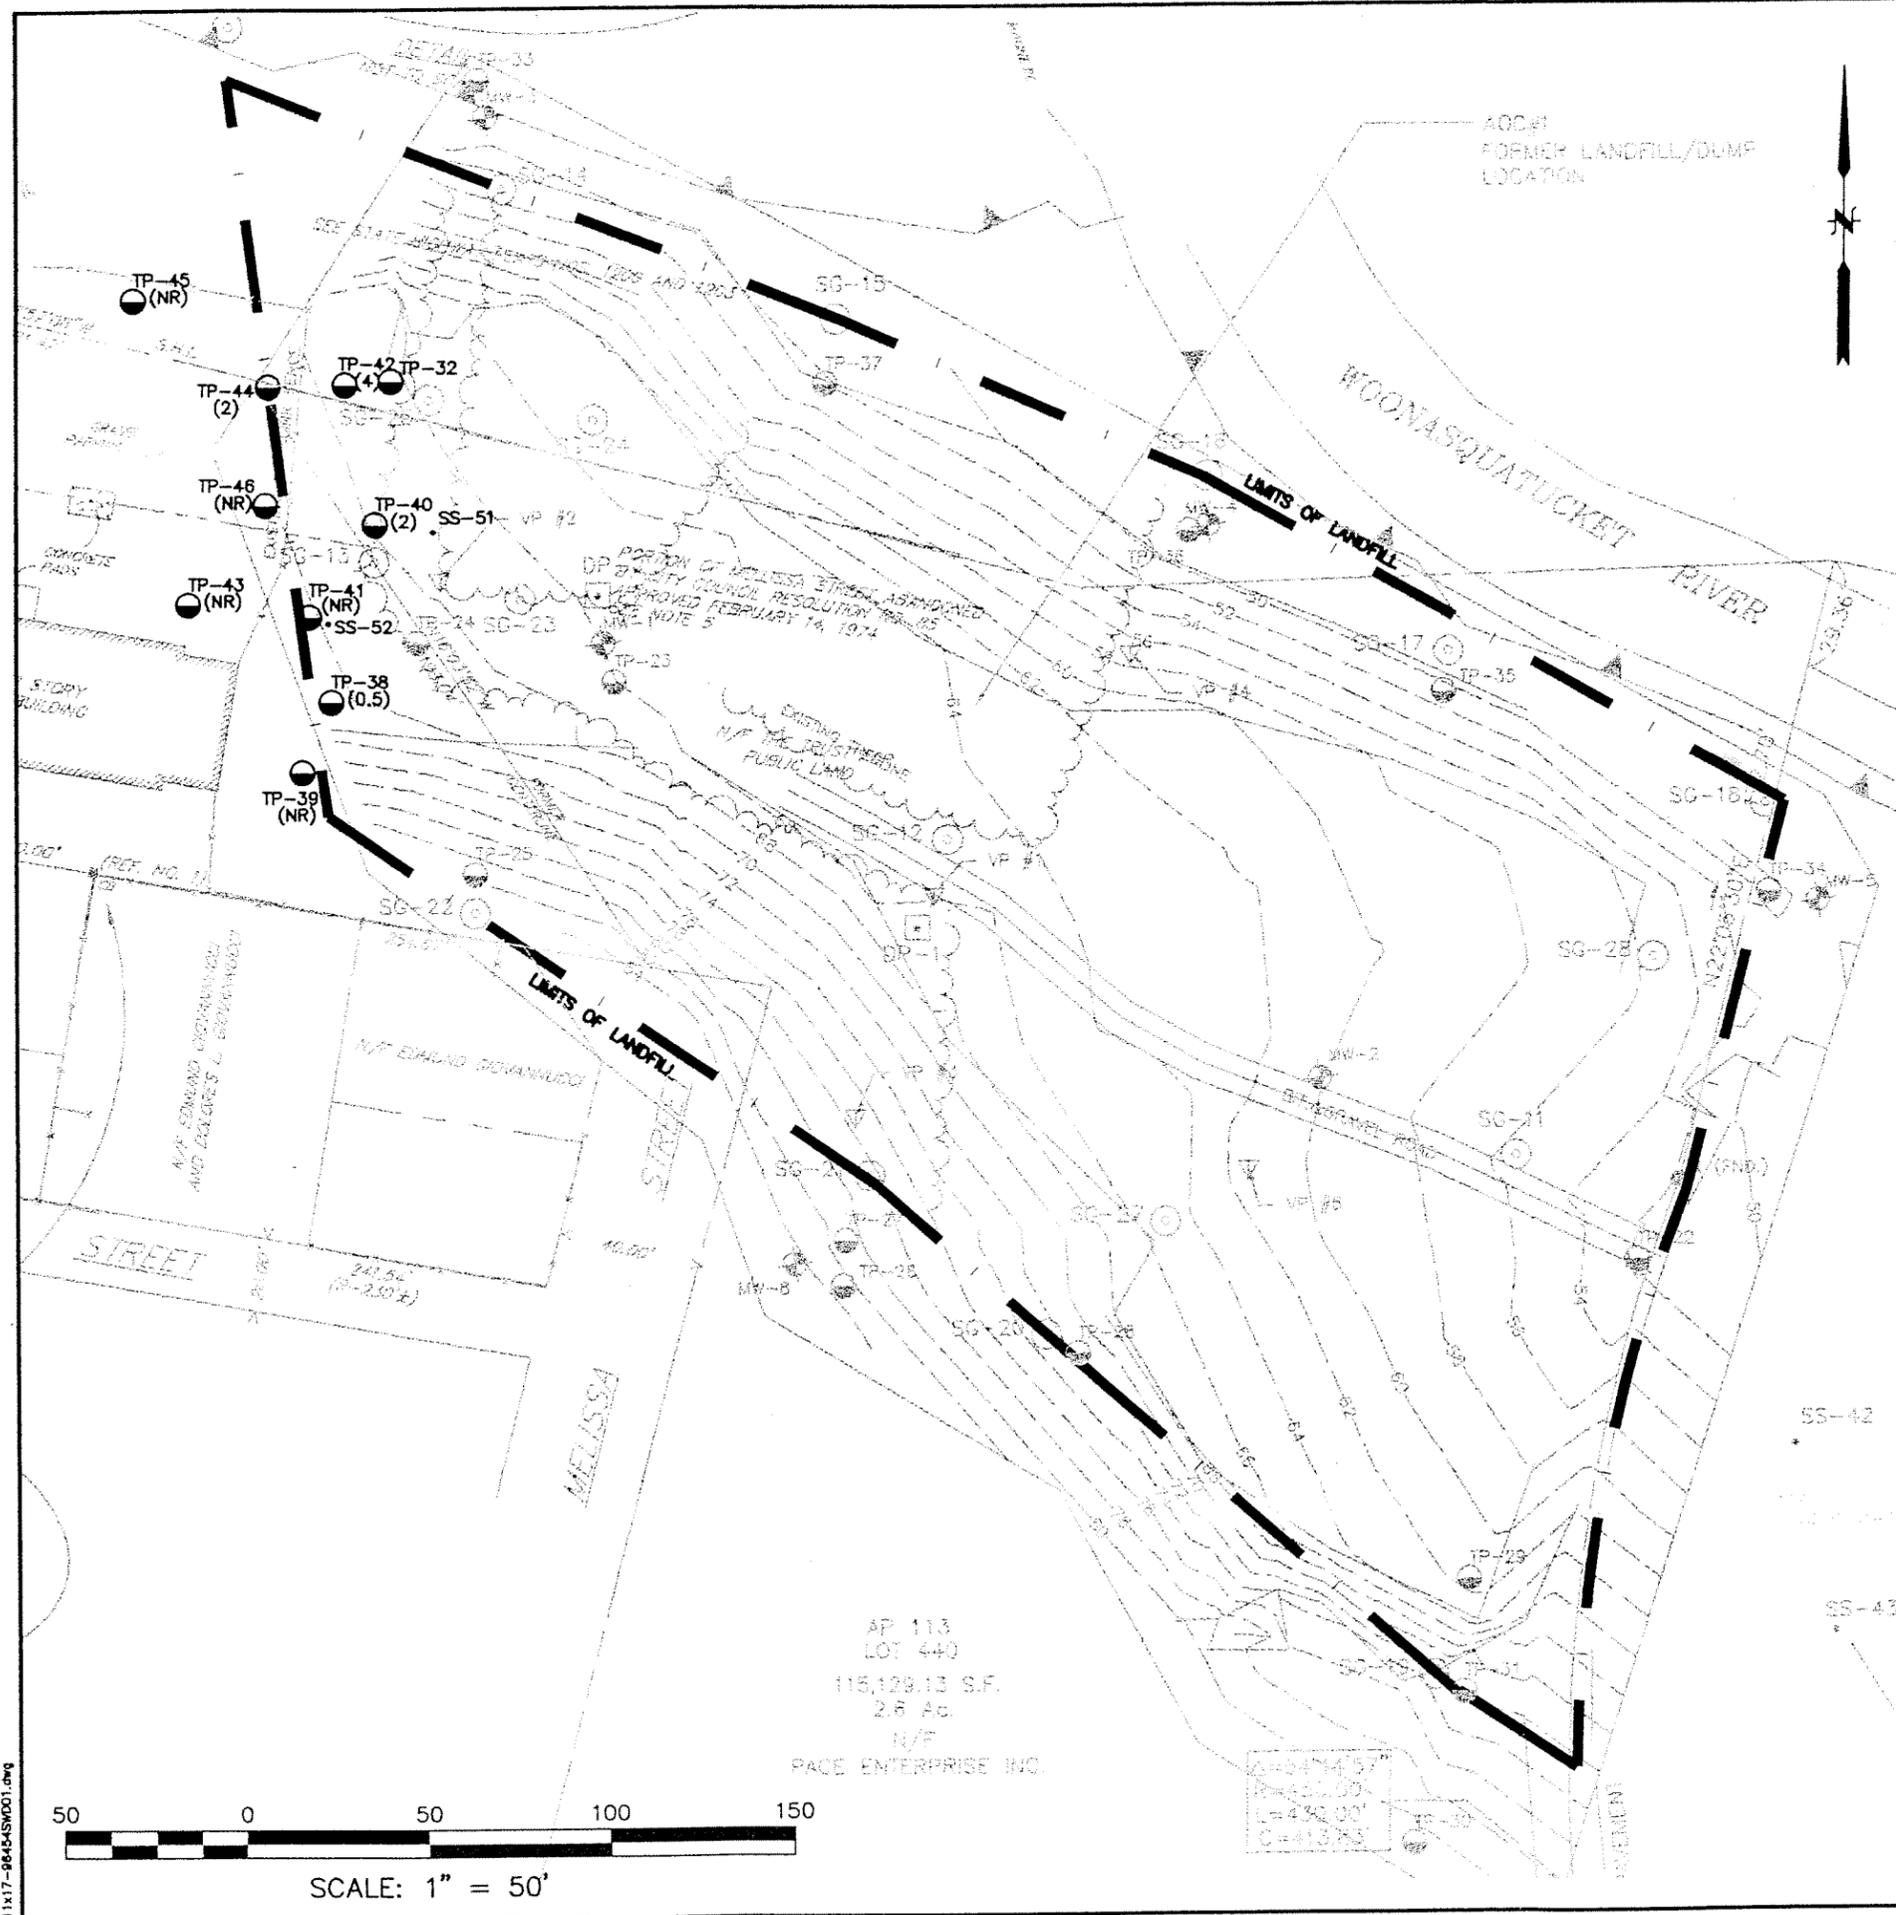
Based upon the observations collected during the test pit excavation, Fuss & O'Neill infers that the western edge of the former landfill is delineated as depicted on the attached site plan. For the purposes of this delineation, the edge of the landfill was assumed to coincide with the termination of the presence of refuse. Fill material was observed in test pits located

Specifically, four test pits, TP-39, TP-43, TP-46, and TP-45, were observed to be free of refuse, and refuse was observed to terminate within test pit TP-44. The locations of these test pits were used to generally demarcate the western extent of the former landfill.

Based upon the existing survey information of the Lincoln Lace site and the recently completed Class I Survey of the Turners Property, Fuss & O'Neill estimates the total size of the former landfill is approximately 2.1 acres. The observed limits of the landfill are depicted on Figure 2.

Subsequent to field activities, a Class I survey was performed on the subject site. Based on the Class I survey, and the existing survey information for the Lincoln Lace site, Fuss & O'Neill estimates the size of the entire former Lincoln Lace landfill is 2.1 acres (see [Figure 2](#)).

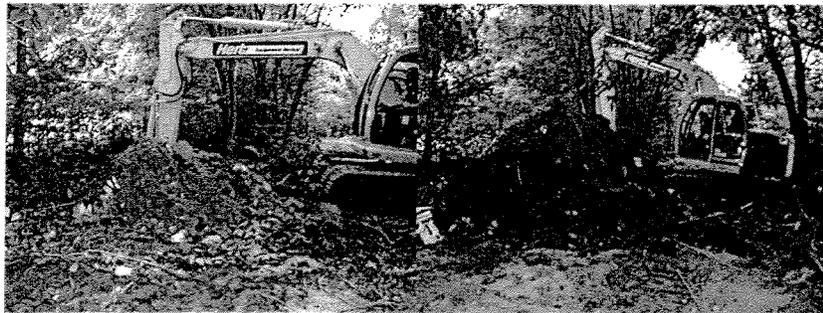
TPH: A slight exceedance of the R-DEC for TPH was detected in the soil sample collected from test pit TP-41 (513 mg/kg) at ten feet below grade. This soil sample was collected from within the refuse layer in this test pit. Asphalt and asphaltic shingles were observed in TP-41 and elevated levels of TPH (and SVOCs) detected in TP-41 may be attributable to the presence of asphalt and asphaltic shingles. All other soil samples contained TPH at concentrations less than the R-DEC.

TP-41

TP-42
