SAFER SEAS DIGEST

LESSONS LEARNED FROM MARINE ACCIDENT INVESTIGATIONS

2016

NATIONAL
TRANSPORTATION
SAFETY BOARD

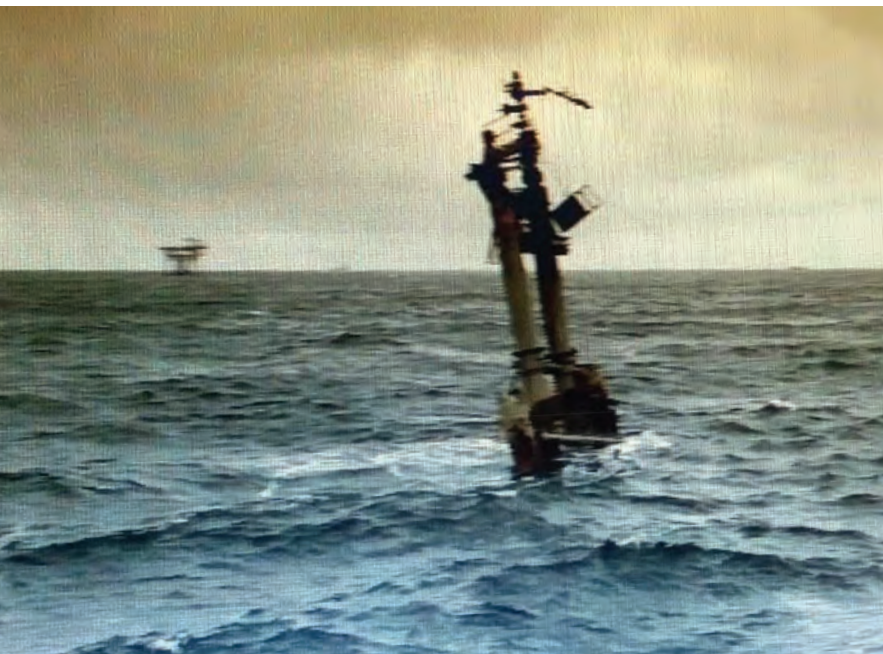
Figure 2: South Timbalier 271A platform after the allision and fire.

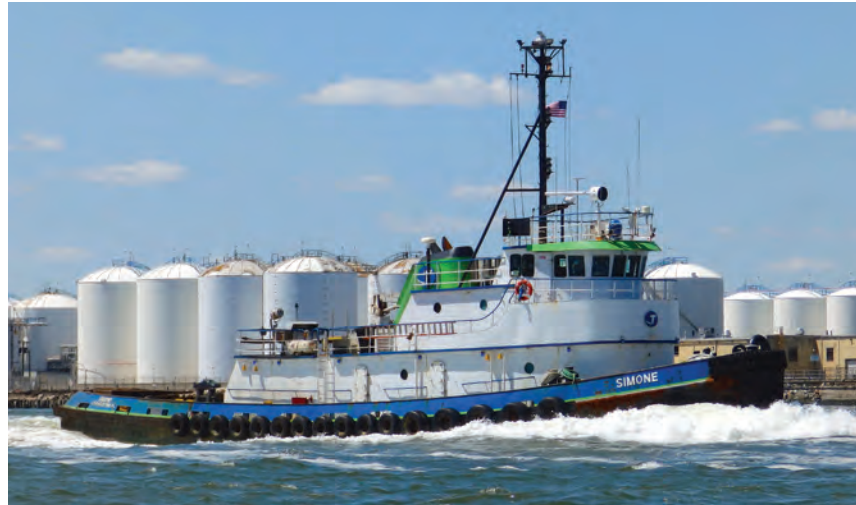
Figure 6: Tugboat *Simone* under way.

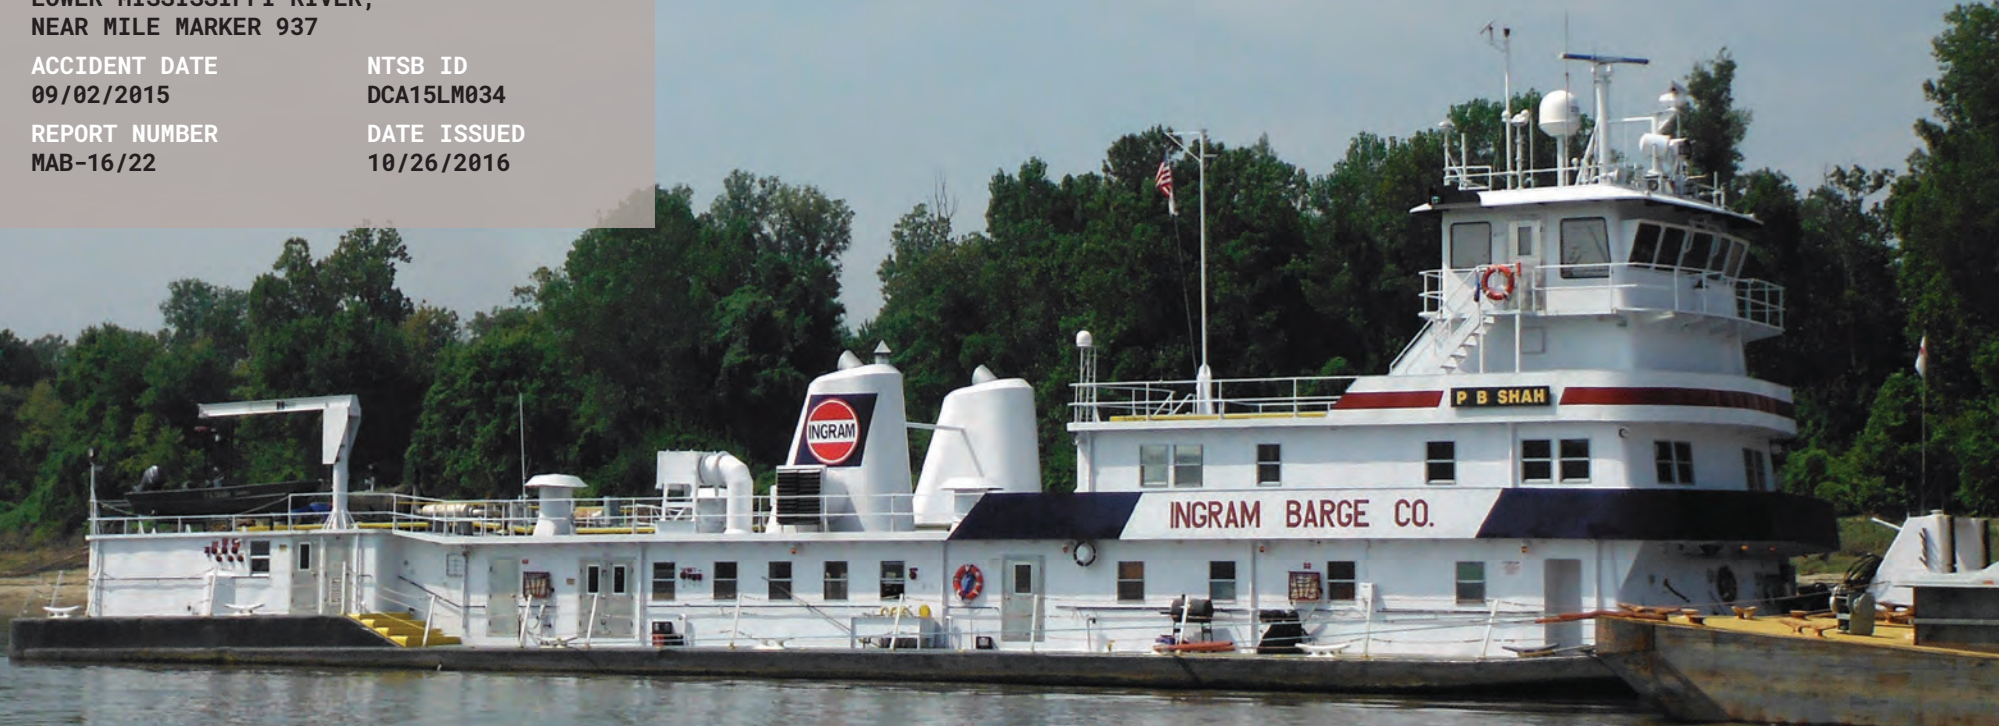
Figure 16: Towing vessel P. B. Shah.

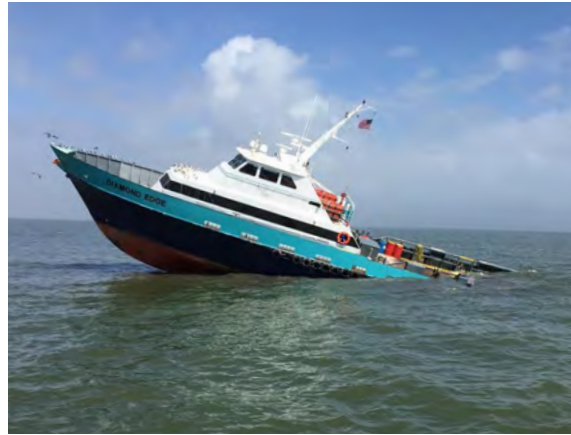
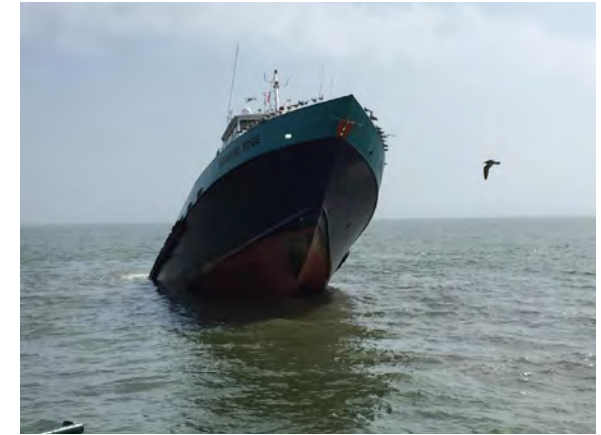
Figures 19–20: Partially submerged passenger vessel *Diamond Edge* following the collision. PHOTOS BY COAST GUARD

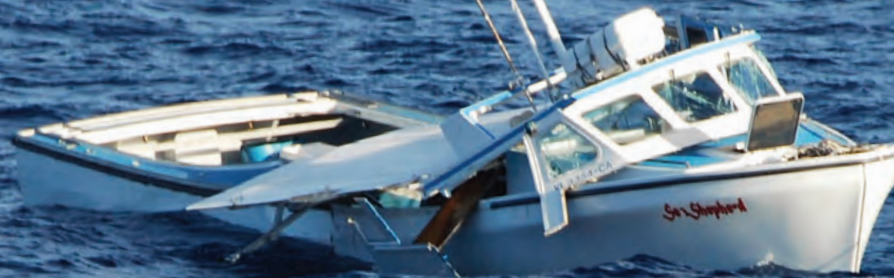
Figure 21: Fishing vessel
Sea Shepherd just after
the collision.

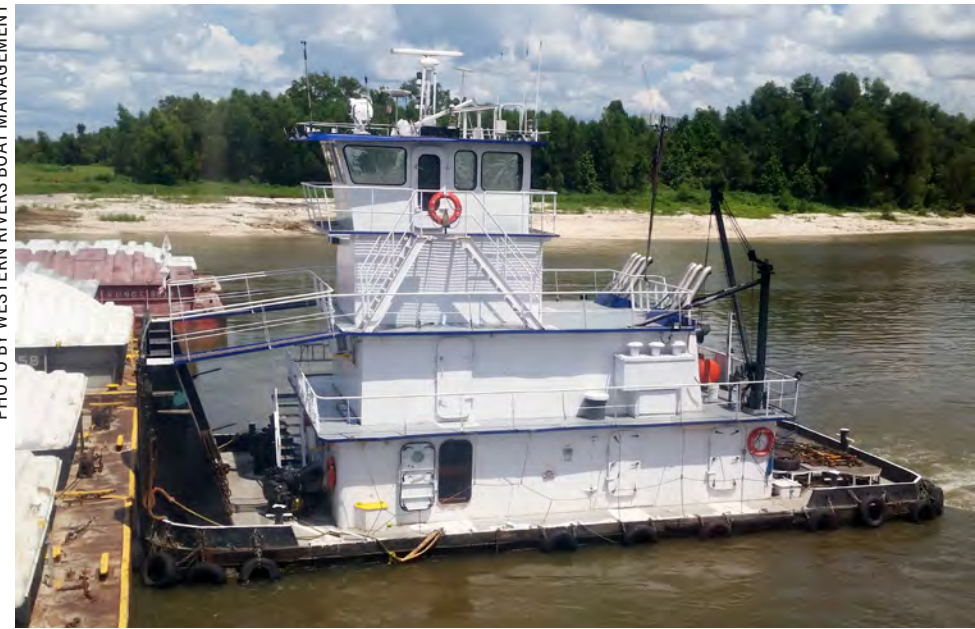
Figure 28: Towing vessel *Miss Natalie*.

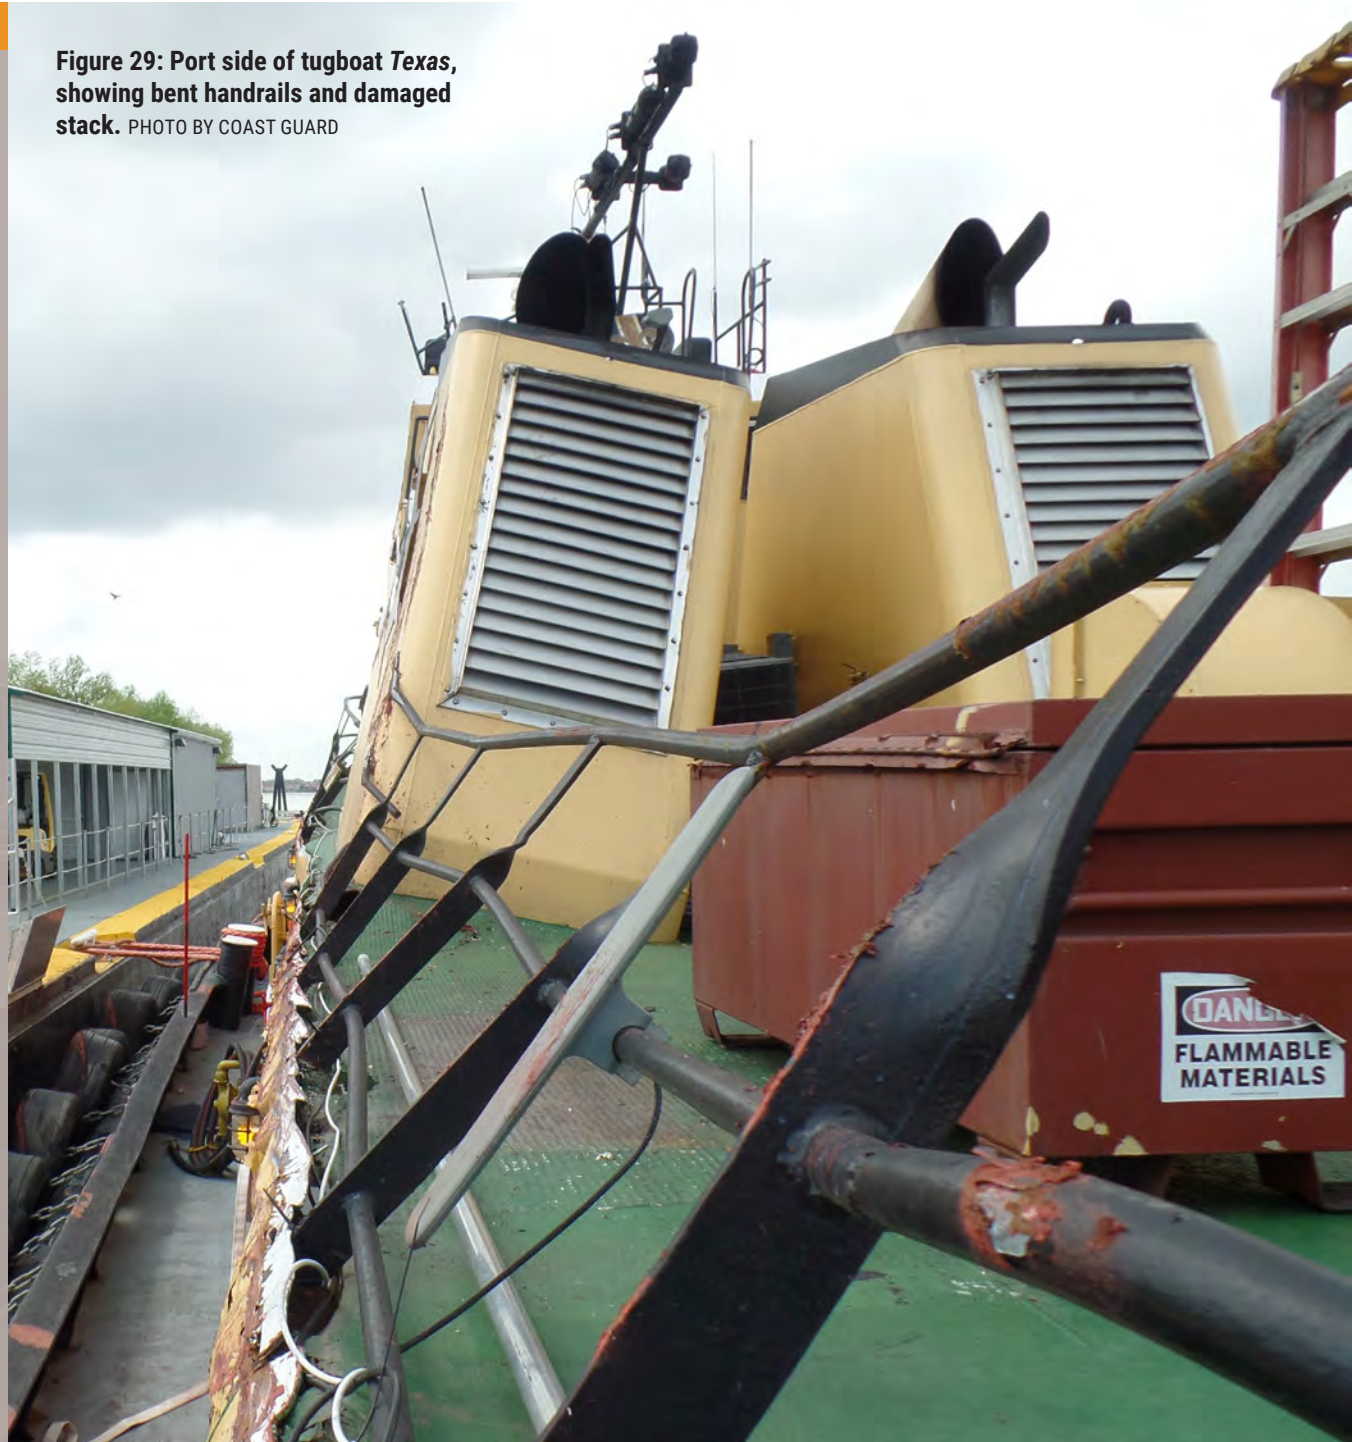
Figure 29: Port side of tugboat *Texas*, showing bent handrails and damaged stack. PHOTO BY COAST GUARD

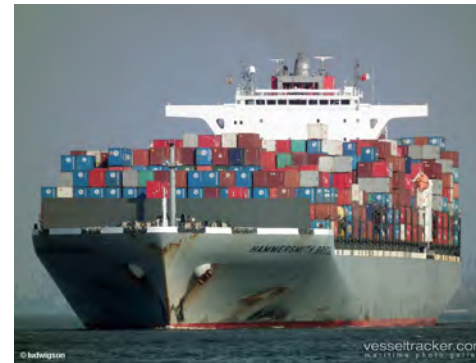
Figure 33: *Hammersmith Bridge* under way. PHOTO COURTESY OF R. LUDWIGSON

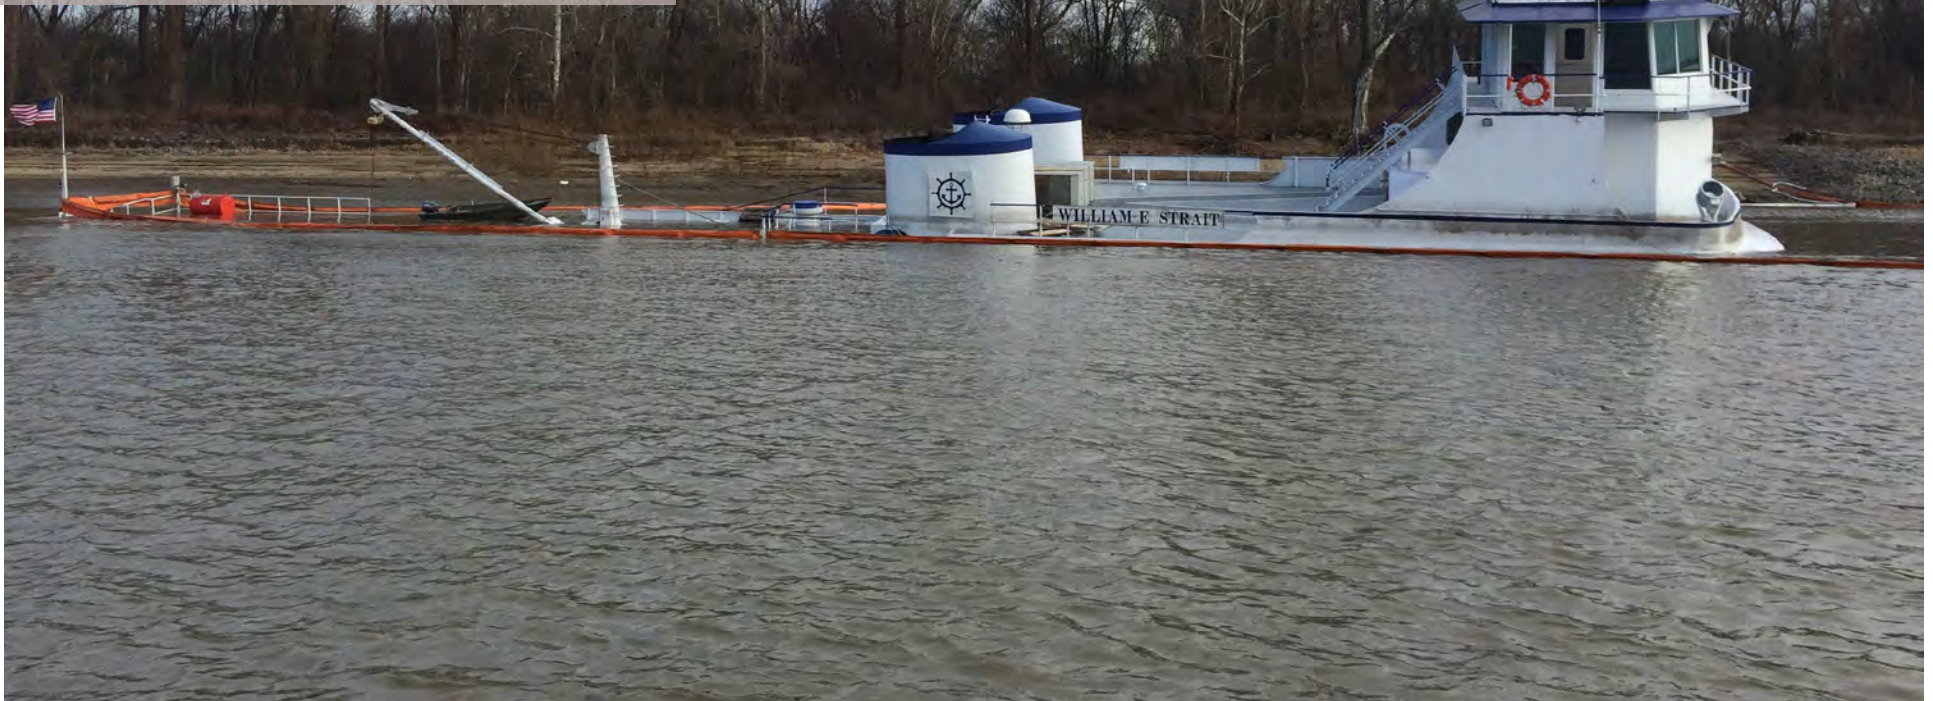
**Figure 34: Partially submerged towing vessel
William E Strait shortly after the collision.**

The *Margaret Ann*’s lead barge sustained a hull penetration and broke free from the tow string, while the second barge received damage to its bow and forward deck area. The *William E Strait* sustained a 6-foot by 5-foot opening in its hull, which allowed rapid flooding of the engine room. Additionally, the force of the collision pushed the port bow of the *William E Strait* into the last row of its tow flotilla, holing a stern void in one of its barges.

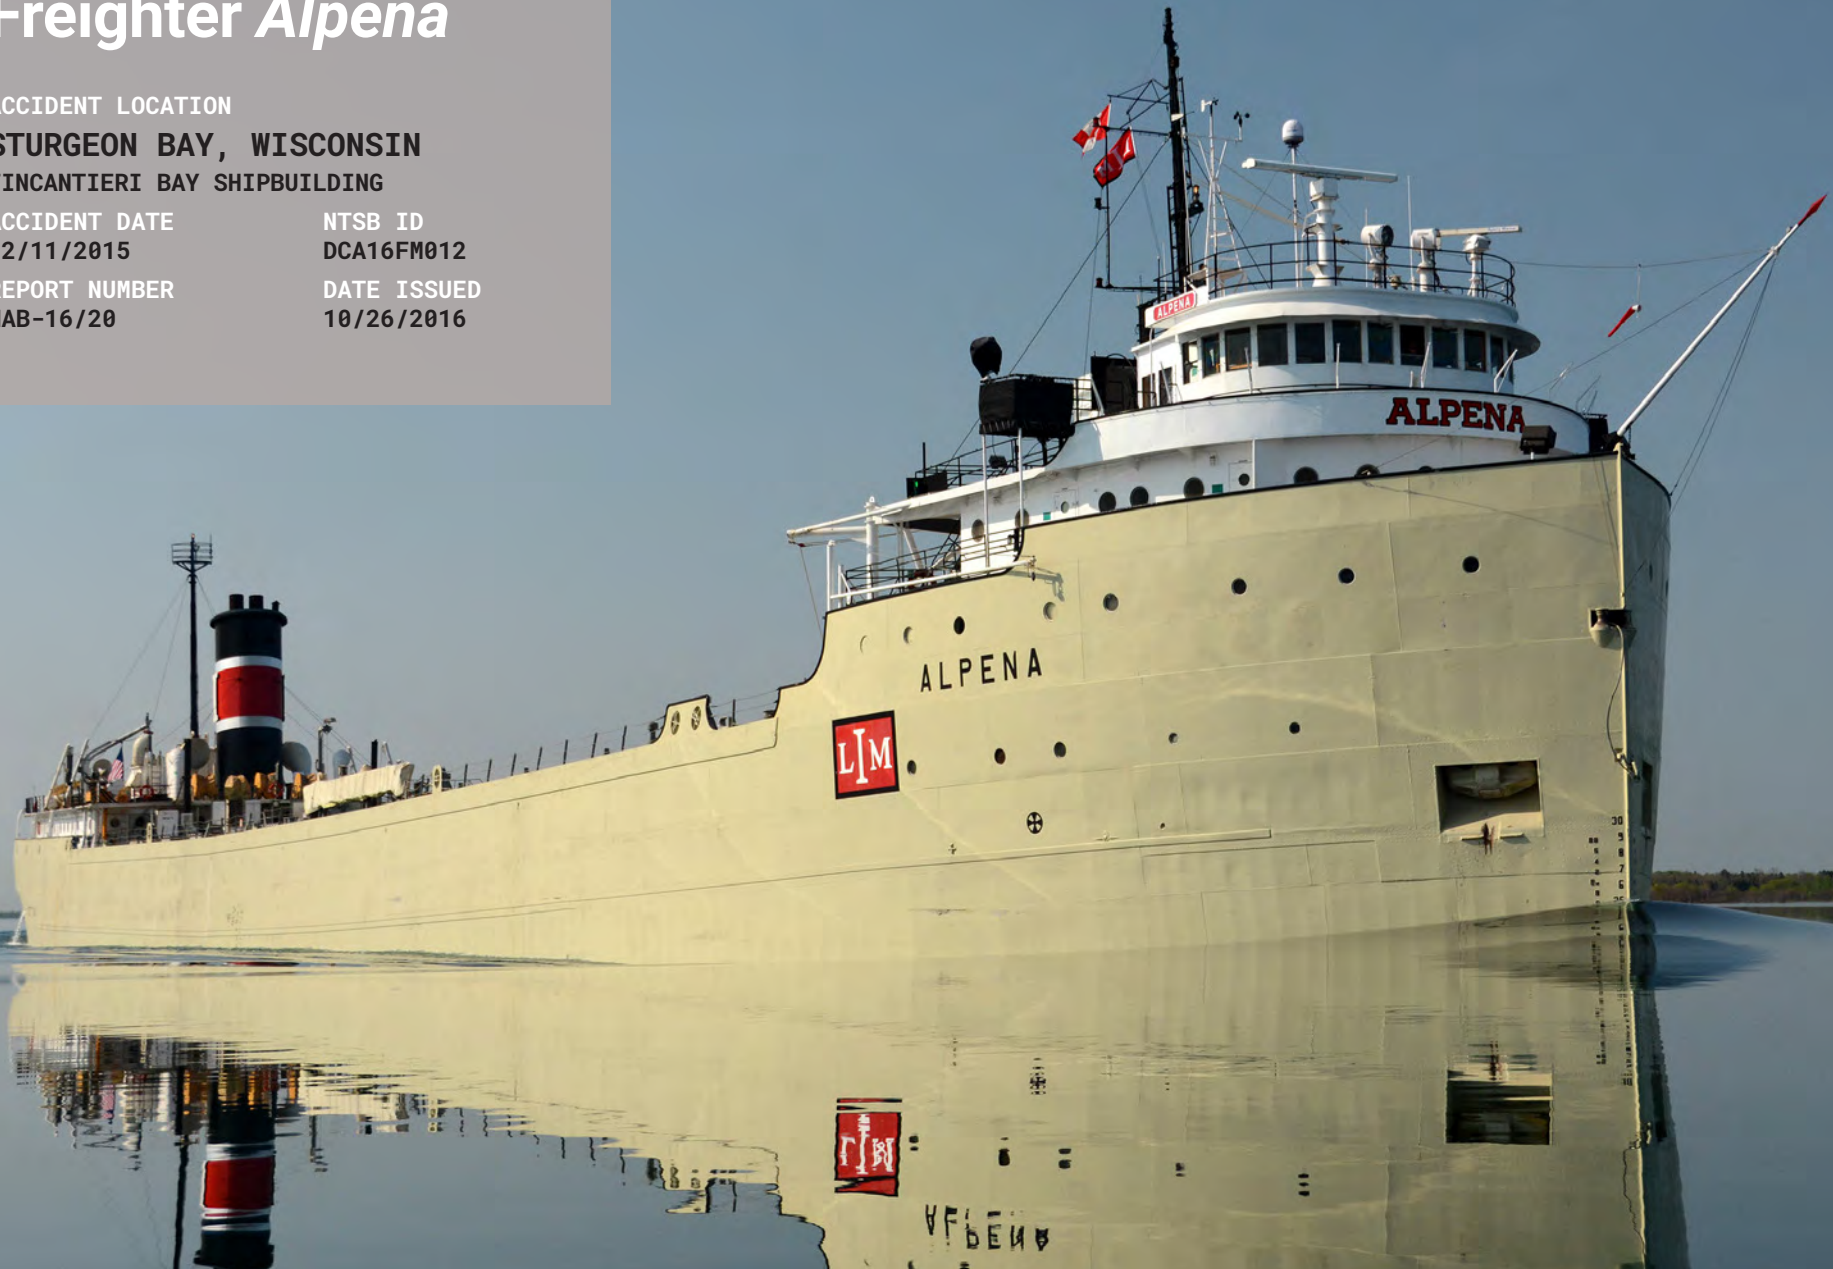
Figure 36: Freighter *Alpena* under way.
PHOTO COURTESY OF ROGER LELIEVRE

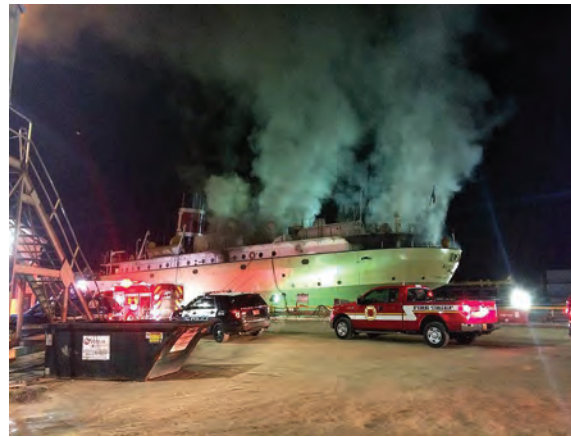
Figure 37: Shoreside fire department units responding to fire on board freighter *Alpena*.

Based on both the Coast Guard and the local fire department investigations, the most likely cause of the fire was an electrical fault in the wiring from the electrical control panel to the aft winch. The electrical system for the aft winch was original to the vessel and complied with regulations for original equipment; however, it did not have the more extensive circuit protection that modern shipboard electrical systems have. (According to the Coast Guard, planned postaccident modifications to

the *Alpena* would feature additional circuit protection in accordance with current regulations.) The power cable to the aft winch was completely melted for a length of 10–15 feet. Similar conductors in the same wiring bundle were not damaged, which led investigators to believe that this specific conductor experienced a fault of some kind rather than being destroyed by the heat of the ensuing fire. As further evidence to support this conclusion, the same cable's sheathing and insulation had signs of significant deterioration on the boat deck, several decks above where the fire started, where the aft winch was located. This area of the vessel was not affected by the fire.

■ The National Transportation Safety Board determined that the probable cause of the fire aboard the *Alpena* was a fault in the electrical wiring providing power to the aft anchor winch.

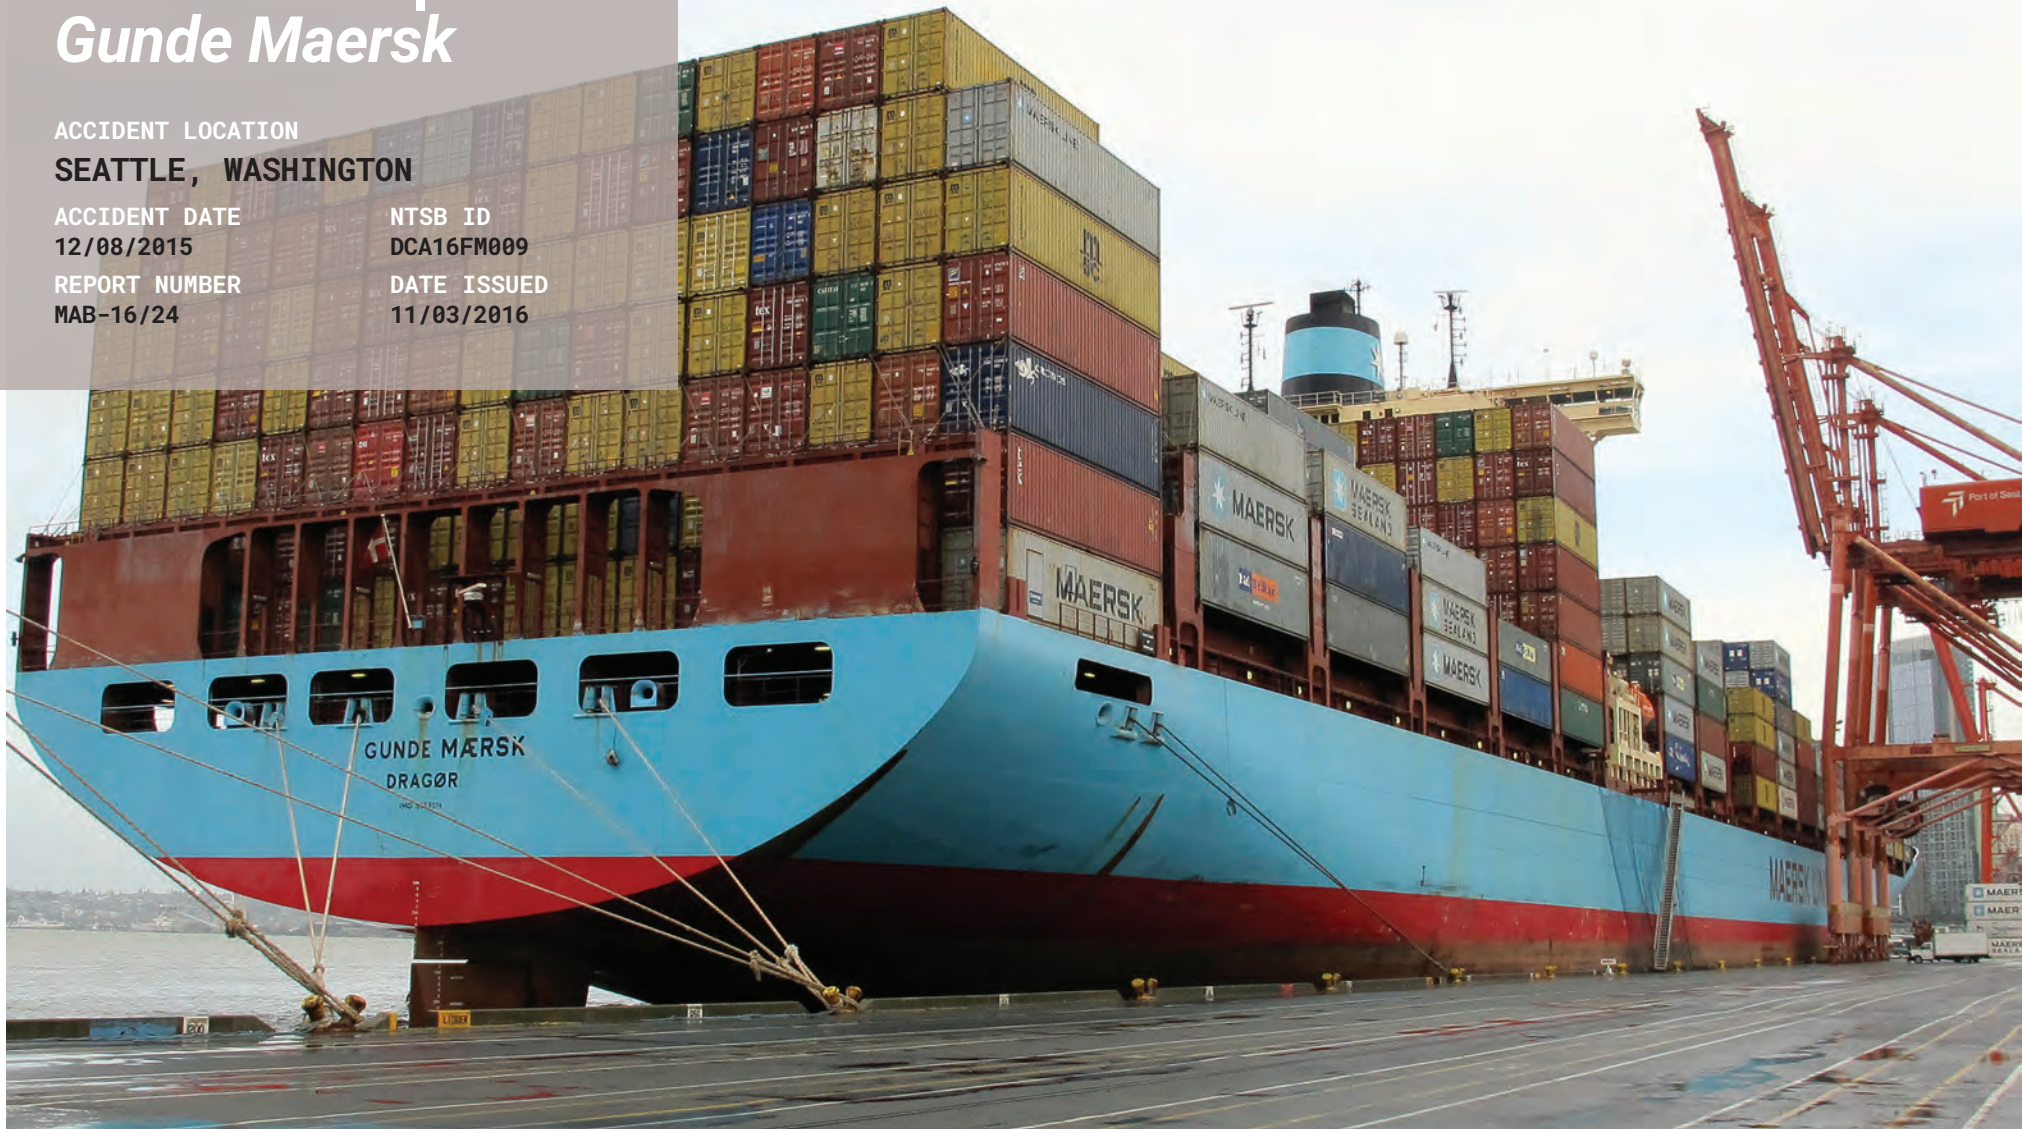
Figure 38: Containership *Gunde Maersk* berthed in Seattle, Washington, two days after the fire.

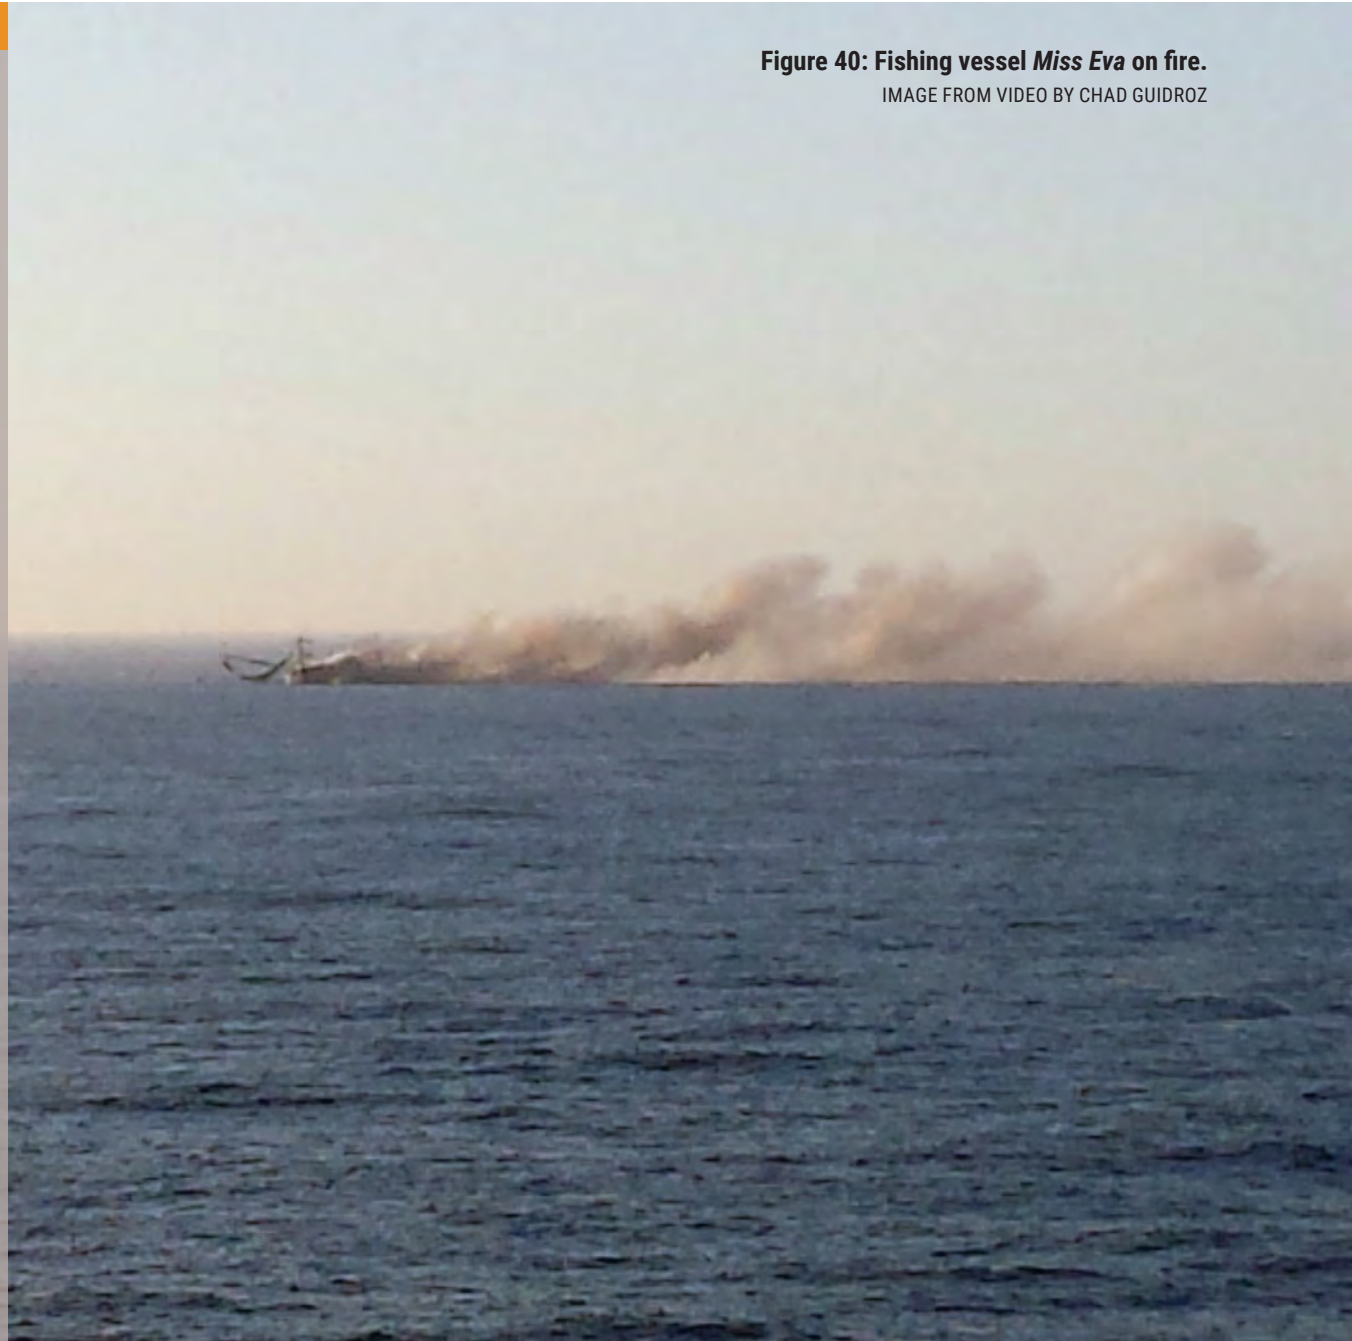
ACCIDENT DATE**12/01/2014****REPORT NUMBER****MAB-16/01****NTSB ID****DCA15LM005****DATE ISSUED****01/14/2016****Figure 40: Fishing vessel *Miss Eva* on fire.**

About 4–6 hours after the fire started, the *Miss Eva* sank. Because of the sinking, investigators could not conduct an inspection of the vessel and were unable to determine the source of the fire in the engine room.

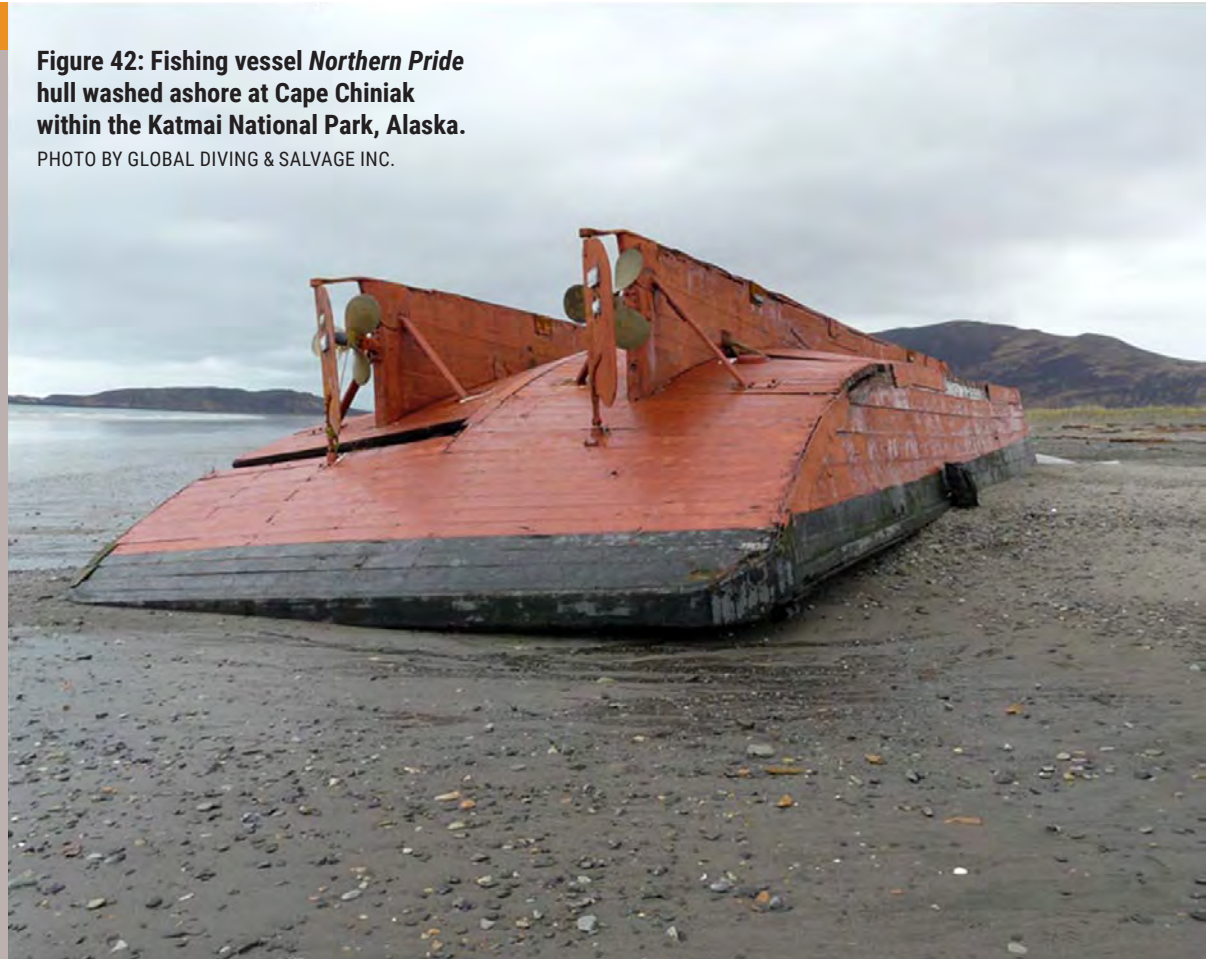
Figure 42: Fishing vessel *Northern Pride* hull washed ashore at Cape Chiniak within the Katmai National Park, Alaska.

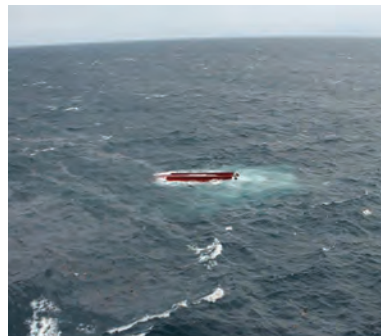
**Figure 43:
Fishing vessel *Northern Pride*
adrift after capsizing.**

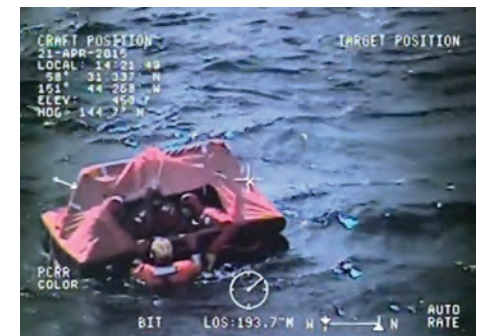
**Figure 44:
Coast Guard rescue
of the fishing vessel
Northern Pride's crew.**

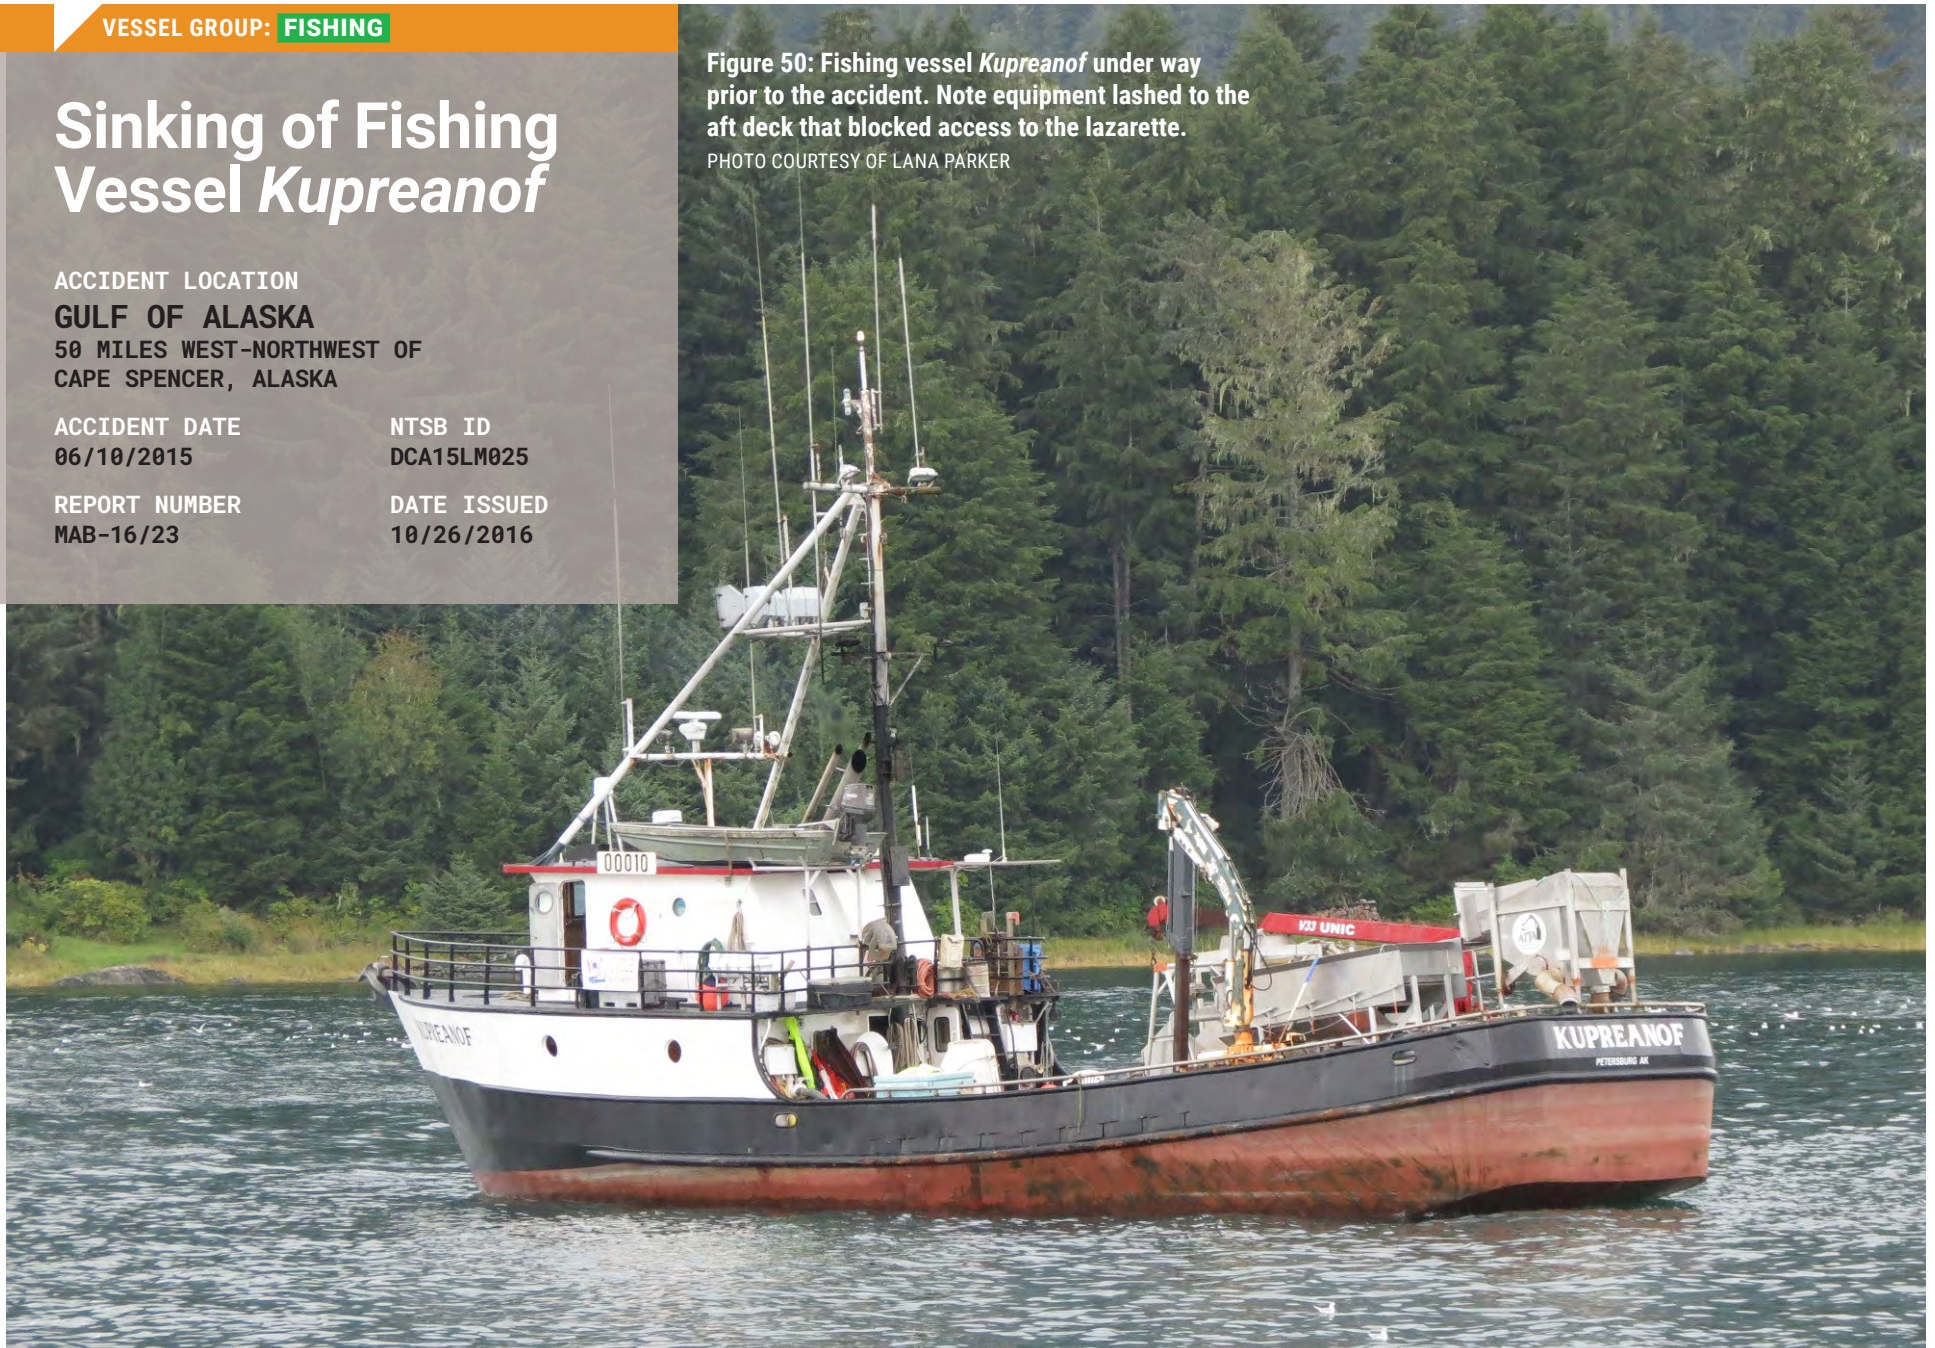
Figure 50: Fishing vessel *Kupreanof* under way prior to the accident. Note equipment lashed to the aft deck that blocked access to the lazarette.

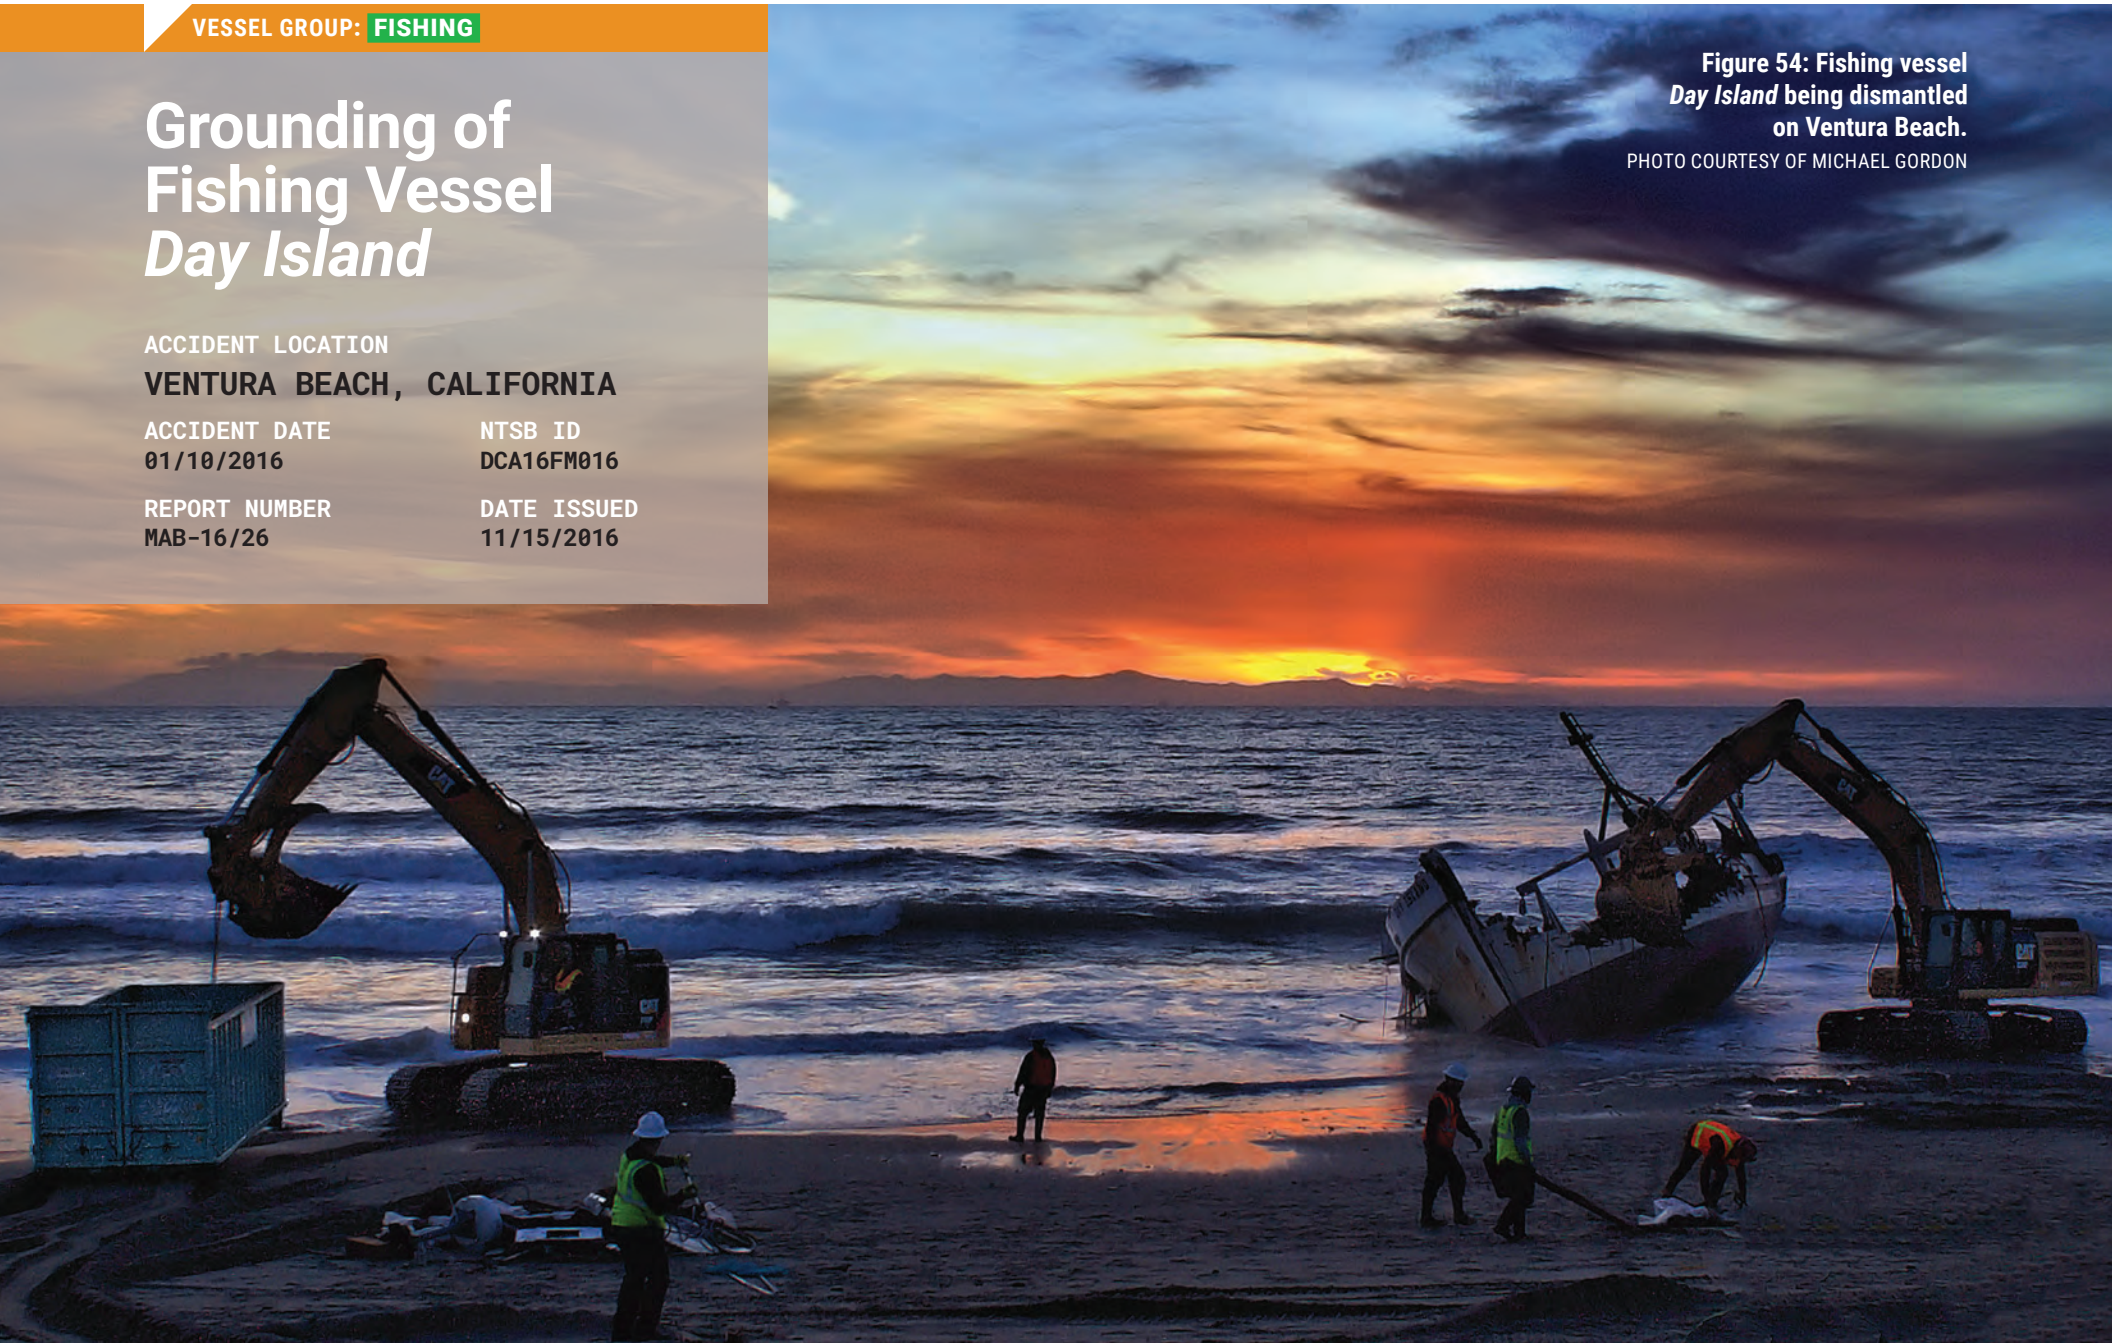
**Figure 54: Fishing vessel
Day Island being dismantled
on Ventura Beach.**

The owner of the *Day Island* was unable to cover the cost of removing the vessel from the beach after the accident. Consequently, he transferred ownership to the state, which then arranged to have the vessel dismantled and removed in pieces in order to reduce environmental damage.
