SAFER SEAS DIGEST

LESSONS LEARNED FROM MARINE ACCIDENT INVESTIGATIONS

2016

NATIONAL
TRANSPORTATION
SAFETY BOARD

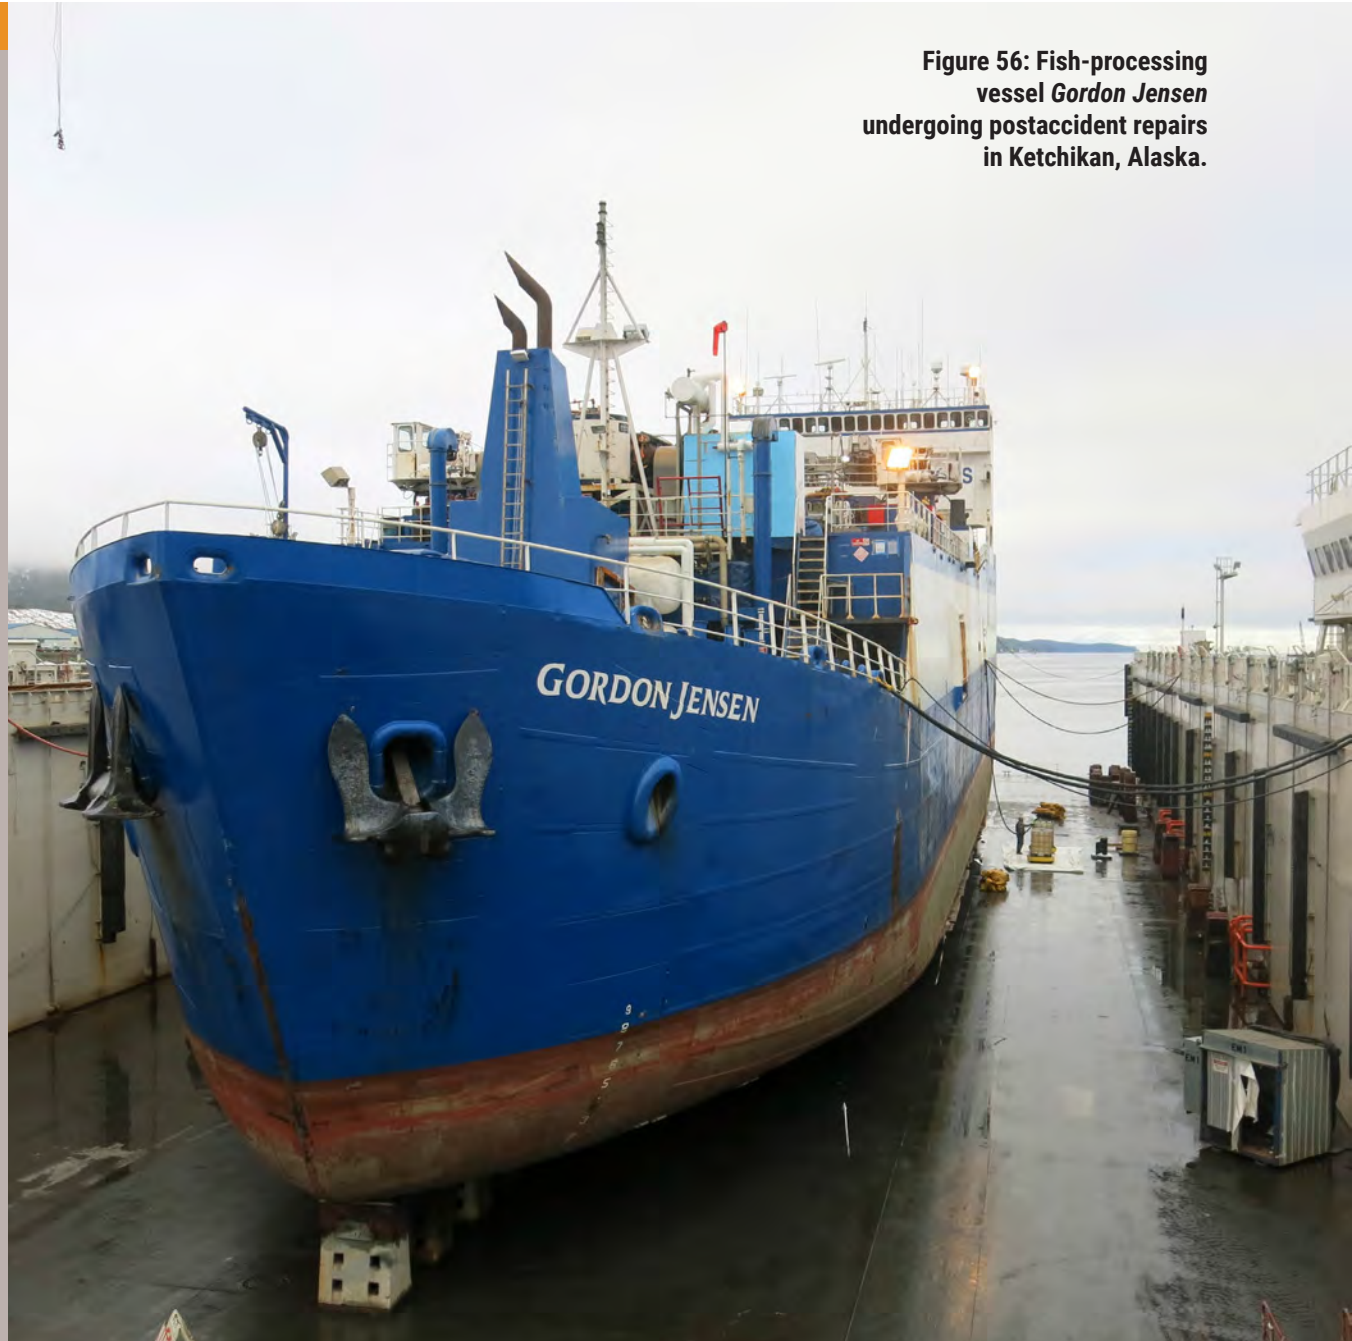
Figure 56: Fish-processing vessel *Gordon Jensen* undergoing postaccident repairs in Ketchikan, Alaska.

■ The National Transportation Safety Board determined that the probable cause of the grounding of fish-processing vessel *Gordon Jensen* was the combined effects of prescription pain medication, over-the-counter cold medication, alcohol, and sleep deprivation, which led to the master's impaired cognitive performance, preventing him from recognizing that he could not effectively perform the duties and responsibilities of master.

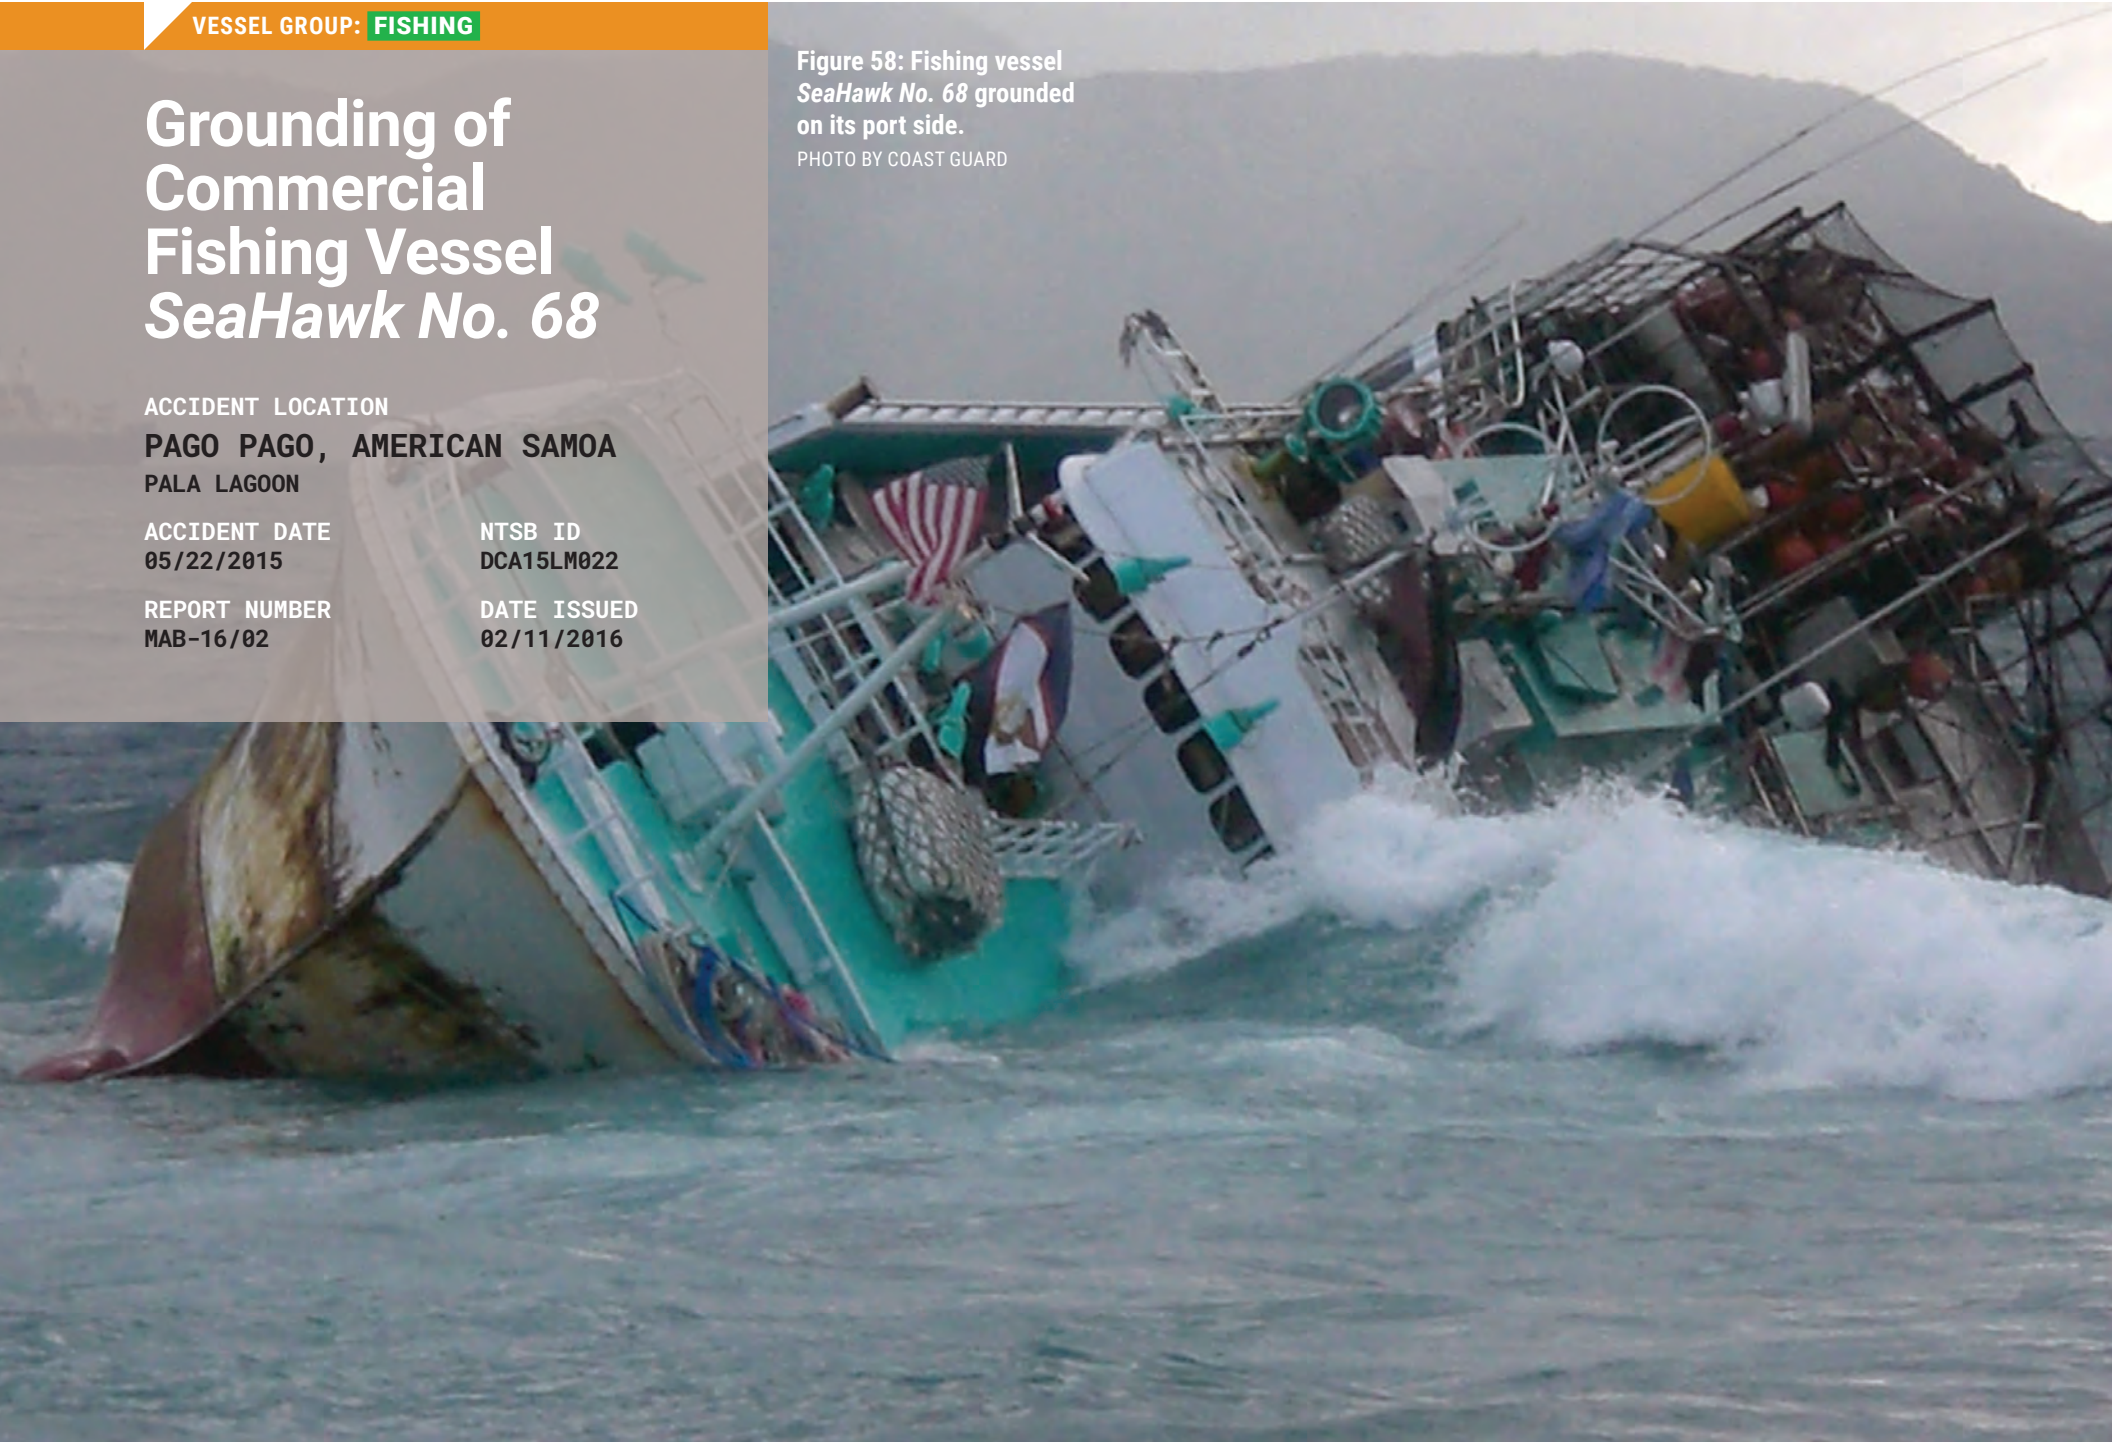
Figure 58: Fishing vessel
SeaHawk No. 68 grounded
on its port side.

At 0520, there was "panic" in the wheelhouse, according to one crewmember, when a large wave came from behind pushing the vessel forward toward a reef. The captain returned to the wheelhouse and attempted to put the engine astern, but the vessel had grounded. The *SeaHawk No. 68* then rolled to its port side. The crew prepared to abandon ship, but had to locate a knife to

■ The National Transportation Safety Board determined that the probable cause of the grounding of the commercial fishing vessel *SeaHawk No. 68* was the captain's failure to effectively monitor the vessel's position and progress as well as provide specific watchstanding instructions. Contributing to this accident was the owner/operator's lack of policies and procedures for navigation and training of vessel crewmembers.

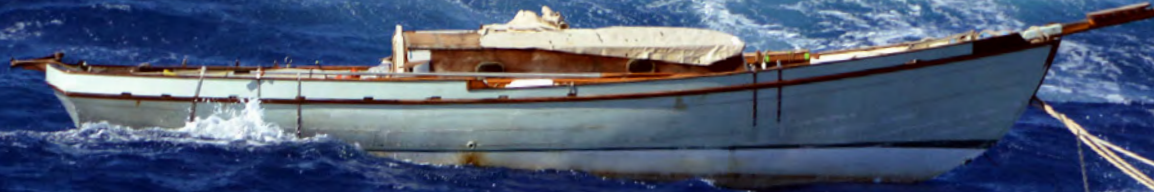
Figure 60: Sailing vessel *Kolina* adrift during Coast Guard search and rescue operations. PHOTO BY COAST GUARD

On November 5, 2015, about 1551 local time, the captain of the recreational sailing vessel *Kolina* radioed US Coast Guard Station Maui (Hawaii) via VHF radio to report that he was adrift in the Alenuihaha Channel between the islands of Hawaii and Maui. He said the vessel's tiller had snapped and he had only a mizzenmast with a trysail for propulsion.
